MINERALS PROGRAM INSPECTION REPORT

MINE NAME: Golddigger I	MINE/PROSPECTING ID#: P-2009-007	MINERAL: Gold	COUNTY: Park
INSPECTION TYPE: Monitoring	WEATHER: Cloudy	INSP. DATE: September 14, 2022	INSP. TIME: 08:00
OPERATOR: Chris Garrison	OPERATOR REPRESENTATIVE: None	TYPE OF OPERATION: MP - Mineral Prospecting	
REASON FOR INSPECTION: Normal I&E Program	BOND CALCULATION TYPE: Partial Bond	BOND AMOUNT: \$4,307.29	
DATE OF COMPLAINT: NA	POST INSP. CONTACTS: U.S. Forest Service	JOINT INSP. AGENCY: None	
INSPECTOR(S): Elliott Russell	INSPECTOR'S SIGNATURE:

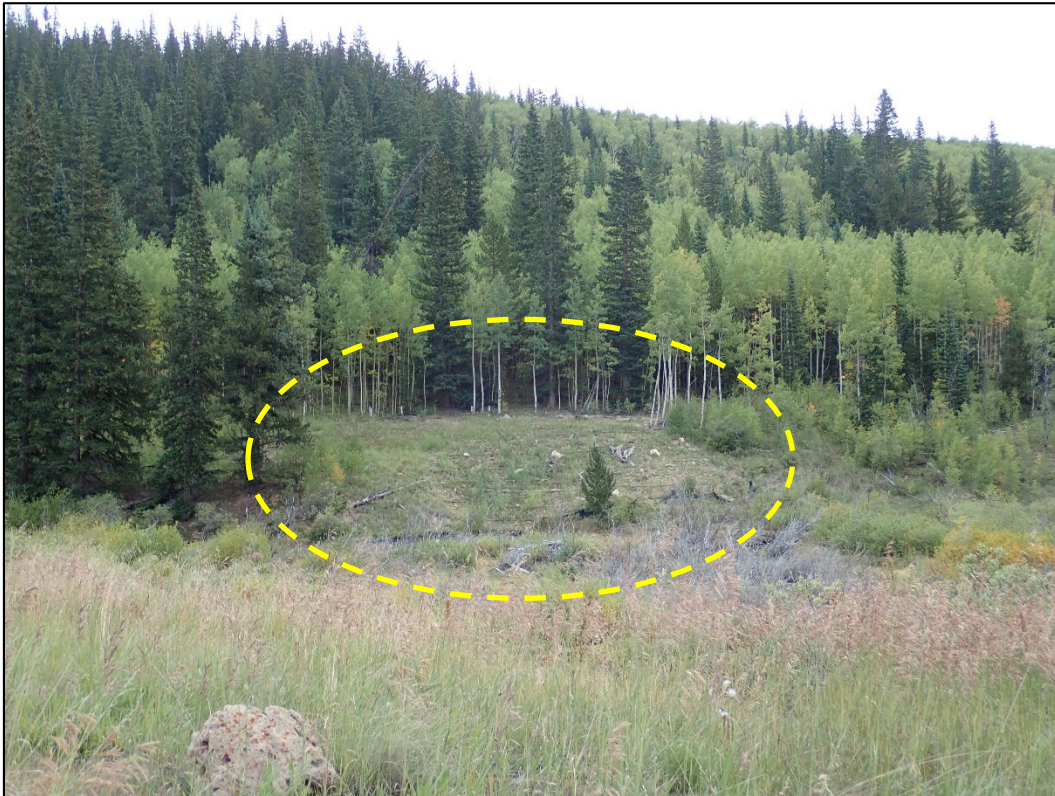
Photo 1. Site overview from FS 659; looking east.

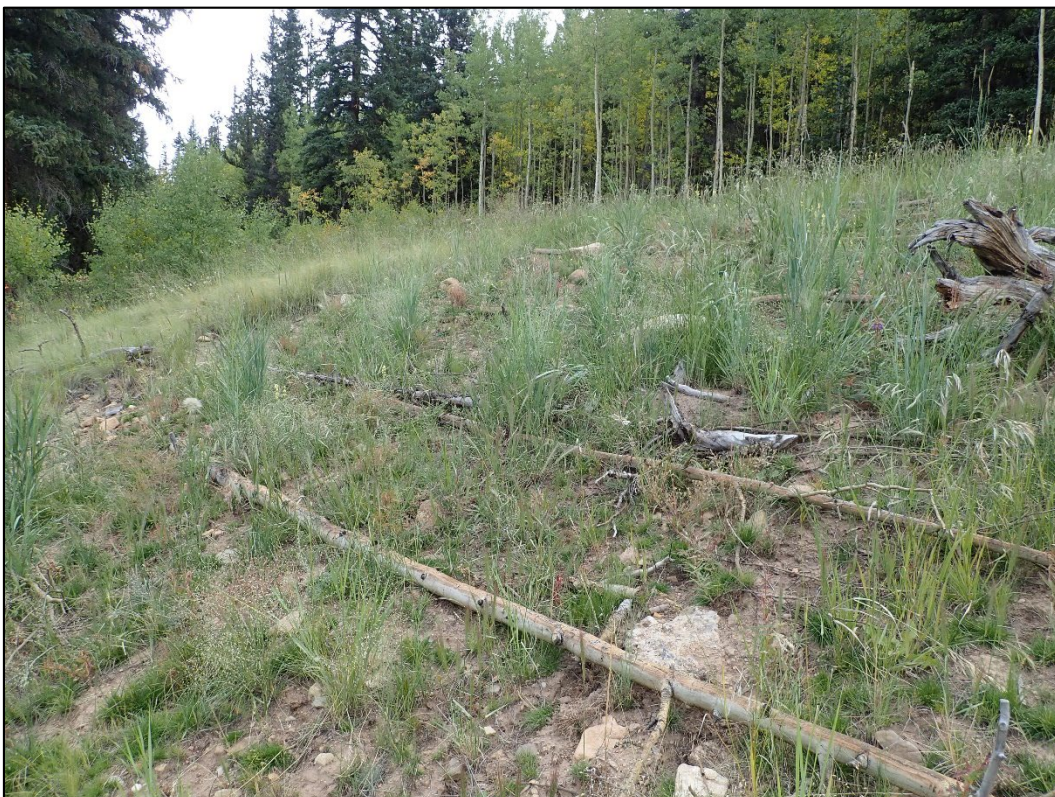
Revegetation: The disturbance area had topsoil replaced and had been seeded with approved reclamation seed mix. The vegetative cover reestablished on the disturbance areas matches adjacent off-site areas. No noxious weed infestations were observed on the revegetated disturbances.

Photo 2. Revegetated disturbance area; looking north.

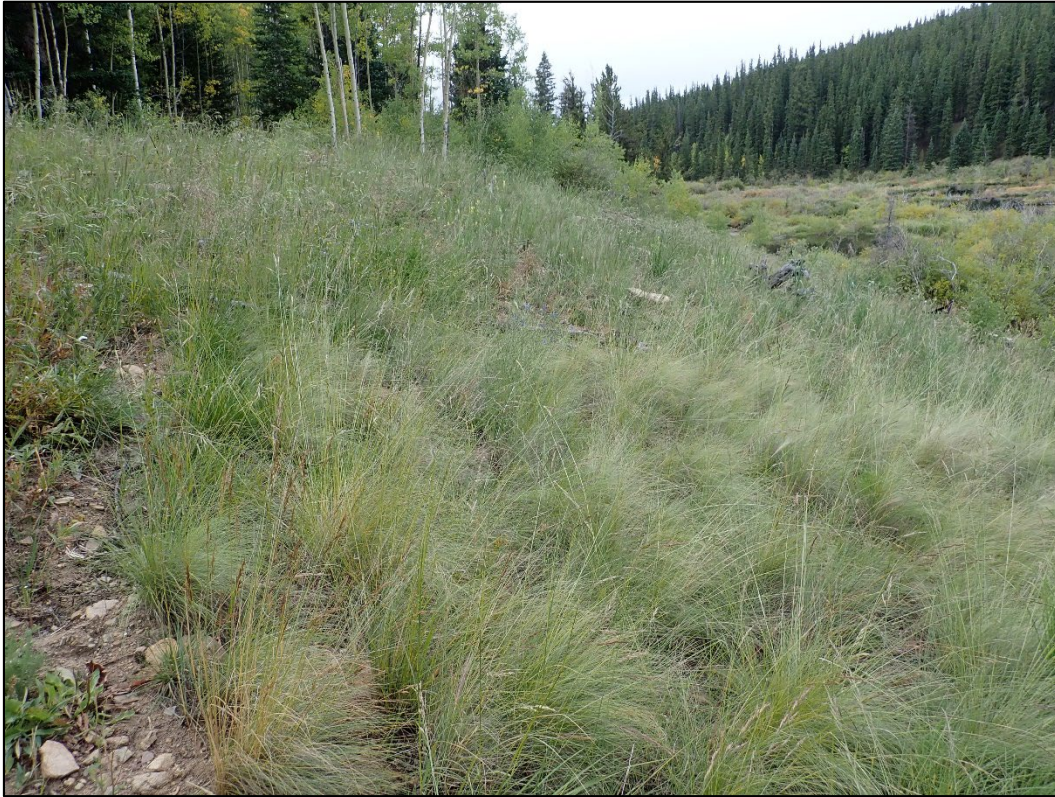
Photo 3. Revegetated disturbance area; looking south.

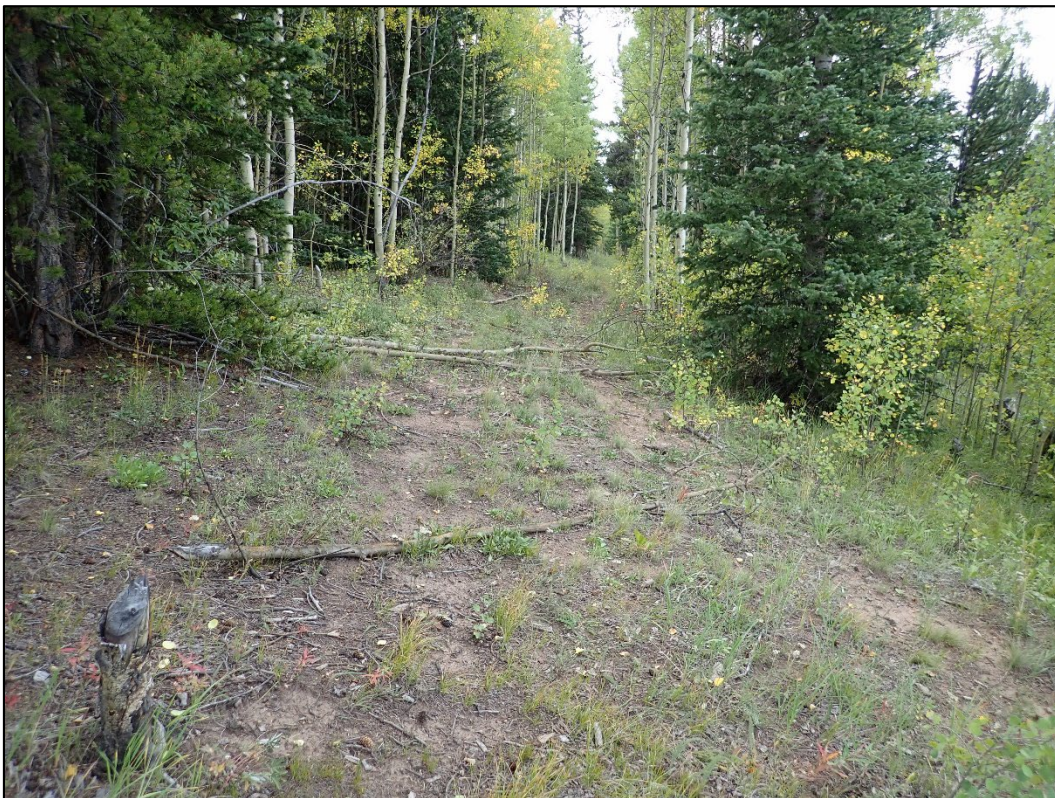
Photo 4. Reclaimed access road along the east side of Beaver creek; looking south.

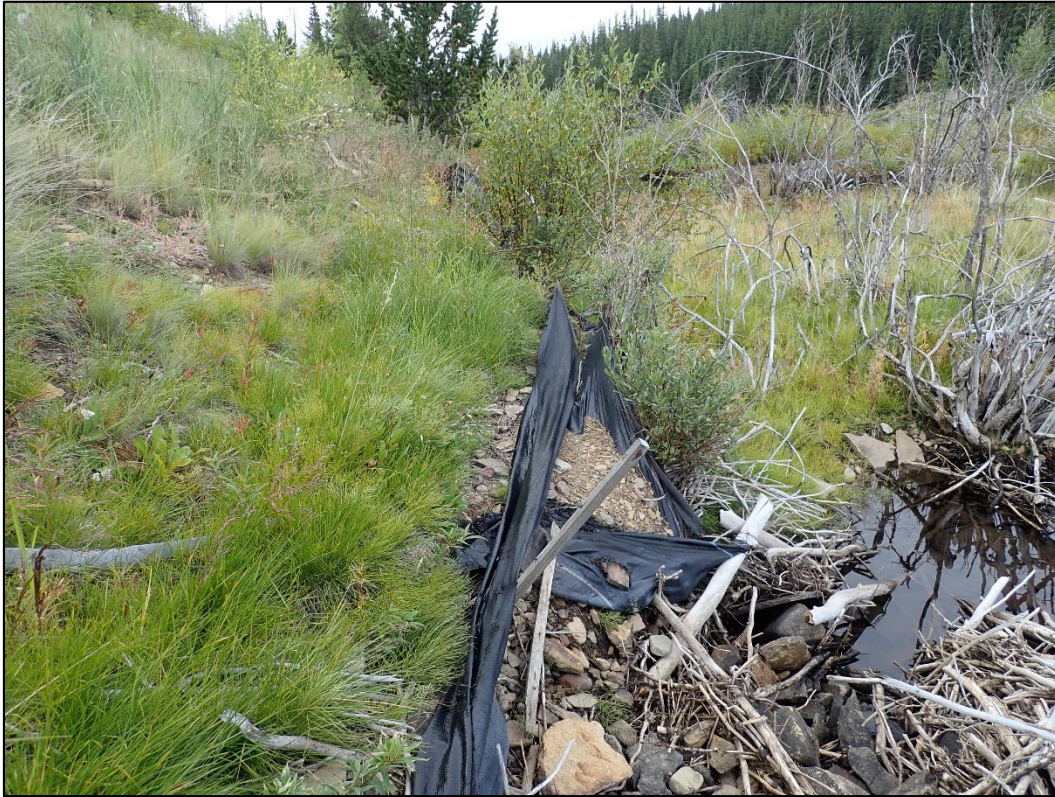
Sediment Control: No erosion problems were observed and no BMPs were needed at the time of the inspection. The prospector utilized a silt fence to prevent sediment from entering Beaver Creek during reclamation. The silt fence was still in place at the time of the inspection, however as the site is adequately revegetated, its purpose is no longer needed. Kevin Smith was directed to remove the silt fence before the site could be released. On November 30, 2022, the Prospector submitted photographs of the completed work.

Photo 5. Silt fence located at toe of reclaimed slope needing to be removed; looking south.
