Foidel Creek Mine Inspection Report

**COLORADO**Division of Reclamation,
Mining and Safety

Permit Number: C-1982-056 Mine Name: Foidel Creek Mine Operator: Twentymile Coal, LLC Operator Address: Ms Miranda Kawcak 29515 Routt County Road No. 27 Oak Creek, CO 80467	County: Routt Operation Type: Underground Permit Status: Active Ownership: Private
	Operator Representative Present: Miranda Kawcak
Operator Representative Signature: (Field Issuance Only)

Inspection Start Date: January 18, 2023 Inspection Start Time: 09:00 AM Inspection End Date: January 18, 2023 Inspection End Time: 12:00 PM		Inspection Type: Coal Partial Inspection Inspection Reason: Normal I&E Program Weather: Clear	
Joint Inspection Agency: None		Joint Inspection Contacts: None	
Post Inspection Agency: None		Post Inspection Contacts: None	
Inspector(s): Hunter Ridley & Zach Trujillo	Inspector's Signature:

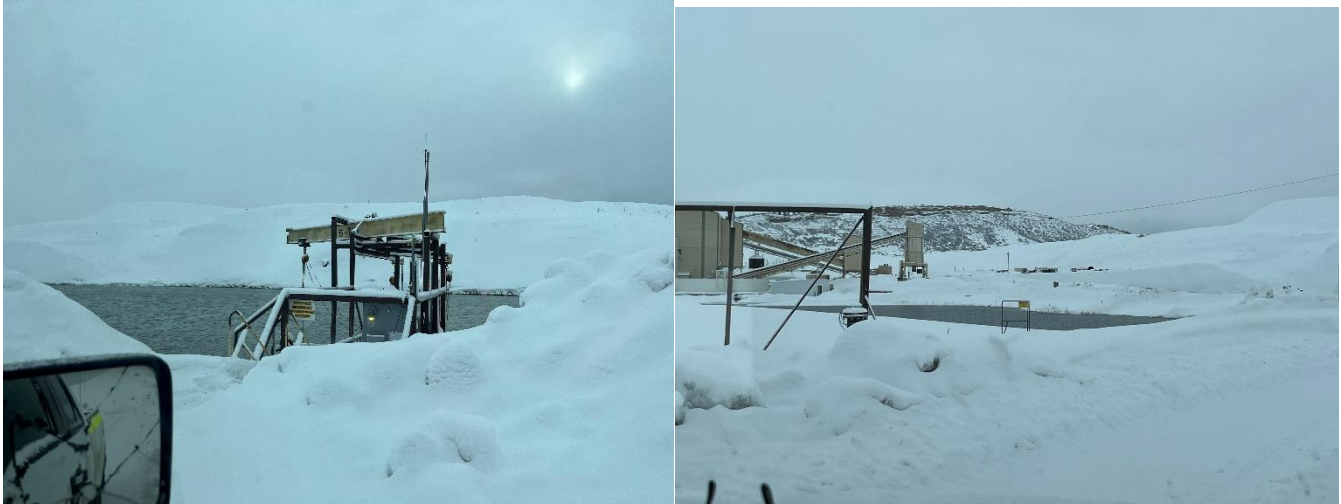
Pond D pump station.

Pond D.

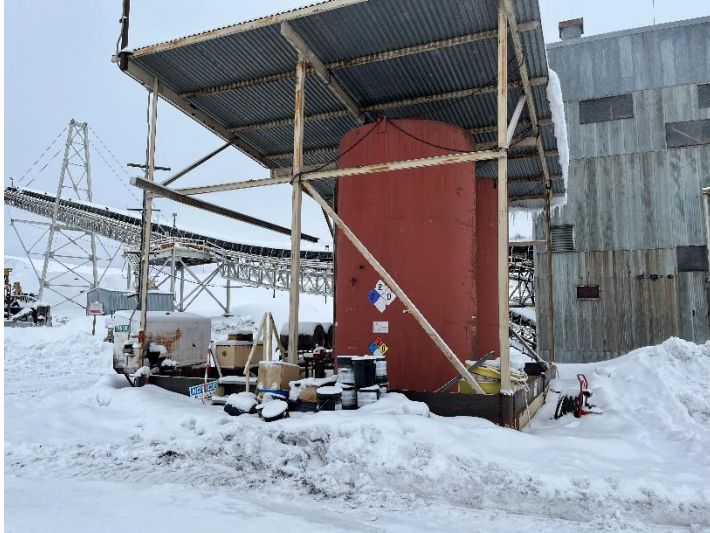
Improper storage of diesel fuel materials were noted (Photo 1). Please move these buckets into the appropriate secondary containment area.

Photo 1: Improper storage of diesel fuel materials, buckets located outside of secondary containment structure.
