Hayden Gulch Loadout Inspection Report

Please see the attached inspection report for the Hayden Gulch Loadout, C- 1992- 081. If you have any questions, feel free to contact me.

| Permit Number: C-1992-081 Mine Name: Hayden Gulch Loadout Operator: Hayden Gulch Terminal, LLC Operator Address: Ms Miranda Kawcak P.O. Box 670 Hayden, CO 81639 | County: Routt Operation Type: Loadout Permit Status: Active Ownership: Private Operator Representative Present: Miranda Kawcak |

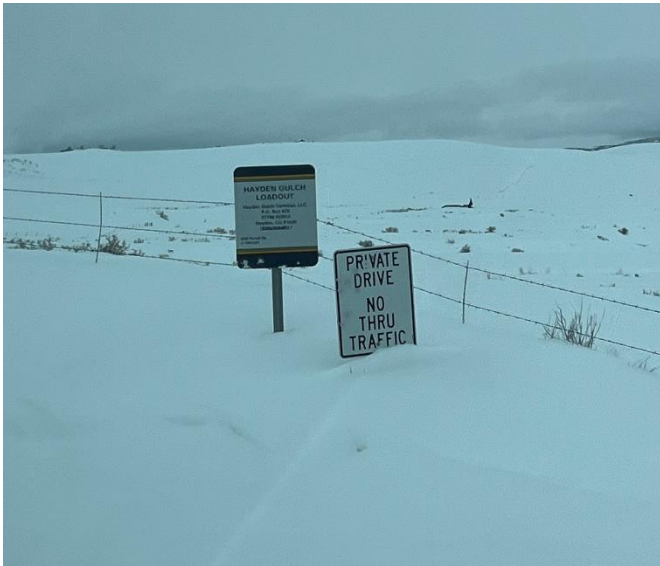
Mine identification markers were visible intermittently along the length haul road. Limited inspection of topsoil piles. However, all visible topsoil piles inspected had signage.

Appropriate signage visible throughout permit area.
