Subject: Summary of Instrumentation Monitoring  
4<sup>th</sup> Quarter 2022  
Bowie Coal Waste Disposal Area No. 2  
Paonia, Colorado

**SUBJECT: Summary Report, 4<sup>th</sup> Quarter 2022, Inclinator and Active Vibrating Wire Piezometer Data October through December 2022, Bowie Mine #2 Coal Waste Disposal Area (CWDA) #2**

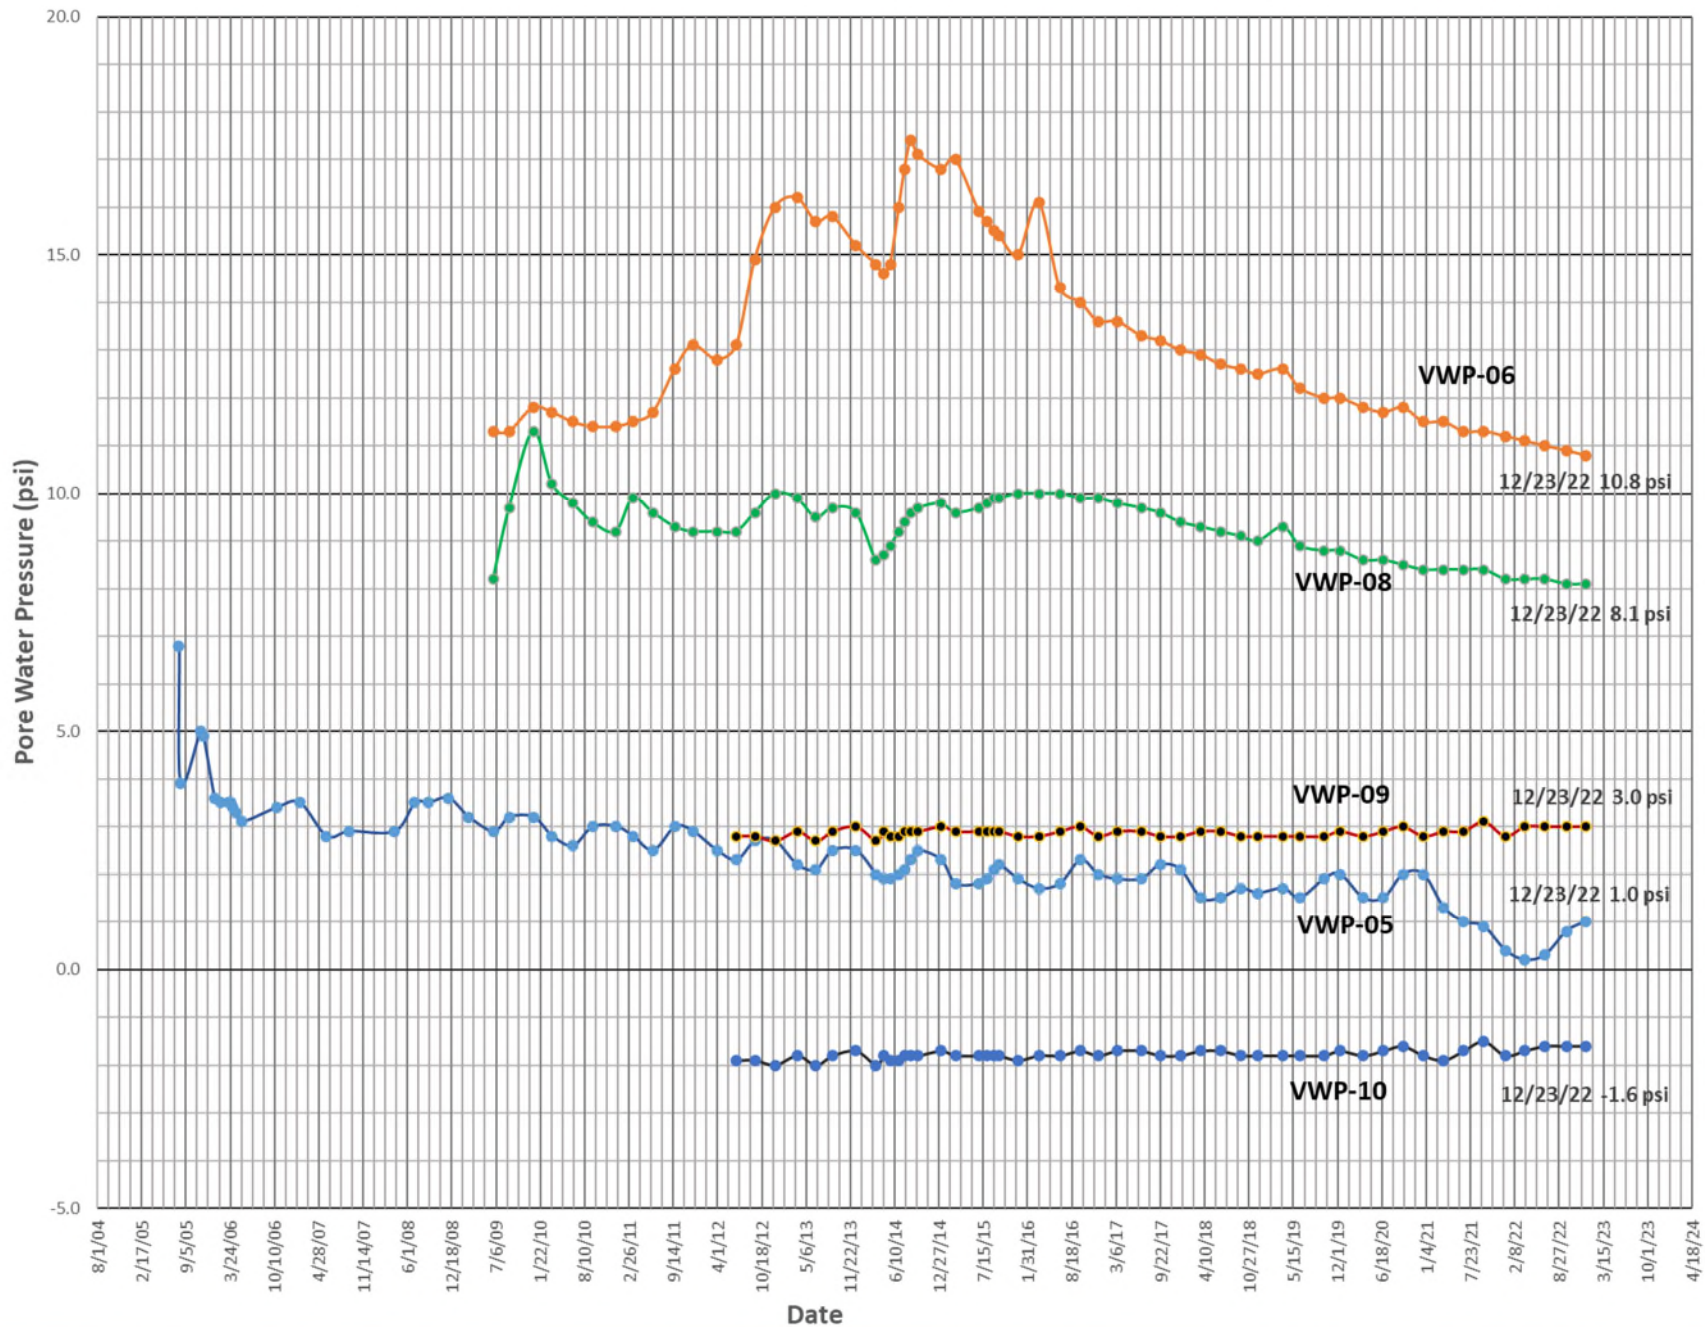
Figure 2 - Bowie Mine #2 - CWDA #2  
Active Vibrating Wire Piezometer Data

As seen on Table 1 and Figure 2, the VWP readings and trends are consistent with recent and historic readings. Pore pressure readings changed by small amounts (-0.1 to -0.4 psi) for four of the five VWP's since the readings one year ago (Q4 2021), while VWP-05 changed by +0.6 psi. When compared with last quarter (Q3 2022), pore pressures also changed by relatively small amounts (0 to 0.2 psi) in all five VWP's. Although four of the five VWP's remain steady or have general declining trends in pore pressure over the life of the VWP's, one of the piezometers (VWP-05) has exhibited pronounced seasonal cyclical behavior for its lifespan. This piezometer generally (but not always) shows low pore pressures for Q1 and Q2 and higher pressures for Q3 and Q4, with a net loss of -5.8 psi over the lifetime of that VWP. The other four VWP's have experienced net changes of +/-0.5 psi or less since installation, meaning current readings are very similar to initial readings. For VWP-09 and VWP-10, pressures have been consistent throughout the lifetime of the piezometers; however, for VWP-06 and VWP-08, they experienced wild fluctuations in pore water pressure in the first half of their lifetimes, but have settled to pressures similar to the installation pressures in the past several years.

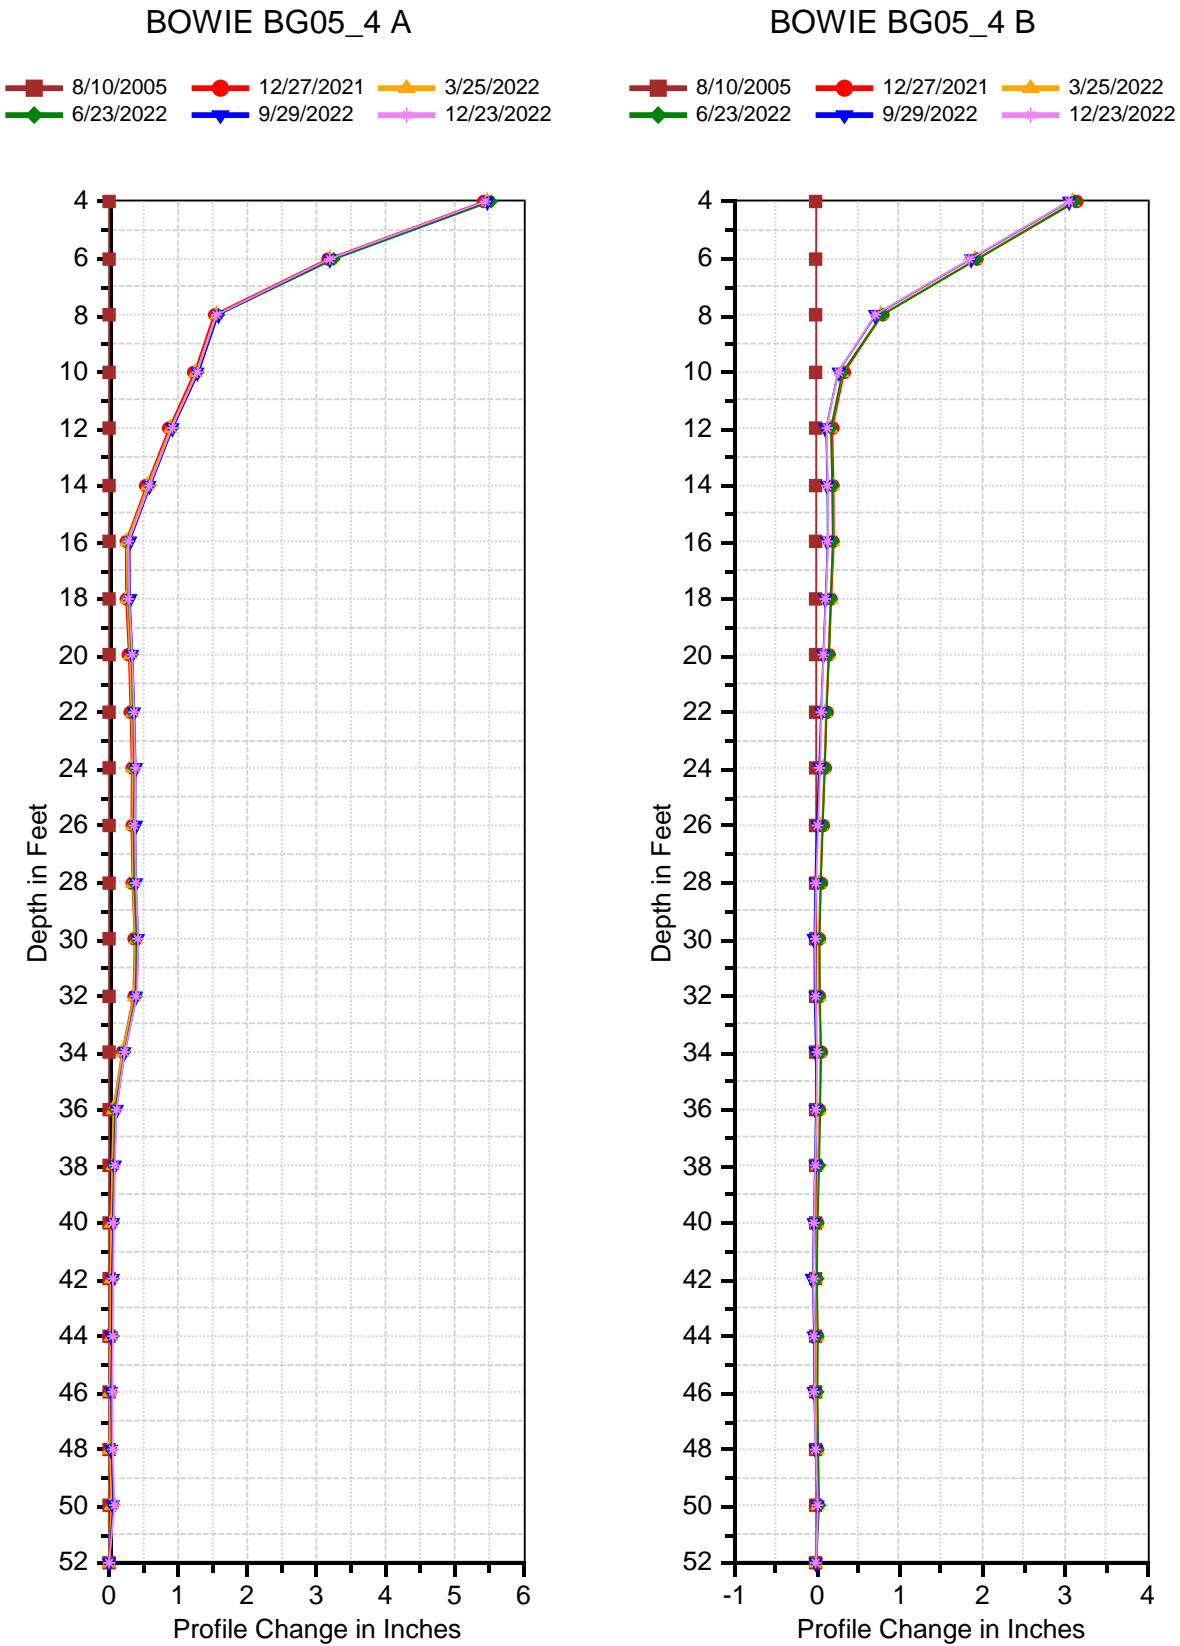
Figure 3 - Inclinometer Displacement Curves

As described in previous reports, historic displacements indicated on the plots for the approximate upper 12-14 feet of the inclinometers since installation in 2005 are due to placement of cover soil on the face of the waste pile during revegetation operations in late 2006 and early 2007. This man-caused displacement is documented in a report by Buckhorn Geotech dated December 22, 2008 to Bowie Resources called *Revised Stability Evaluations for Coal Mine Waste Disposal Area No. 2, Bowie No. 2 Mine*.

Based on the current inclinometer readings, there has not been evidence of significant downslope movement (Axis A) in any of the inclinometers since 2007 and they are generally consistent with previous readings. Some "noise" which is understood to be relatively common in orthogonal direction (Axis B) readings, was observed over the past few years for all three inclinometers. This can be due to various mechanical or installation causes that are unrelated to slope movement. For example, grout voids, poor grout coverage, or soil settlement around the instrument can all contribute to vibrations and pipe movement that impacts inclinometer readings. Software bias adjustments were applied which filtered this noise. All readings were

consistent with previous ones and the "displacement" error was within equipment tolerances and not deemed to be due to slope movement.
