MINERALS PROGRAM INSPECTION REPORT
PHONE: (303) 866-3567

MINE NAME: Pikeview Quarry	MINE/PROSPECTING ID#: M-1977-211	MINERAL: Limestone (general), granite, granite gneiss and dolomite	COUNTY: El Paso
INSPECTION TYPE: Monitoring	WEATHER: Clear	INSP. DATE: December 14, 2022	INSP. TIME: 12:40
OPERATOR: Continental Materials Corporation	OPERATOR REPRESENTATIVE: Jerry Schnabel	TYPE OF OPERATION: 112c - Construction Regular Operation	
REASON FOR INSPECTION: Normal I&E Program	BOND CALCULATION TYPE: None	BOND AMOUNT: \$13,389,784.00	
DATE OF COMPLAINT: NA	POST INSP. CONTACTS: None	JOINT INSP. AGENCY: None	
INSPECTOR(S): Timothy Cazier, P.E. Hunter Ridley	INSPECTOR'S SIGNATURE:

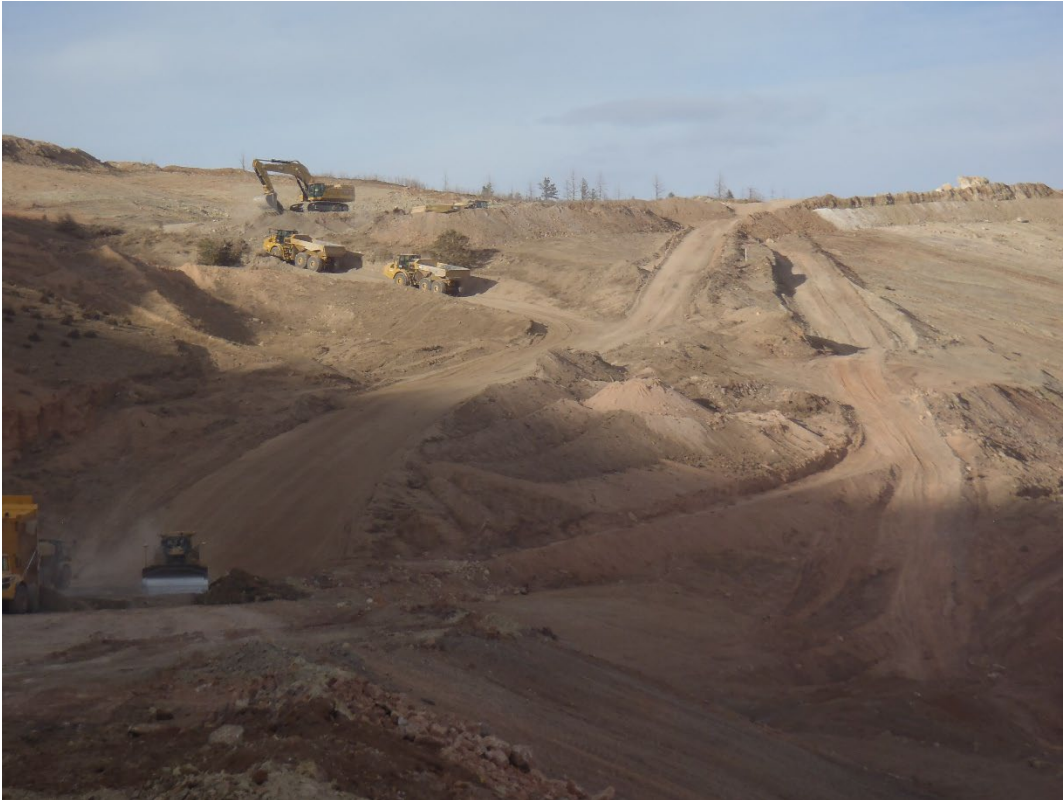
Photo 1. Active excavation of north borrow area (looking north from top of backfill).

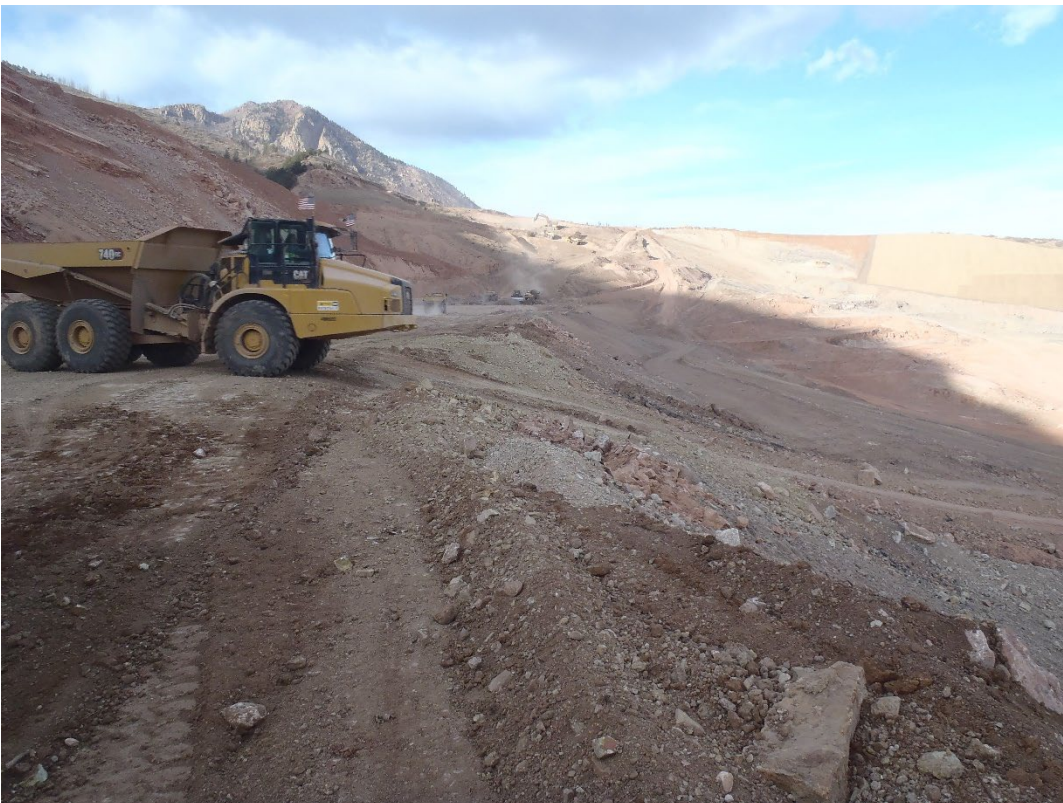
Photo 2. 2H:1V backfill (looking north).

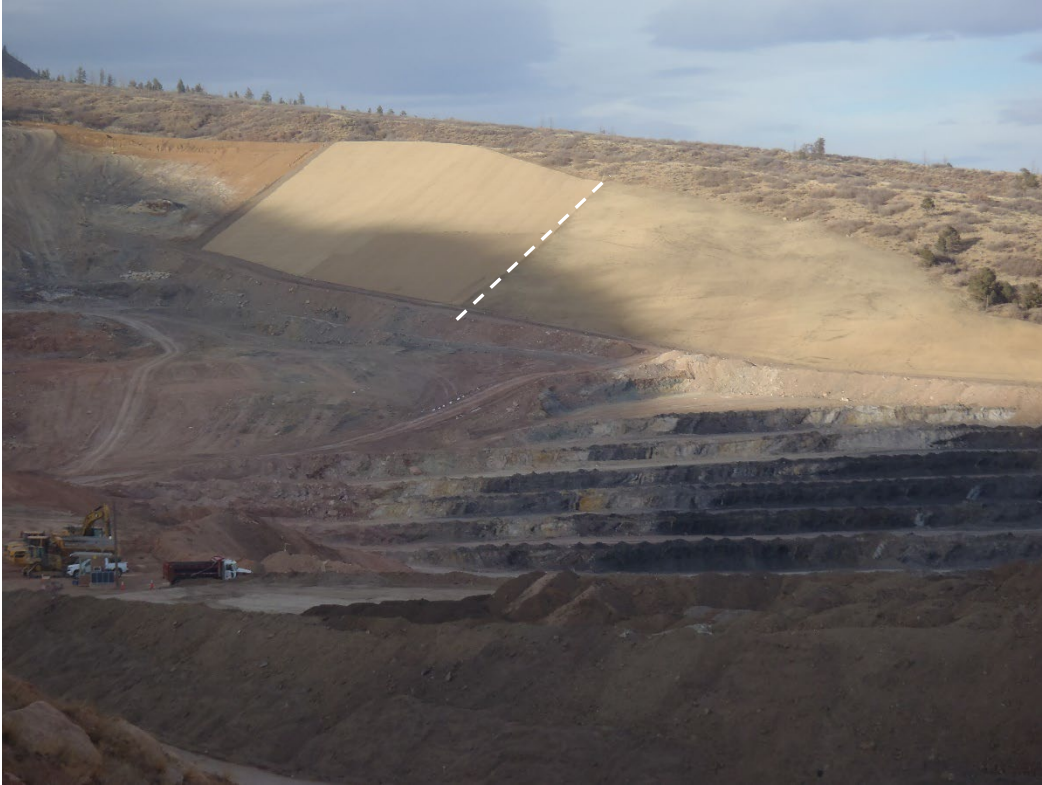
Photo 3. Seeded north borrow area (coconut matting on left side, hydromulch on the right).

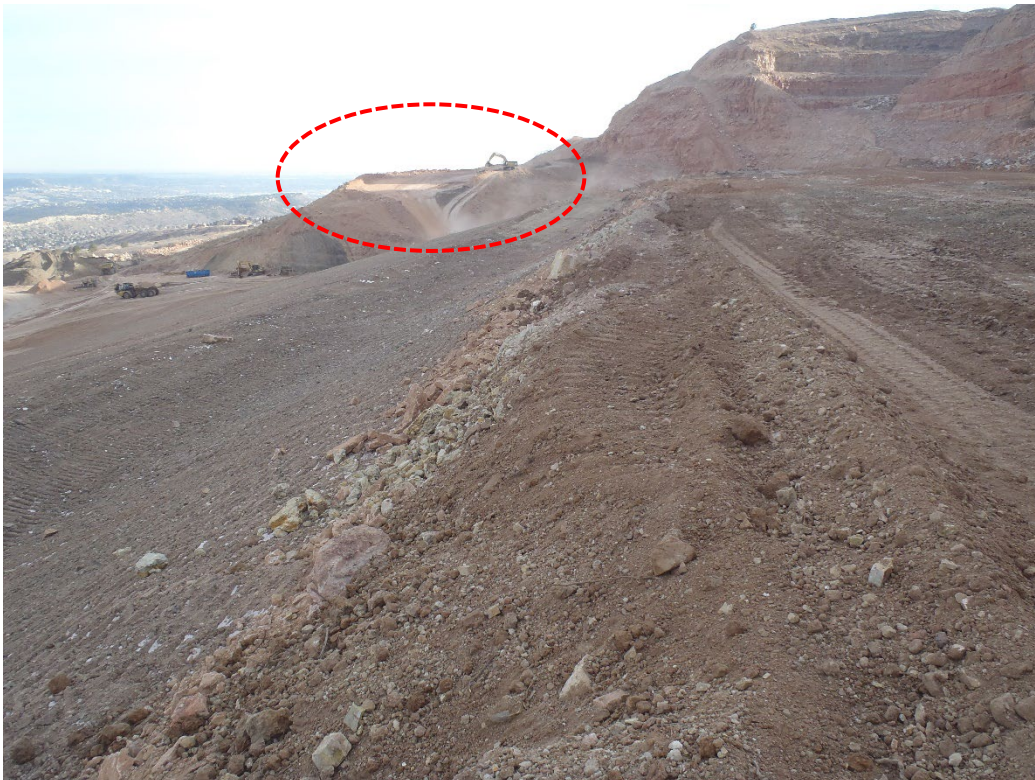
Backfill/Grading: The site was continuing to import backfill from offsite, but this material was no longer being placed offsite truck drivers directly in the pit area, but was being stockpiled on the floor, near the south end, away from the backfill area where it was to be loaded into onsite haul trucks for backfill placement. Backfill was being actively excavated from the north borrow area (**Photo 1**) and placed in lefts to build up the 2H:1V outslope portion of the backfill (**Photo 2**). The east side of the north borrow area had been graded, topsoiled and seeded (**Photo 3**). Site representatives indicated this area consisted of 4.6 acres. Two acres on the west side had been covered with a coconut fiber mat, and the 2.6 acres on the east side had been hydromulched. Additional material had been removed from the south borrow area near the horseshoe section (**Photos 4 and 5**).

Photo 4. Active excavation of south borrow area (looking south).

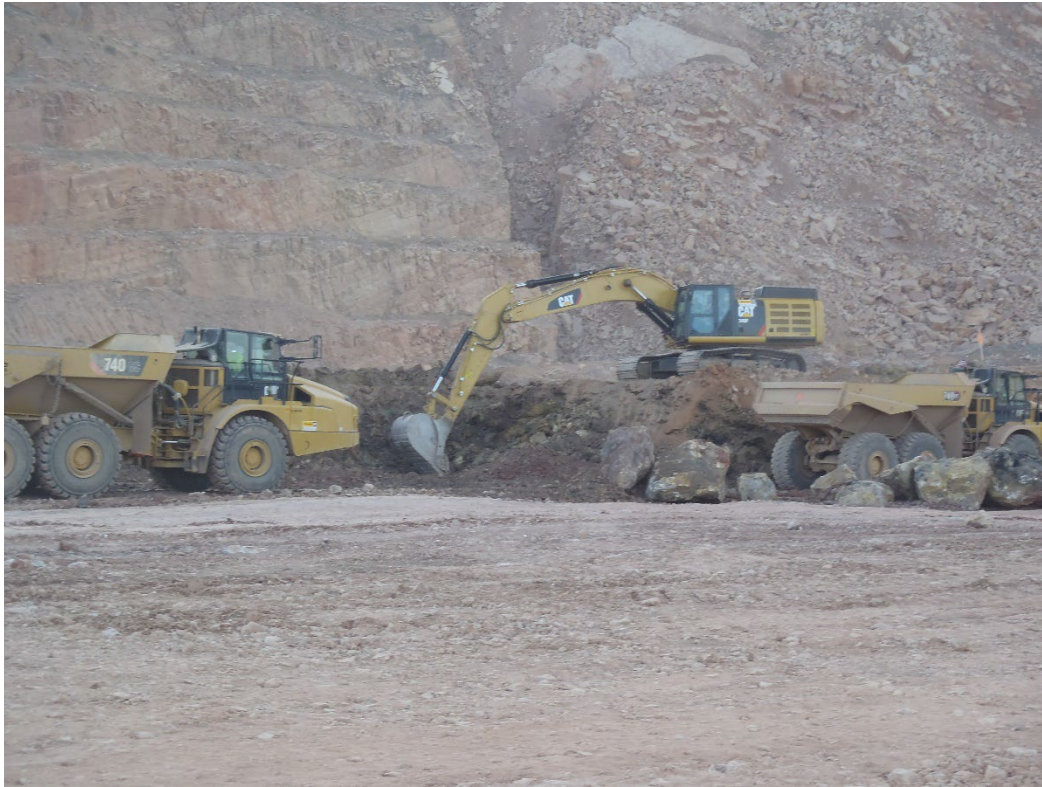
Photo 5. Excavator loading trucks in south borrow area.
