MINERALS PROGRAM INSPECTION REPORT
PHONE: (303) 866-3567

| MINE NAME: Buffalo Hunter Lode | MINE/PROSPECTING ID#: M-2016-015 | MINERAL: Sand and gravel | COUNTY: Custer |
| INSPECTION TYPE: Surety Release Inspection | WEATHER: Clear | INSP. DATE: January 24, 2023 | INSP. TIME: 10:30 |
| OPERATOR: Lucky VI Quarry | OPERATOR REPRESENTATIVE: Ed Lyons | TYPE OF OPERATION: 110c - Construction Limited Impact | |

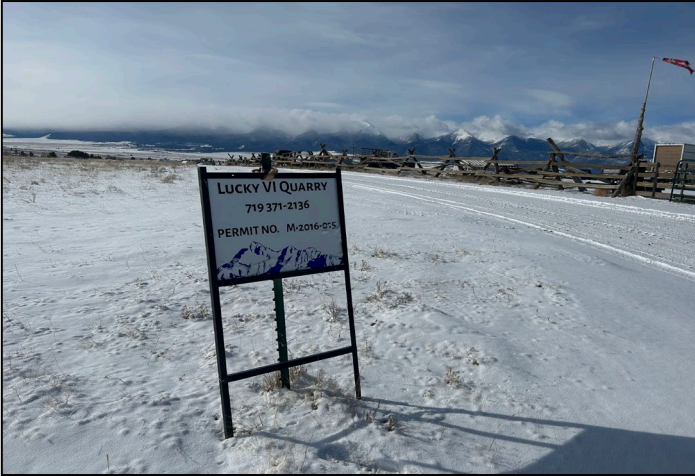
The site identification sign was observed during the inspection (photo 1). The existing disturbance is currently within the marked permit boundary. At the time of this inspection, the permit corners for the remaining 6.34 acres were clearly marked, and DRMS collected GPS data for these corners.

Photo 1 – Site identification sign at site entrance from Oak Creek Grade Road.

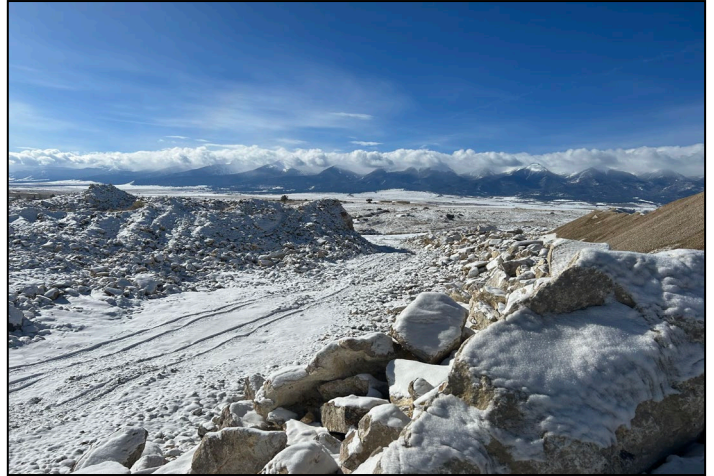
Although no excavation was taking place at the time of the inspection, heavy equipment and a crusher were working in the north-central part of the site to process material into existing product stockpiles. There were stockpiles of topsoil placed along the east permit boundary, and the large historic cut that existed prior to mining has been backfilled. (photos 2-4)

Photo 2 – East side of site where large pre-mining trench has been backfilled.

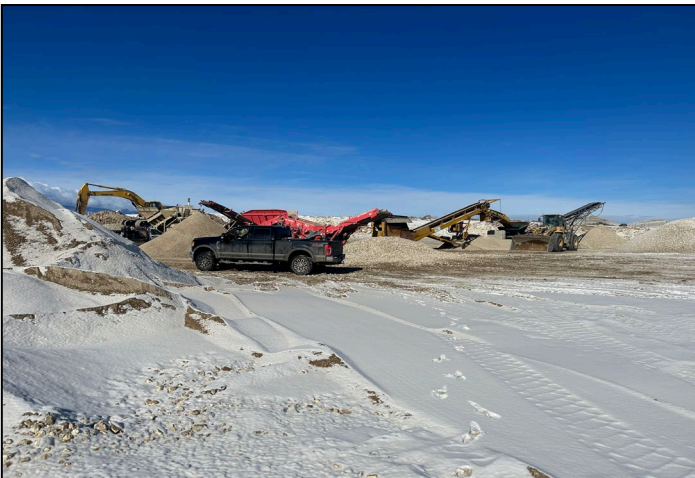
Photo 3 – Material processing and stockpile area located in north-center area of site.

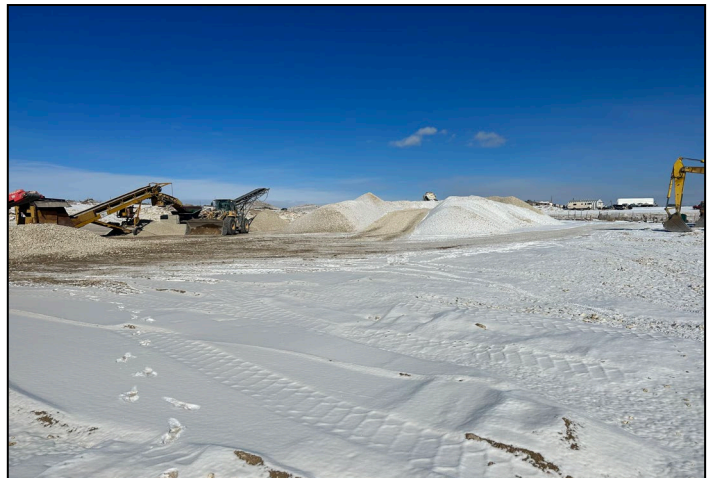
Photo 4 – Material processing and stockpile area located in north-center area of site.
