PERMIT INFORMATION

Permit Number: C-1981-038 Mine Name: Bowie No. 1 Mine Operator: Bowie Resources, LLC Operator Address: Mr. Basil R Bear P.O. Box 1488 Paonia, CO 81428	County: Delta Operation Type: Underground Permit Status: Active Ownership: Private
	Operator Representative Present: None
Operator Representative Signature: (Field Issuance Only)

INSPECTION INFORMATION

Inspection Start Date: January 24, 2023 Inspection Start Time: 14:30 Inspection End Date: January 24, 2023 Inspection End Time: 15:45	Inspection Type: Coal Partial Inspection Inspection Reason: Normal I&E Program Weather: Cloudy
Joint Inspection Agency: None	Joint Inspection Contacts:
Post Inspection Agency: None	Post Inspection Contacts:
Inspector(s): Robert Zuber, P.E.	Inspector's Signature: <i>Robert D. Zuber</i> Signature Date: 1/26/2023

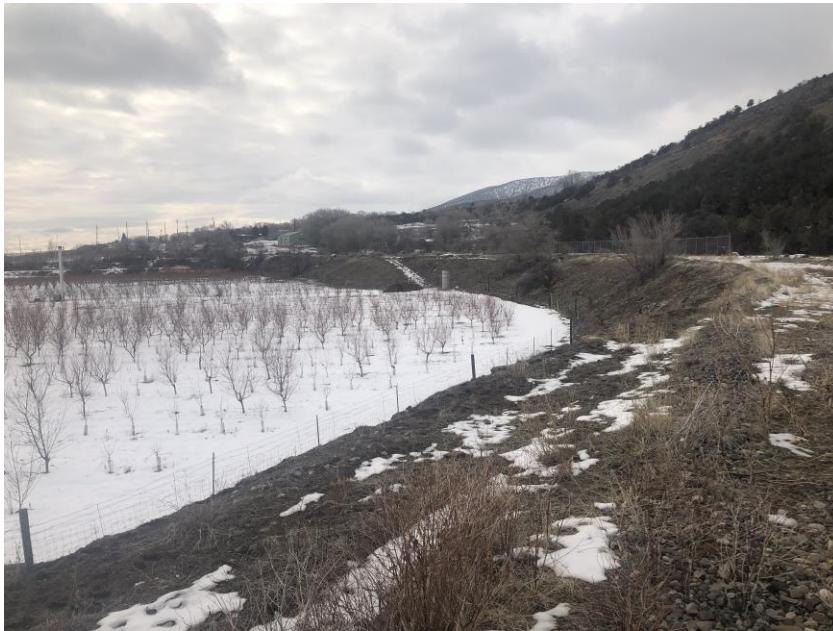
No erosion was seen at the loadout, including the steep slope between the loadout and the orchard below. The trestle across the river appears stable.

Loadout slope, looking southwest

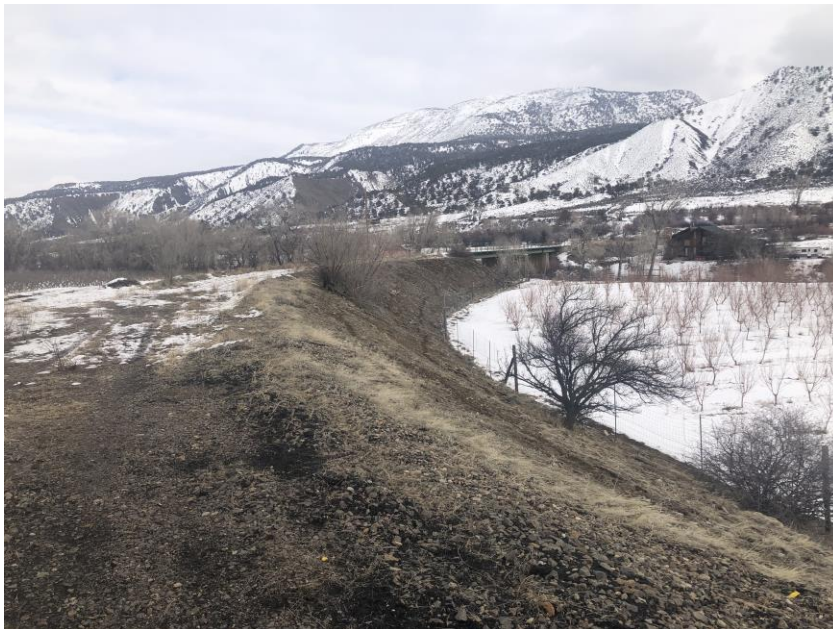
Loadout slope, looking northeast toward trestle

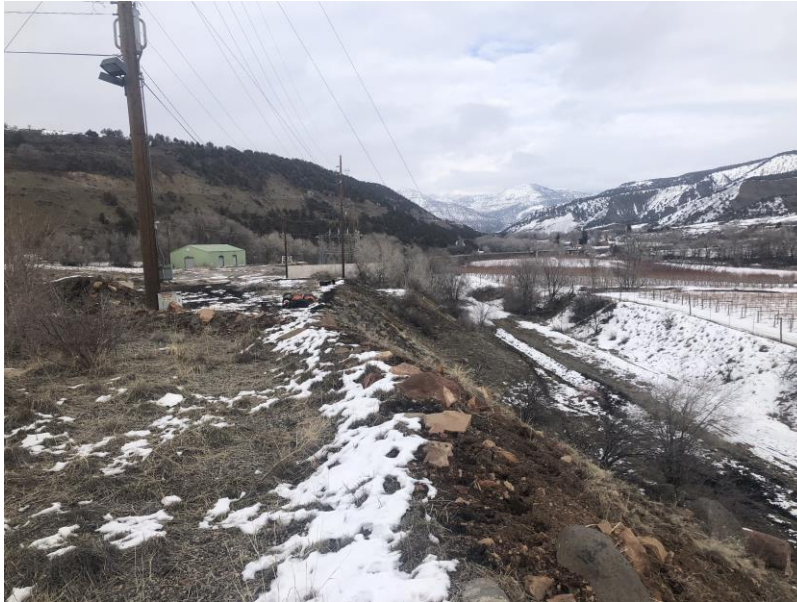
Loadout slope west of substation (looking northeast)

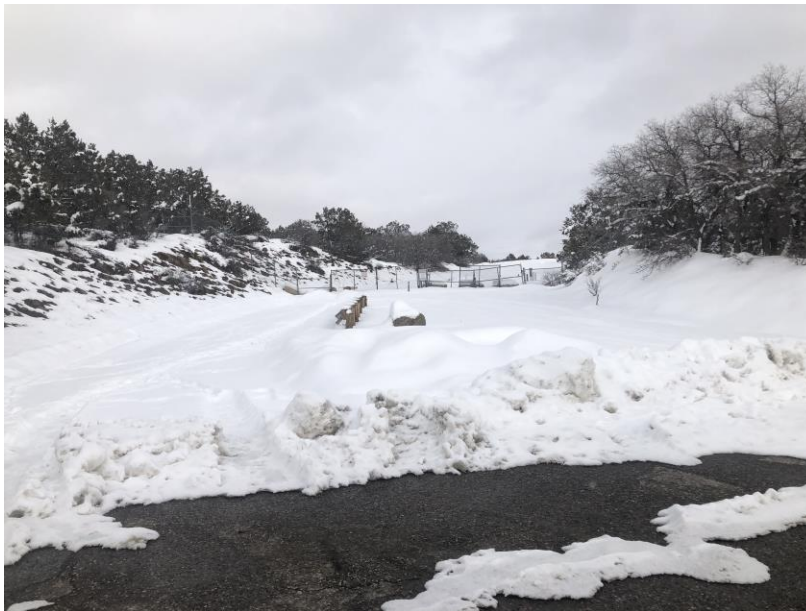
East Mine Road – snowed in

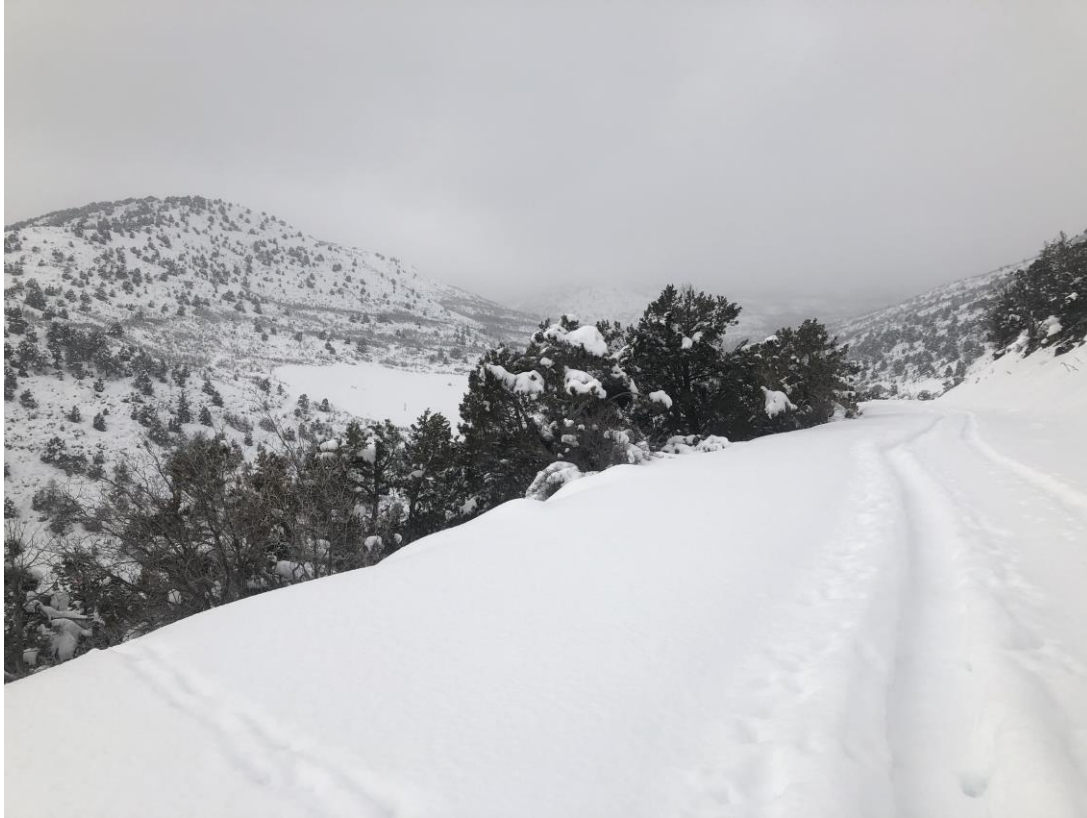
Johnson Road on way to West Mine
