**PERMIT INFORMATION**

<b>Permit Number:</b> C-1996-083 <b>Mine Name:</b> Bowie No. 2 Mine <b>Operator:</b> Bowie Resources, LLC <b>Operator Address:</b> Mr. Basil Bear P.O. Box 1488 Paonia, CO 81428	<b>County:</b> Delta <b>Operation Type:</b> Underground <b>Permit Status:</b> Active <b>Ownership:</b> Private
	<b>Operator Representative Present:</b>  Basil Bear
<b>Operator Representative Signature: (Field Issuance Only)</b>

**INSPECTION INFORMATION**

<b>Inspection Start Date:</b> January 24, 2023 <b>Inspection Start Time:</b> 12:45 <b>Inspection End Date:</b> January 24, 2023 <b>Inspection End Time:</b> 14:30		<b>Inspection Type:</b> Coal Partial Inspection <b>Inspection Reason:</b> Normal I&E Program <b>Weather:</b> Cloudy	
<b>Joint Inspection Agency:</b>  None		<b>Joint Inspection Contacts:</b>  	
<b>Post Inspection Agency:</b>  None		<b>Post Inspection Contacts:</b>  	
<b>Inspector(s):</b>  Robert Zuber, P.E.	<b>Inspector's Signature:</b>  <i>Robert D. Zuber</i>		<b>Signature Date:</b>  1/27/2023

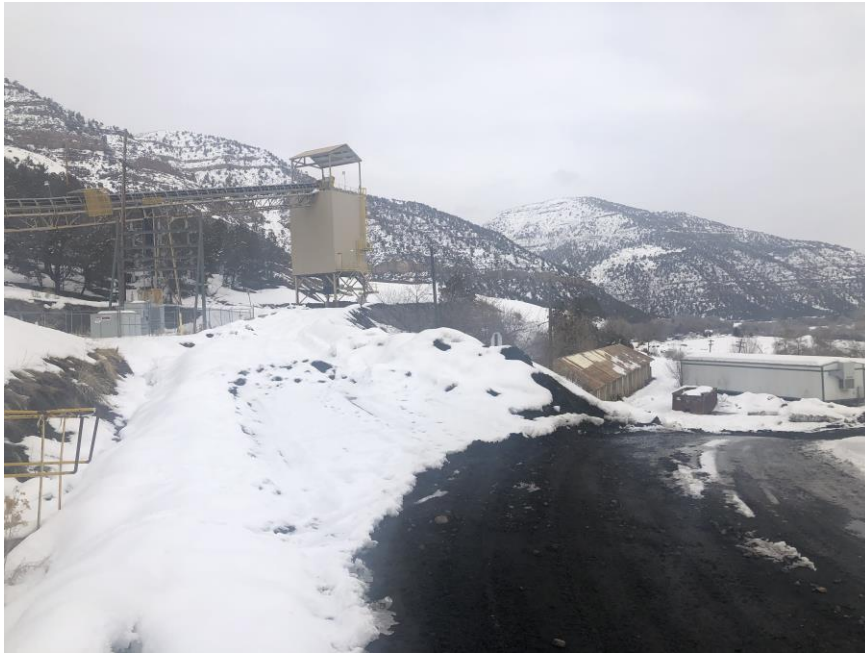
**Road to Gob Pile #2 on left**

Overall the gob piles appeared stable. They were inspected from afar due to snow. No slides or other significant problems were observed.

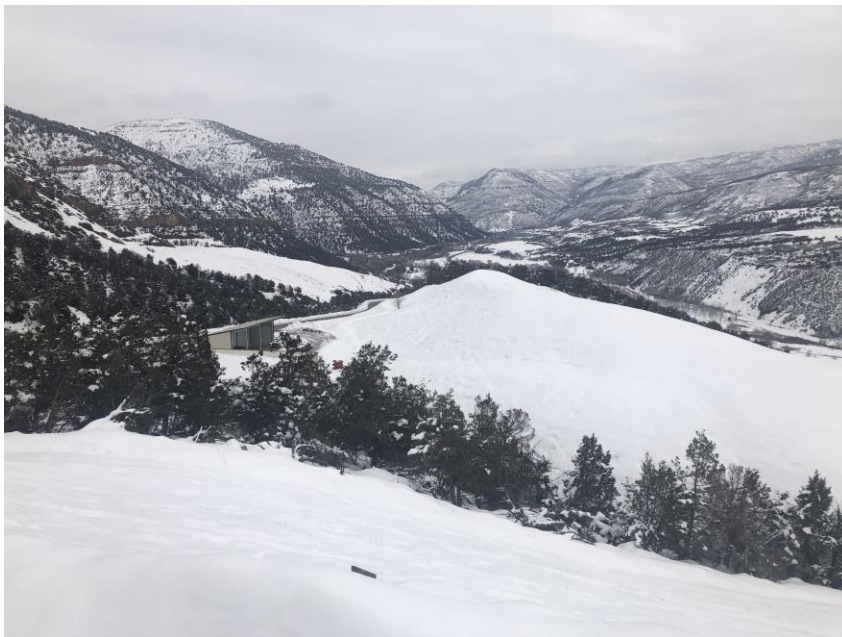
**Topsoil Stockpile A in middle and Gob Piles 1, 2, and 4 in back left**

No erosion or other problems were seen with topsoil stockpiles or coverfill piles.

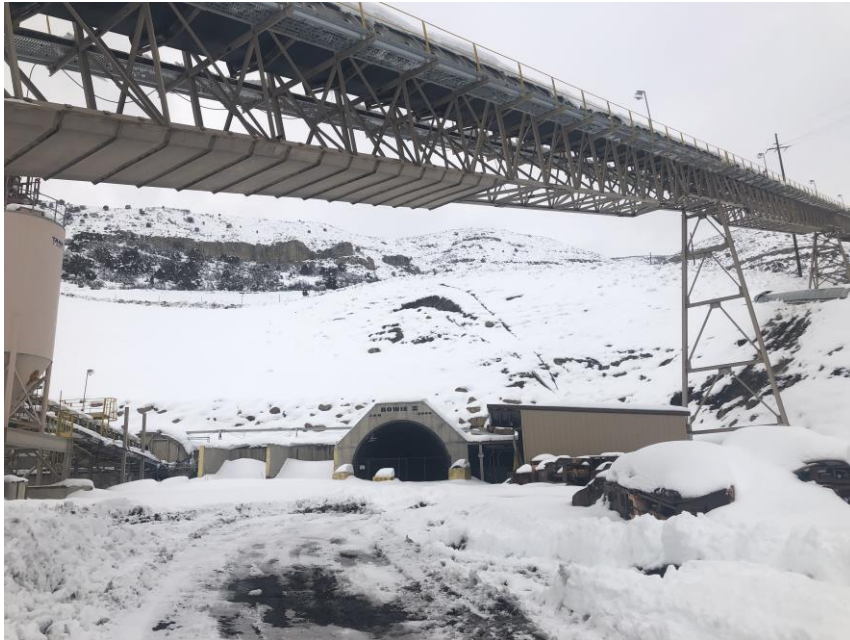
It appears that slumps have not moved significantly in the recent past. These include slumps by the B Portal and by Curve Number 11 along the Haul Road.

**Slump at B Portal**

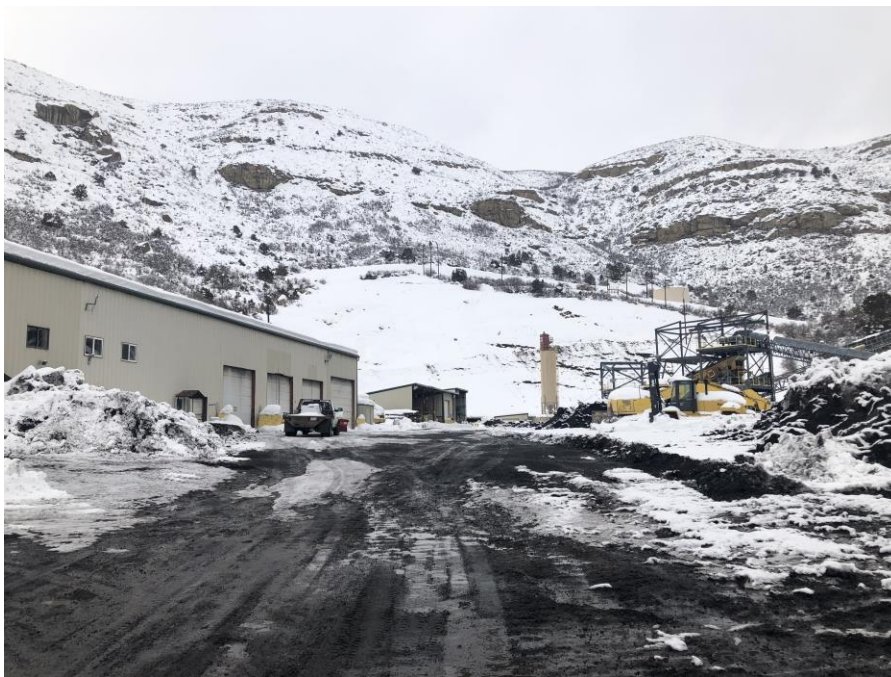
**D Portal Bench with slope below Utility Bench in back**

- The slope below the Utility Bench
- D Portal bench
- B Portal bench
- Material storage area beside Topsoil Stockpile A
- Conveyor corridors
- Slopes above and below the Coal Stockpile Pad
- The area around the office
- The slopes below and above the Preparation Plant and nearby water tank
- Pump House and Filter Building
- Old power plant
- Storage area west of Pond D
- The Unit Train Loadout.

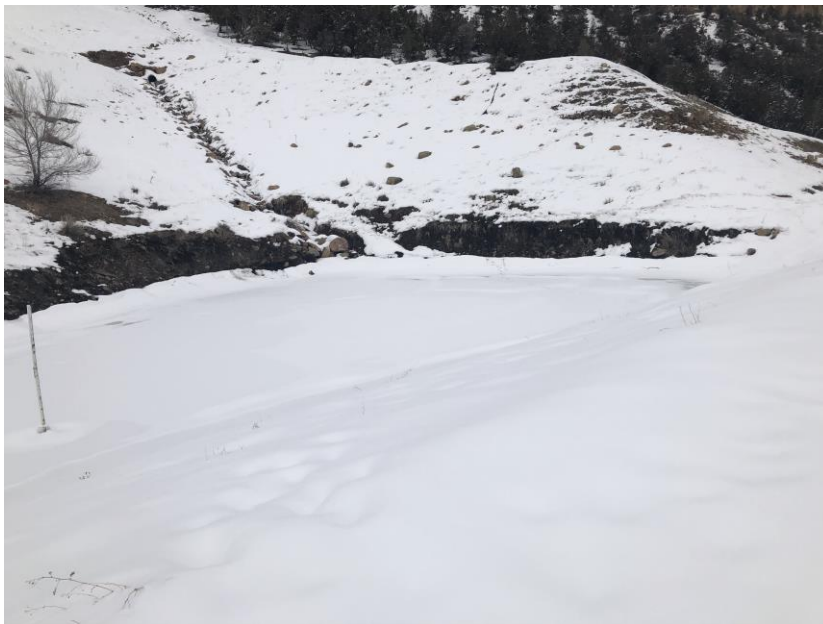
**Pond F**

Two sediment ponds were inspected: F and J. Neither of the ponds was discharging. Both contained ice and snow, well below spillways. No significant problems were identified with embankments, spillways, inlet channels, or other features of the ponds.

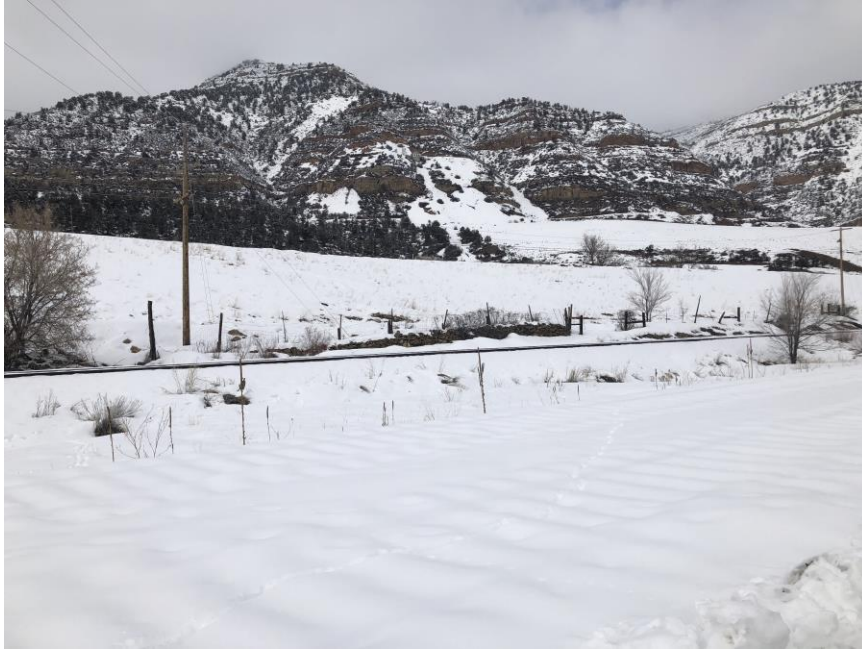
**Area below Gob Pile #3**

BRL reclamation work on Gob Pile #3 has been suspended for the winter. Per current BRL plan, the backfilling, grading, topsoiling, and seeding will be completed on this gob pile in 2023.
