MINERALS PROGRAM INSPECTION REPORT

MINE NAME: Yevoli Cobblestone Pit	MINE/PROSPECTING ID#: M-2007-003	MINERAL: Sand and gravel	COUNTY: Fremont
INSPECTION TYPE: Monitoring	WEATHER: Cloudy	INSP. DATE: November 15, 2022	INSP. TIME: 10:45
OPERATOR: Yevoli Cobblestone Inc	OPERATOR REPRESENTATIVE: Mark Yevoli	TYPE OF OPERATION: 112c - Construction Regular Operation

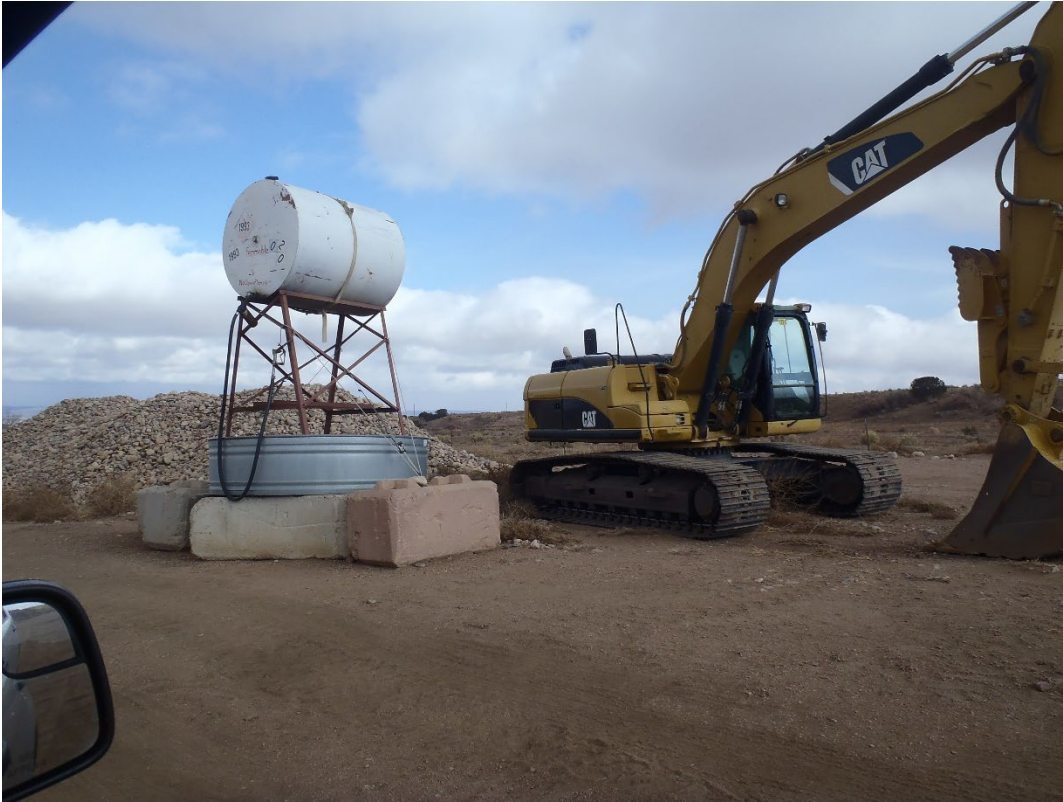
Acid And Toxic Materials: Above ground fuel storage tanks were observed and had adequate secondary containment (see **Photo 1**).

Photo 1. Above ground fuel storage tank with secondary containment.

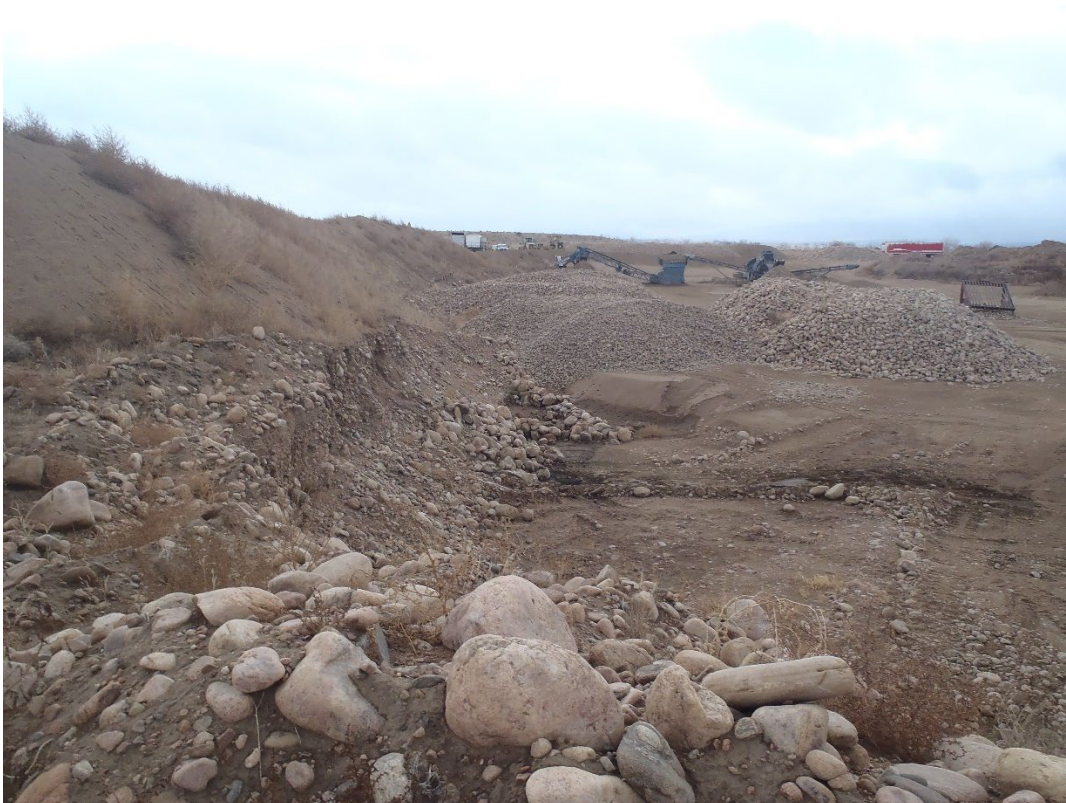
PROBLEM/POSSIBLE VIOLATION: Problem No. 2: Failure to maintain the active highwall to a length of 200 feet or less as committed to as part of the approval of CN-1.

Gen. Compliance with Mine Plan: The operation has disturbed more area than is currently allowed by the reclamation bond. Based on GPS measurements combined with Google Earth imagery, the DRMS estimated 13 acres have been disturbed (see **Figure 1**). The bond only covers 11 acres of disturbance. **The disturbance in excess of what is bonded is cited as Problem 1 on p. 1 of this report.** In addition, the site is limited to 200 linear feet of active highwall that has not been flattened to 3H:1V slopes in order to keep bonding requirements low. The estimated active highwall length was about 250 feet at the time of the inspection (see **Photos 2 and 3**). **The exceedance of the 200-ft limit of active highwall is cited as Problem 2 on p. 1 of this report.** Highwalls were estimated to be 15 feet in height and appeared stable.

Photo 2. Active highwall (north end, looking SE).

CORRECTIVE ACTIONS: The operator shall submit a Technical Revision, with the required \$216 revision fee, to update the current approved mine plan to reflect a more practical maximum length of active highwall by the corrective action date. This can be part of the same technical revision required for Problem No. 1.

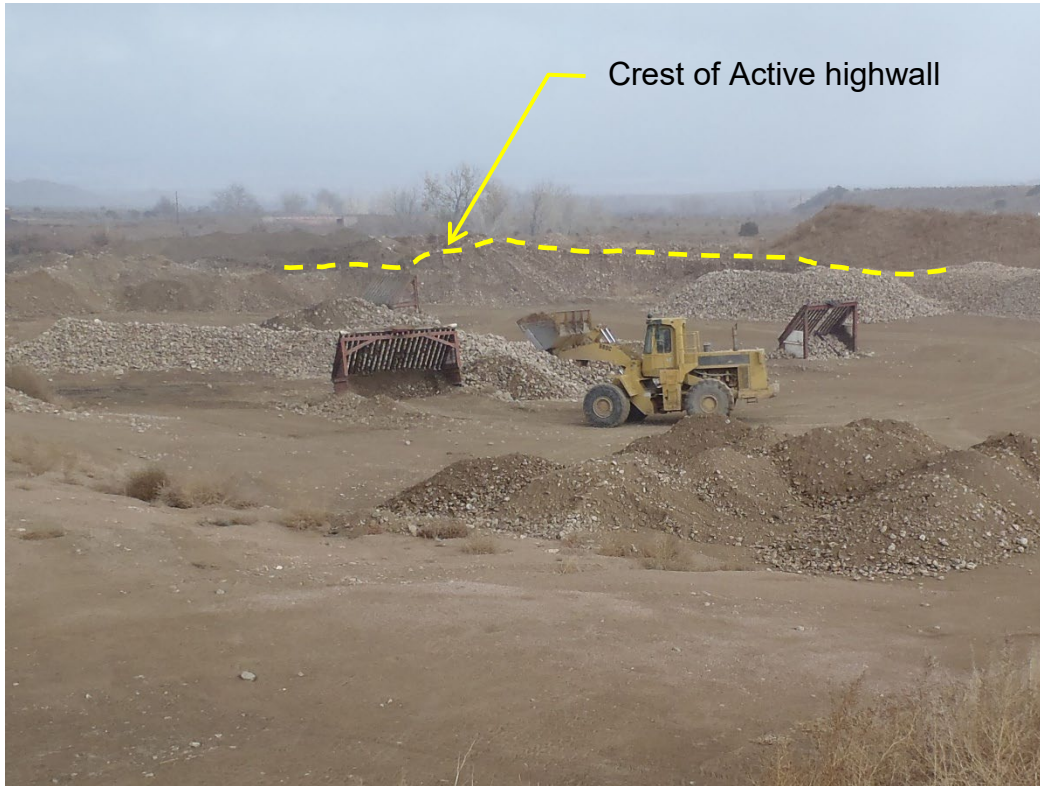
Support Facilities On-site: A screen plant, multiple grizzly screens, an excavator, and two loaders were observed on site (see **Photos 3** and **4**).

Photo 3. Active highwall (looking north across pit).

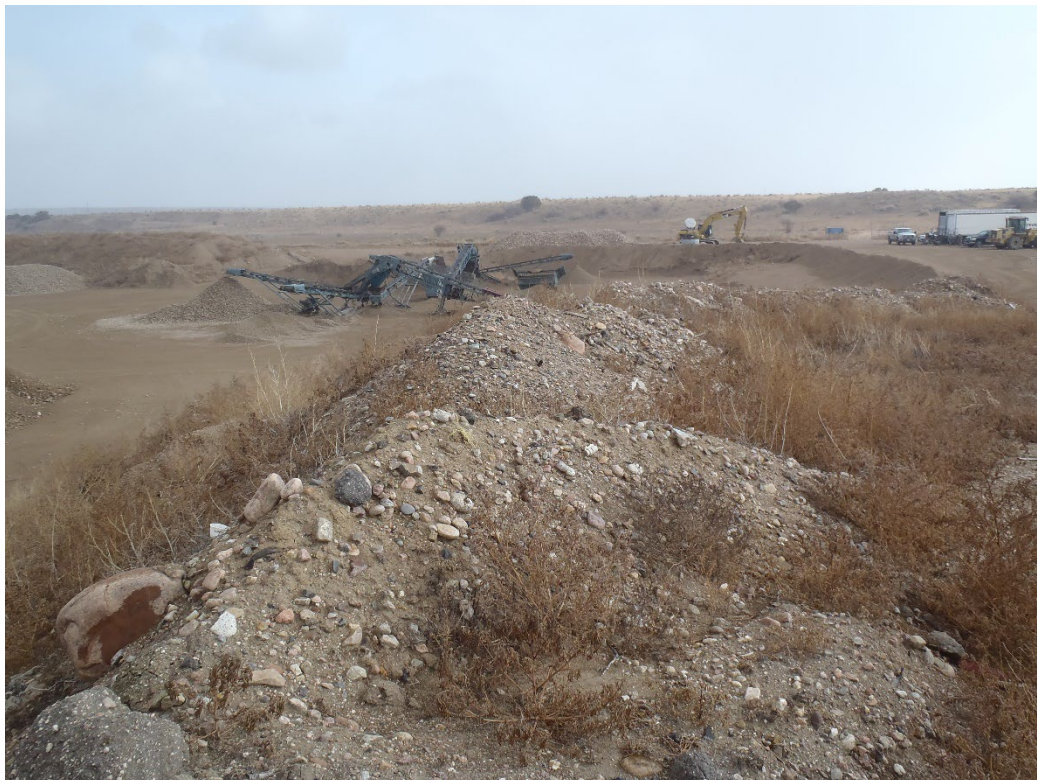
Photo 4. Screen plant and excavator (looking east).

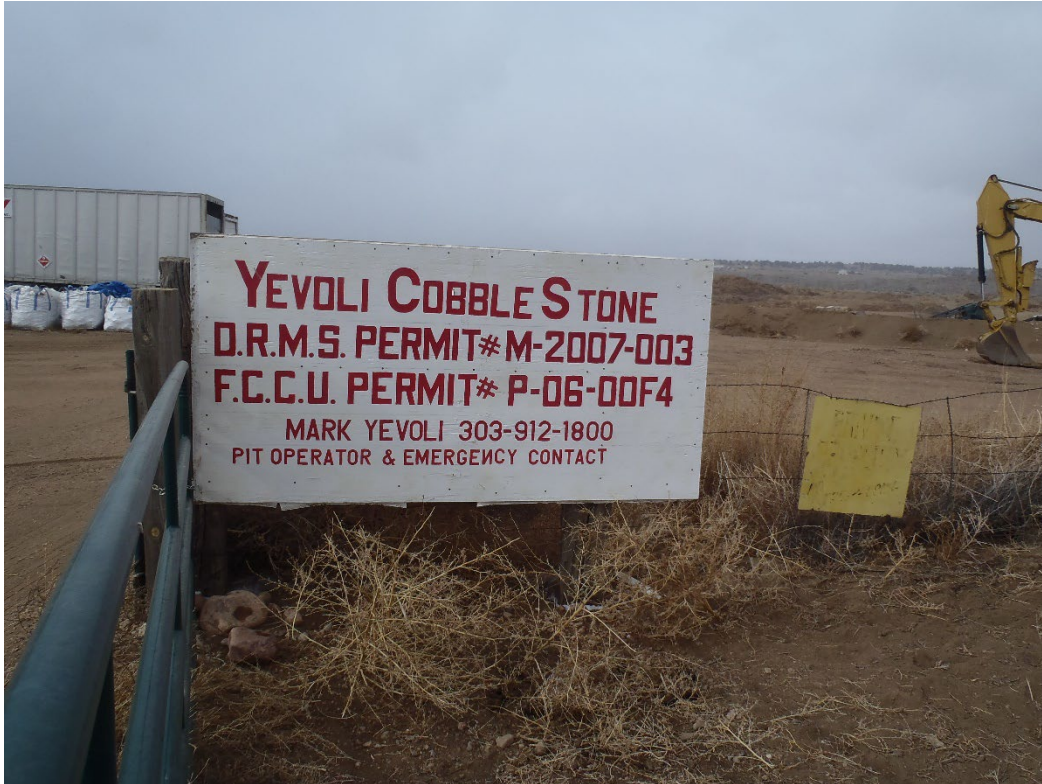
Signs and Markers: The permit sign was properly posted (see **Photo 5**) and boundary markers were observed to delineate both the mine excavation limits (see **Photo 6**) and the affected area boundary (mostly fences) which for this site is coincident with the permit boundary.

Photo 5. Permit sign at entrance.

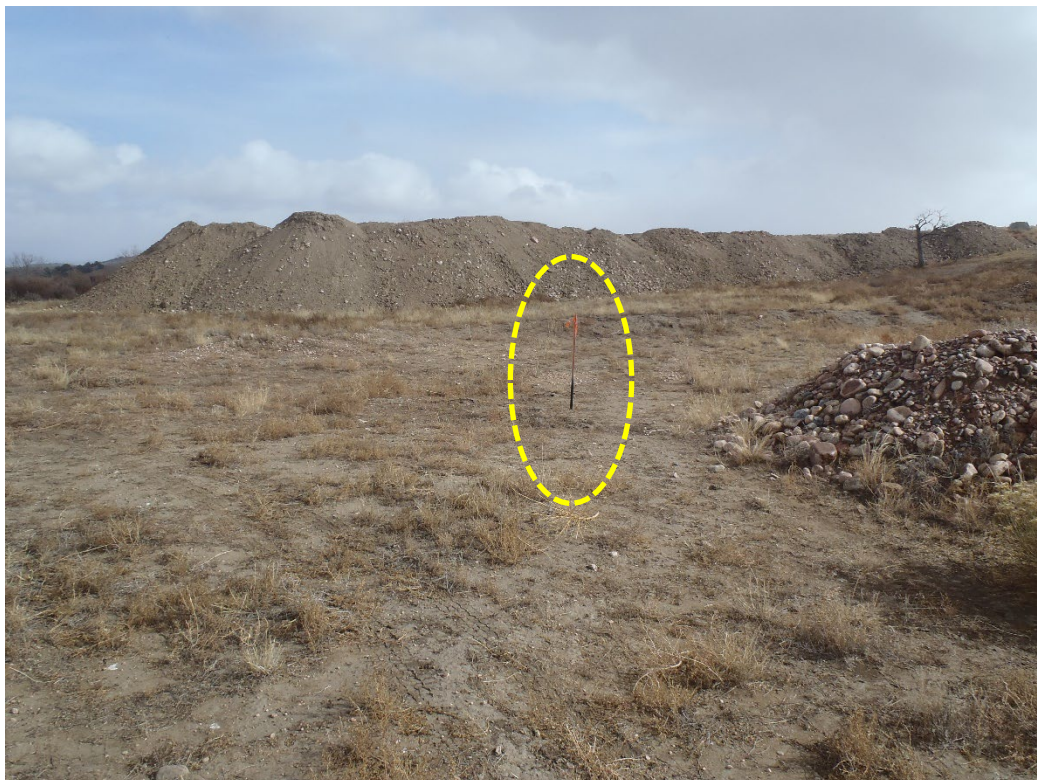
Photo 6. Typical mine excavation limit marker (west side, looking north).

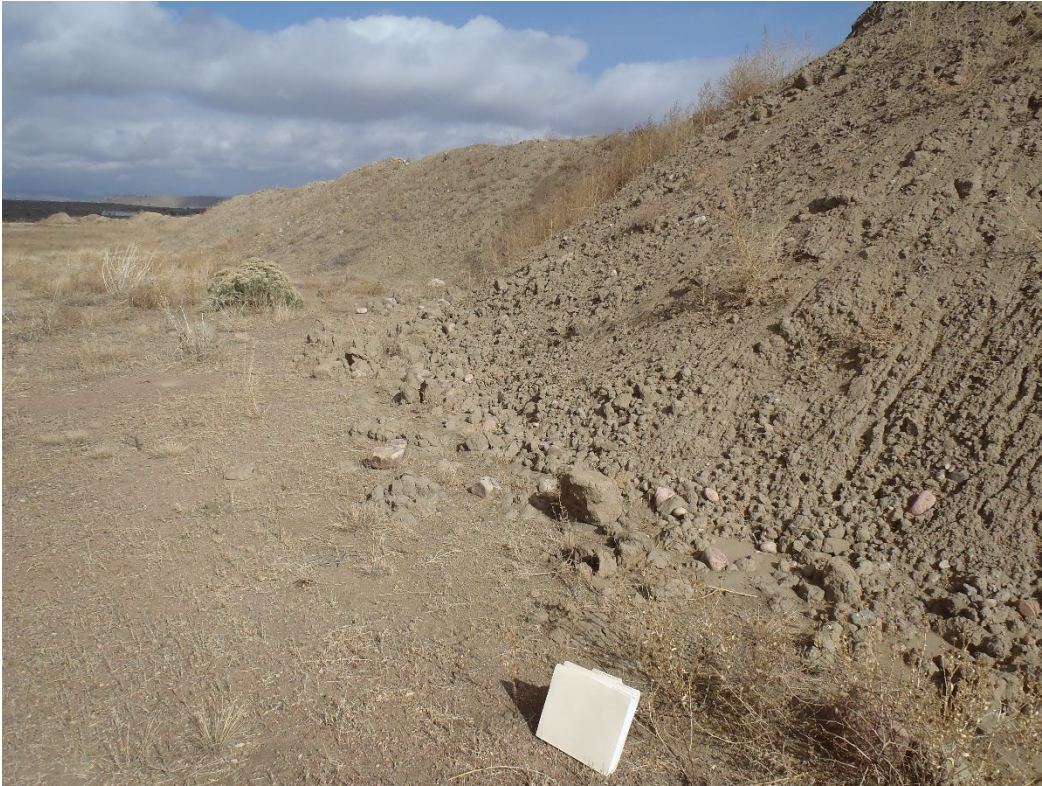
Topsoil: Two topsoil stockpiles were observed: one on the southwest (see **Photo 7**) and the other on the east side between the east access road and the active pit (see **Photo 8**).

Photo 7. West side of west topsoil stockpile (looking NW).

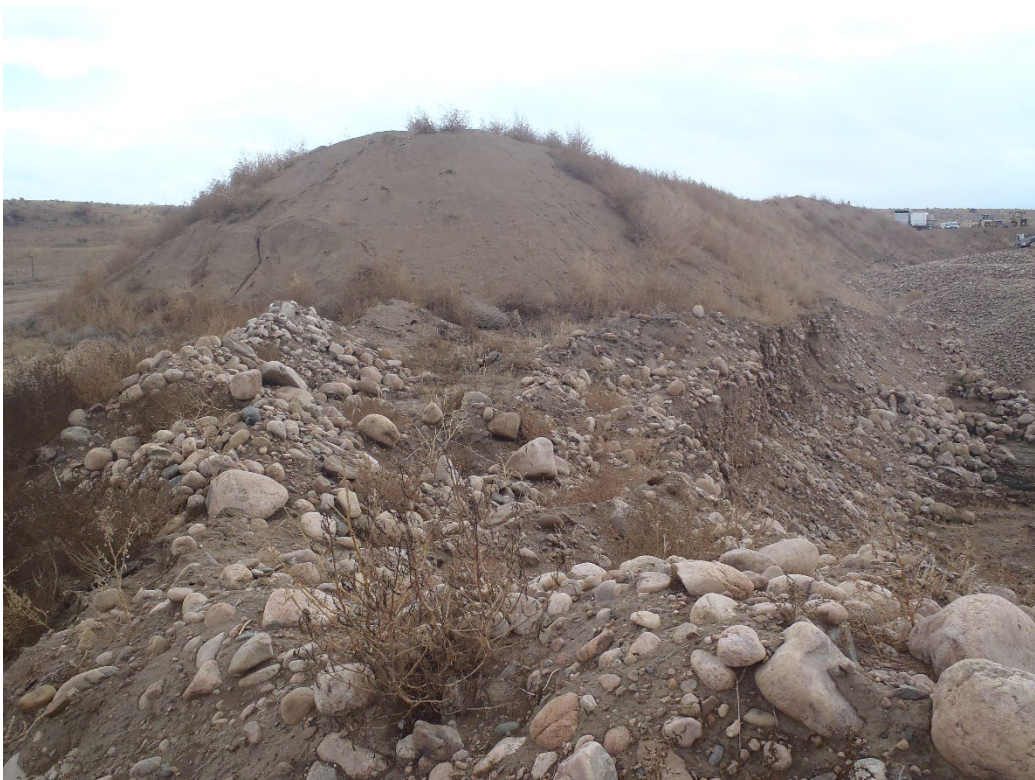
Photo 8. West side/north end of east topsoil stockpile (looking SE).

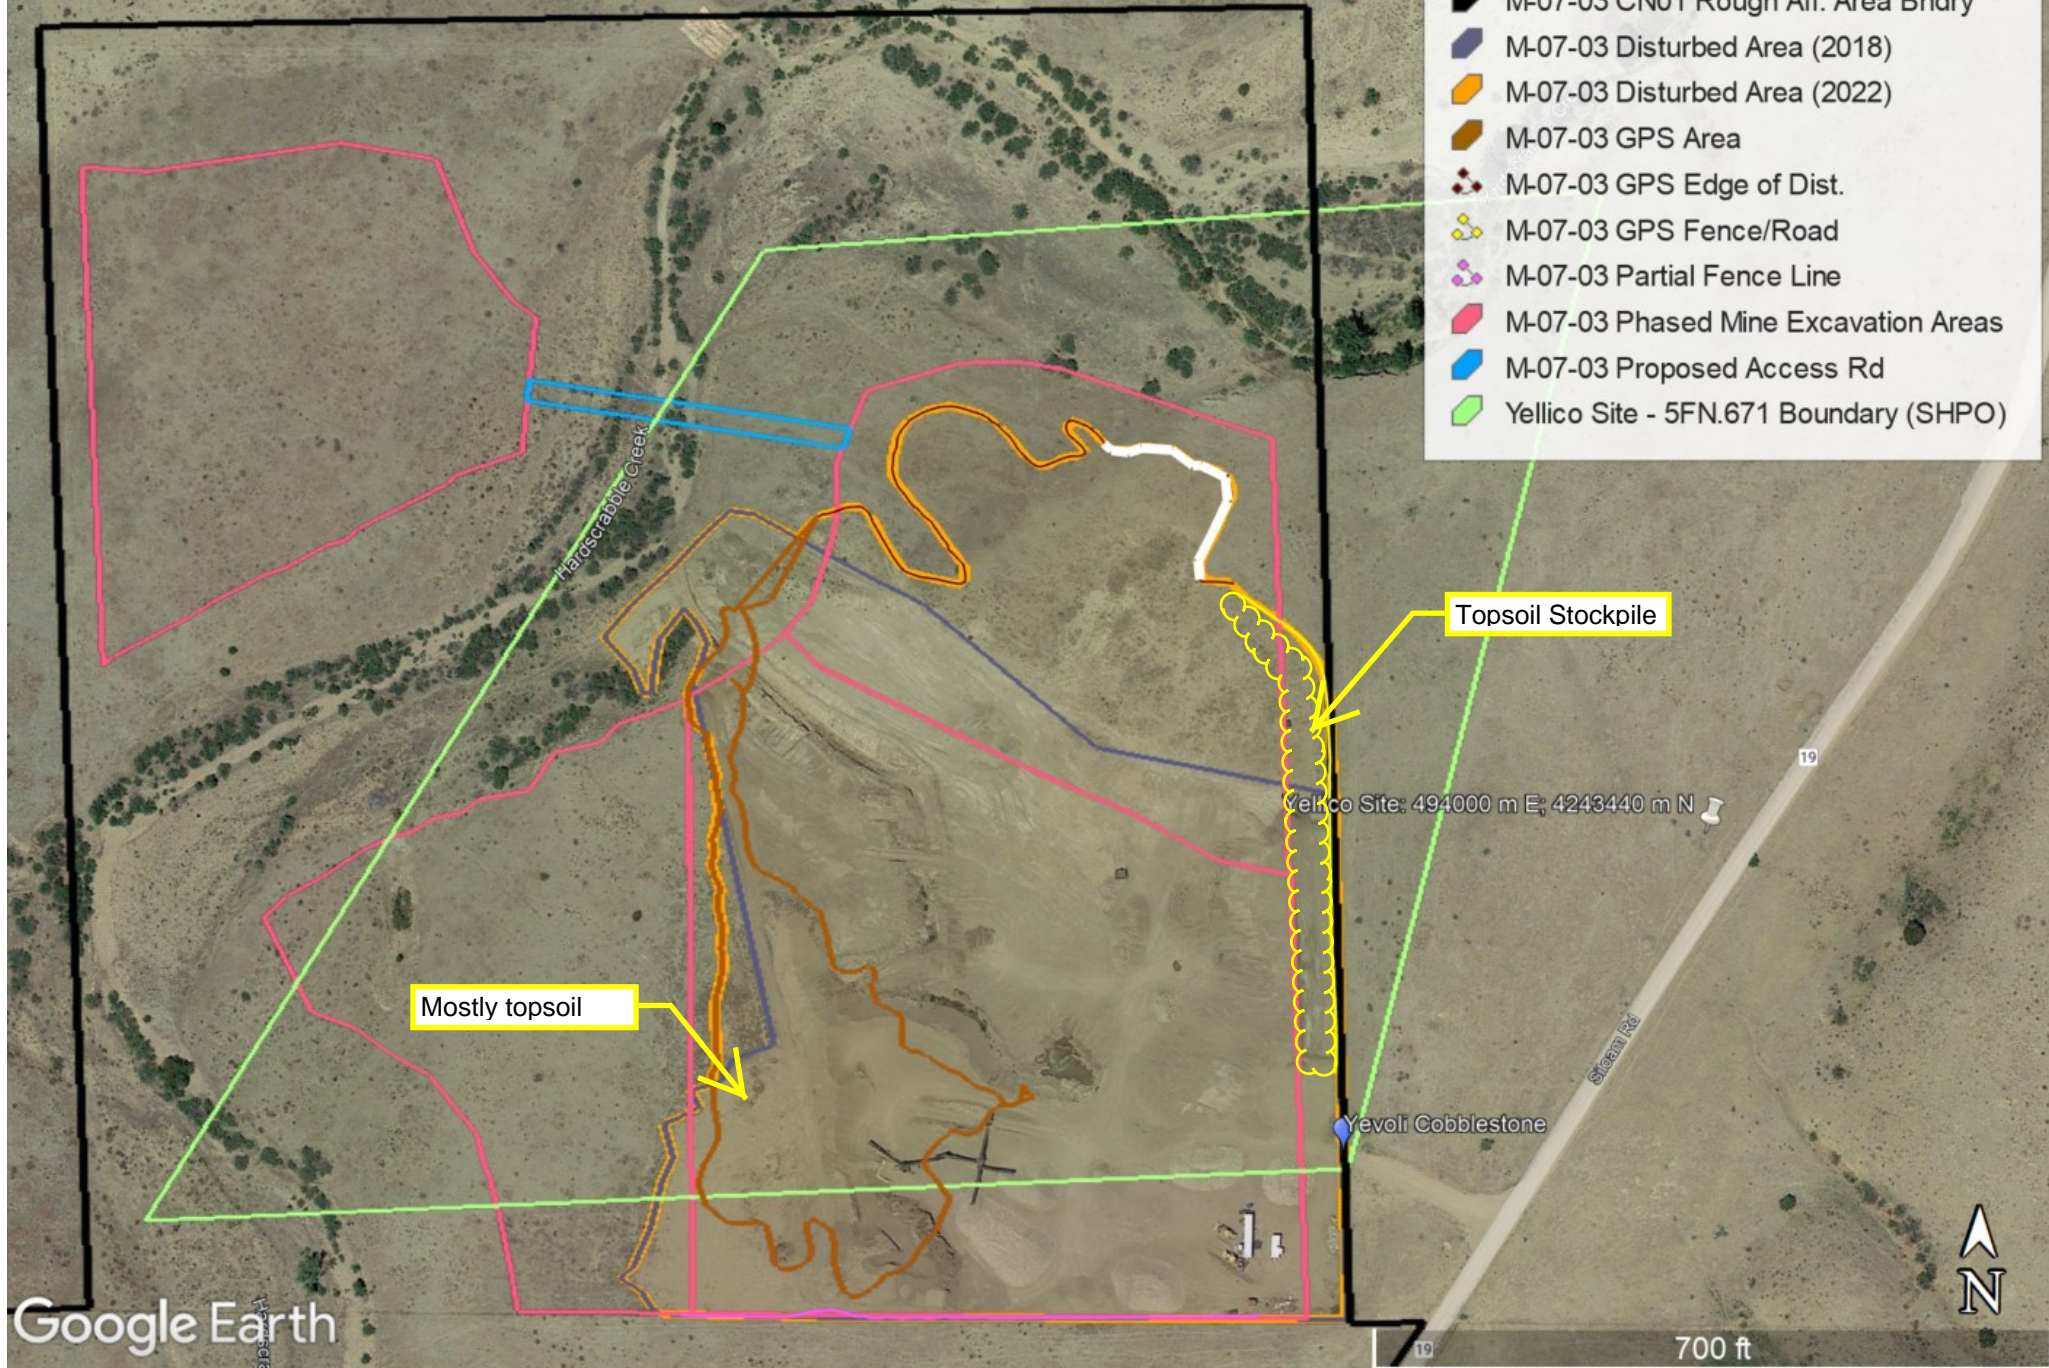
Figure 1. Yevoli Cobblestone 2022 Post Inspection Map.

PROBLEM/POSSIBLE VIOLATION: Problem No. 1: Pursuant to C.R.S. 34-32.5-112 (1)(c)(VI), the mine plan needs to be updated to reflect the current disturbed area greater than the 11 bonded acres. The operator must provide sufficient information to describe or identify how the operator intends to conduct the operation.

CORRECTIVE ACTIONS: The operator shall submit a Technical Revision, with the required \$216 revision fee, to update the current approved mine plan to reflect existing affected area (~13 acres) and proposed activities by the corrective action date.
