**MINERALS PROGRAM INSPECTION REPORT**  
**PHONE: (303) 866-3567**

<b>MINE NAME:</b> Pit 1	<b>MINE/PROSPECTING ID#:</b> M-1999-073	<b>MINERAL:</b> Sand	<b>COUNTY:</b> Costilla
<b>INSPECTION TYPE:</b> Surety Release Inspection	<b>WEATHER:</b> Clear	<b>INSP. DATE:</b> December 27, 2022	<b>INSP. TIME:</b> 13:20
<b>OPERATOR:</b> Evan L. Melby, Inc.	<b>OPERATOR REPRESENTATIVE:</b> Linda Overdeer	<b>TYPE OF OPERATION:</b> 110c - Construction Limited Impact	
<b>REASON FOR INSPECTION:</b> Surety Release Requested	<b>BOND CALCULATION TYPE:</b>	<b>BOND AMOUNT:</b> No Bond Held	
<b>DATE OF COMPLAINT:</b> NA	<b>POST INSP. CONTACTS:</b> None	<b>JOINT INSP. AGENCY:</b> None	
<b>INSPECTOR(S):</b> Lucas West	<b>INSPECTOR'S SIGNATURE:</b>

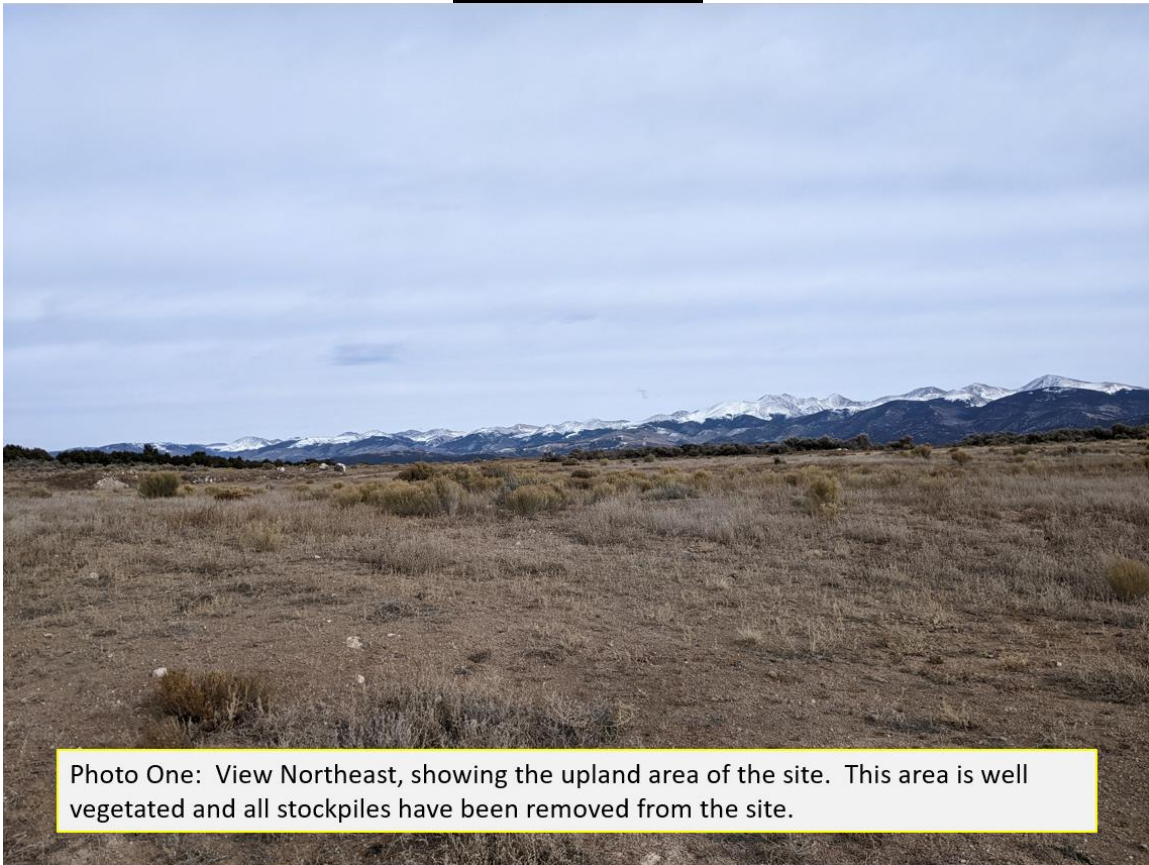
Reclamation activities at the site have been completed and no mining or reclamation equipment was observed on site. The proper Mine Identification signage was posted at both entrances to the site. The site consists of two main areas, the pit where mining activities were conducted and the upland area that was used for material stockpiling and minimal processing. The upland area was never excavated, and stockpiles were placed directly on the ground surface. All stockpiles have been removed, and the area is well vegetated. The area can be seen in Photos One and Two. The vegetative cover of the upland area is dense, diverse and appears to be capable of self-regeneration as multiple years biomass was observed.

Photo One: View Northeast, showing the upland area of the site. This area is well vegetated and all stockpiles have been removed from the site.

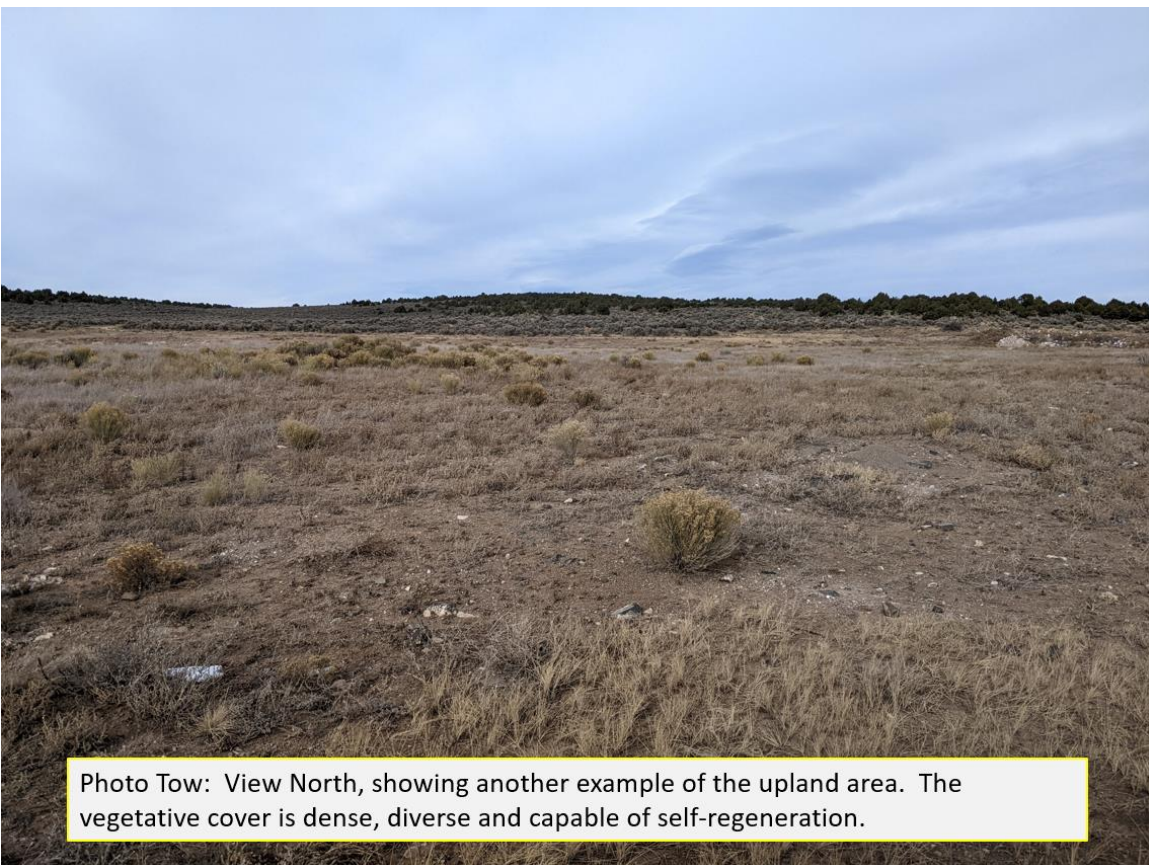
Photo Two: View North, showing another example of the upland area. The vegetative cover is dense, diverse and capable of self-regeneration.

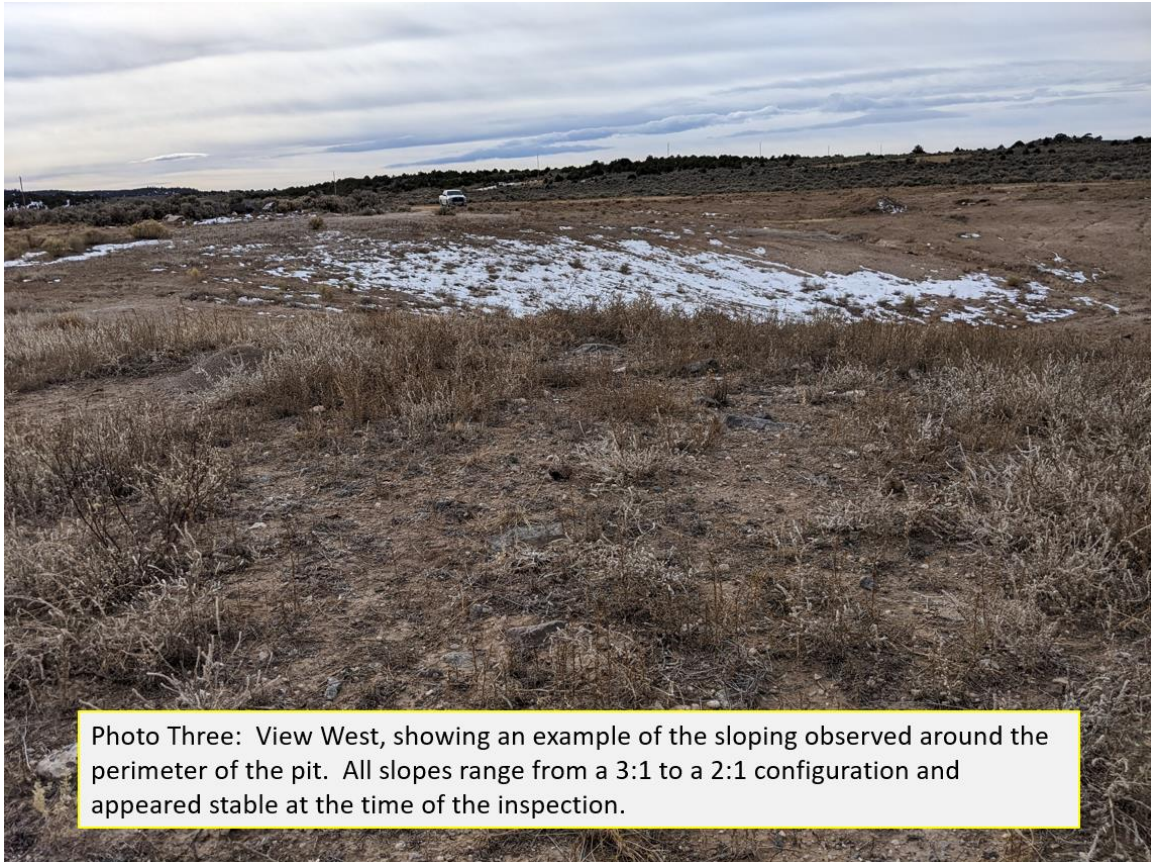
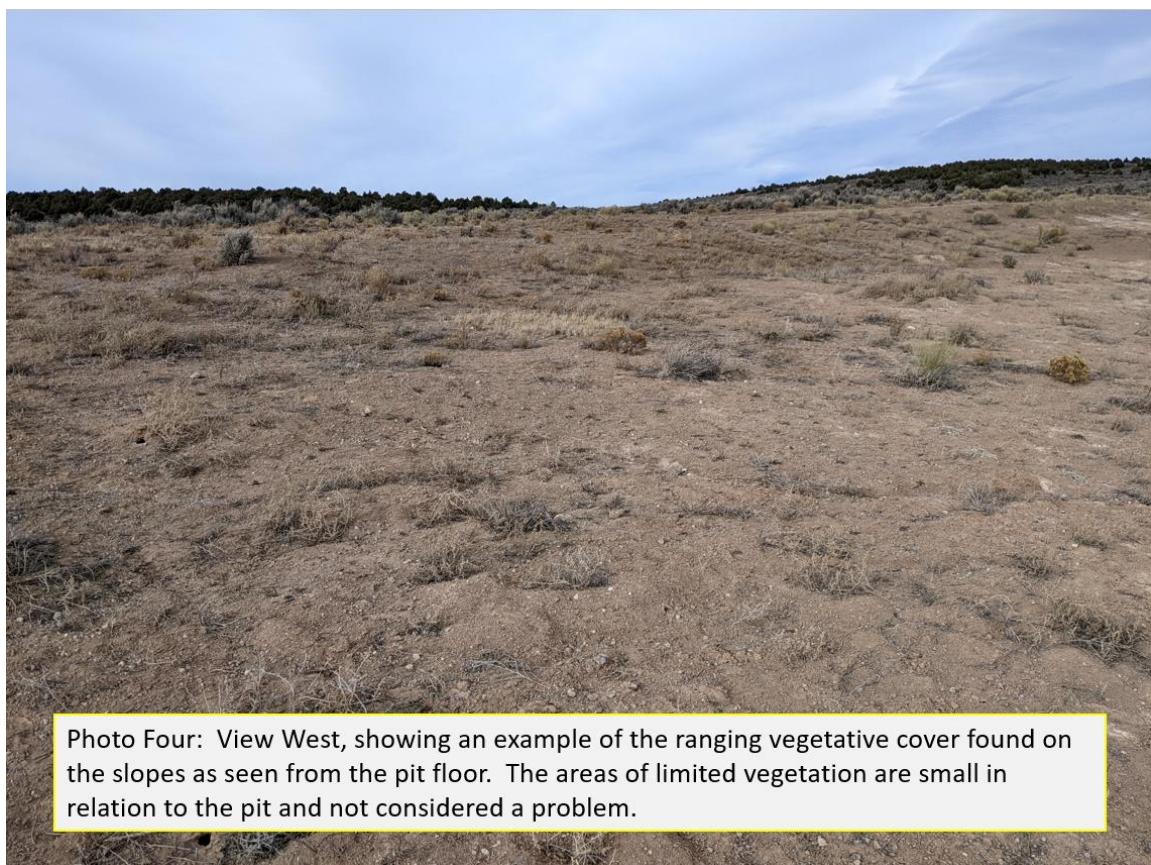
The Pit area has had the side slopes graded to 3H: 1V with isolated areas at approximately 2H: 1V. All slopes appeared to be stable and no signs of settling, slumping or erosion was noted. The pit floor is relatively flat and in good condition. The side slopes are well vegetated with only minor areas of sparse vegetative cover. The majority of the slopes are densely vegetated with native grass species. Examples of the pit area can be seen in Photos Three and Four.
