MINERALS PROGRAM INSPECTION REPORT

MINE NAME: Apache 9	MINE/PROSPECTING ID#: M-1978-009	MINERAL: Clay (general) and sand and gravel	COUNTY: El Paso
INSPECTION TYPE: Surety-Related Inspection	INSPECTOR(S): Timothy Cazier, P.E.	INSP. DATE: June 29, 2022	INSP. TIME: 10:30
OPERATOR: General Shale Brick, Inc.	OPERATOR REPRESENTATIVE: Jason McGraw	TYPE OF OPERATION: 112c - Construction Regular Operation	
REASON FOR INSPECTION: Surety Release Requested	BOND CALCULATION TYPE: Complete Bond	BOND AMOUNT: \$181,161.00	
DATE OF COMPLAINT: NA	POST INSP. CONTACTS: Colo. Land Board	JOINT INSP. AGENCY: None	
WEATHER: Clear	INSPECTOR'S SIGNATURE:

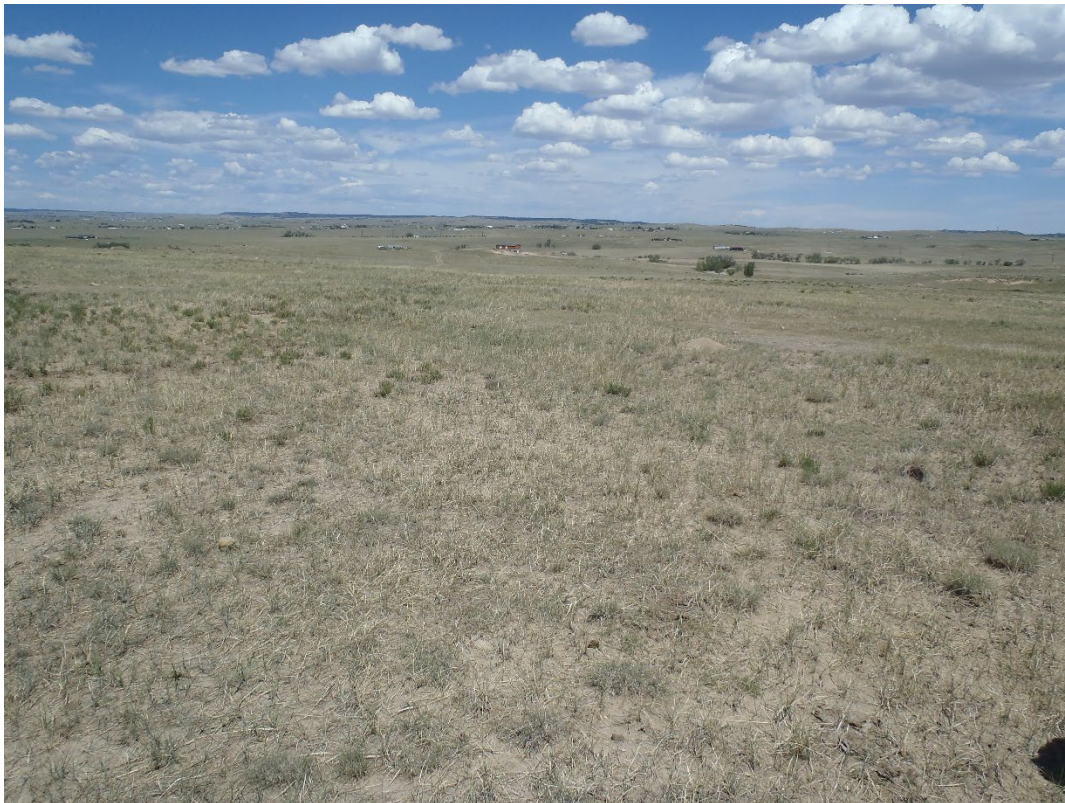
Areas included in the surety reduction request had been backfilled and graded (see **Photos 1, 2 and 3**) some time ago.

Reclamation Success: The 5.3-acre area in Stage 3 (north area - see **Photo 1**) and the 7.7-acre area in Stage 2A (south area - see **Photos 2** and **3**) requested for surety relief are considered reclaimed. However, as they are not released from the permit, the DRMS may hold a bond for reseeding and weed management.

Photo 1. Reclaimed portion of Stage 3 (5.3 acres, looking north).

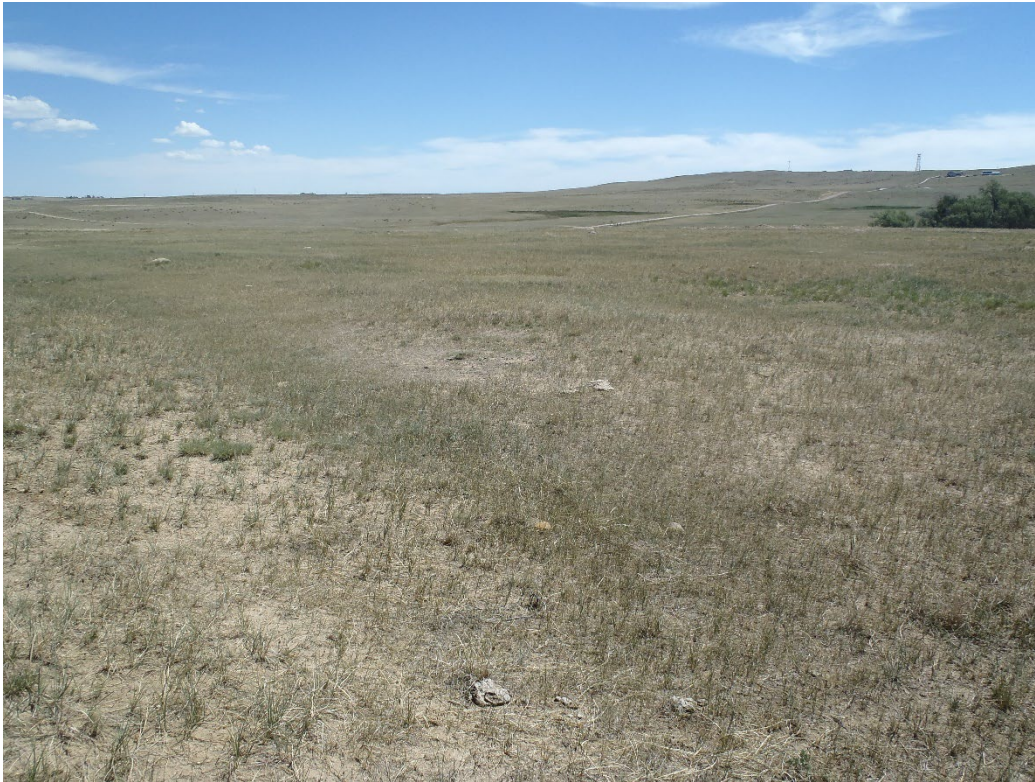
Photo 2. Reclaimed portion of Stage 2A (north end of 7.7 acres, looking SE).

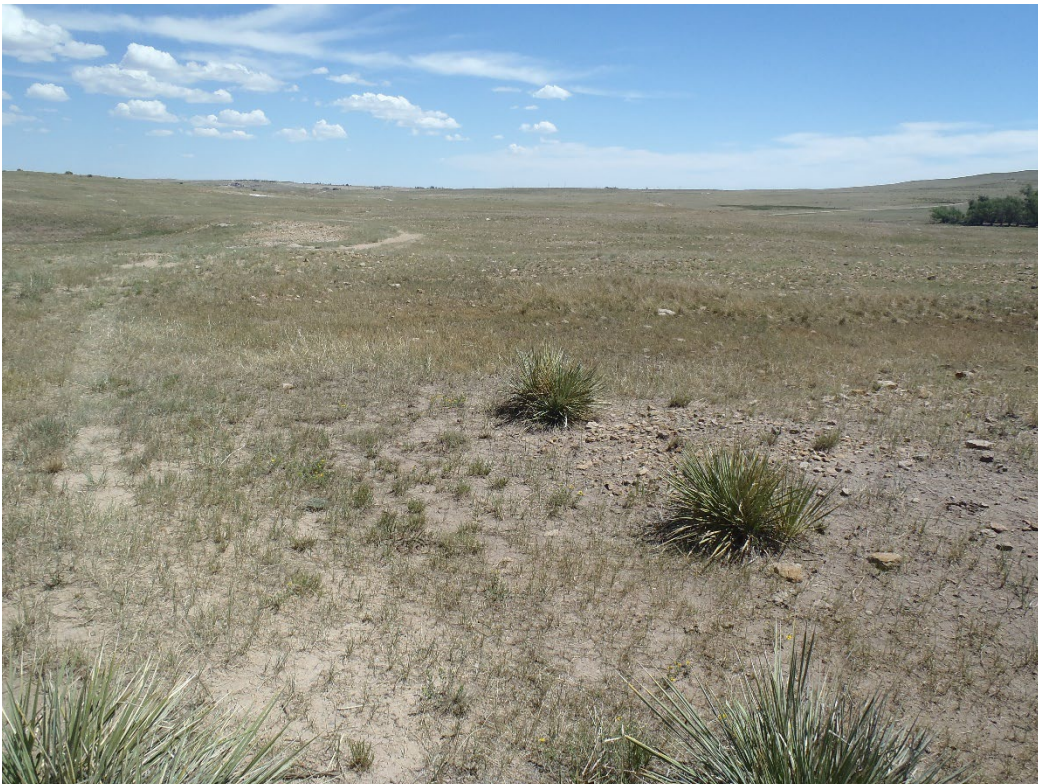
Photo 3. Reclaimed portion of Stage 2A (south end of 7.7 acres, looking north).

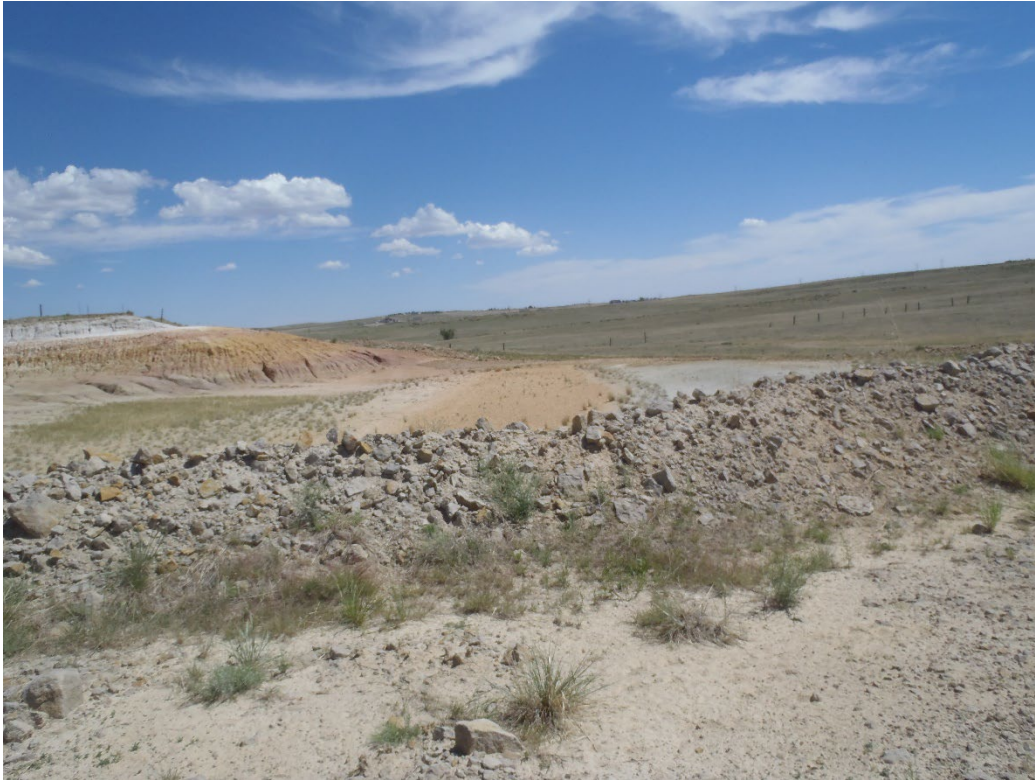
Excess Spoil and Dev. Waste: Overburden piles consist of stockpiled caprock (see **Photo 4**).

Photo 4. Caprock overburden storage (north pit, looking NE).

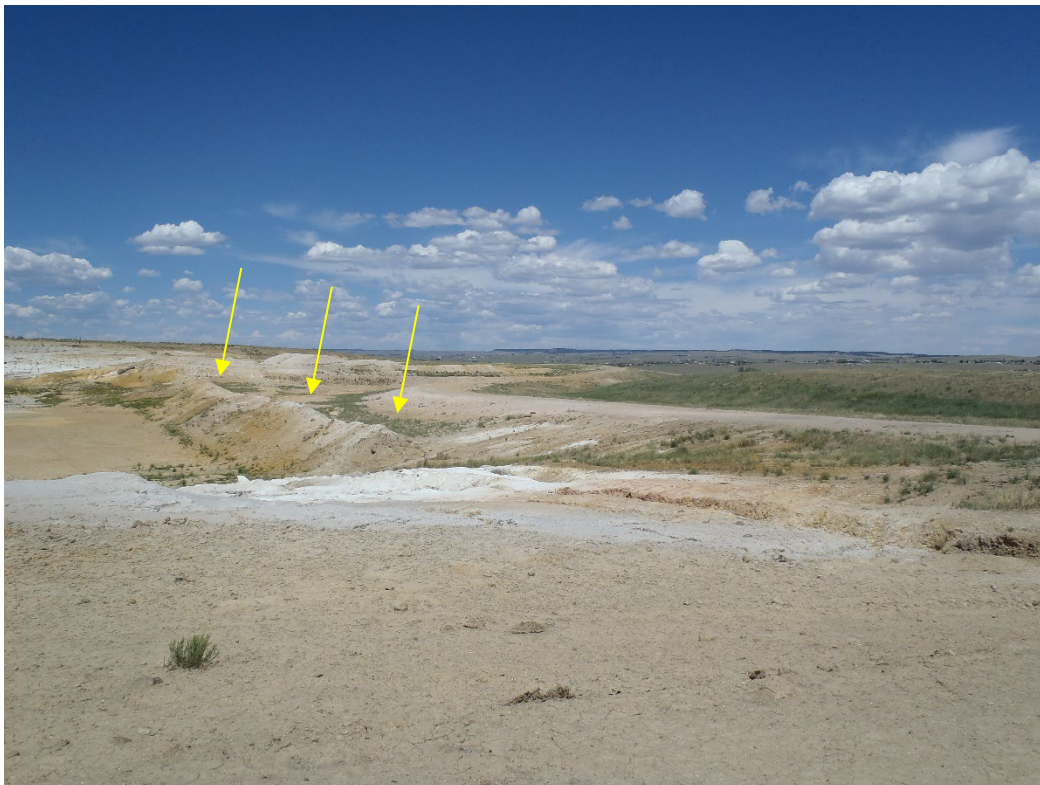
2018 inspection. Mr. McGraw explained he had installed berms (see **Photo 5**) around the south pit to prevent stormwater from entering the depression. As the south pit had no water in it during this inspection (see **Photo 6**), the DRMS determined the installation of BMPs has proven effective and demonstrated the previously observed standing water was not groundwater. The potential problem related to exposed groundwater during the 2018 inspection is considered resolved.

Photo 5. Berm on north side of south pit (looking WNW).

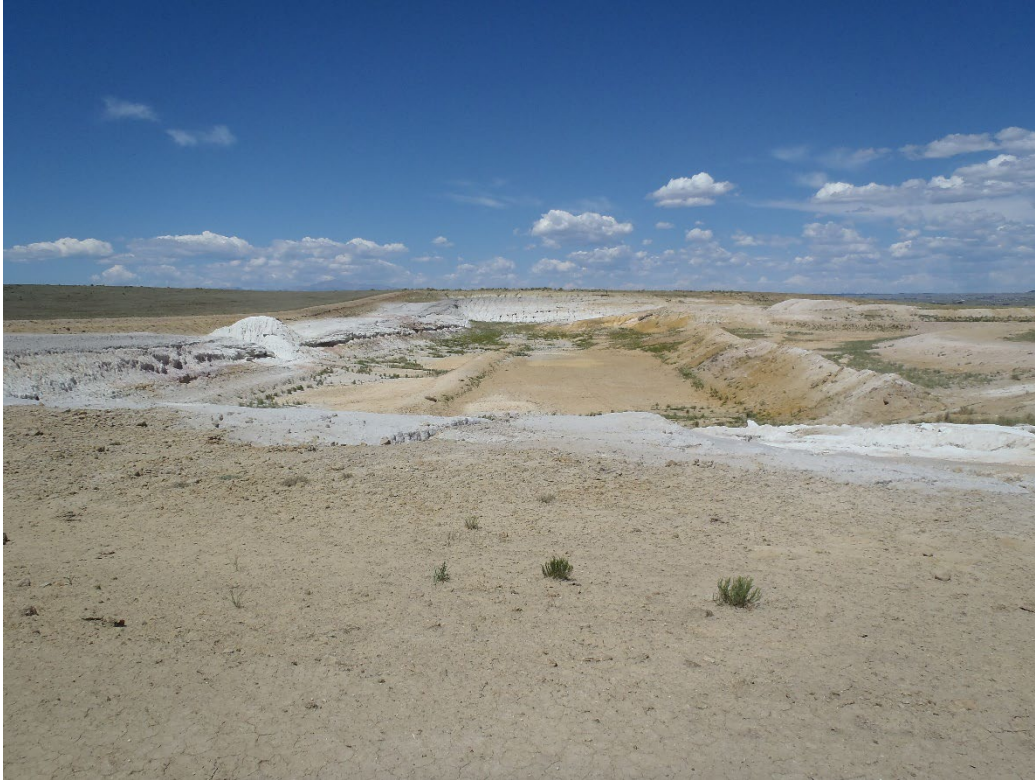
Highwalls were benched in the north pit (see **Photo 7**) with the upper highwall being about 5 feet high and the lower bench being about 7 feet high. The lower bench width is about 100 feet wide. The crest of the upper bench is about 50 feet from the north edge of the Stage 3 affected area boundary (*note Stage 2B is due north and adjacent to Stage 3*). The central pit was not visited as the focus was on the surety reduction areas, for which travel bypassed the central pit. The south pit (see **Photo 6**) is not benched, but appeared stable with the exception of some erosion which is captured in the pit.

Photo 6. Dry south pit (looking west).

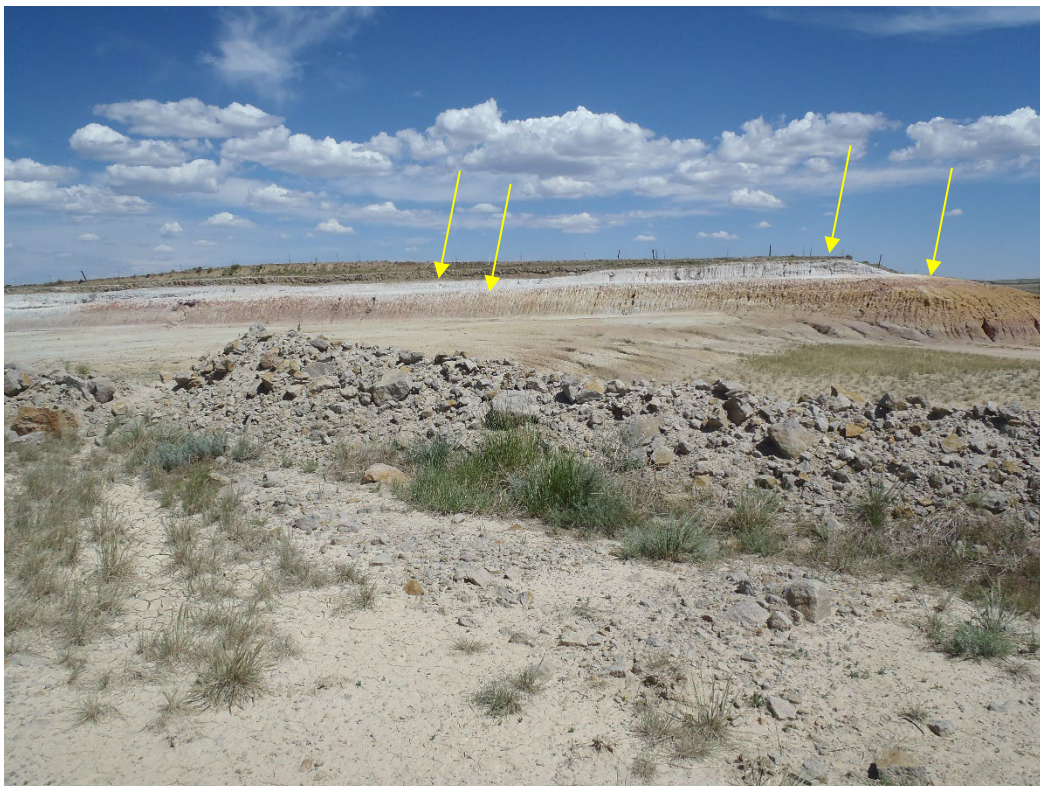
Photo 7. North pit upper and lower benches (looking north).

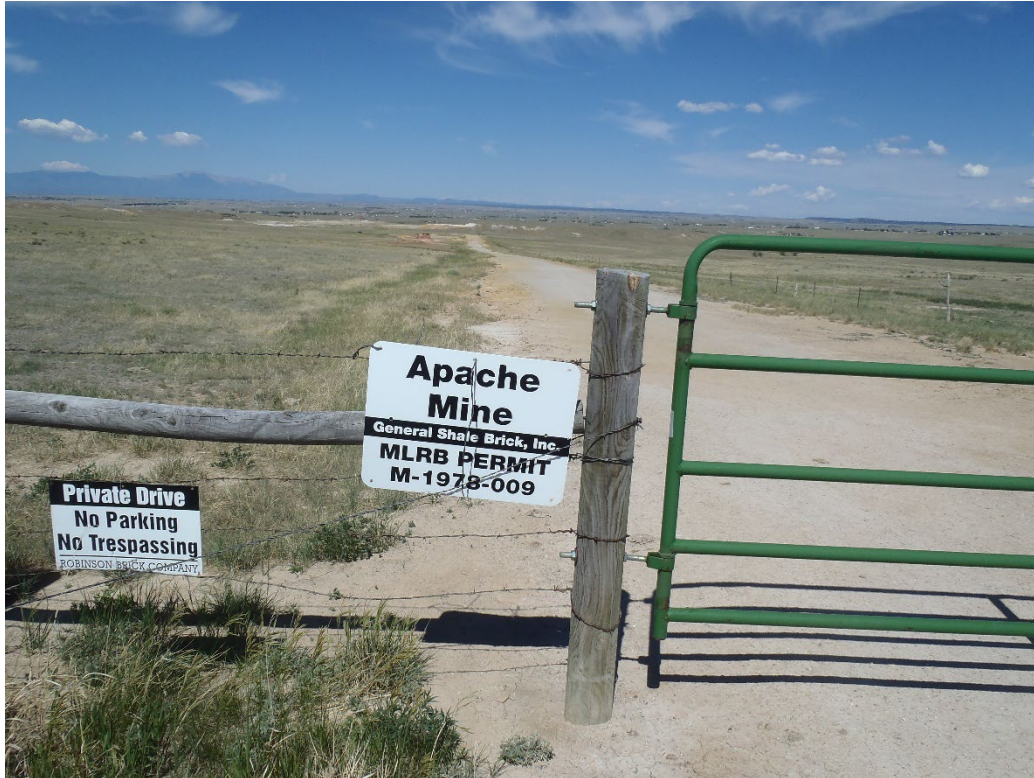
Signs and Markers: The permit sign was properly posted (see **Photo 8**) and boundary markers were observed. The Permittee should be aware that any area considered reclaimed for either a surety reduction or a partial acreage release should to be marked in the field (if not impractical) so as not to be re-disturbed without a

Photo 8. North entrance permit sign.

revision to the permit. Given the complex shapes of the two areas requested for surety relief and that the site is occasionally grazed by cattle, the DRMS would accept a map outlining these areas along with vertex point coordinates (long/lat or UTM) delineate the permit boundary (pursuant to Rule 301.12(3)).
