To: Jerald Schnabel
Continental Materials Corp.
From: Paul Kos
Denver, CO 80222
File: December 2022 Monitoring Summary
Date: January 31, 2023

Reference: December 2022 Geotechnical Monitoring Summary Pikeview Quarry

CONTINENTAL MATERIALS
CORP.
PIKEVIEW QUARRY SLOPE
MONITORING

Title
OBSERVATIONS FROM
DECEMBER INSPECTION

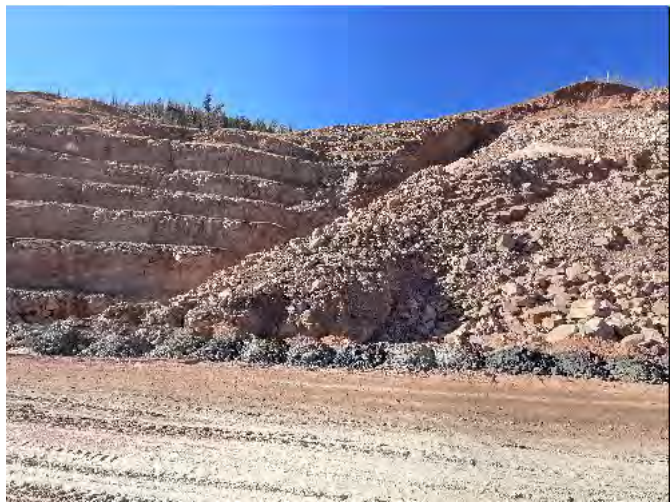
6. Buffer zone on the south-end of the pit floor

- A safety buffer zone is being kept between the active work areas and the toe of the slide to stop any rocks that might come loose during grading operations. Compacted fill is placed in the buffer zone as the buttress fill is placed. (Photo 6)

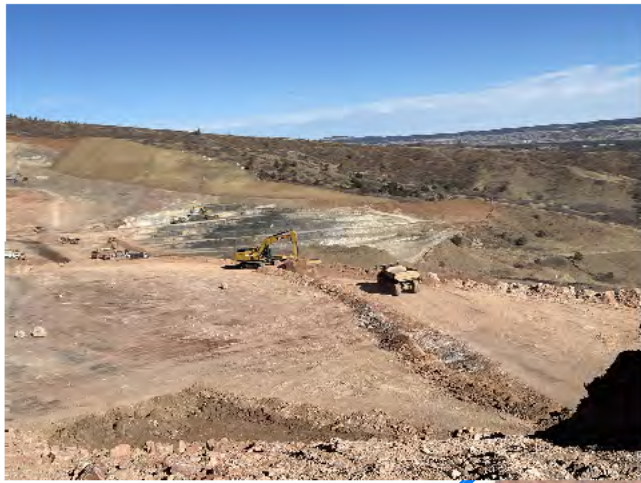
5. NBA benches in the northeast from haul road

- No cracking was observed on the native granite slopes above the extents of the disturbed area. (Photo 7)
- Operators continue to place compacted material in the buttress zone. Material is excavated from the North and South Borrow Areas. Material is initially excavated in benches for the majority of the excavation to efficiently remove the material; these benches are removed for final grading (Photo 5)

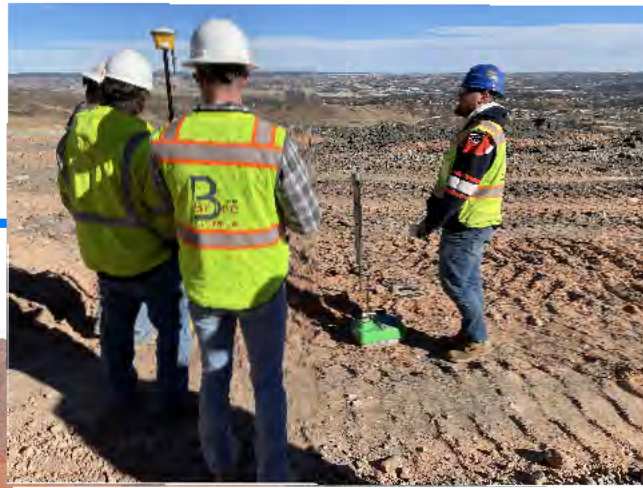
4. Nuclear gauge testing on compacted floor

- Compaction testing continues at the rate of at least one test per 5000 cubic yards of fill placed in the buttress area. (Photo 4)
- Offsite topsoil was stockpiled at the base of the buttress area with the additional topsoil and growth medium.

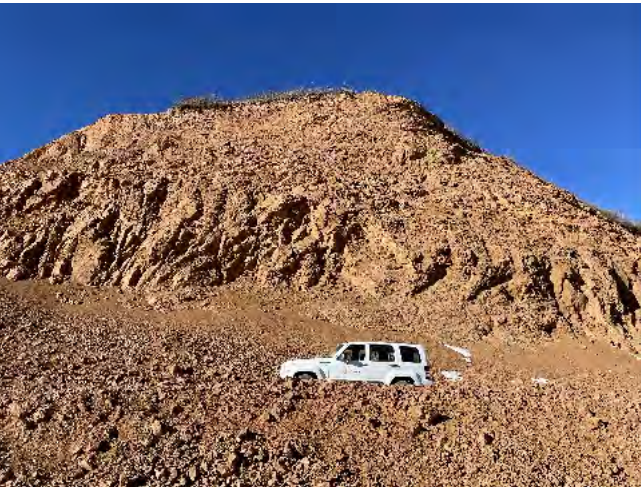
7. View of middle peak above the slide

- Known cracks were monitored for changes. Currently the cracks are not growing in any of the areas on the slopes of the site. The hummocky field in the area immediately above the southern extent of the slide shows evidence of cracking but they are not fresh or active. No new or open cracks were found immediately inside or next to the slide area. (Photo 7)

NOTE 1:
NO CRACKS

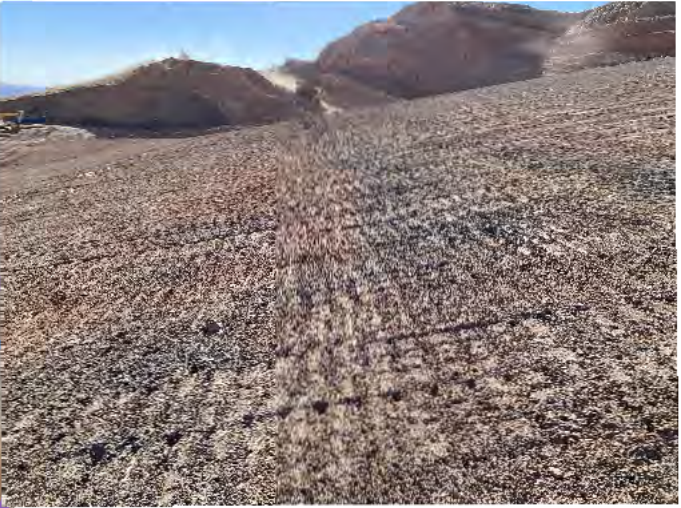
2. Slope at final grade in pit floor

- Reclamation grading began in February 2022 and continued throughout December.
- The slope below the first bench has been placed to the final grade, and this slope was traversed on foot and examined for cracks or signs of instability by Stantec engineers. No cracks or signs of instability were identified. (Photo 2)

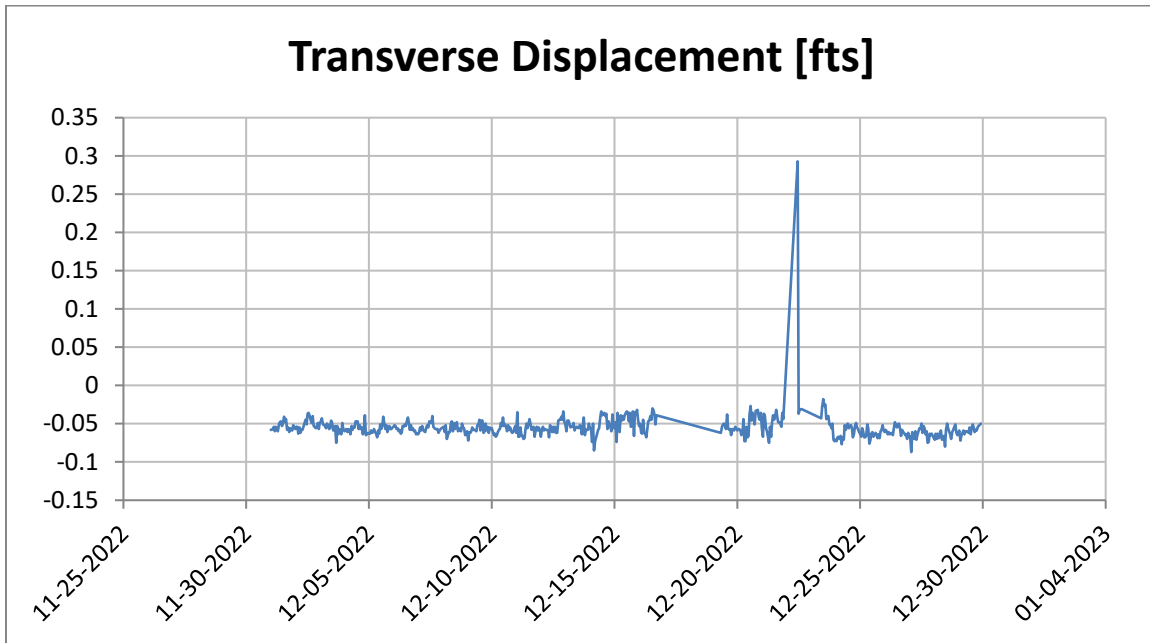
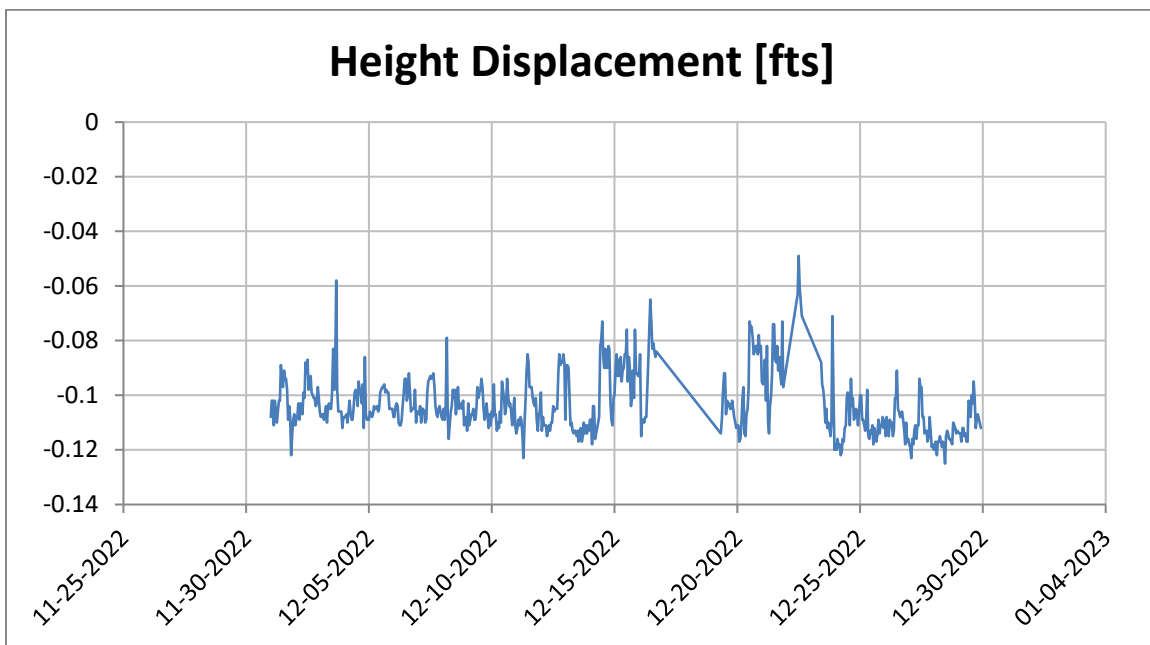
Prism BR1

The data show stable conditions with no movement for 12 of 15 prisms with recorded displacements limited to data scatter and not actual movements. Prisms BR1, BR2, and NP66 are located above the landslide, and these prisms also recorded slope creep movements at slow velocity. This settlement is likely related to the landslide material consolidating under its own weight. New prisms are placed in areas where slope creep movements are likely to be recorded; therefore, slope creep movements being recorded at more locations is expected to occur. Plots of the transverse and height displacements for each prism are included in Appendix B.

1. Survey accuracy is +/-0.016 feet.
2. Alarm threshold is +/-0.35 feet.
3. Transverse displacement is in the horizontal direction. Positive direction means closer to the robotic station.
4. Height displacement is in the vertical direction. Positive direction means higher in elevation.
5. Prism records slope creep movements with slow velocity.
6. Data errors were recorded at each prism on December 22 due to poor weather and communication issues.

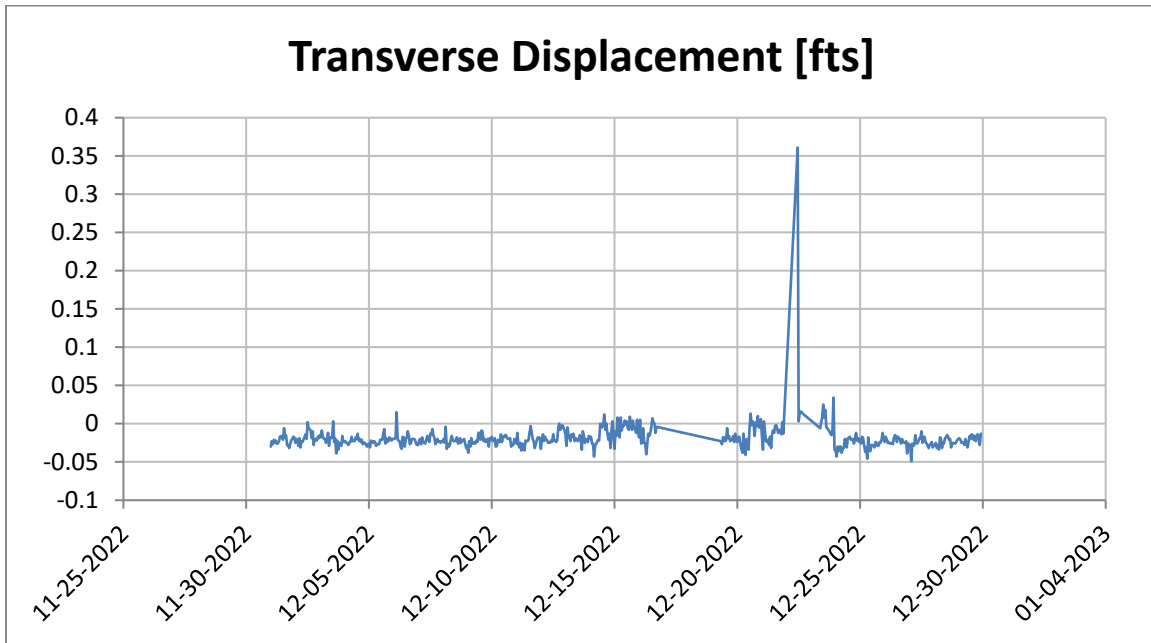
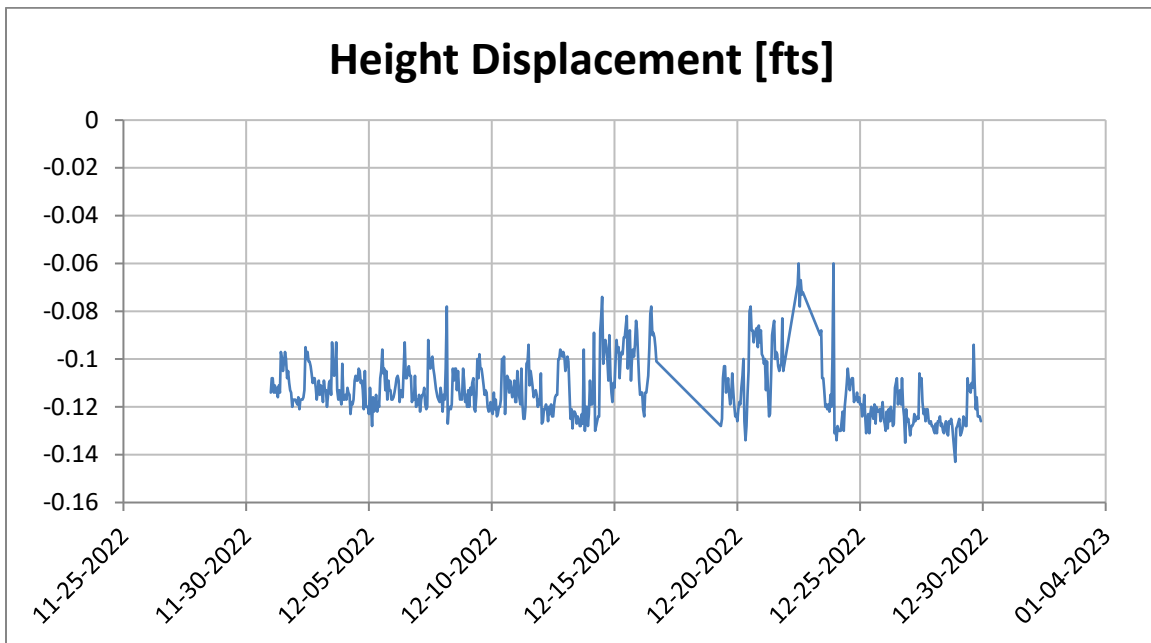
Prism BR2

1. Survey accuracy is +/-0.016 feet.
2. Alarm threshold is +/-0.35 feet.
3. Transverse displacement is in the horizontal direction. Positive direction means closer to the robotic station.
4. Height displacement is in the vertical direction. Positive direction means higher in elevation.
5. Prism records slope creep movements with slow velocity.

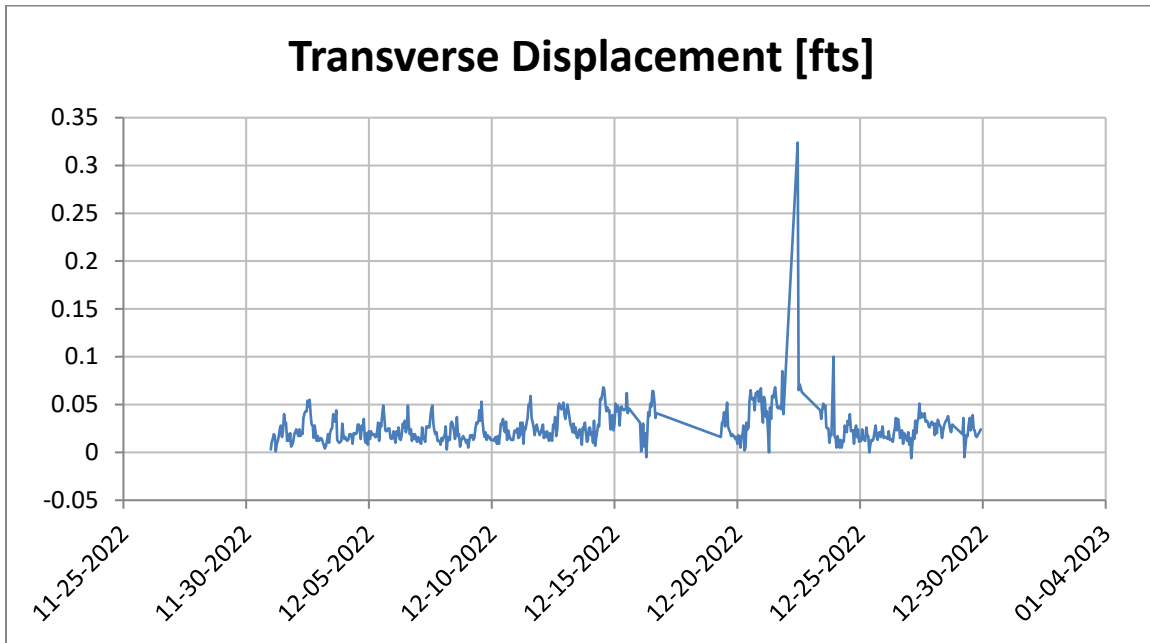
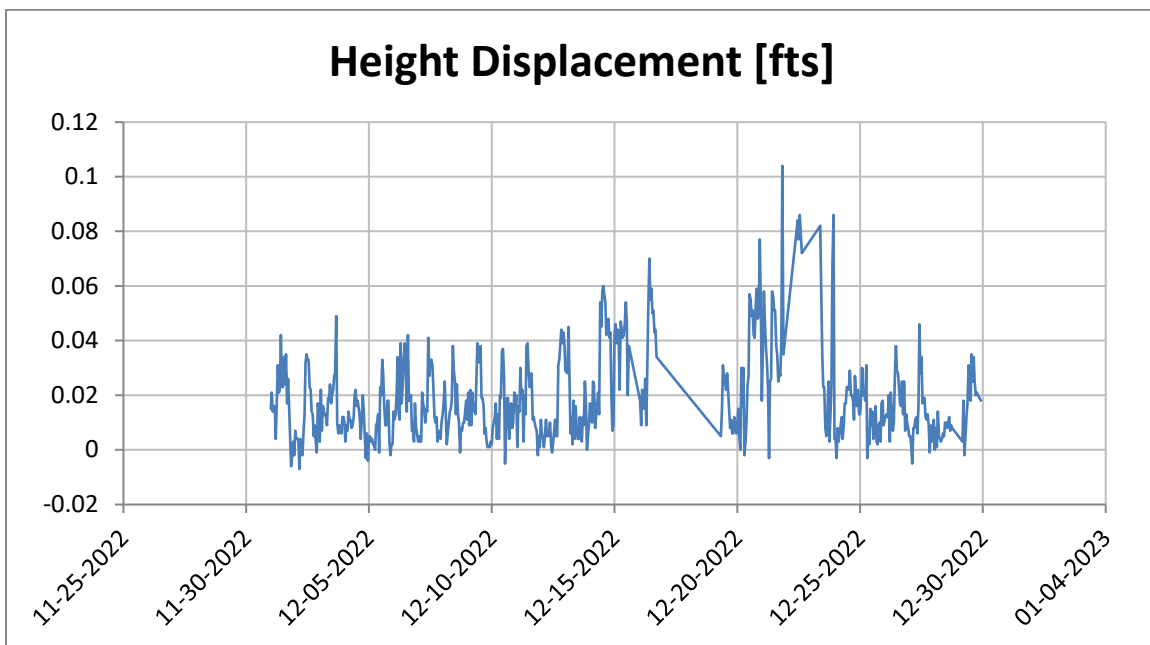
Prism NP2

1. Survey accuracy is +/-0.016 feet.
2. Alarm threshold is +/-0.35 feet.
3. Transverse displacement is in the horizontal direction. Positive direction means closer to the robotic station.
4. Height displacement is in the vertical direction. Positive direction means higher in elevation.
5. Exceedance alerts were received on 12/16, 12/21, 12/22, 12/23, and 12/24.

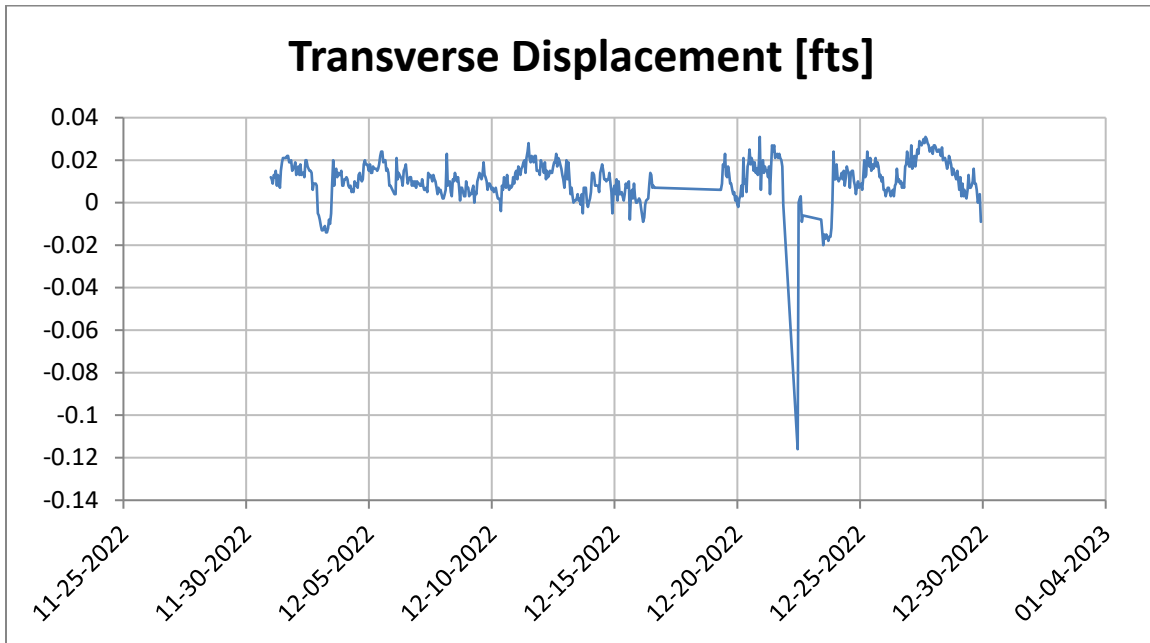
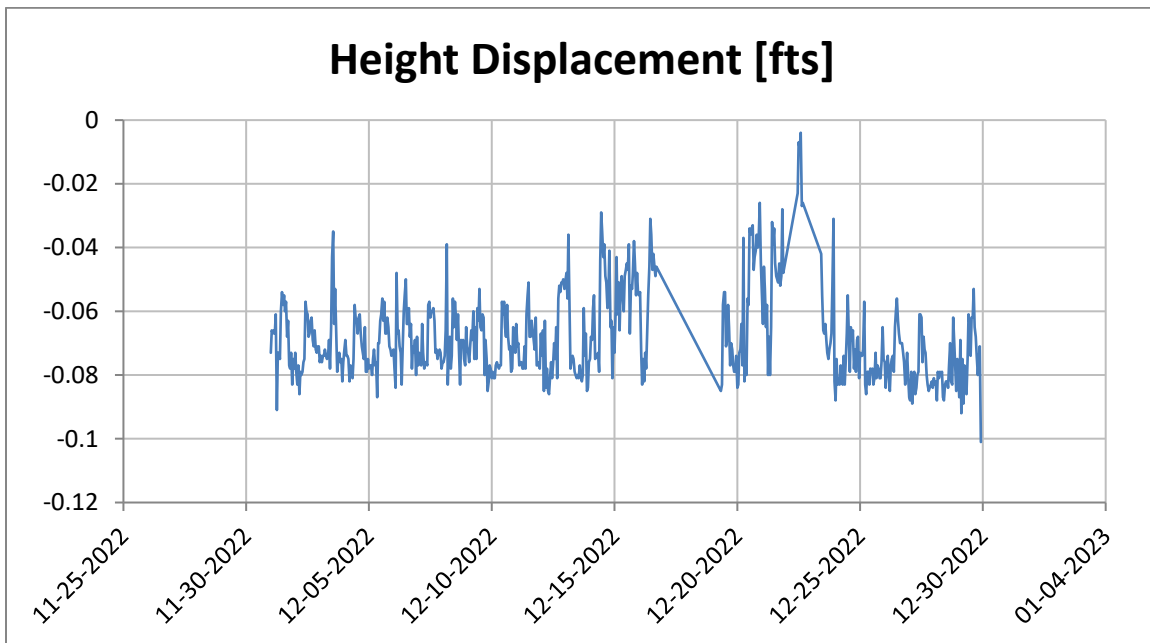
Prism NP66

1. Survey accuracy is +/-0.016 feet.
2. Alarm threshold is +/-0.35 feet.
3. Transverse displacement is in the horizontal direction. Positive direction means closer to the robotic station.
4. Height displacement is in the vertical direction. Positive direction means higher in elevation.
5. Prism records slope creep movements with slow velocity.
6. Exceedance alerts were received on 12/22.

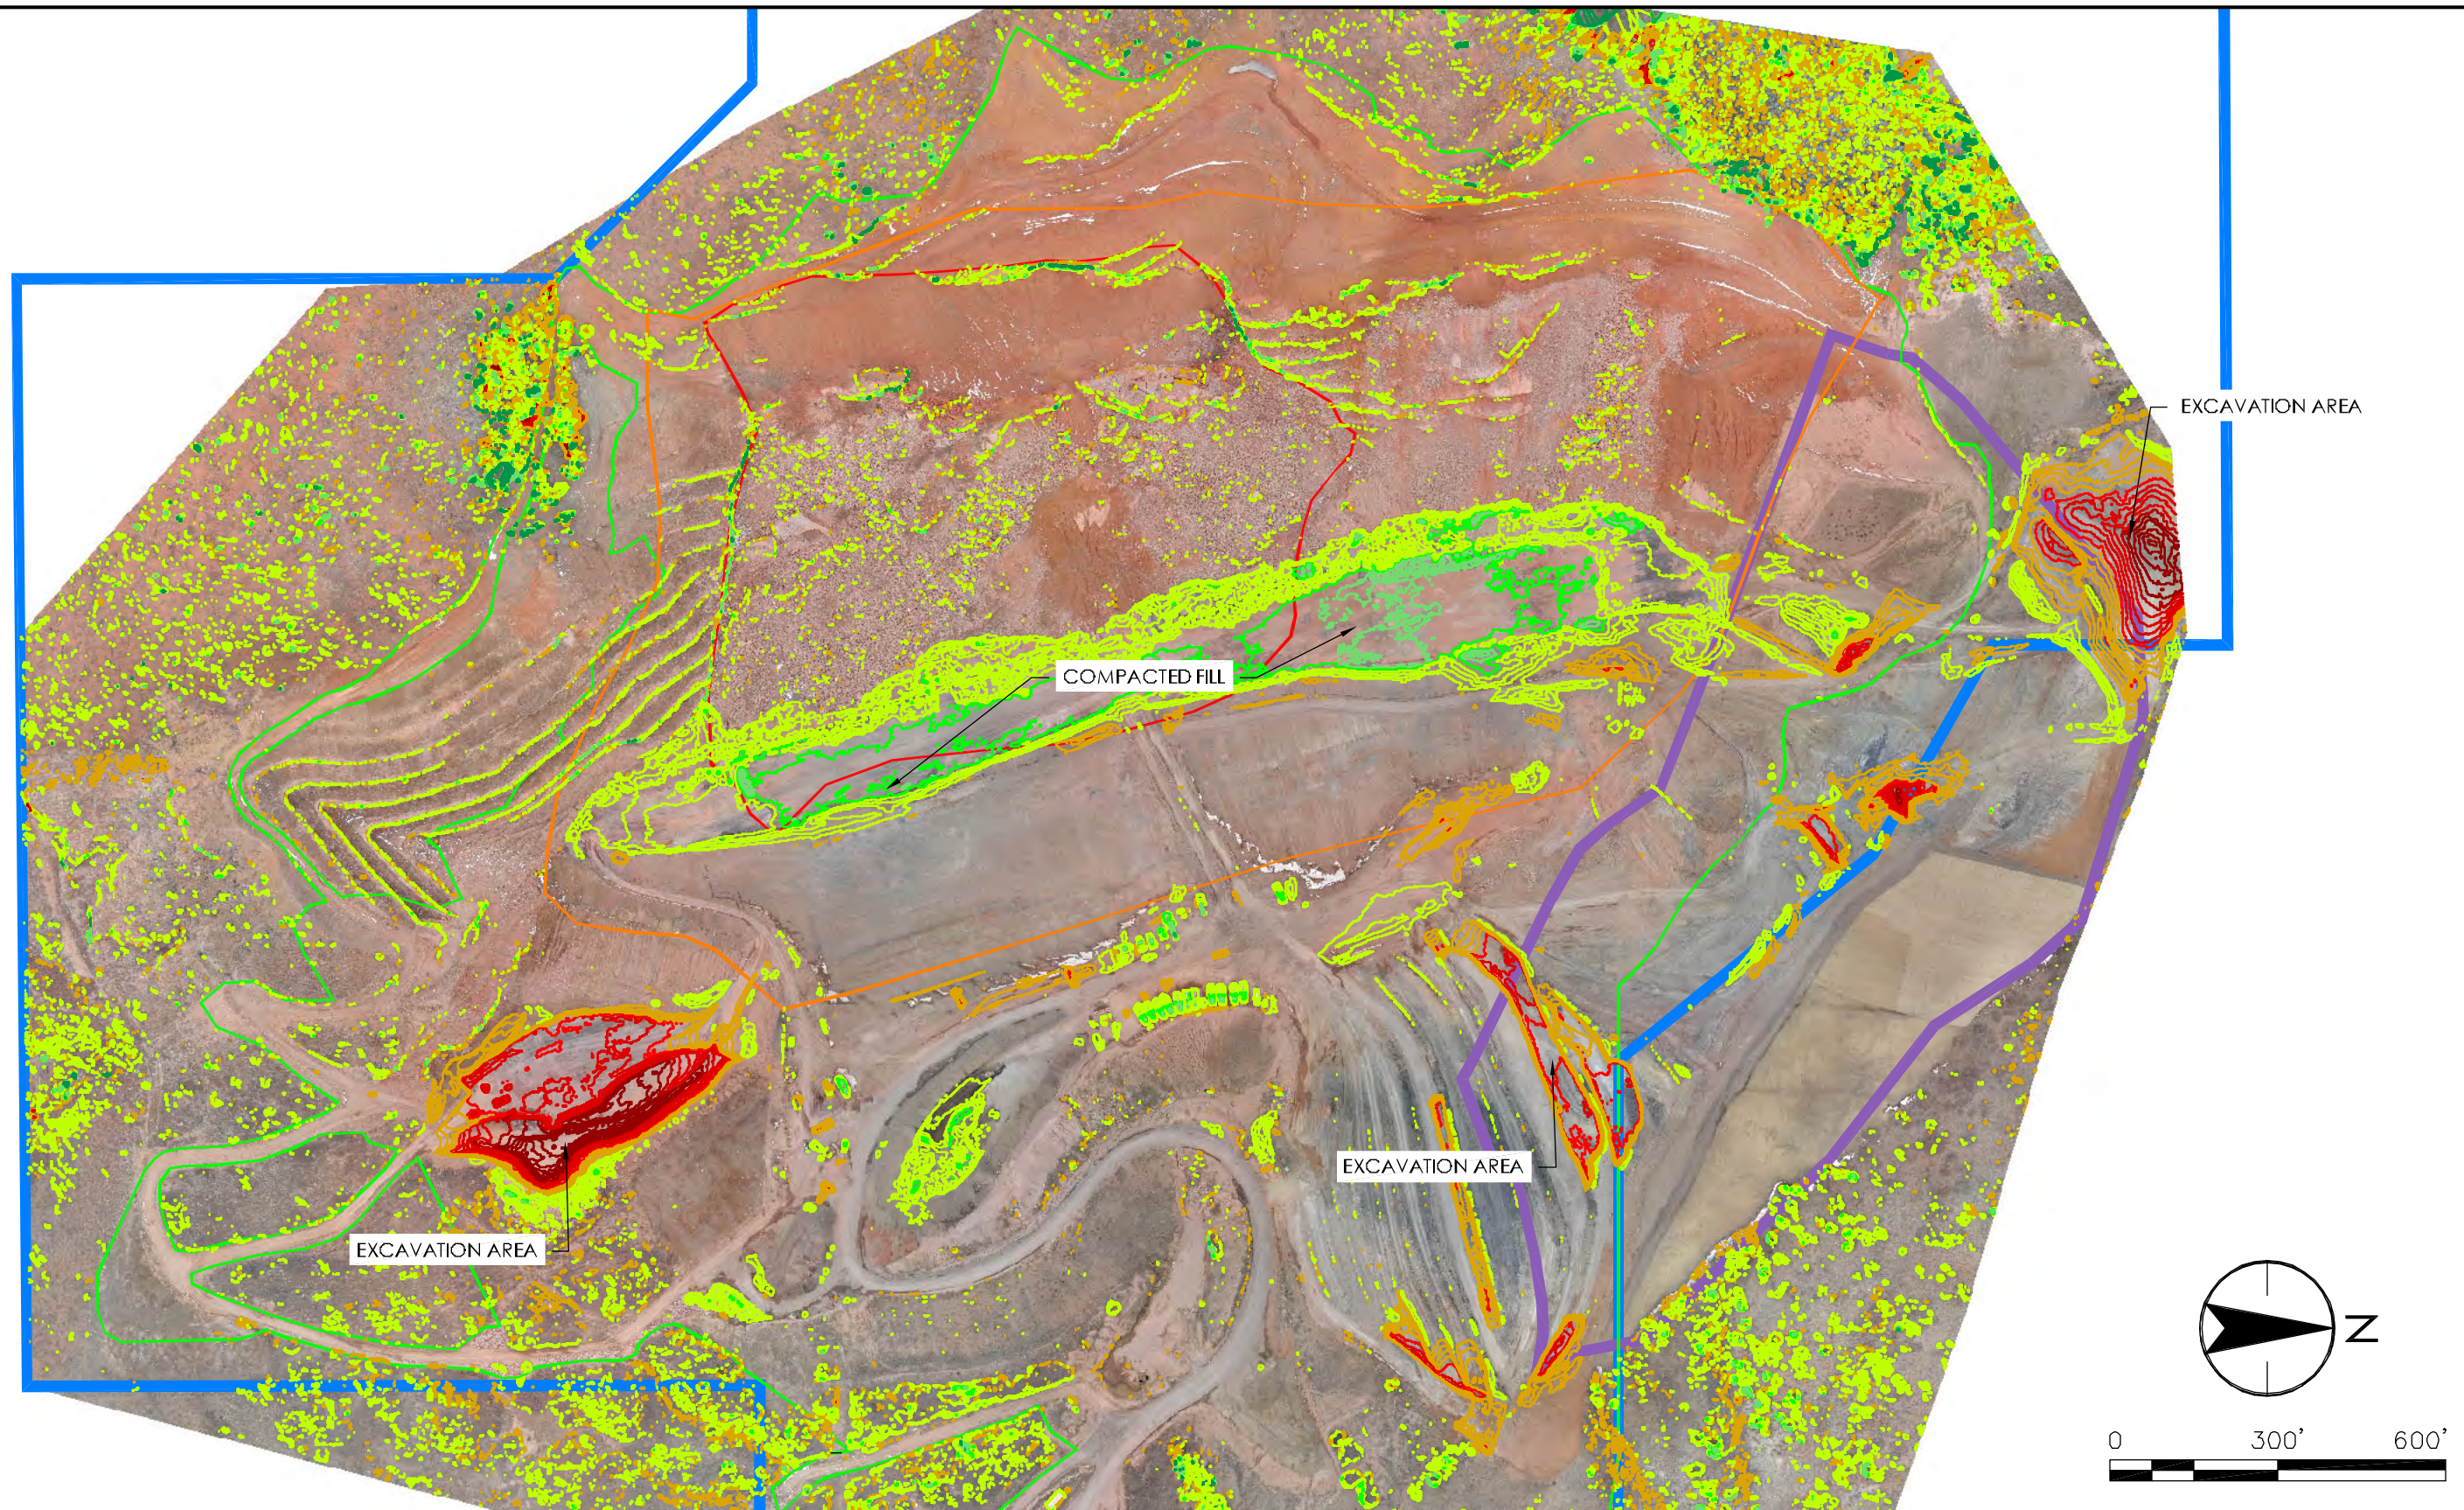
Figure No.
5

The December topography was also compared to the November topography to identify changes in the site topography. Comparison of the two surveys showed the placement of the fill material at the toe of the landslide. Fill material is excavated from the Shop Borrow Area or imported from offsite projects, including the North Borrow Area. No slope movements or other changes in topography were identified. The current imagery and topography are included in Figures 1 and 3, and the comparison surface is included as Figure 5 in Appendix C.

As previously reported in the September 2020 monitoring report, there are limitations with the method of comparing drone surveys from different months. The drone data indicate changes in the slopes along each of the reclamation benches, buildings, and areas with trees or shrubs. These areas are stable, and the changes are the result of survey limitations on or near vertical slopes.
