COLORADO

MINERALS PROGRAM INSPECTION REPORT

MINE NAME: Midway Pit	MINE/PROSPECTING ID#: M-1988-018	MINERAL: Sand and gravel	COUNTY: El Paso
INSPECTION TYPE: Monitoring	WEATHER: Cloudy	INSP. DATE: January 24, 2023	INSP. TIME: 09:00
OPERATOR: Midway Aggregates, RLLP	OPERATOR REPRESENTATIVE: Joe Baxter & Tim Gerken	TYPE OF OPERATION: 112c - Construction Regular Operation

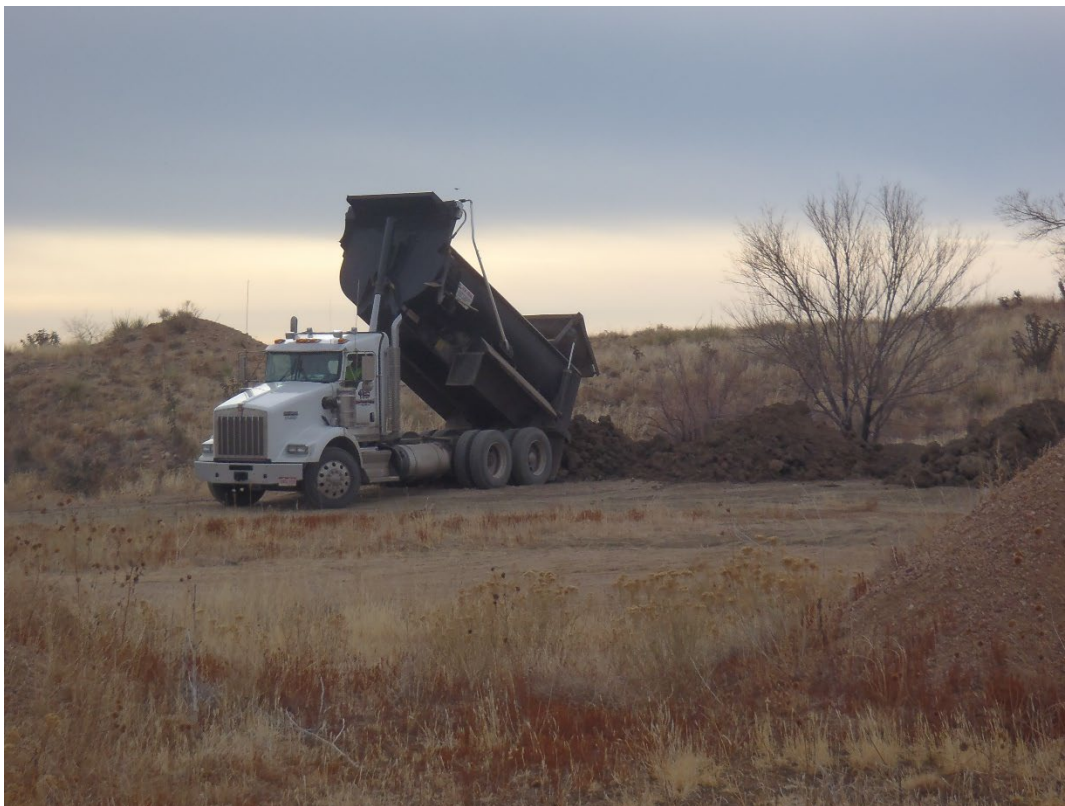
PROBLEM/POSSIBLE VIOLATION: Problem No. 2: The site is utilizing off-site fill without prior approval by the Division per 3.1.5(9) of the Rule.

Backfilling and Grading: No change in grading was observed from the previous inspection. Sufficient backfill material appeared to be available for highwall backfill. Shortly after arrival, an independent contractor (Pate Construction) arrived in a haul truck bringing in offsite fill. The driver indicated he and others had been bringing offsite fill for some time. He estimated he'd brought in roughly 70 loads and had about a dozen trips left. He stated the material was coming from the nearby Fort Carson. The area where the imported material had been placed was observed (see **Photo 1**) during the inspection. Most of the material was a mixture of sand and clay (see **Photo 2**), but there was also a considerable amount of what appeared to be concrete bases for guardrail posts (see **Photo 3**) and some sections of asphalt. The placed imported material appeared to be clean and inert as required by Rule 3.1.5(9). The approved permit does not allow the import of backfill material. **The absence of written approval for the importation of backfill material is cited as Problem No. 2 on p. 1 of this report.**

Photo 1. Placing imported fill (east end, looking south).

CORRECTIVE ACTIONS: The operator shall provide a notarized affidavit, stating that the fill is, in fact, inert and addressing all requirements pursuant to Rule 3.1.5(9), which describes the intended use of inert/off-site fill by the corrective action date.

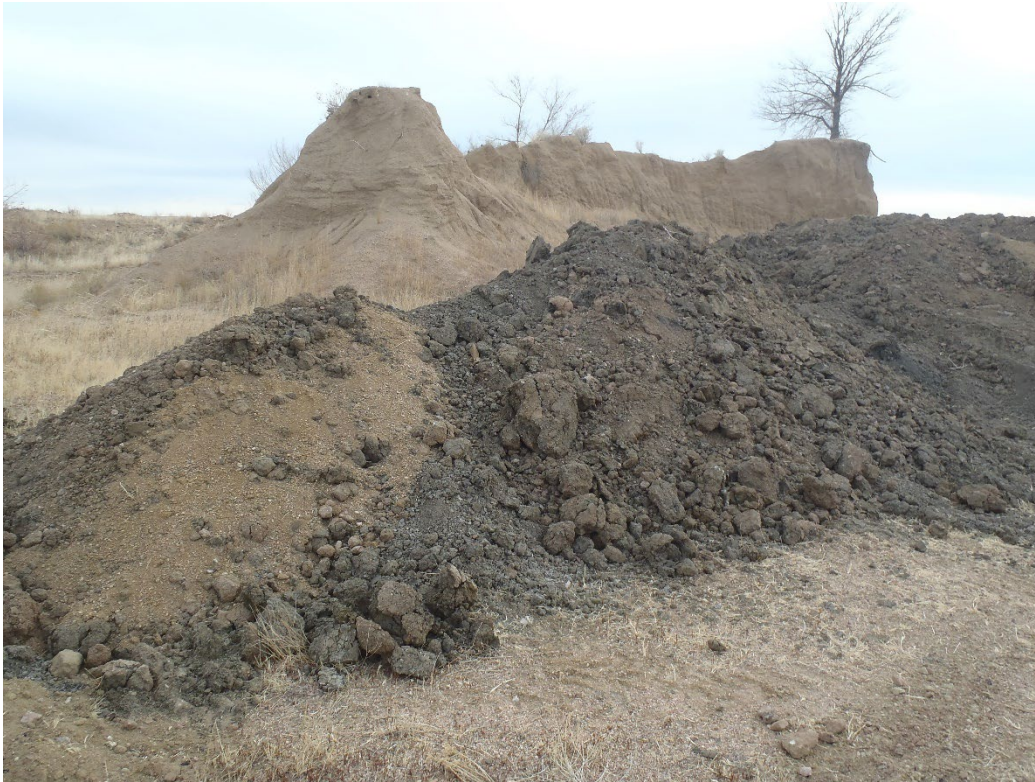
Photo 2. Placed imported fill (sand and clayey material – east end looking east).

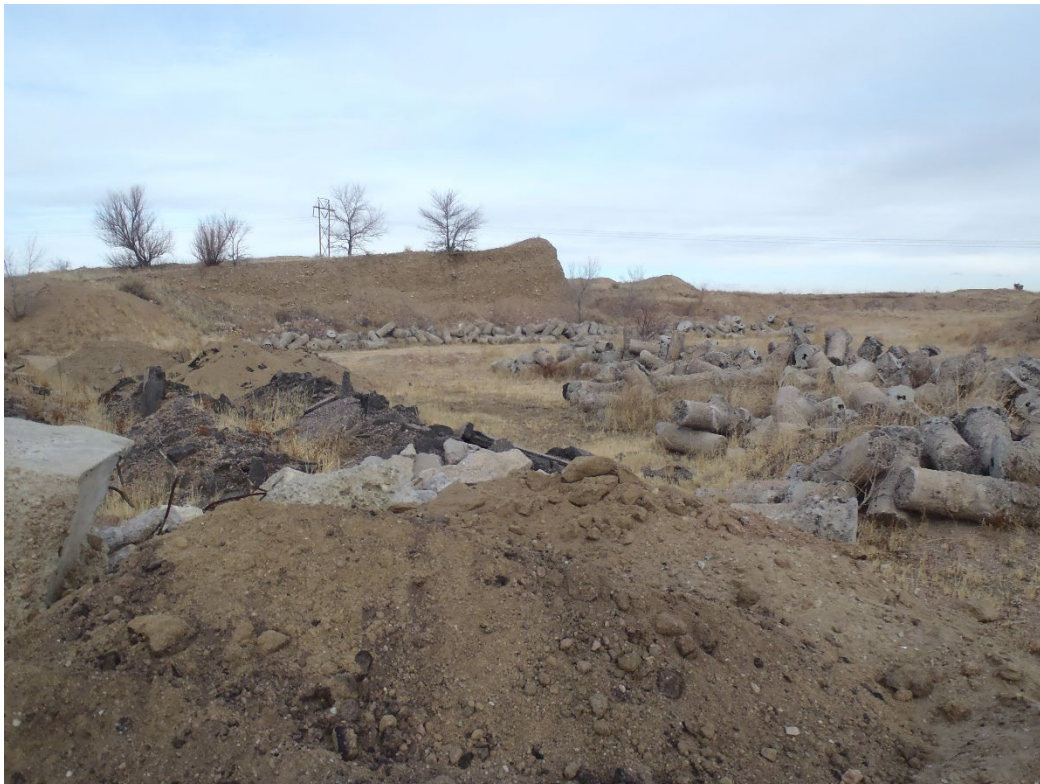
Photo 3. Placed imported fill (asphalt and concrete – east end looking north).

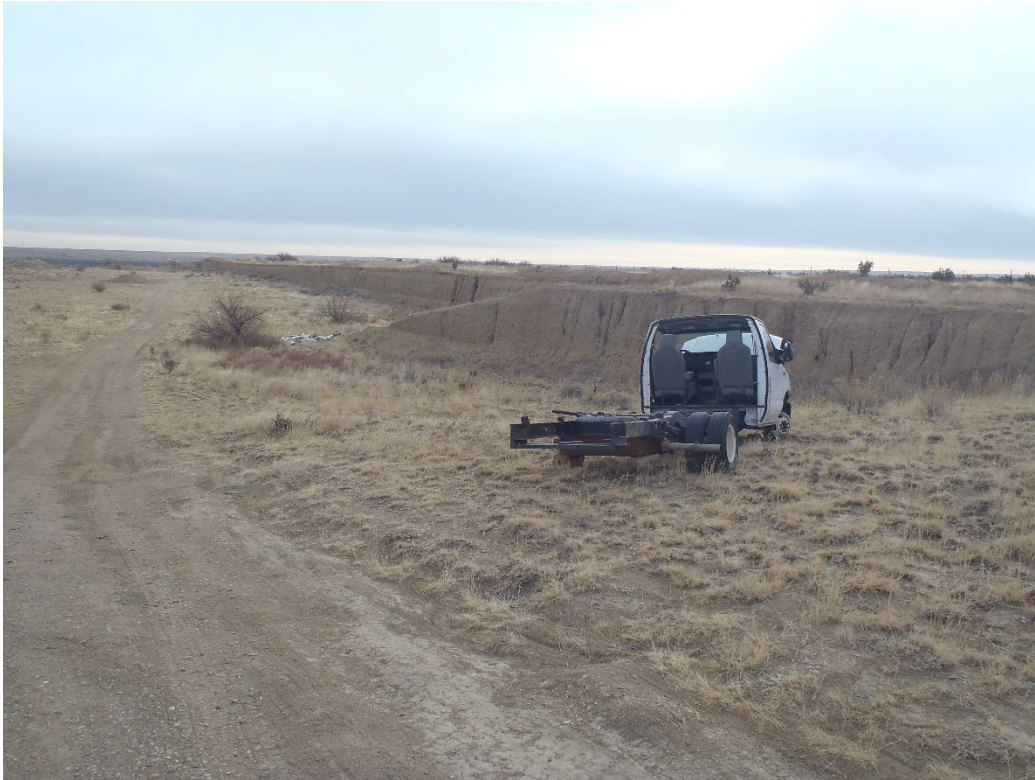
Reclamation Success: No reclamation has been initiated. The remains of what appeared to be a passenger van (see **Photo 4**) was found at the west end of the site. This and other observed trash (see **Photos 5** and **6**) will need to be removed for final reclamation.

Photo 4. Remains of passenger van (west end, looking SE).

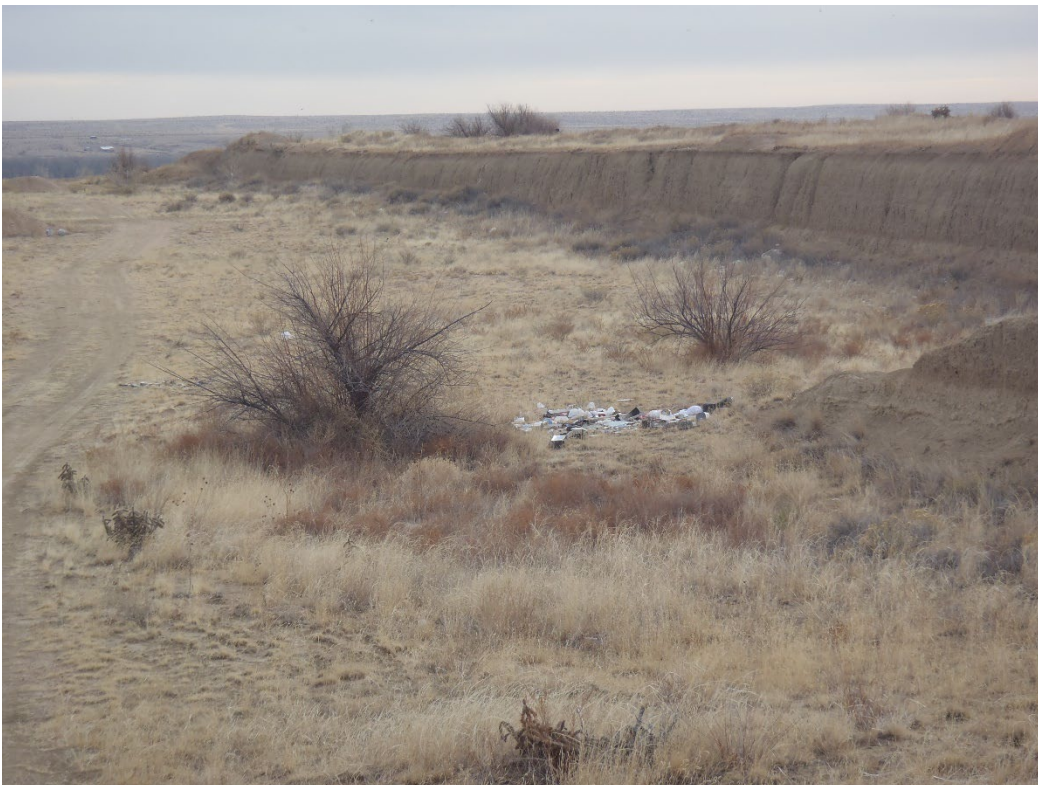
PROBLEM/POSSIBLE VIOLATION: Problem No. 4: Tamarisk (salt cedar) trees are present within or have volunteered into the permit area and are becoming established. This is a problem for failure to employ weed control methods for a state listed noxious weed species within the permitted area, and to reduce the spread of weeds to nearby areas as required by Section 3.1.10 (6) of the rule.

Revegetation: Some large tamarisk were observed in the west pit (see **Photo 5**) and near where the access road enters the floor of the east side (see **Photo 7**), also near where the imported fill was placed. **The presence of a noxious weed List B species is cited as Problem No. 4 on p. 2 of this report.** The Permittee should implement the approved weed control program (TR-3) to reduce propagation of tamarisk on site. No revegetation had been initiated.

Photo 5. Tamarisk and trash in west pit (looking SE).

CORRECTIVE ACTIONS: The operator shall implement the existing weed control plan in accordance with Section 3.1.10 (6) of the Rule and submit documentation demonstrating the tamarisk on site have been treated by the Corrective Action date.

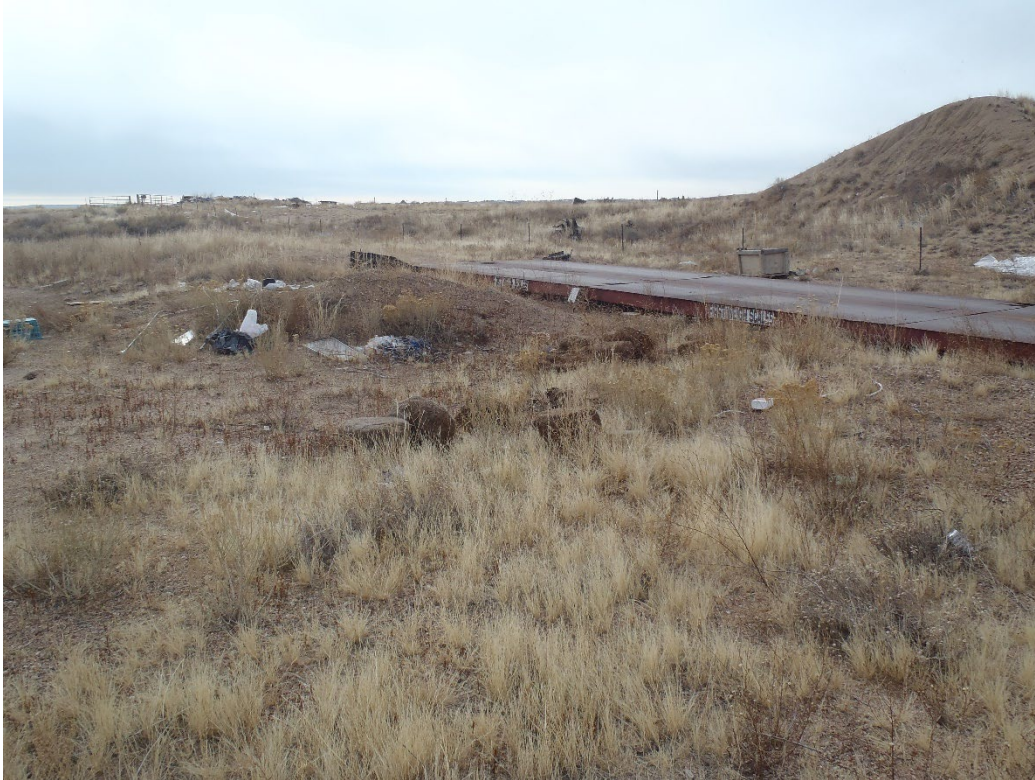
Photo 6. Trash near truck scale (scale house removed).

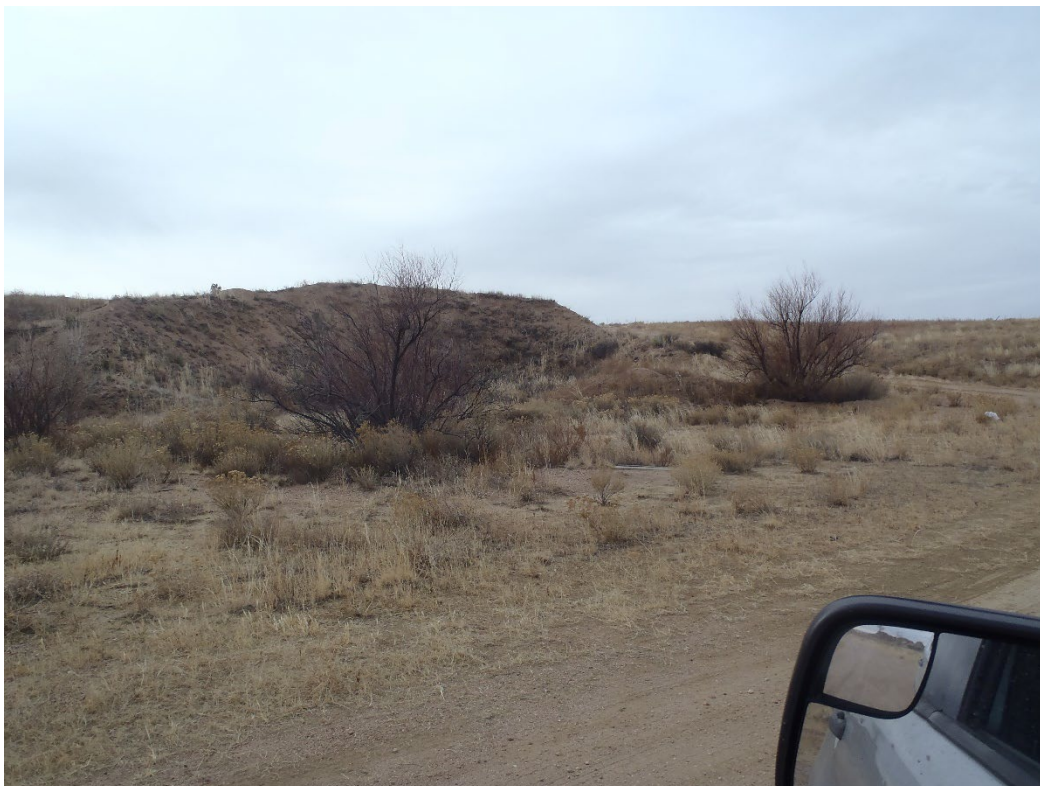
Photo 7. Tamarisk near access road entrance into east pit floor (looking SW).

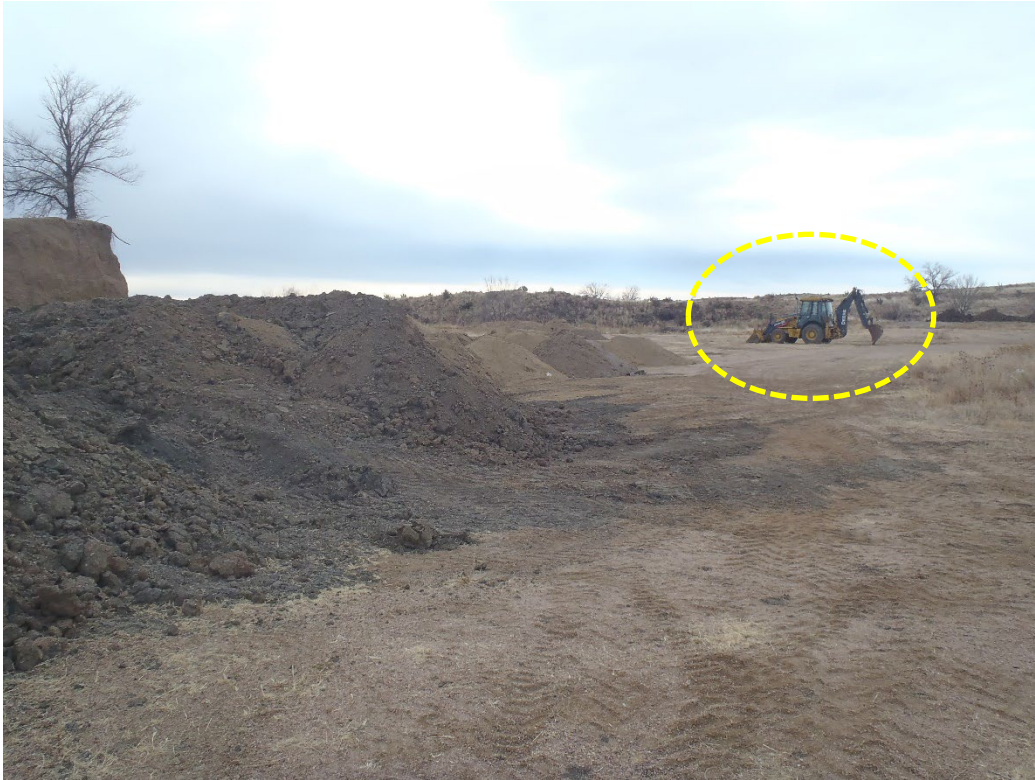
Support Facilities On-site: A backhoe observed on site (see **Photo 8**). Mr. Baxter stated the scale house had been recently removed due to vandal activity on site. The truck scale remained.

Photo 8. Backhoe on south end of east pit floor, imported fill on left (looking south) .

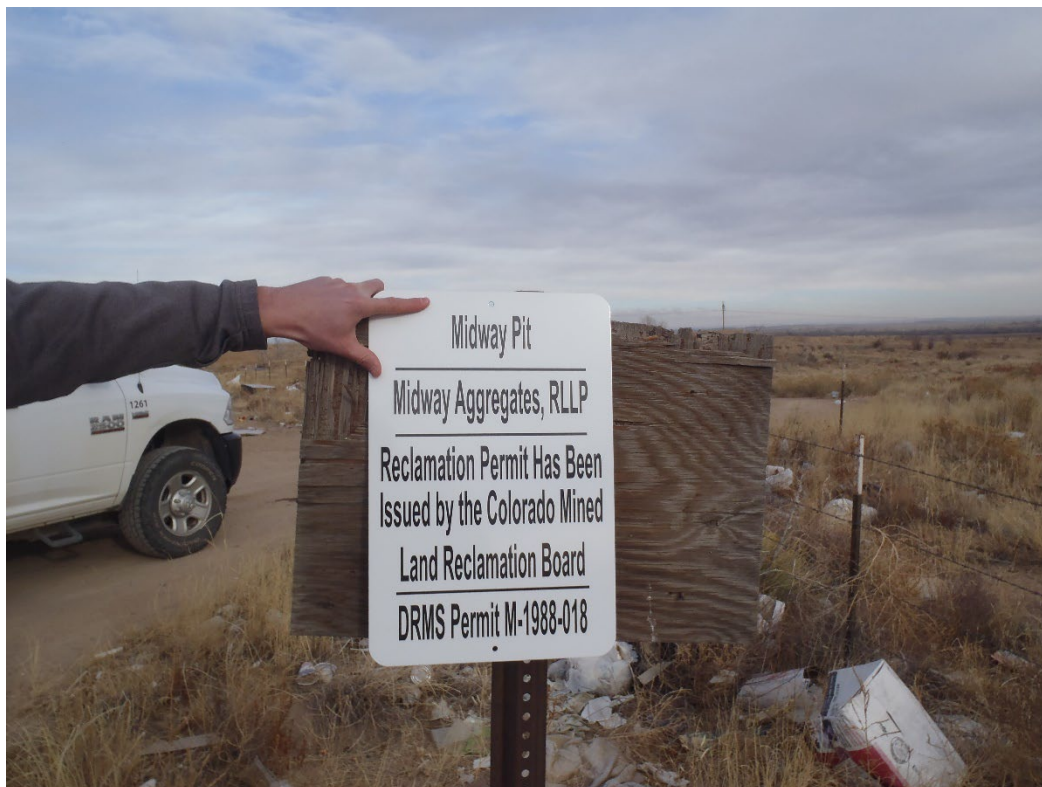
Signs and Markers: The permit sign was observed at the site entrance off Boca Raton Heights road (see **Photo 9**) and fences were observed to delineate the affected area boundary.

Photo 9. Permit sign at entrance.
