**MINERALS PROGRAM INSPECTION REPORT**  
**PHONE: (303) 866-3567**

<b>MINE NAME:</b> Daniels Sand Pit 2	<b>MINE/PROSPECTING ID#:</b> M-1973-007-SG	<b>MINERAL:</b> Sand and gravel	<b>COUNTY:</b> El Paso
<b>INSPECTION TYPE:</b> Monitoring	<b>WEATHER:</b> Clear	<b>INSP. DATE:</b> November 3, 2022	<b>INSP. TIME:</b> 09:00
<b>OPERATOR:</b> Aggregate Industries - WCR, Inc.	<b>OPERATOR REPRESENTATIVE:</b> Neil Whitmer, Wyatt Webster, Grant Smith	<b>TYPE OF OPERATION:</b> 112c - Construction Regular Operation	
<b>REASON FOR INSPECTION:</b> Normal I&E Program	<b>BOND CALCULATION TYPE:</b> Partial Bond	<b>BOND AMOUNT:</b> \$1,038,500.00	
<b>DATE OF COMPLAINT:</b> NA	<b>POST INSP. CONTACTS:</b> None	<b>JOINT INSP. AGENCY:</b> None	
<b>INSPECTOR(S):</b> Timothy Cazier, P.E. Amber Michels	<b>INSPECTOR'S SIGNATURE:</b>

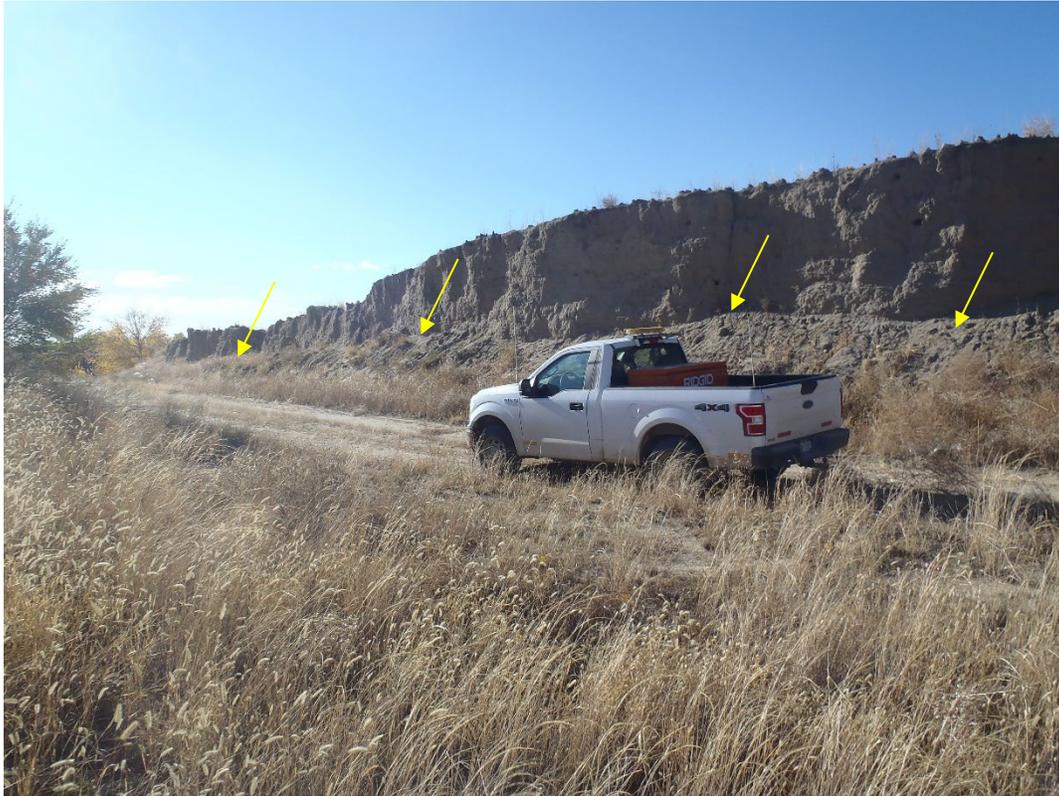
**Backfilling and Grading:** Sufficient backfill material appeared to be available. There is a tall berm (see **Photo 1**) on the west side of the old wash pond. Site representatives this berm may be in the CDOT right-of-way for Academy Blvd. [The ownership of this berm needs to be determined in order to finalize the reclamation grading approach: push down from the crest, or truck material from elsewhere on site and backfill.](#) The east side of the berm, facing the old wash pond is sloughing and is not stable. However, offsite impacts are negligible as the elevation on the wash pond side and the Academy Blvd. side are about the same as can be seen from a photo taken during the December 12, 2016 inspection (see **Photo 2**).

Photo 1. Old wash pond berm – vertical side (note sloughing [arrows], looking south).

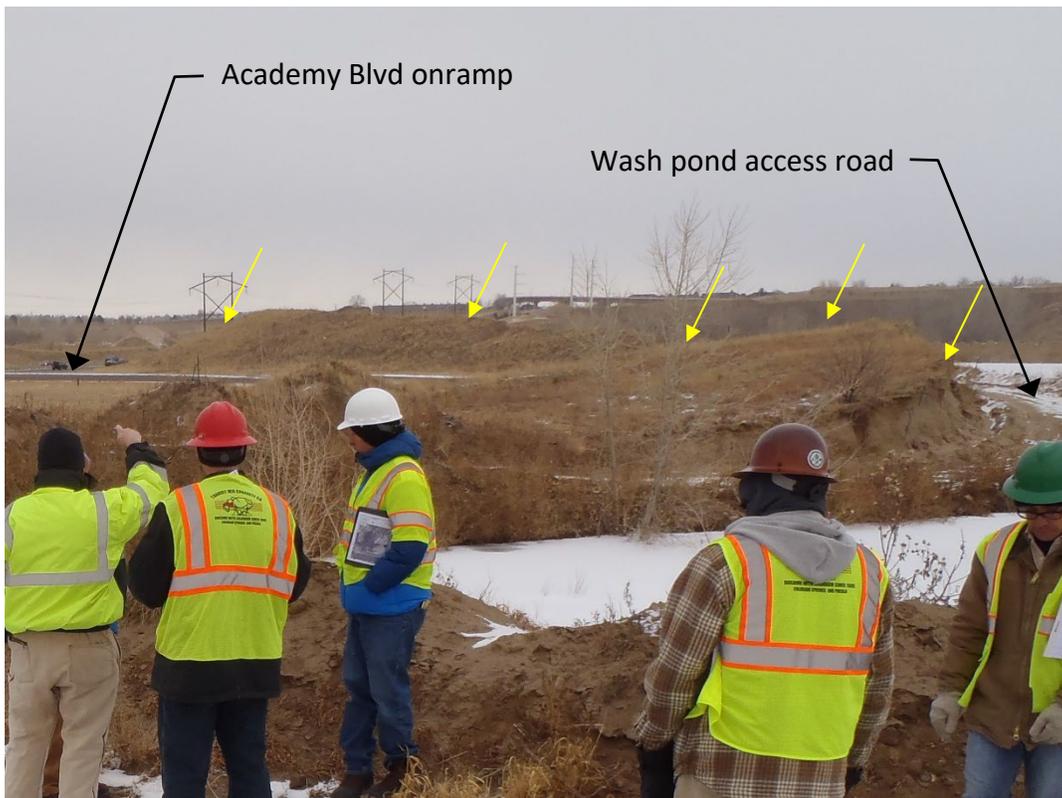
Photo 2. Berm (arrows) between old wash pond & Academy Blvd (12/7/16 photo, looking NW).

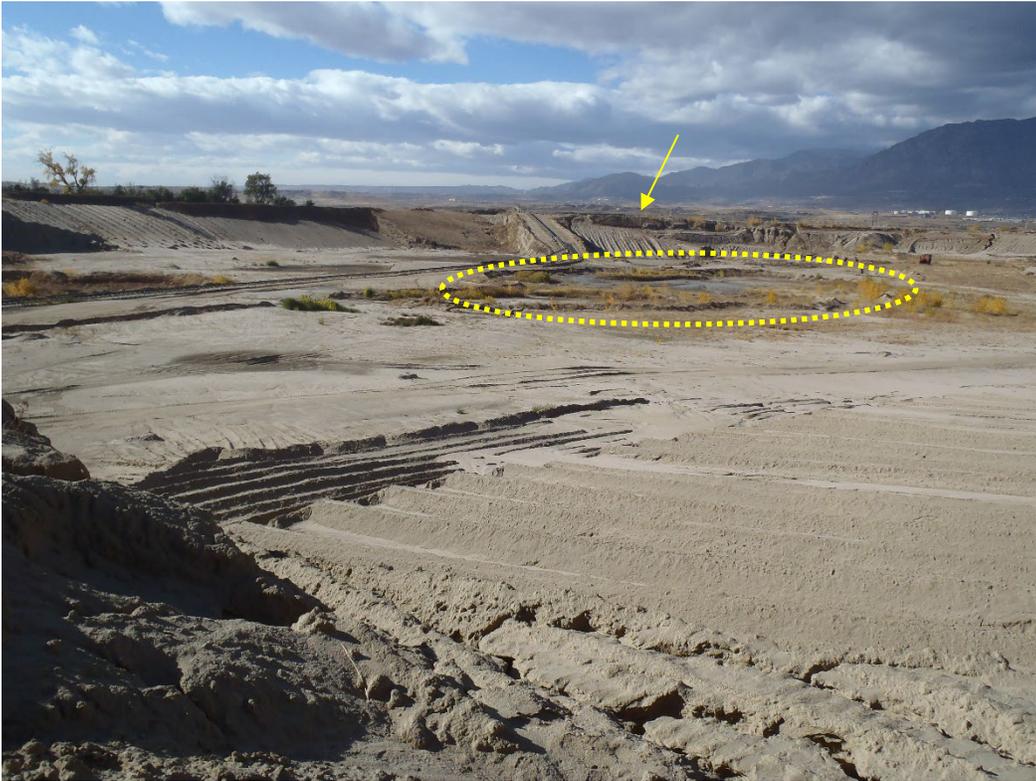
**Hydrologic Balance:** Standing water was observed in the active pit (see **Photo 3**). This is expected due to the sandy nature of the native material, when the adjacent Fountain Mutual Ditch is flowing, as it was at the time of the inspection (see **Photo 4**). The ponded water is not considered groundwater.

Reclamation Success: The Permittee is performing concurrent reclamation as backfill continues in the west sediment basin (see **Photo 6**) where it is nearly complete. Highwalls in the west (see **Photo 3**) and north sides (see **Photo 5**) of the main pit are being flattened for final reclamation. The highwall between the new wash pond and the Fountain Mutual Ditch (see **Photo 7**) was flattened as part of a 2020 complaint inspection and subsequent corrective action. The Permittee submits monthly status reports on the stability of this flattened highwall. As such, the DRMS is aware this slope has required periodic repair for erosion as the Permittee is experiencing a challenge in getting vegetation established on this south facing slope.

Photo 3. Main pit: standing water [circled] and highwall flattening [arrow] (looking SW from east end).

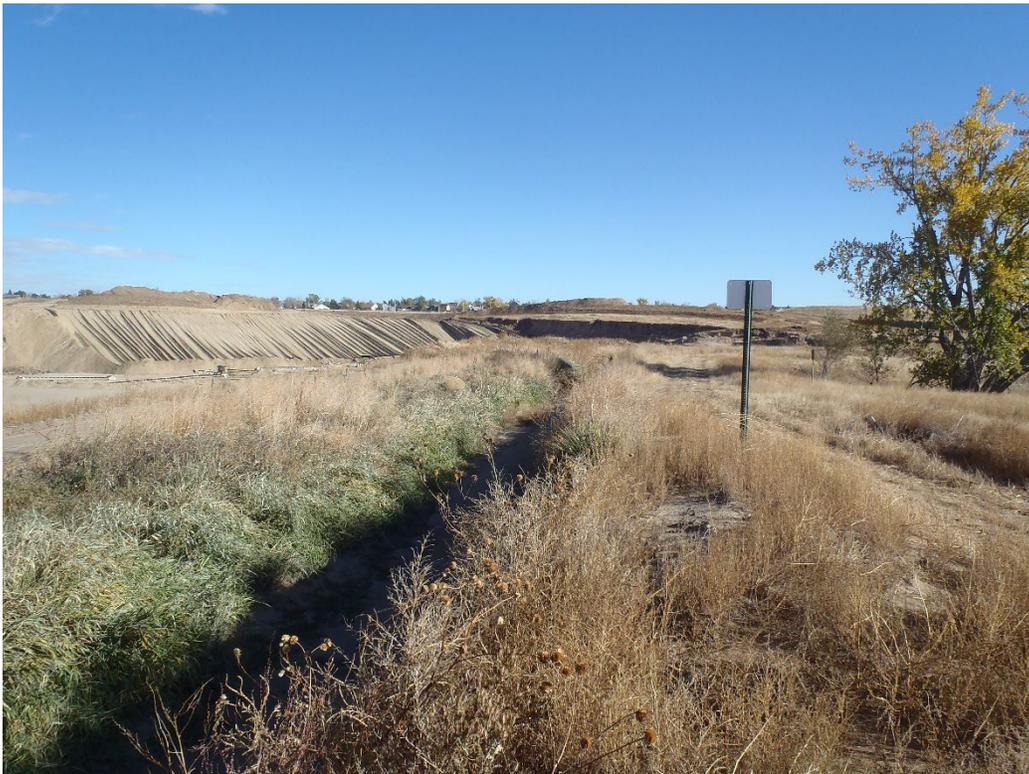
**Gen. Compliance with Mine Plan:** The operation appeared to be in compliance with the approved mine plan. The maximum allowed disturbed area is 286.12 acres (based on the approval of AR-2 in 2018). Google Earth was used to measure the disturbed area, which was approximately 233 acres, based on 2022 imagery. Site representatives indicated there was about a year and half left in the mine life. As such, the mine is actively flattening the highwalls (see **Photos 4** and **5**). The stated plan was to finish mining towards the east end of the active pit.

Photo 4. Fountain Mutual Ditch (flowing) and flattening NE higwalls (looking ENE).

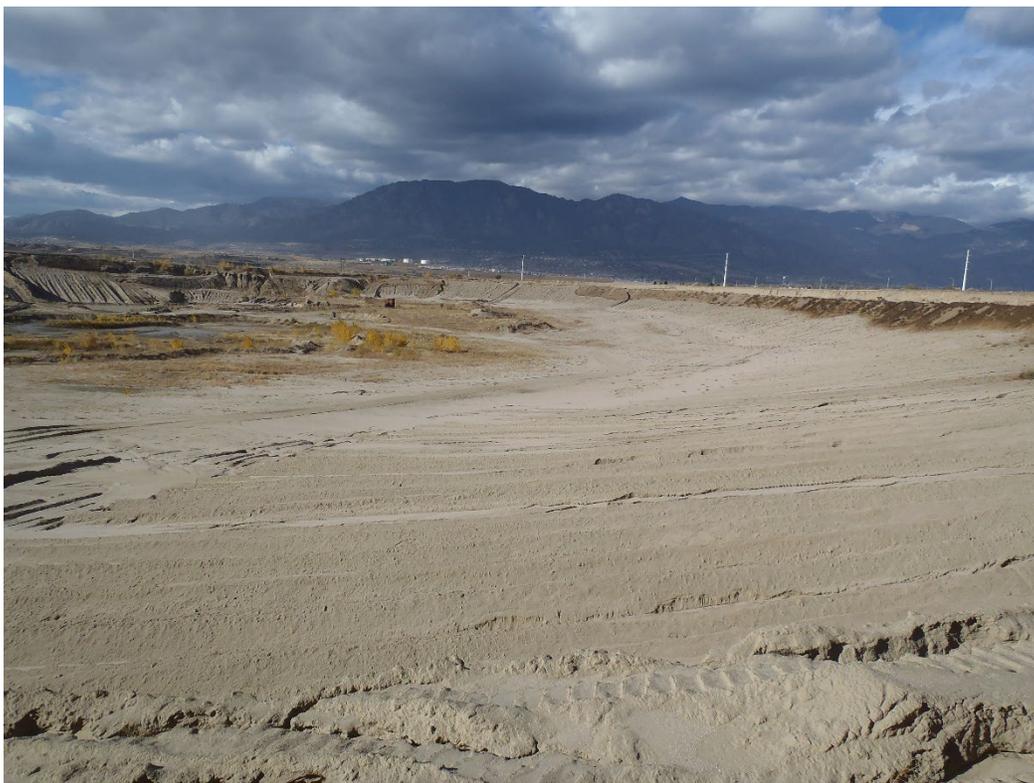
Photo 5. Flattening north highwalls in main pit (looking west).

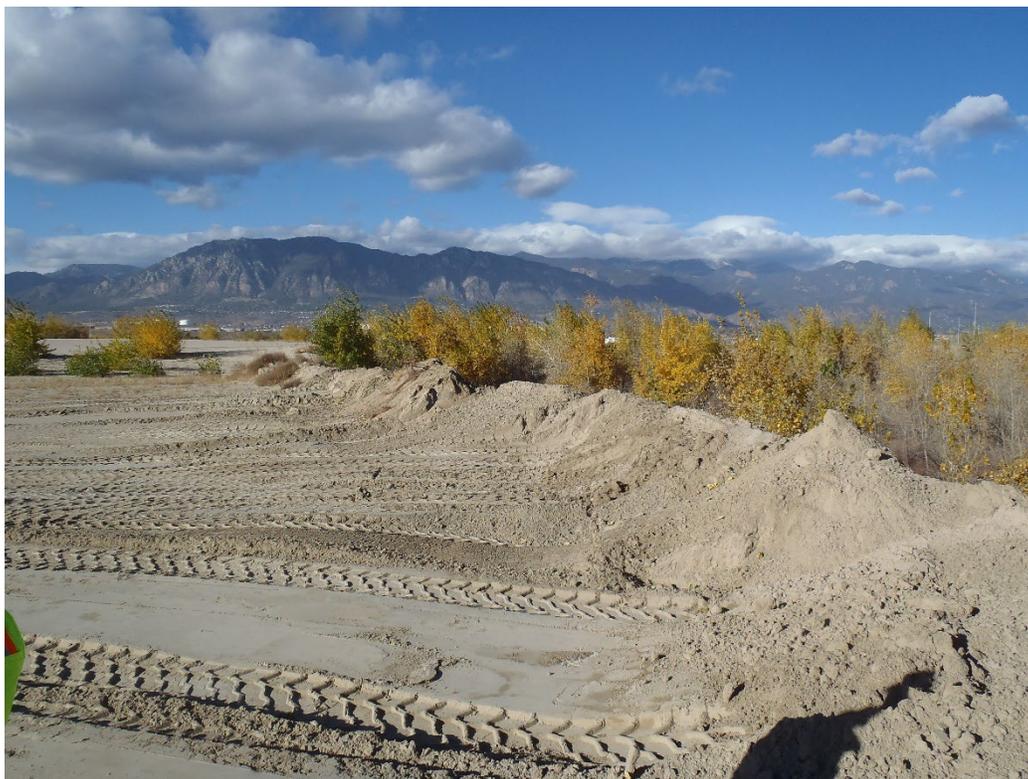
Photo 6. Backfilling west sediment basin (looking west from SE corner of backfill).

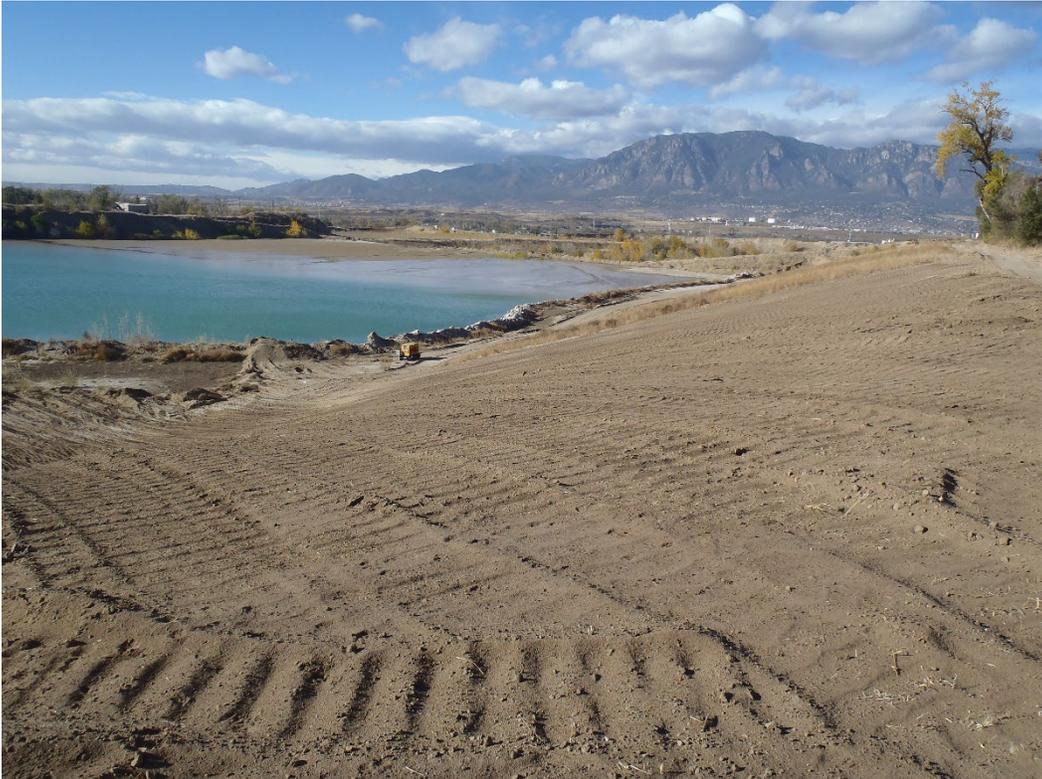
Photo 7. Flattened highwall between Fountain Mutual Ditch and new wash pond (Looking SW).

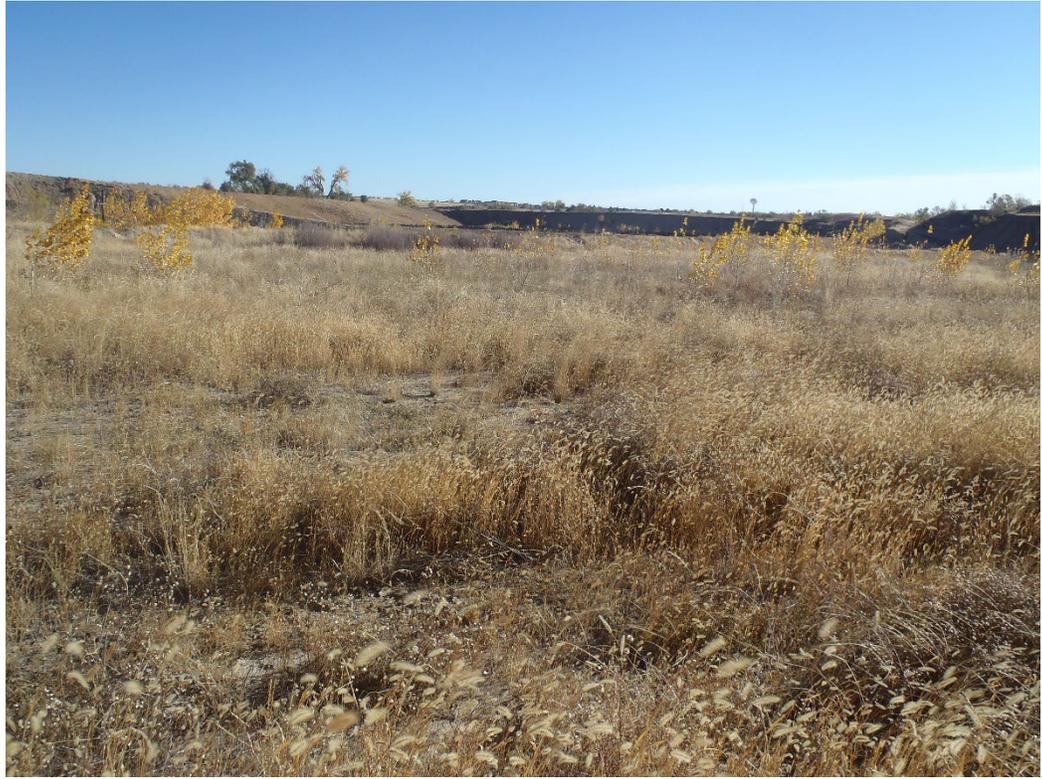
Revegetation: Site representatives indicated they had not seeded any areas at the time of the inspection. Volunteer vegetation appeared well established on the surface of the old wash pond (see **Photo 8**). No noxious weeds were observed.

Photo 8. Established volunteer vegetation on old wash pond (looking NE from west side).

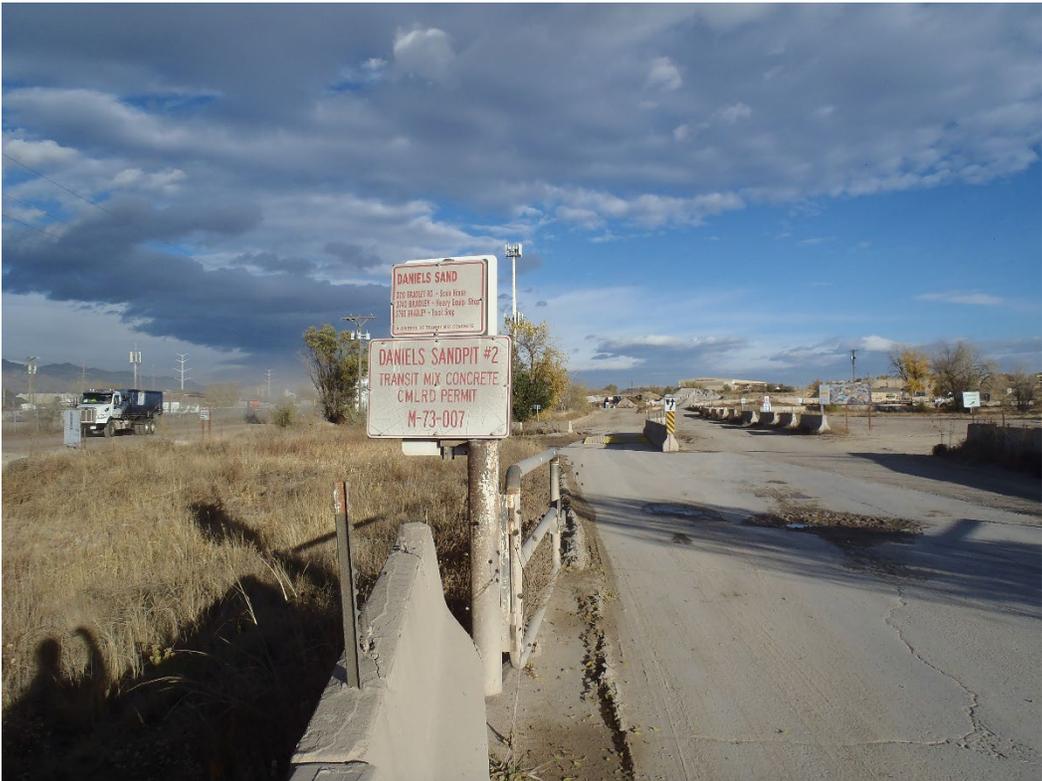
Signs and Markers: The permit sign was properly posted (see **Photo 9**) and boundary markers were observed to be consistent with previous inspections.

Photo 9. Permit sign at entrance off Bradley Road.

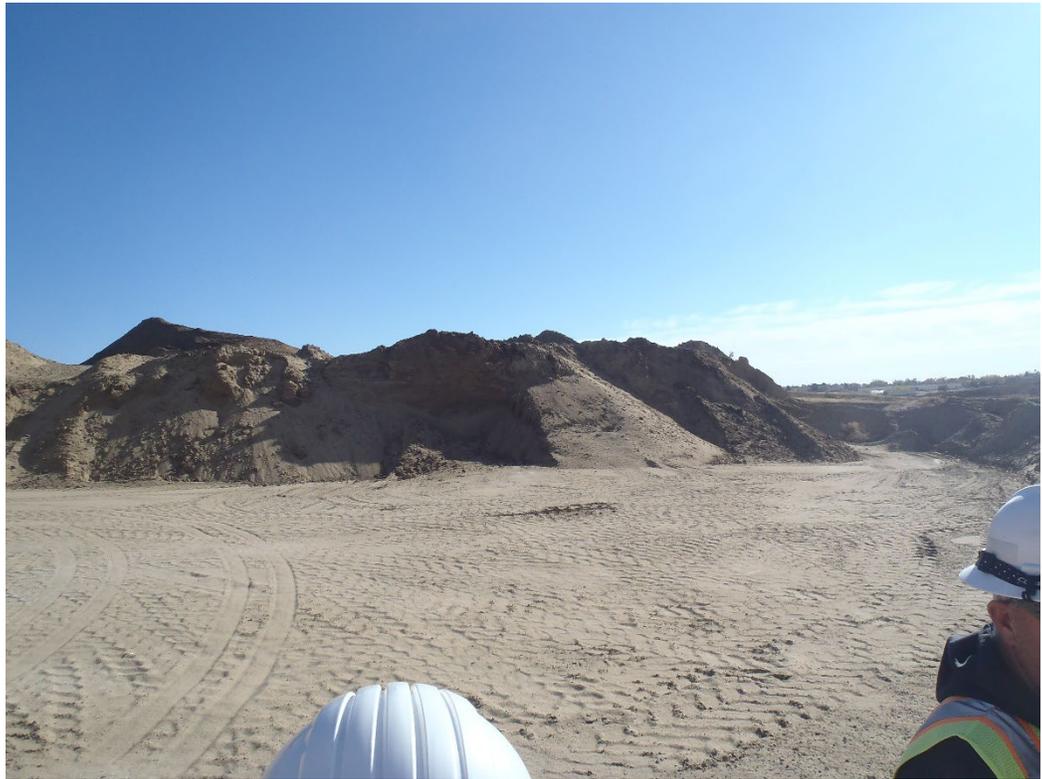
Topsoil: The topsoil stockpile NE of the main pit (see **Photo 10**) was being moved and placed along the crest of the west end of the active pit to accommodate final mining and for reclamation.

Photo 10. Topsoil stockpile being moved (NW of main pit, looking east).

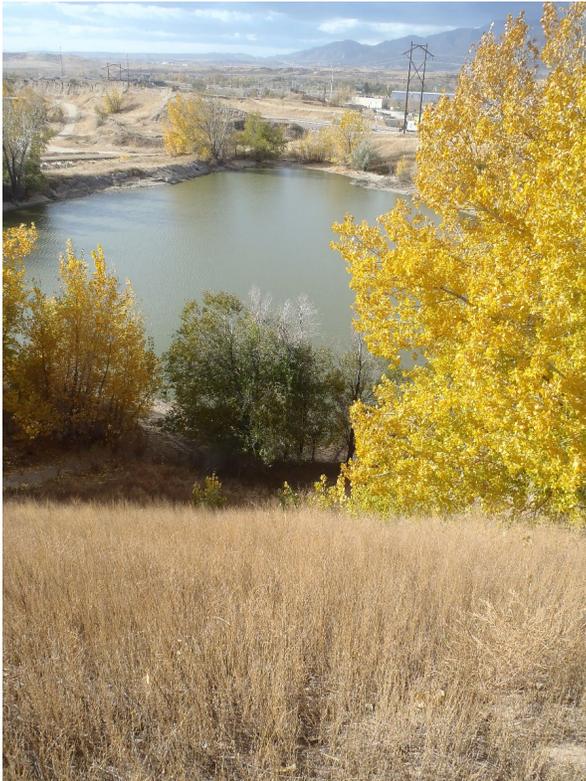
Post Inspection Meeting: A close out meeting was held at the crest of the slope above the augmentation pond (see **Photo 11**) as this slope presents a challenge. The slope is vegetated (volunteer succession), but is too steep for final reclamation (see **Photo 12**). Mr. Smith indicated he thought there was enough room at the toe of this slope to flatten it without impacting the augmentation pond, which will remain after reclamation. The other item discussed was the aforementioned berm between the old wash pond and Academy Blvd. No problems or possible violations were cited.

Photo 11. Augmentation Pond (looking SW from crest of slope).

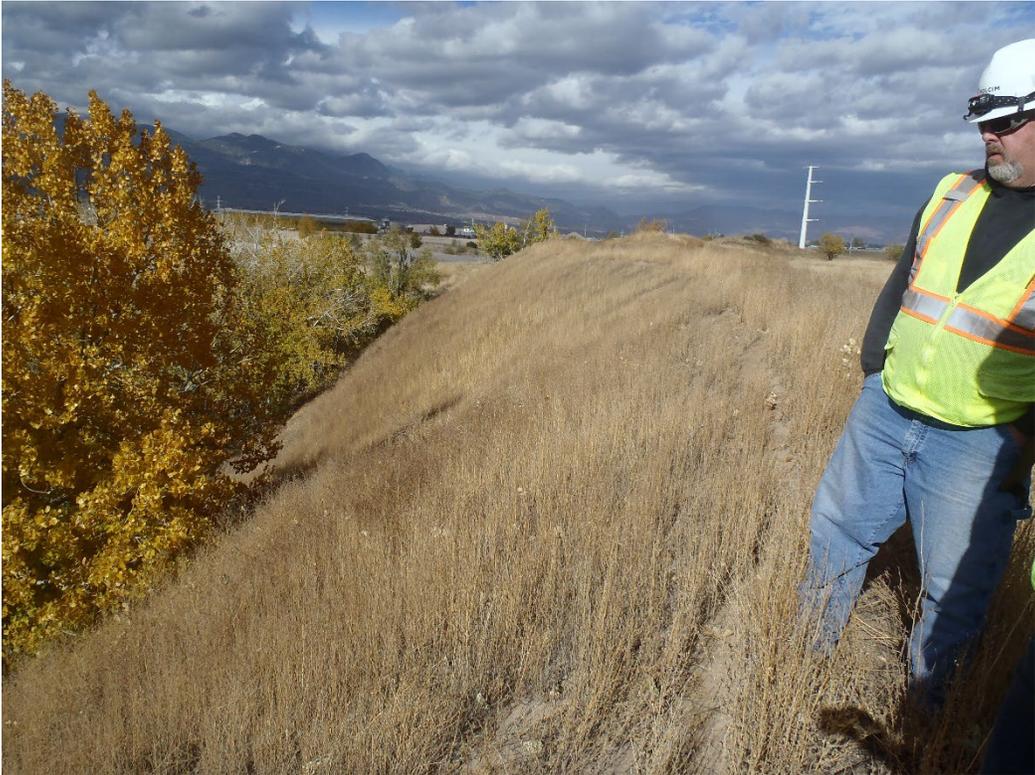
Photo 12. Steep slope above Augmentation Pond (looking NW).
