MINERALS PROGRAM INSPECTION REPORT
PHONE: (303) 866-3567

MINE NAME: Ghost River Gravel Pit	MINE/PROSPECTING ID#: M-2003-002	MINERAL: Sand and gravel	COUNTY: Huerfano
INSPECTION TYPE: Monitoring	WEATHER: Clear	INSP. DATE: January 26, 2023	INSP. TIME: 08:05
OPERATOR: HCR High Country Repair	OPERATOR REPRESENTATIVE: Natasha Goldberg	TYPE OF OPERATION: 110c - Construction Limited Impact

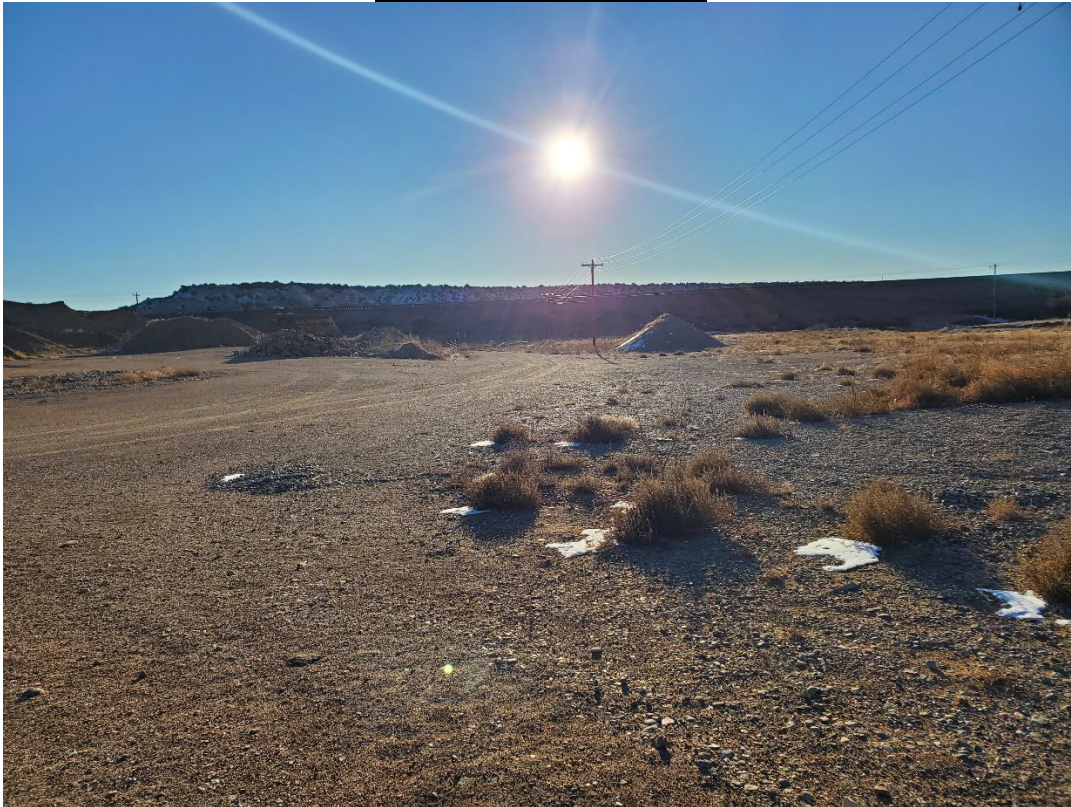
No permit sign was observed at the entrance to the mine site.

Photo 1: Looking east at the site entrance from near the southern boundary of the permit area.

The operator shall, at the entrance of the mine site, post a sign which shall be clearly visible from the access road with the following: the name of the operator, a statement that a reclamation permit for the operation has been issued by the Colorado Mined Land Reclamation Board; and the permit number. The operator shall submit photo documentation that a proper sign has been posted by the corrective action date.

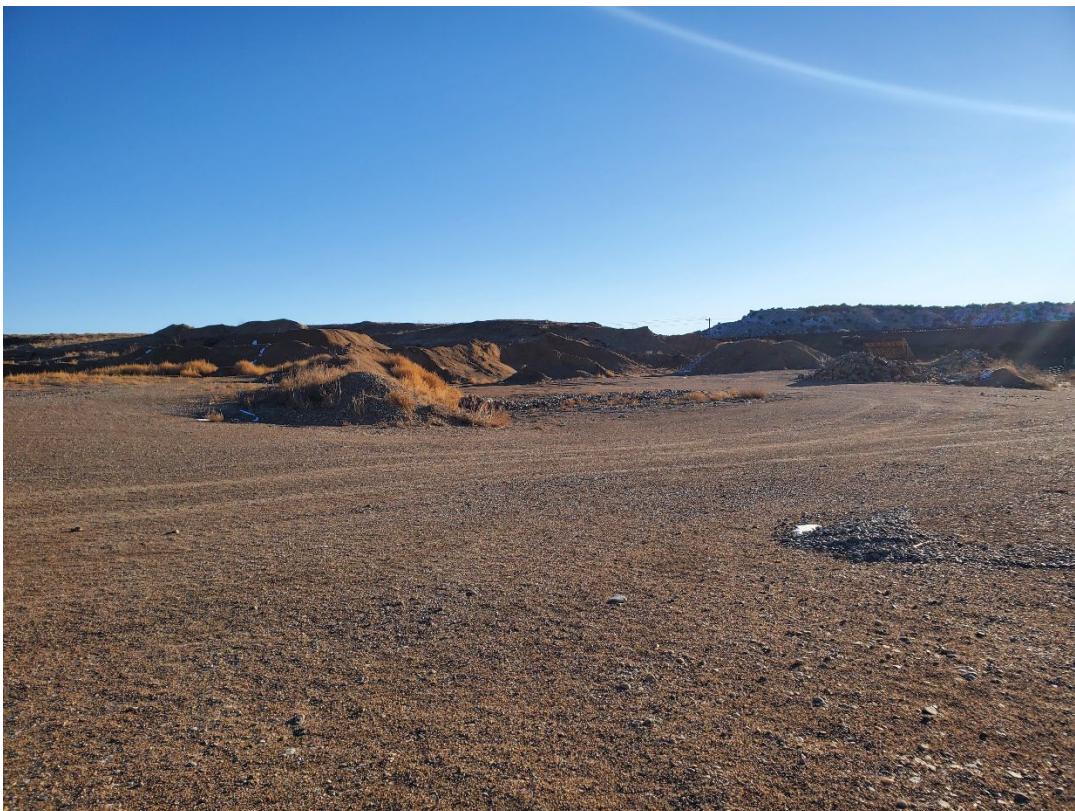
Photo 2: Looking northeast from the southern boundary at the pit.

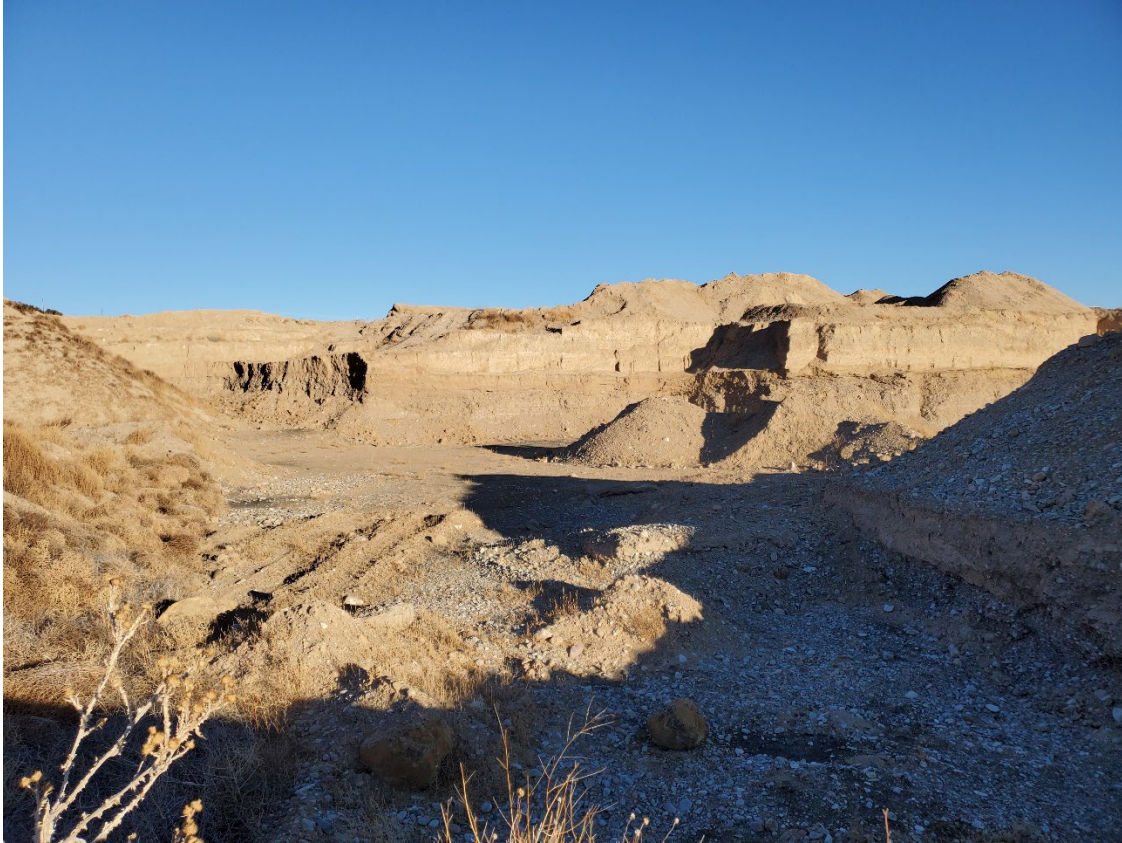
The permit is currently under a Board ordered cease and desist action. We walked the extent of the highwall and it appeared that no activity has occurred since the last inspection and the operator is in compliance with the cease and desist order. The equipment located outside the south-east area of the boundary during the last inspection had been removed.

Photo 3: Looking west at near vertical highwalls.

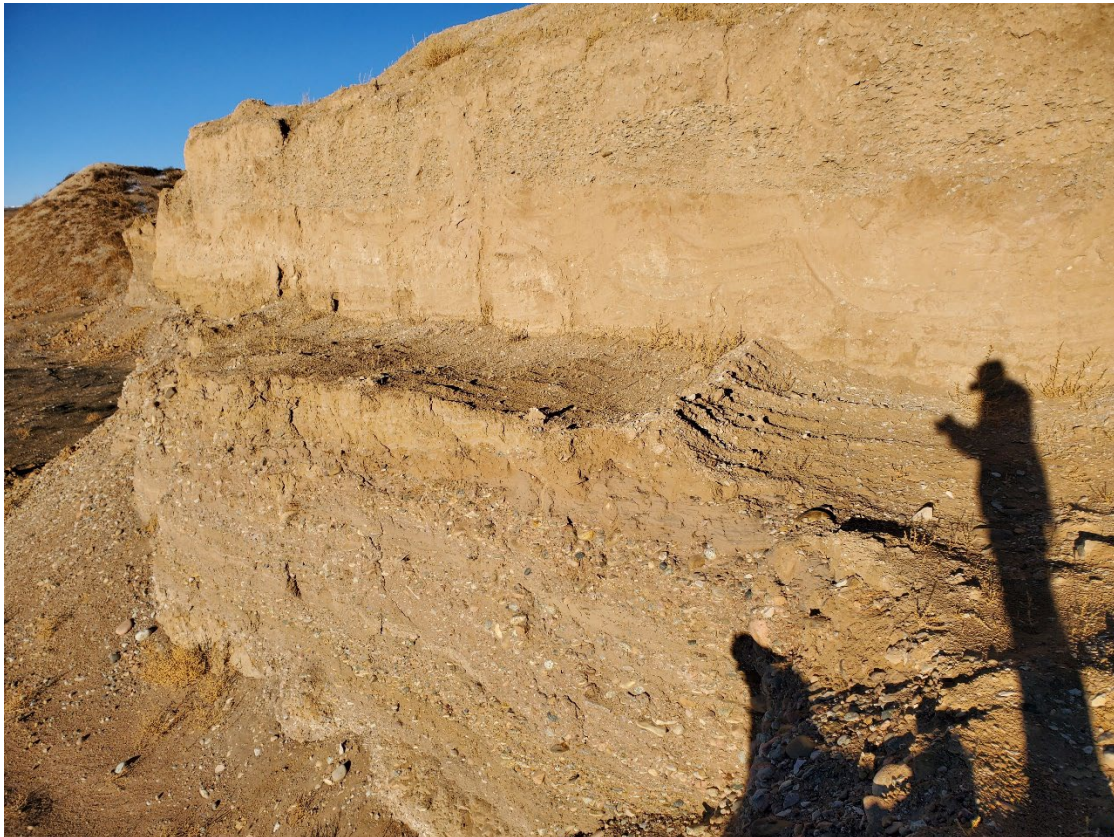
Photo 4: Looking southwest. Standing on middle ledge of high wall.

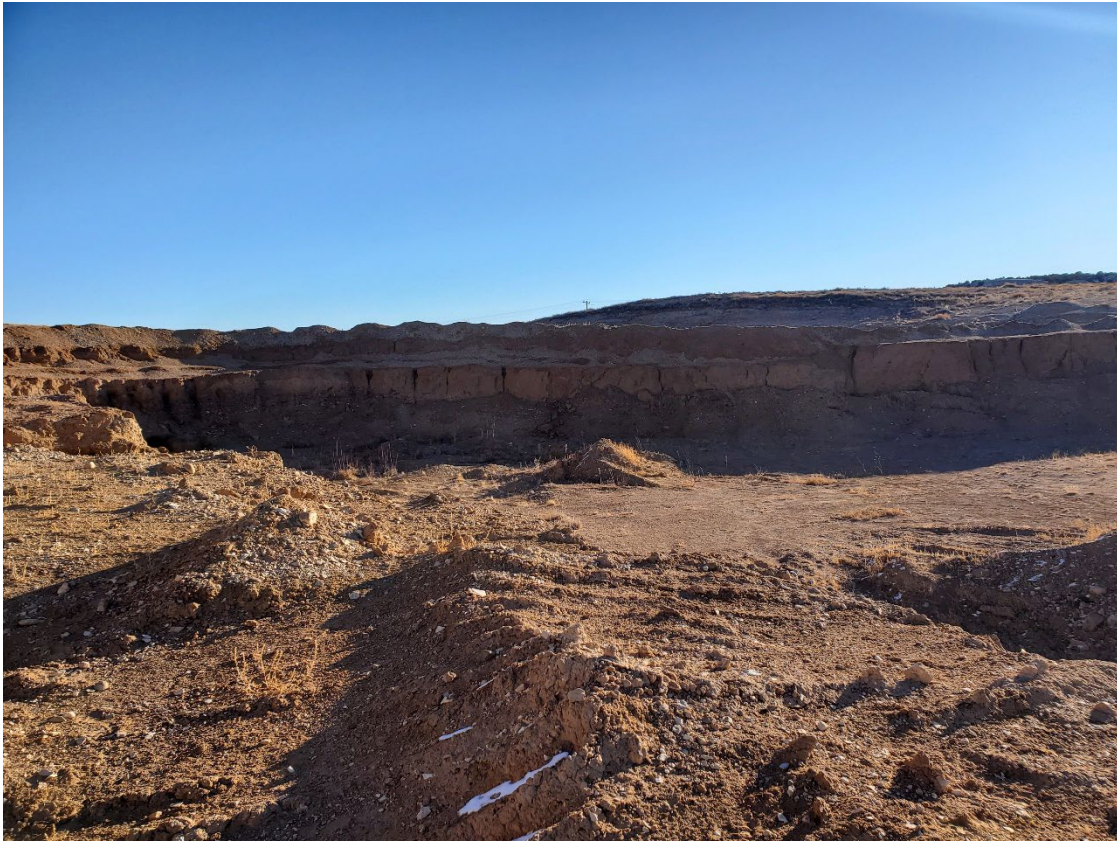
Photo 5: Looking East across pit at highwall.

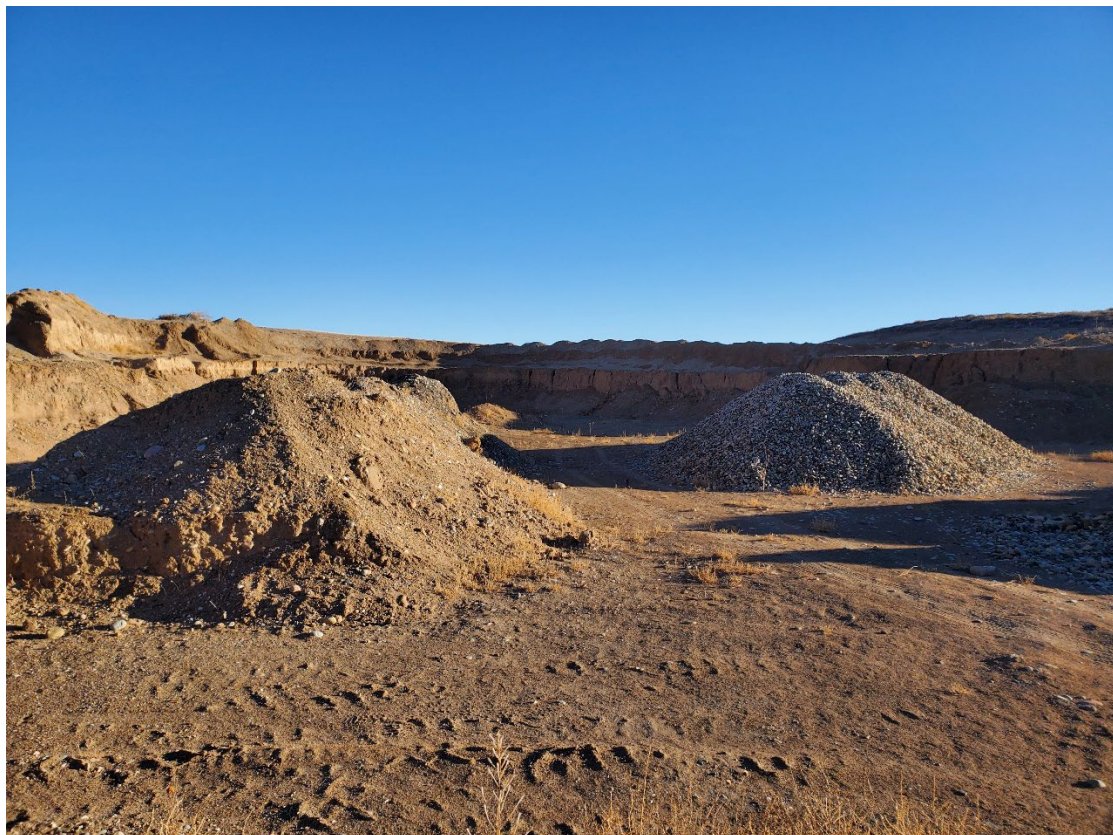
Photo 6: Looking North across the pit at product stockpiles.

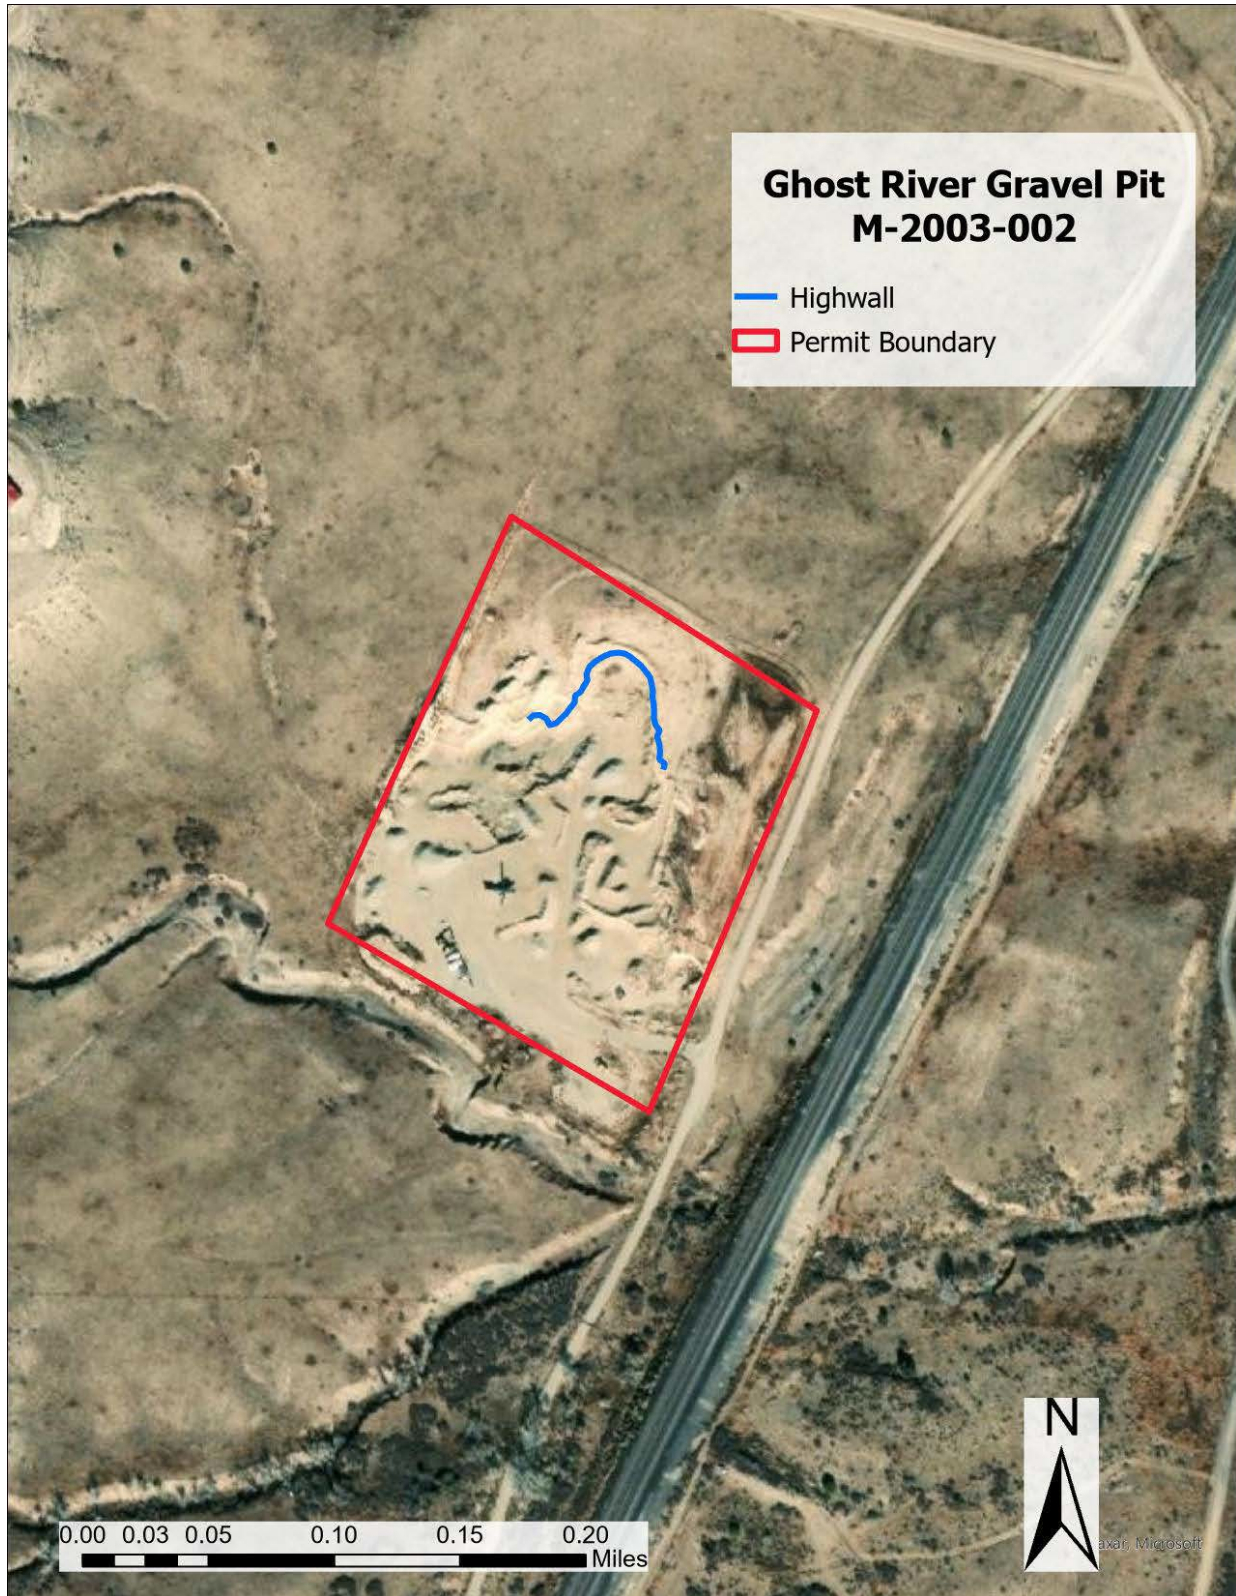
Photo 7: Map outlining extent of highwalls.
