PERMIT INFORMATION

| Permit Number: C1981033 Mine Name: Bear Mine Operator: N/A Operator Address: N/A | County: Gunnison Operation Type: Underground Permit Status: Revoked Ownership: Private |

INSPECTION INFORMATION

| Inspection Start Date: January 23, 2023 Inspection Start Time: 14:00 Inspection End Date: January 24, 2023 Inspection End Time: 12:00 | | Inspection Type: Coal Partial Inspection Inspection Reason: Normal I&E Program Weather: Clear | |

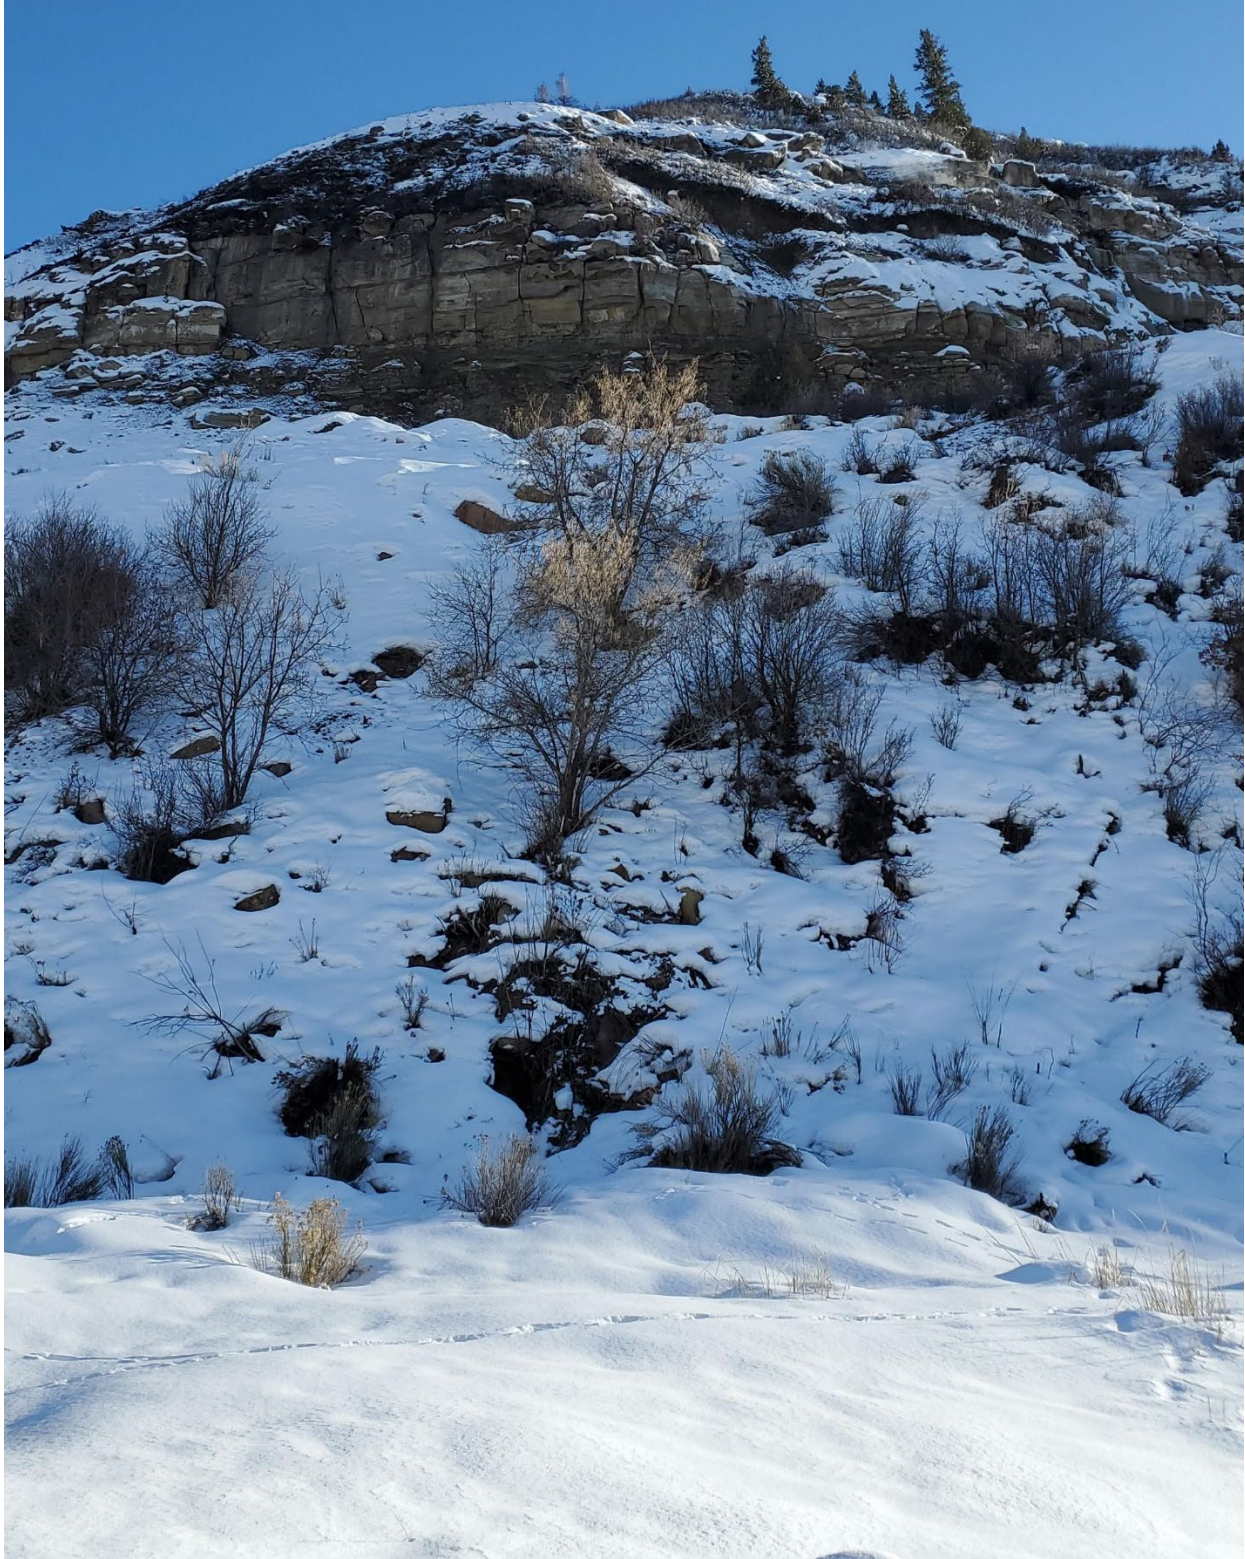
Figure 1: Slide area from below

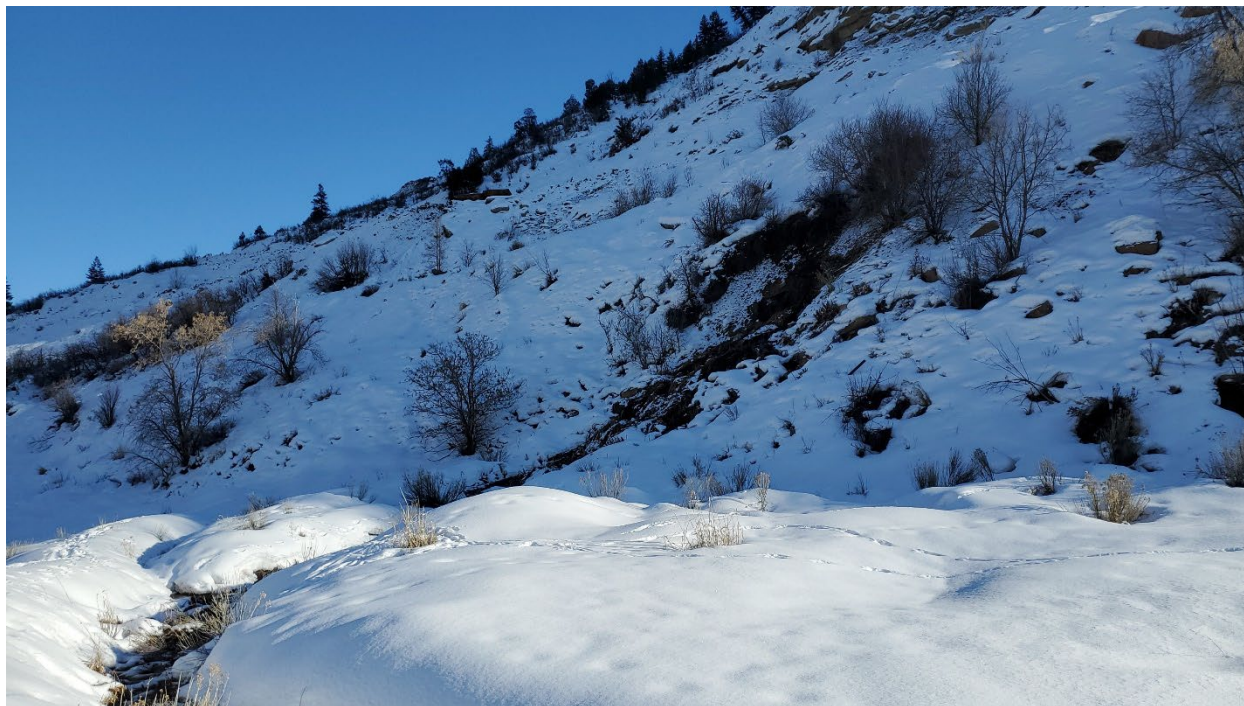
The groundwater seep was very obvious in the snowy surroundings, where the elevated temperature of the water kept the area free of snow.

Figure 2: Groundwater seep

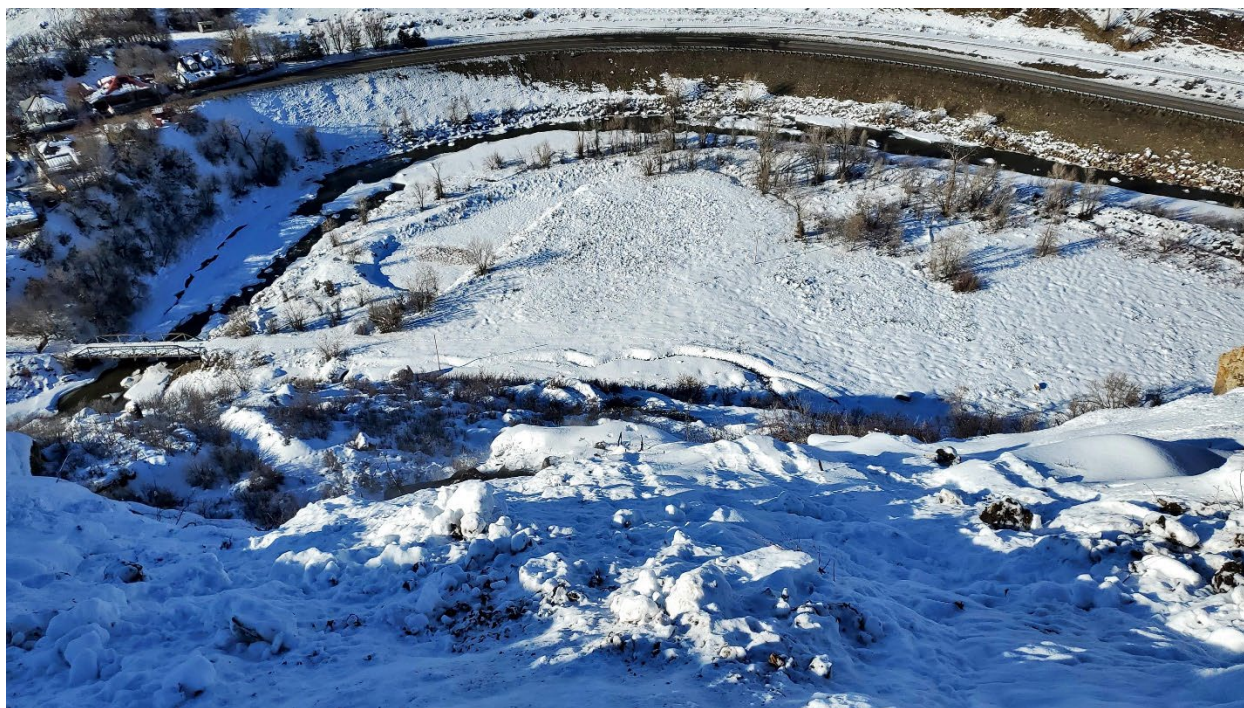
Figure 3: Overview of site from bench above slide area

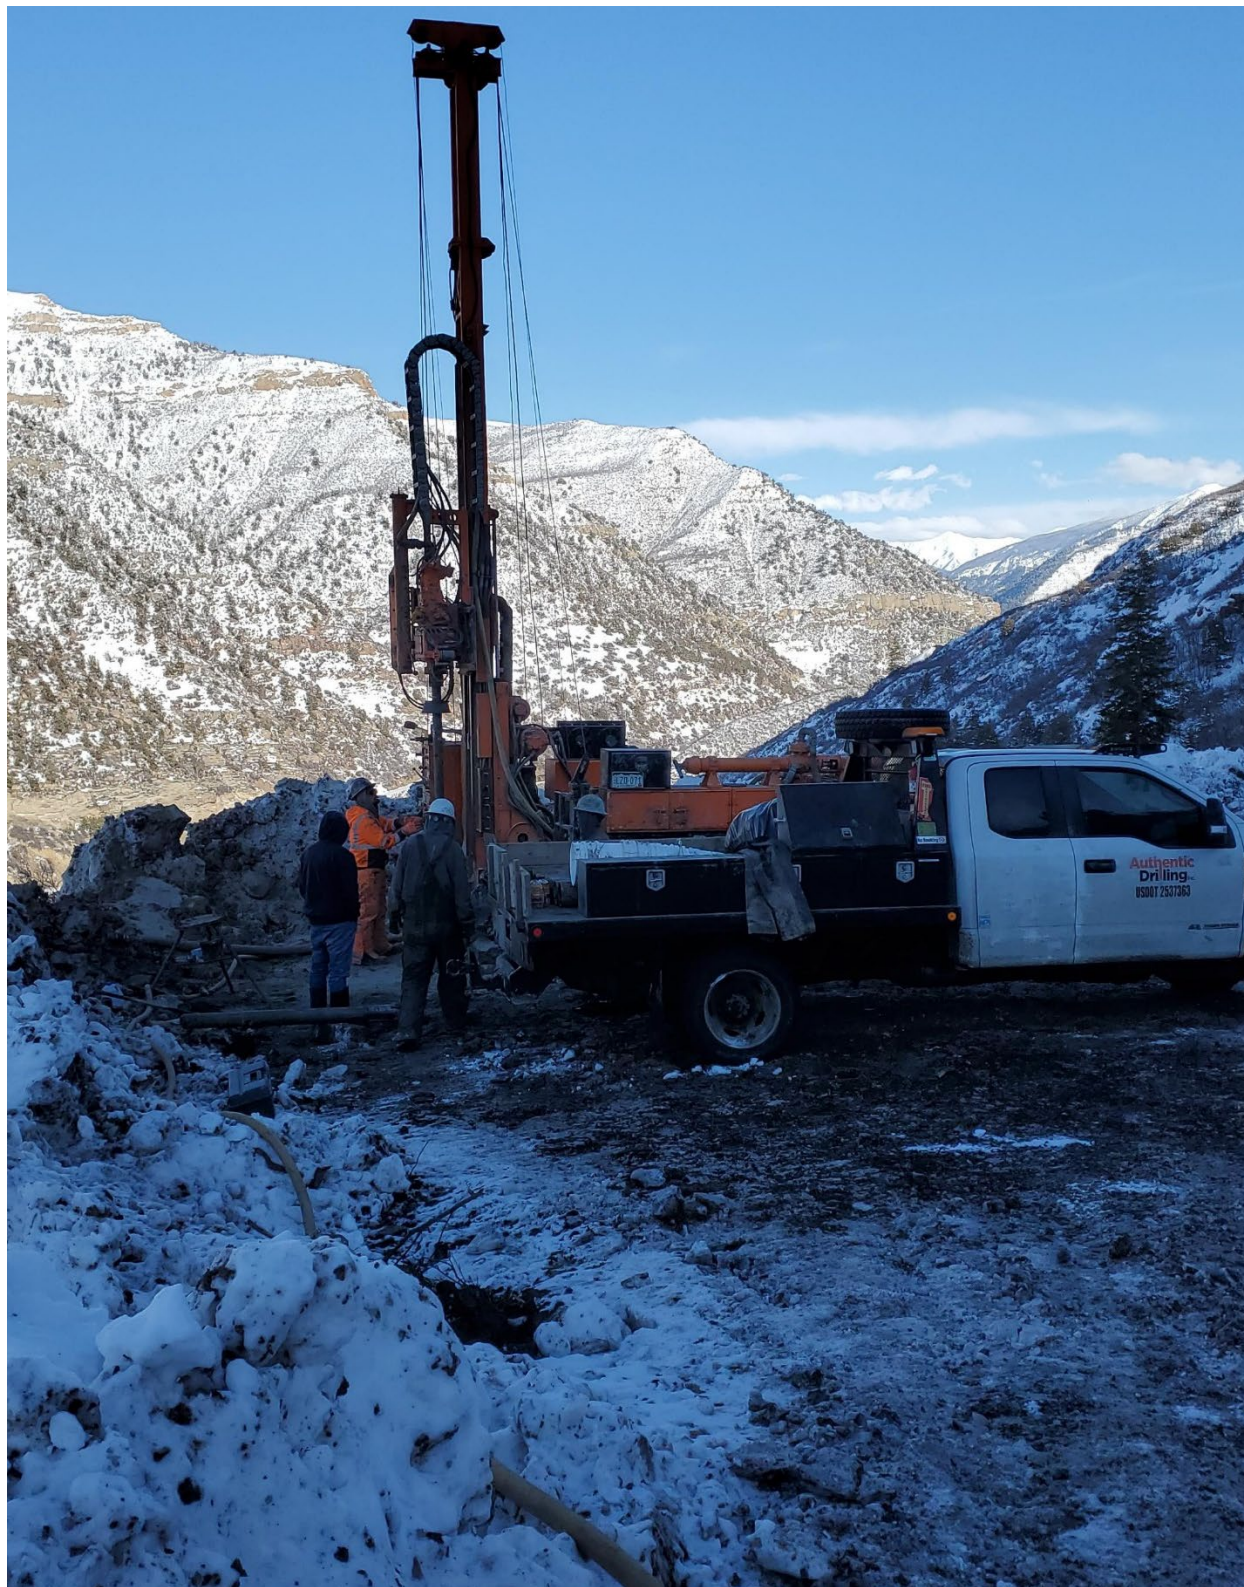
The drilling project on the bench above the slide area was still in progress. At the time of the inspection seven holes had been drilled using an air rotary drill, one core hole had been drilled (in an attempt to circumvent problems with circulation of drilling mud) and a final hole was being drilled in order to install an inclinometer.

Figure 4: Authentic Drilling drill rig installing inclinometer

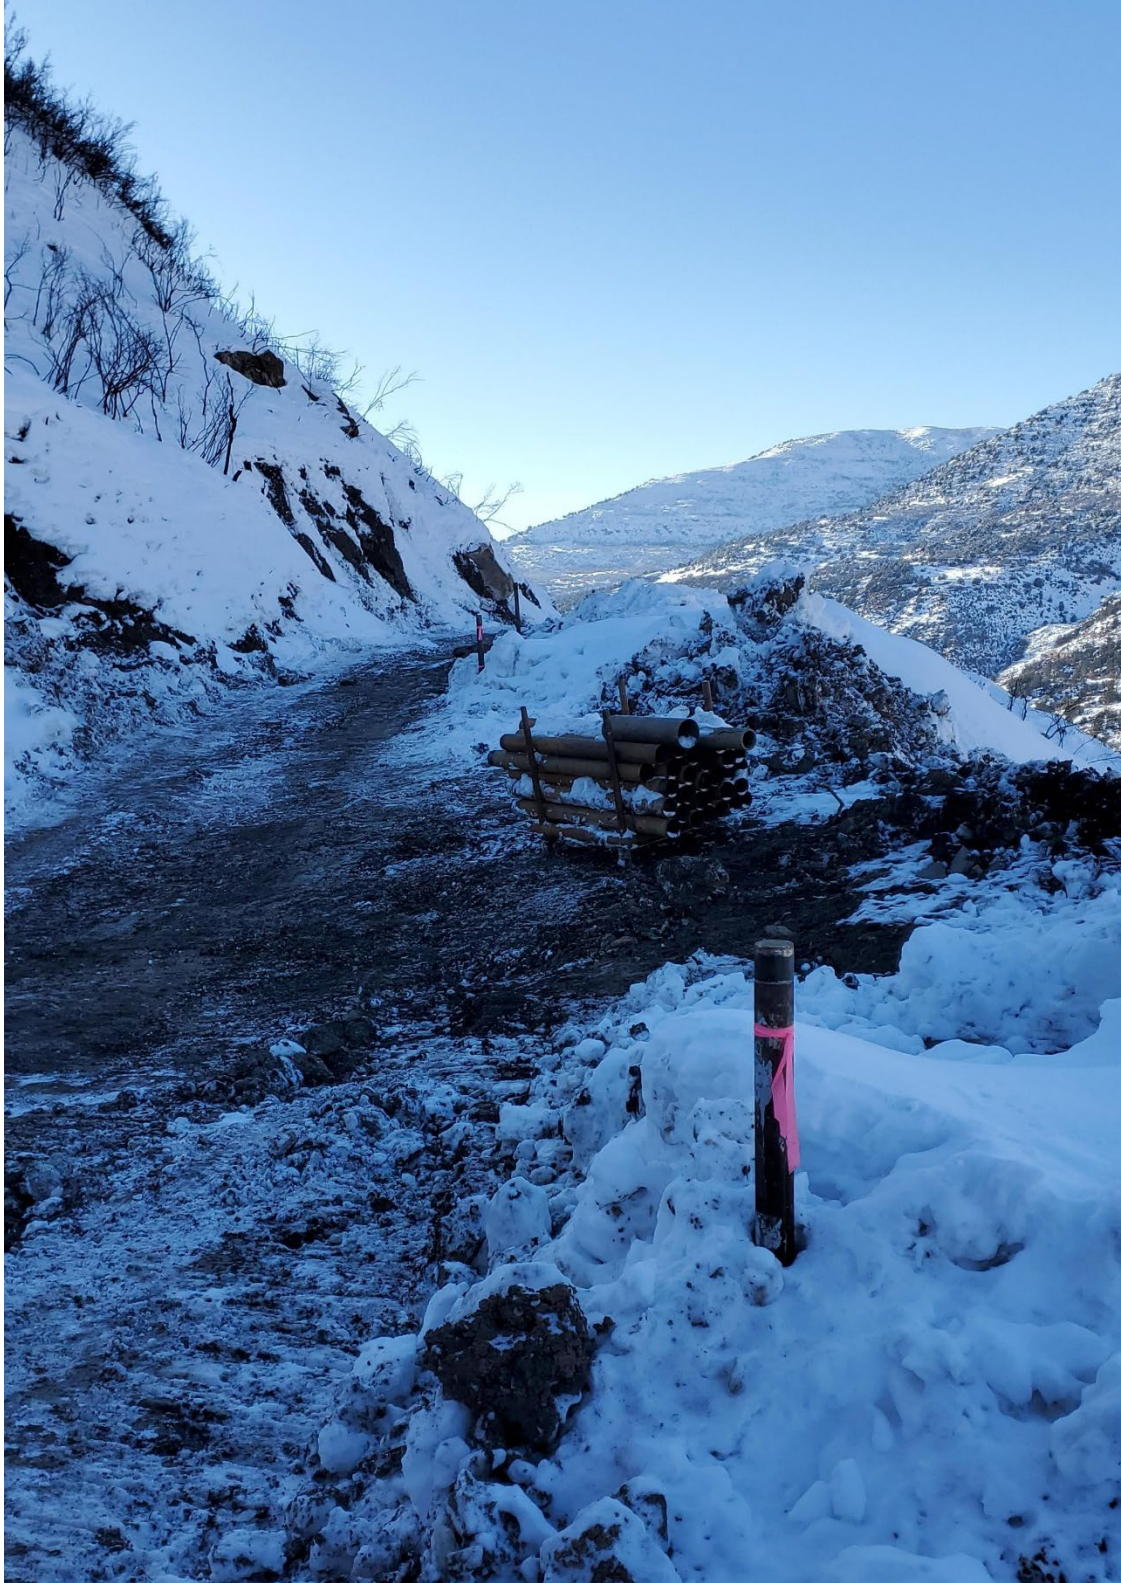
Figure 5: View along bench from east to west

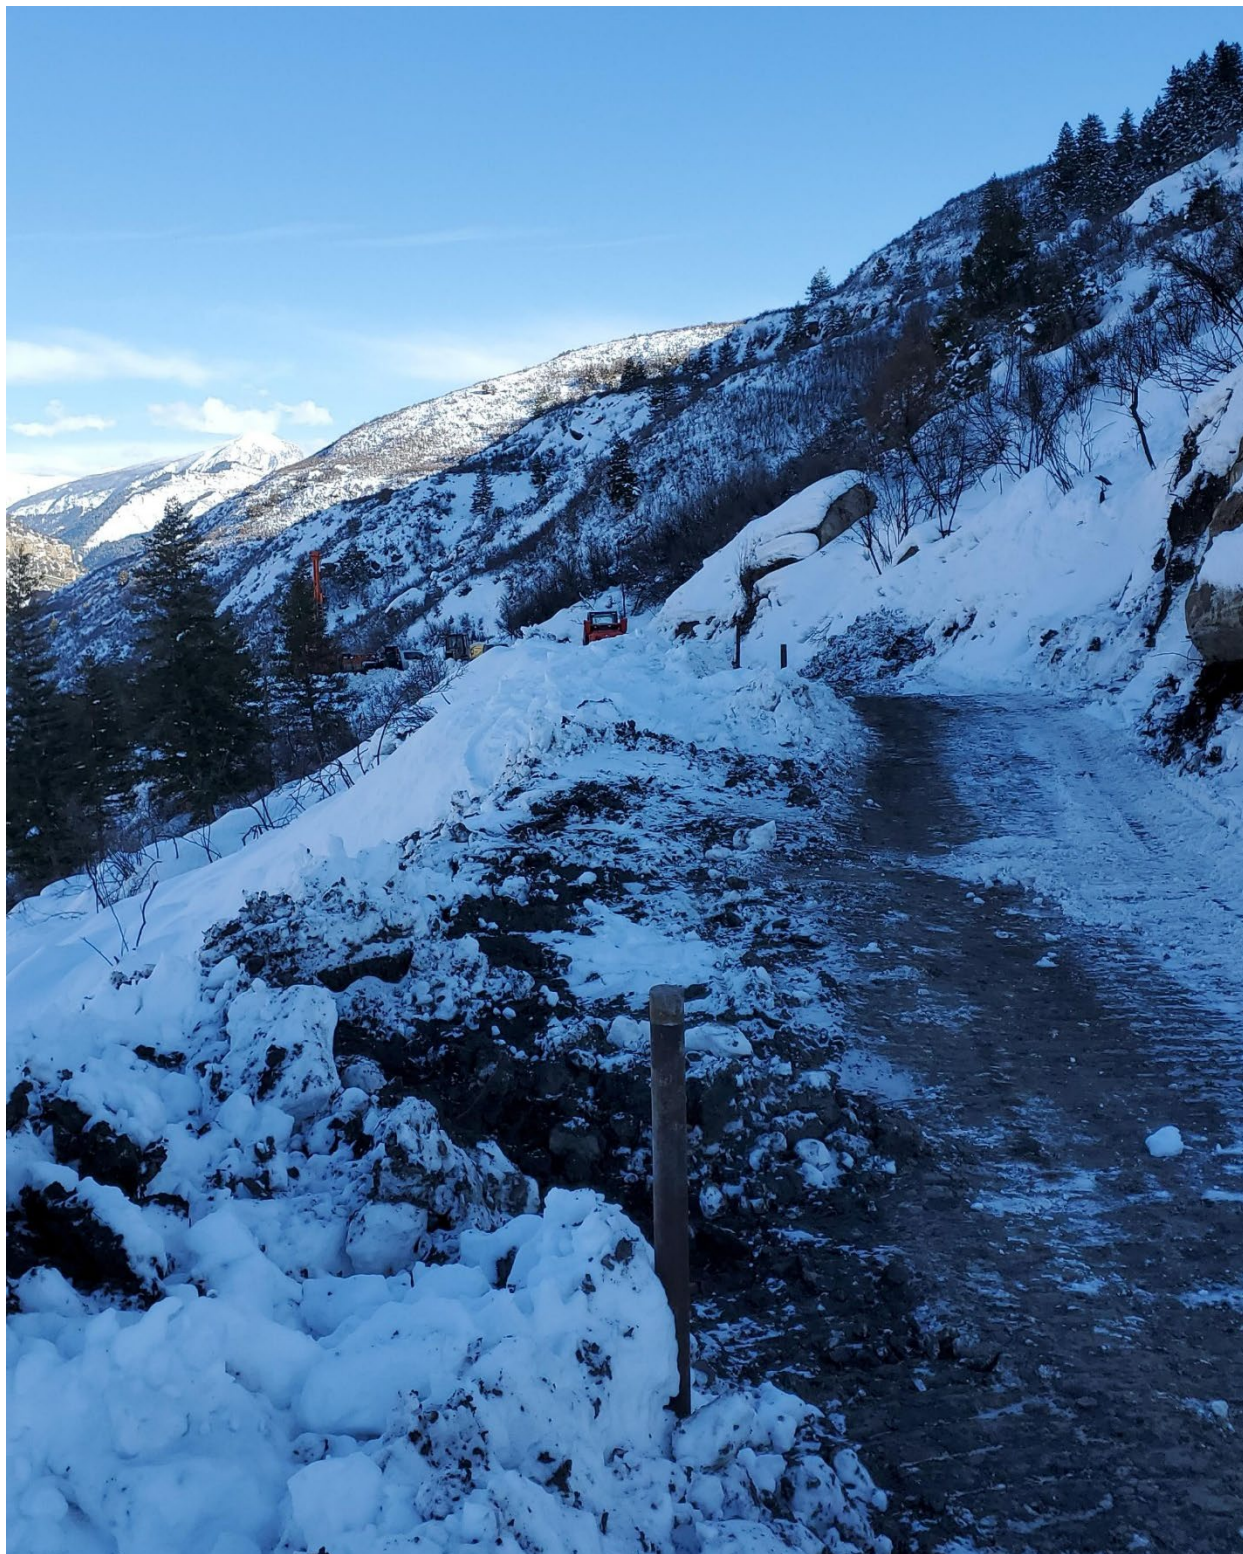
Figure 6: View along bench from west to east
