MINERALS PROGRAM INSPECTION REPORT
PHONE: (303) 866-3567

| MINE NAME: Potts Pit #2 | MINE/PROSPECTING ID#: M-2006-013 | MINERAL: Gravel, sand and bor for construction | COUNTY: Huerfano |
| INSPECTION TYPE: Monitoring | WEATHER: Windy | INSP. DATE: January 26, 2023 | INSP. TIME: 09:30 |
| OPERATOR: Eastern Colorado Aggregates, R.L.L.L.P. | OPERATOR REPRESENTATIVE: Baxter Kirkland | TYPE OF OPERATION: 112c - Construction Regular Operation | |

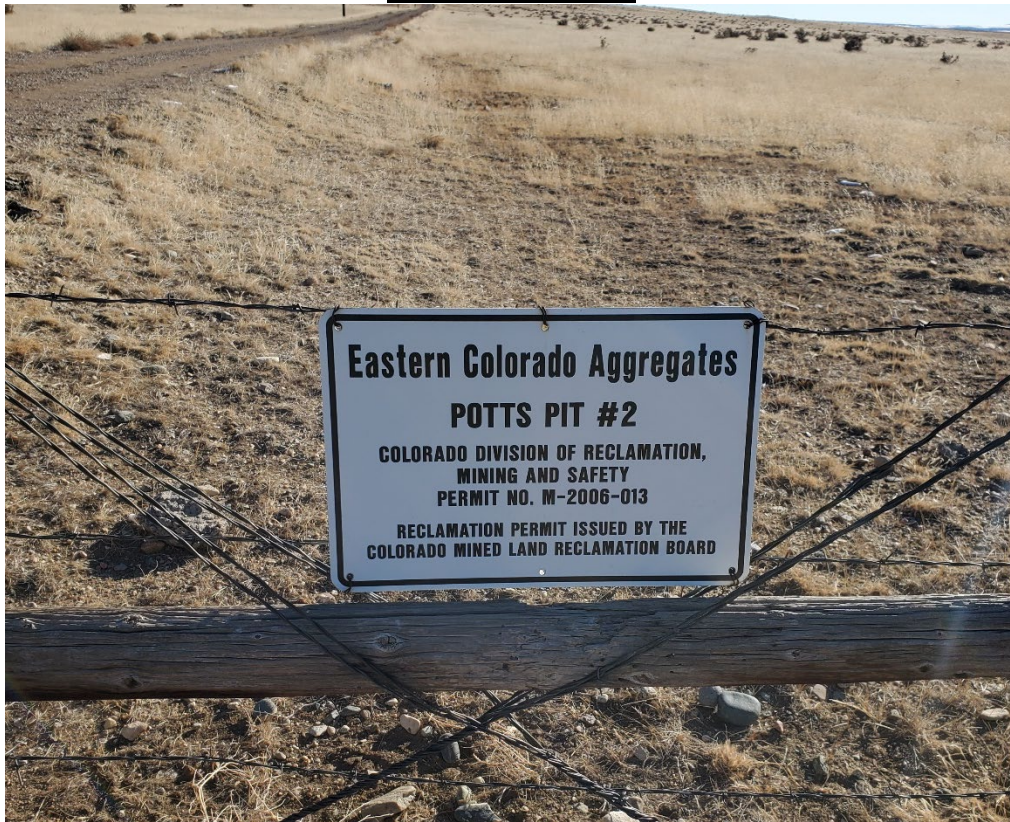
The mine identification sign and permit boundary markers were observed.

Photo 1: Permit sign at site entrance.

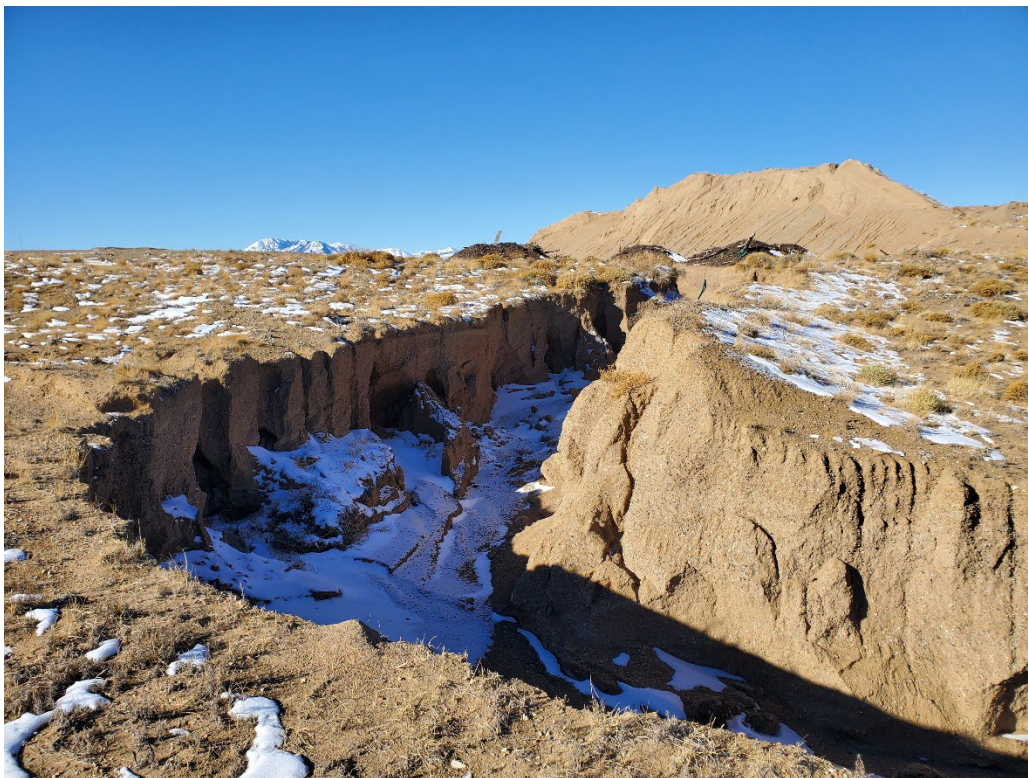
PROBLEM: Erosion gullies and ruts were observed on-site. This is a problem at this time for failure to protect the affected land from erosion pursuant to C.R.S. 34-32.5-116(4)(j).

Large erosion gullies and ruts were observed at the north central side of the affected land. These erosional features have been identified in previous DRMS inspections. Mr. Kirkland said that he would work on filling in the erosion gullies in the northeast portion of the Phase I(a) area and the northwest portion of the Phase I(amendment) area starting the week following the inspection. The operator/permittee also indicated that some of the deeper erosion rills in the Phase I(b) area will be addressed through reclamation. This issue is cited as a problem at the beginning of this report.

Photo 2: Looking west at substantial erosion gully located in northeast corner of the Phase I(a) permit area.

CORRECTIVE ACTIONS: The operator shall provide photo documentation to the Division verifying erosion gullies and ruts have been repaired, and that the site has have been reconstructed and stabilized to prevent erosion damage by the corrective action date.

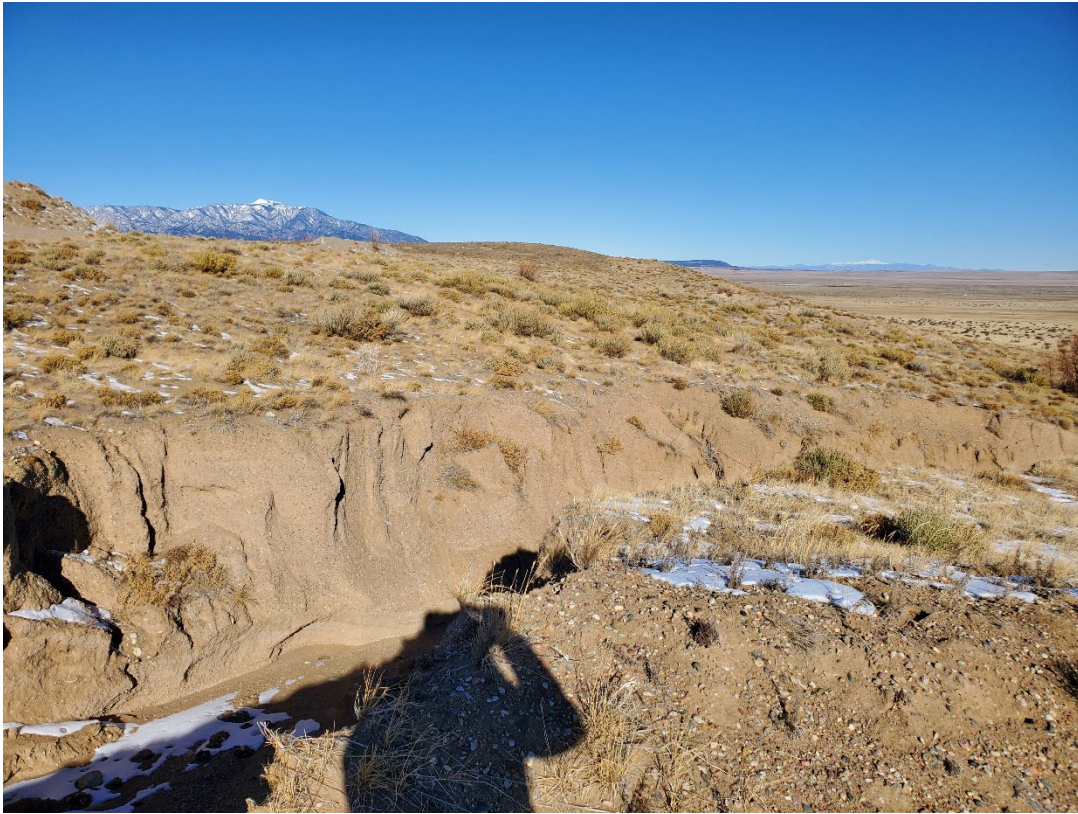
Photo 3: Looking northwest at erosion gully in northeast corner of the Phase I(a) Permit area.

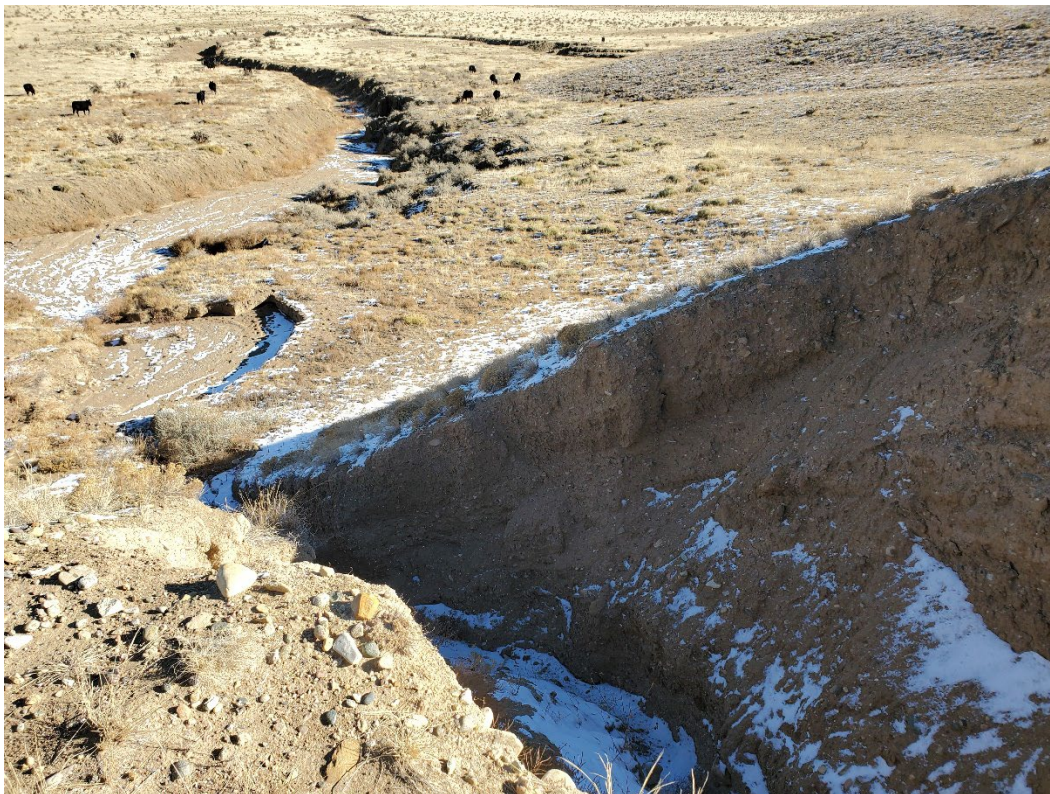
Photo 4: Looking east at substantial erosion into the north west corner of the Phase I(amendment area) of the permit.

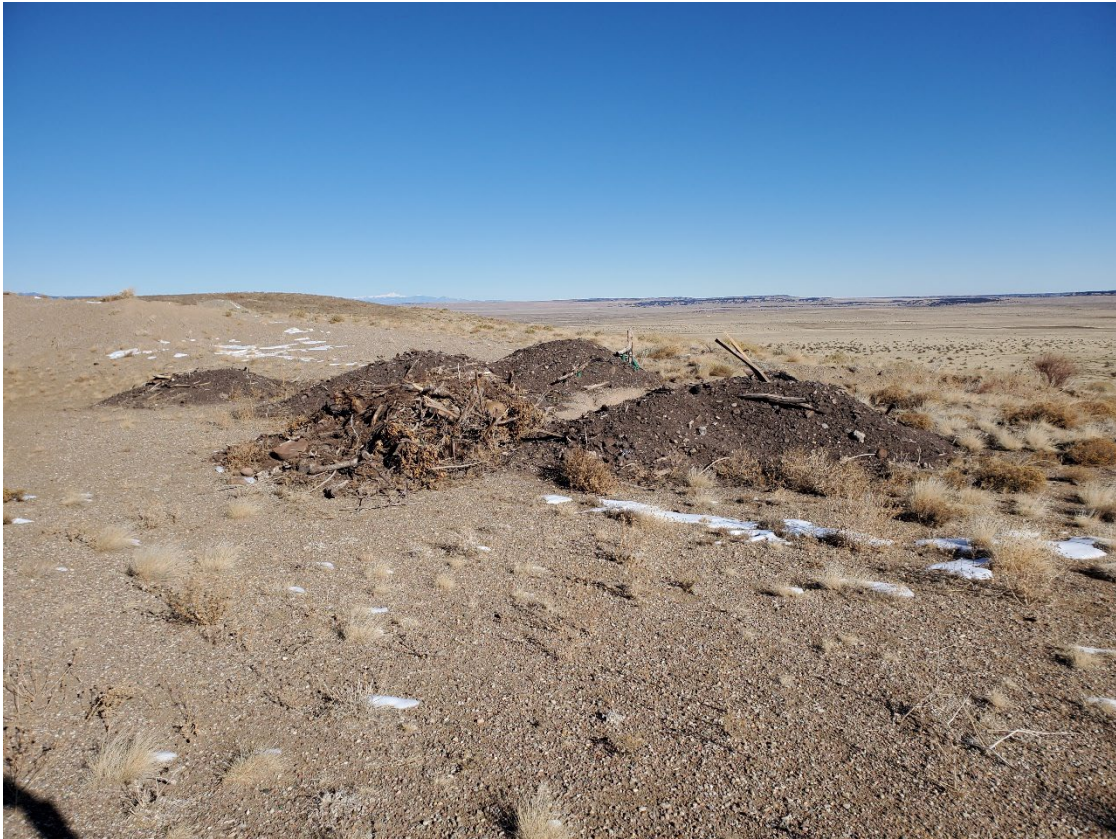
The operator/permittee noted that a bulldozer not owned by the permittee was seen on the property a month prior to the inspection. Several small piles of soil and wood debris were stockpiled at the site. The resulting waste piles are thought to have been left by an unknown party. The operator plans to remove these piles and try to determine who was on the property to prevent this from occurring again.

Photo 5: Waste piles left by trespasser.

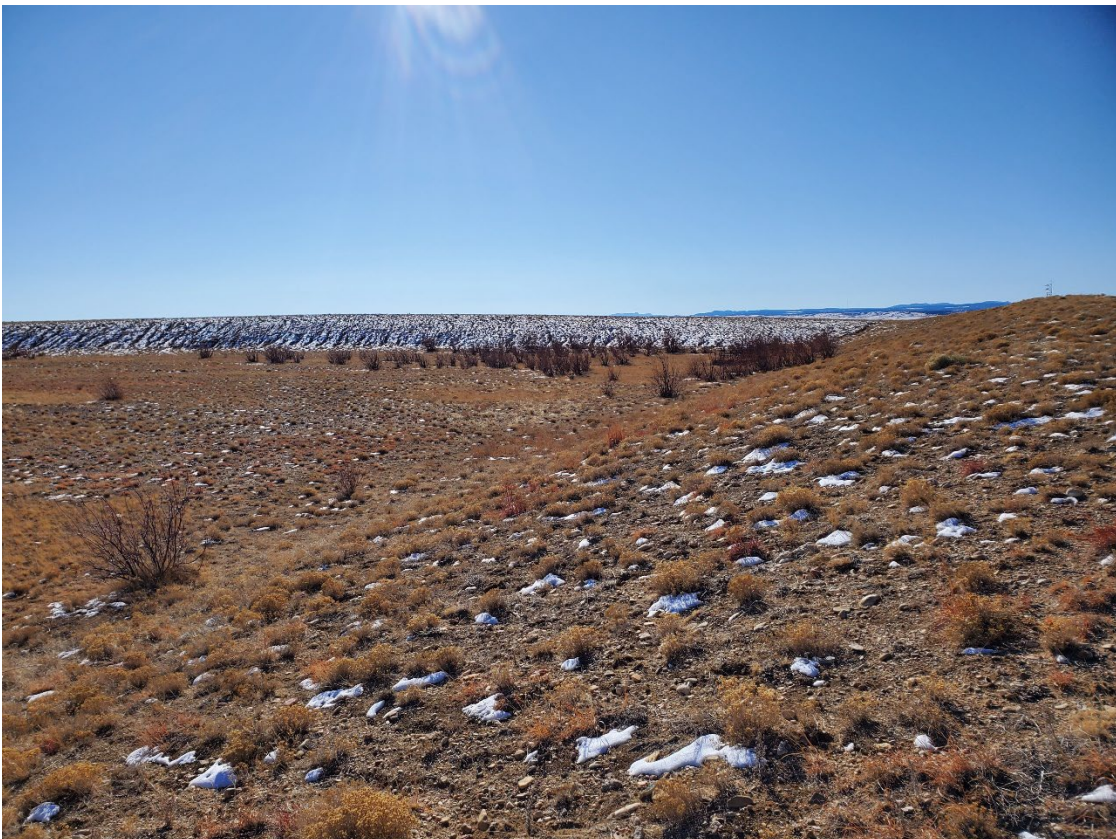
PROBLEM: Tamarisk (salt cedar) trees are present within or have volunteered into the permit area and are becoming established. This is a problem for failure to employ weed control methods for a state listed noxious weed species within the permitted area, and to reduce the spread of weeds to nearby areas as required by Rule 3.1.10(6).

As noted during the last DRMS inspection, Tamarisk trees have established at the site. The Operator must implement the approved weed control plan to address the infestation of Tamarisk trees observed at the site. This issue is cited as a problem at the beginning of the report.

Photo 6: Looking south into the Phase I(b) permit area at substantial establishment of Tamarisk.

CORRECTIVE ACTIONS: The operator shall implement the existing weed control plan for the site. The permittee/operator shall submit documentation of the weed control activities by 6/30/2023. This documentation may include, photographs of the weed control activities and documentation of treatment methods (mechanical, herbicide, etc.) used.

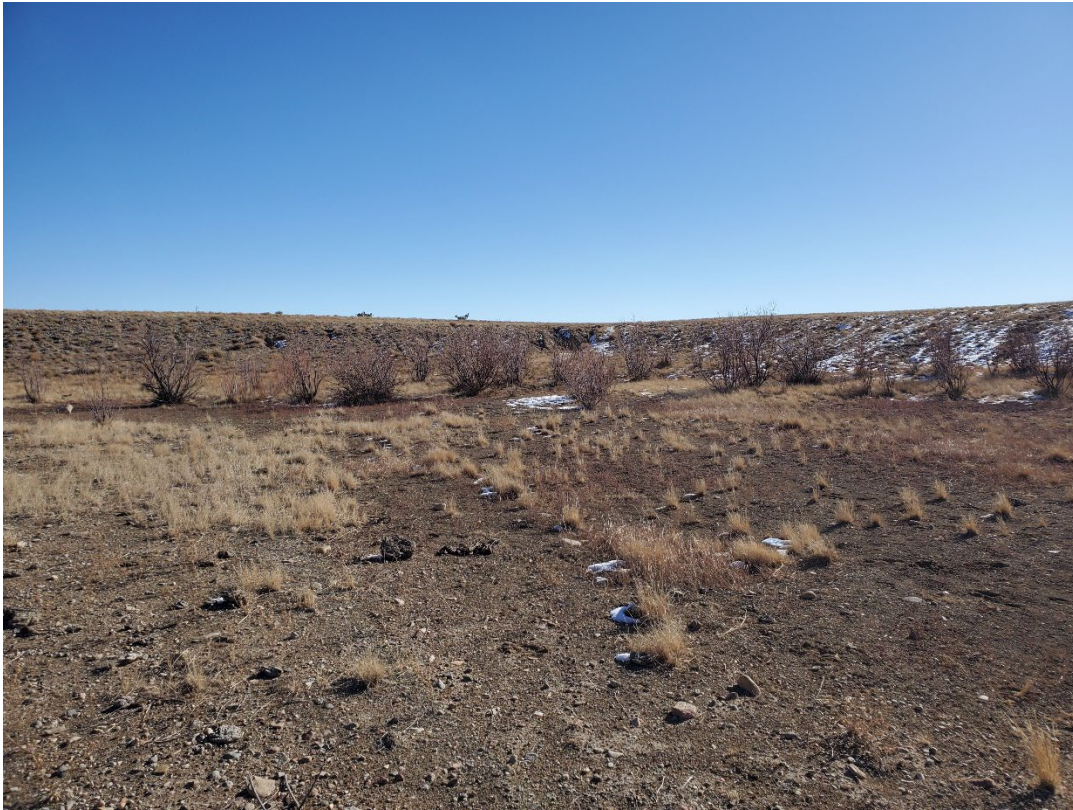
Photo 7: Looking southeast at Tamarisk established in the Phase I(b) permit area, and at erosion rills on the slope.

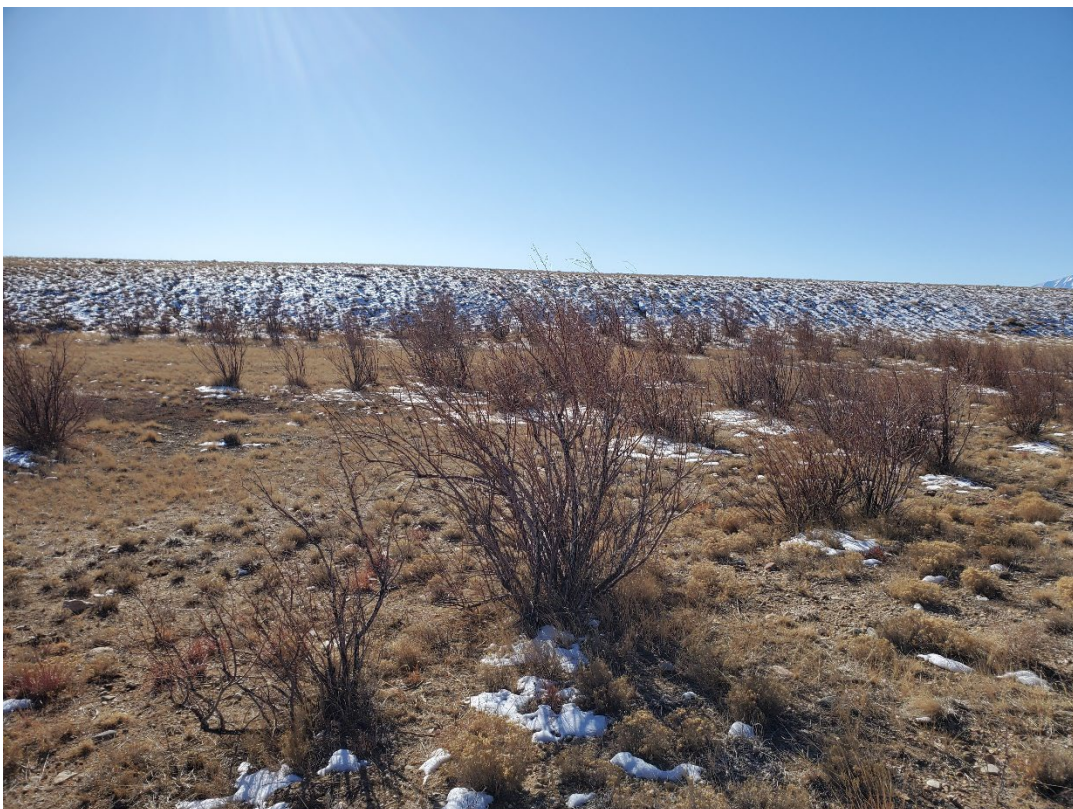
Photo 8: Looking south into the Phase I(b) permit area at Tamarisk and small erosion rills on the slope.
