**MINERALS PROGRAM INSPECTION REPORT**  
**PHONE: (303) 866-3567**

| <b>MINE NAME:</b><br>Lone Tree Pit | <b>MINE/PROSPECTING ID#:</b><br>M-2014-034 | <b>MINERAL:</b><br>Sand and gravel | <b>COUNTY:</b><br>Huerfano |
| <b>INSPECTION TYPE:</b><br>Monitoring | <b>WEATHER:</b> Windy | <b>INSP. DATE:</b><br>January 26, 2023 | <b>INSP. TIME:</b><br>11:00 |

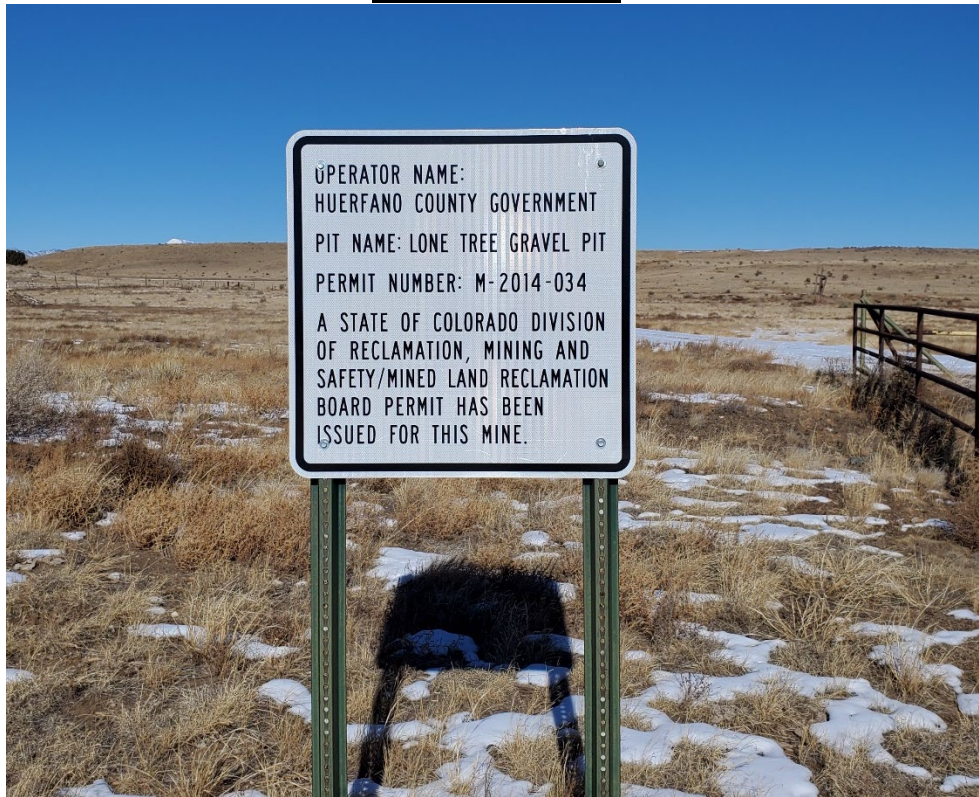
A permit sign was observed at the entrance to the site. Boundary markers were also observed around the permit area. We measured the affected acreage using GPS and told the operator that they are within the boundary but they are very close to the boundary in some areas, especially the eastern and north eastern edges of the Phase I area, and to be mindful of this during reclamation.

**Photo 1:** Permit sign at access road entrance.

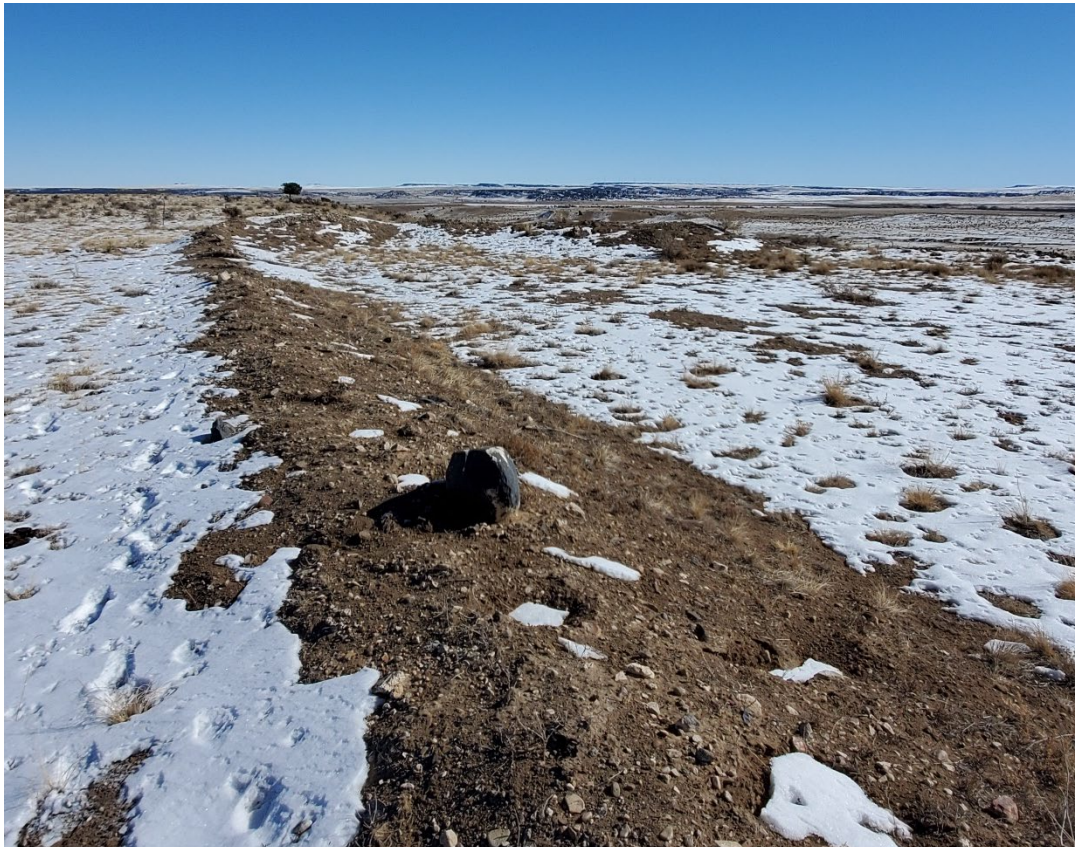
**Photo 2:** Looking at Eastern most point of permit boundary, while walking the outside of the affected area.

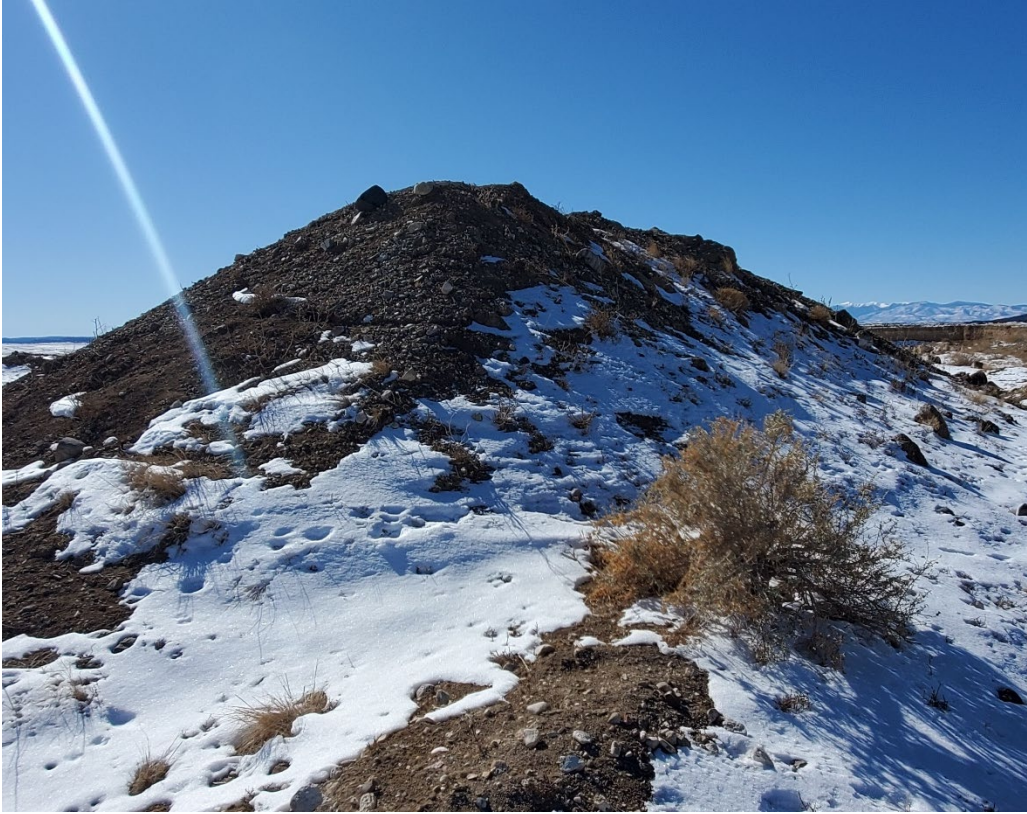
The asphalt pile on site is going to be crushed by dozers running over it and then the crushed asphalt will be added to processed mined material. Product stockpiles were observed near the road in the base of the pit. Additional stockpiles acting as a ramp for equipment were also observed.

**Photo 3:** Looking west at stockpiled material used as a ramp for equipment.

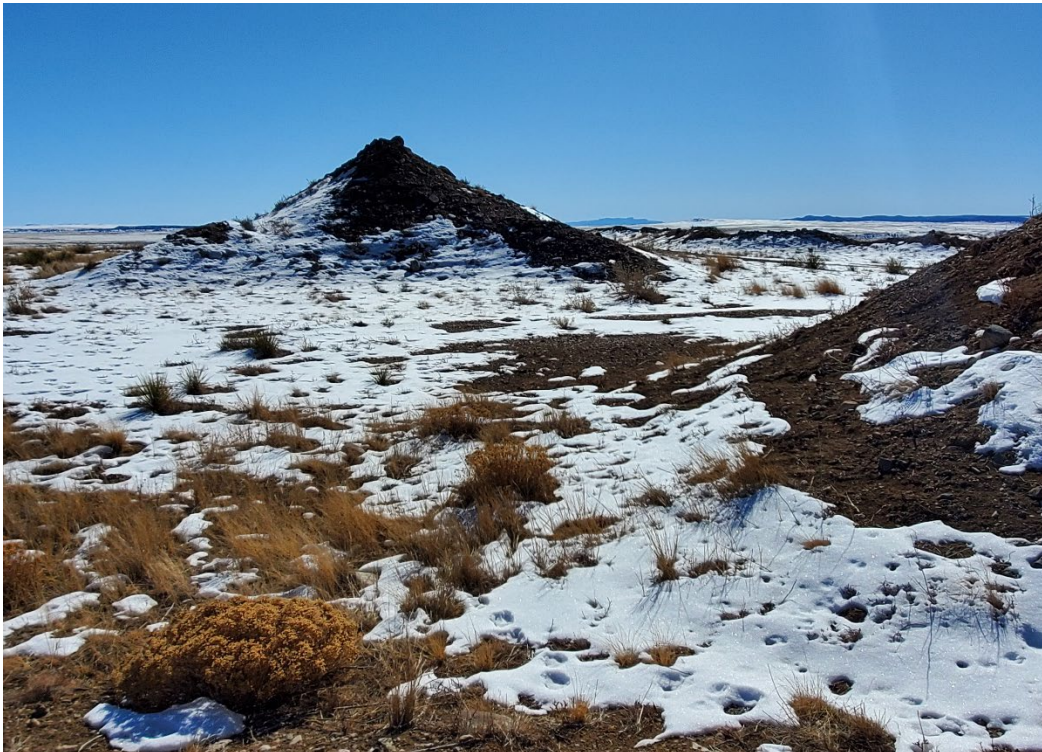
**Photo 4:** Looking south at stockpiled material used as a ramp for equipment.

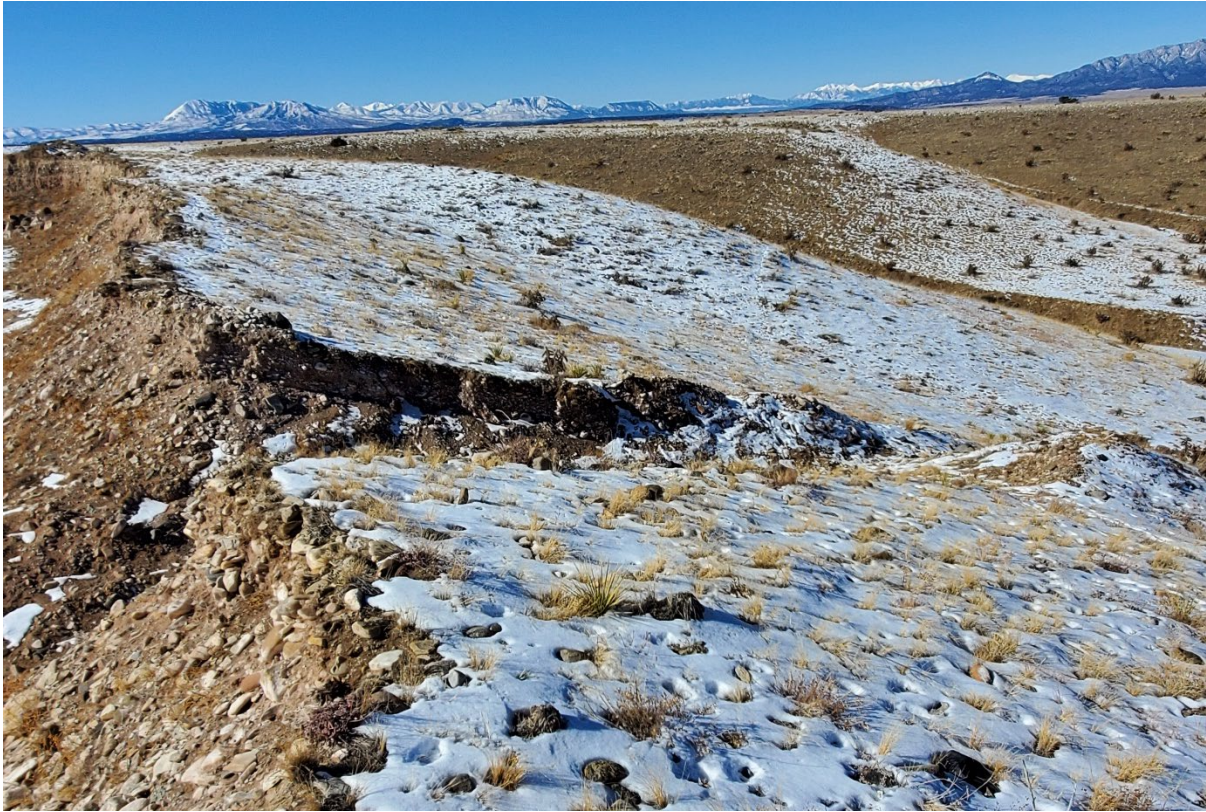
**Photo 5:** Looking west, eroded wall and material reaching near the northern edge of the Phase I boundary.

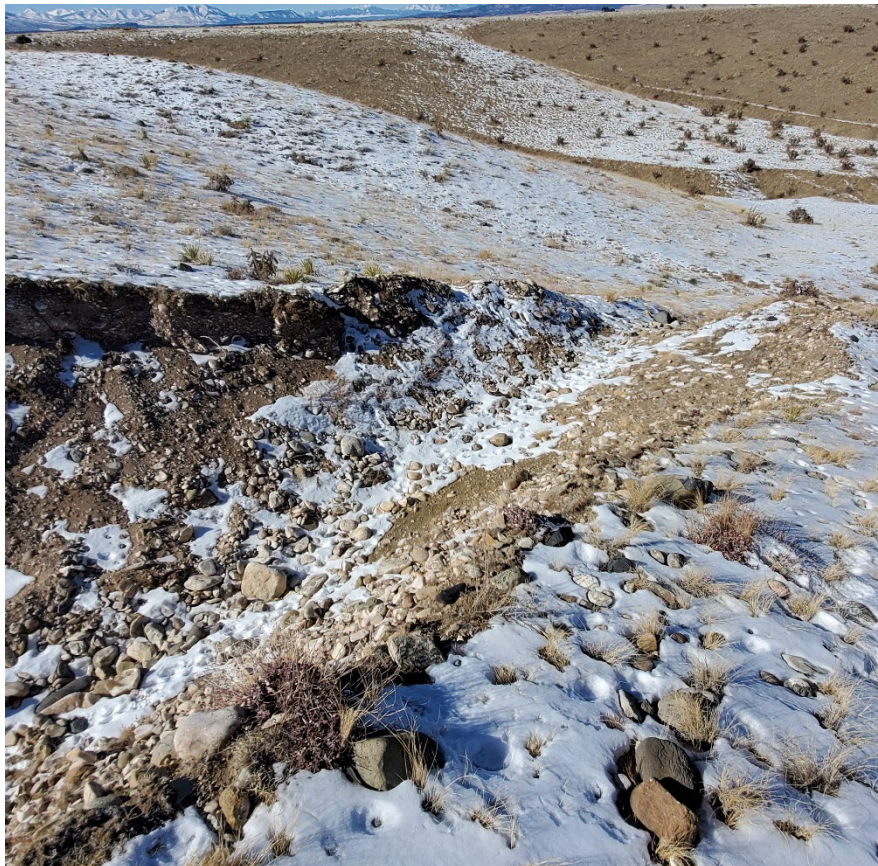
**Photo 6:** Looking northwest downslope of eroded wall along northern edge of the Phase I boundary.

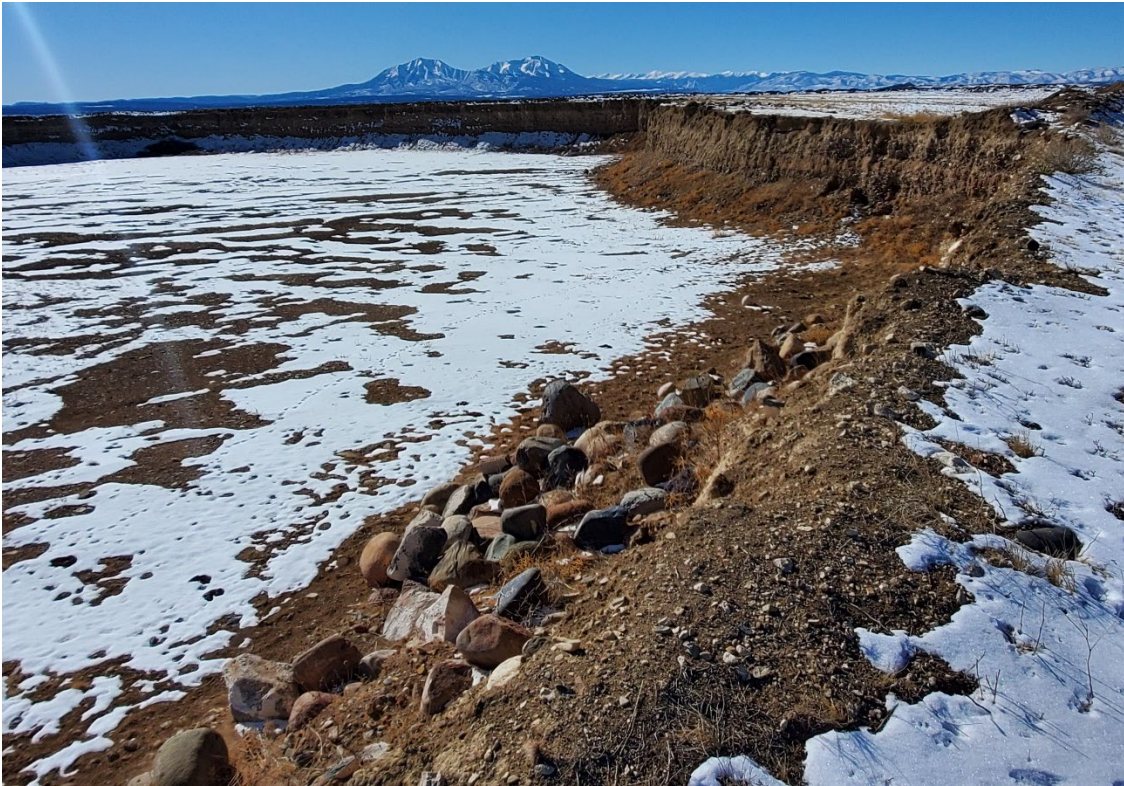
**PROBLEM:** The current mine plan needs to be updated and clarified pursuant to C.R.S. 34-32.5-112 (1)(c)(VI). The operator must provide sufficient information to describe or identify how the operator intends to conduct the operation.

High walls were observed in the pit. The current mining plan says that excavation will be conducted by pushing slopes to 3H: 1V. The current reclamation plan states "no highwalls are planned at this open pit mine". We mapped the extent of the high walls using GPS and estimated the height of the highest wall using a clinometer. We estimated the highest wall to be about 26.6 feet tall. The operator/permittee will need to submit a technical revision addressing the creation of highwalls as part of the mining plan.

**Photo 7:** View of highwall along northern and western edges of the pit.

**CORRECTIVE ACTIONS:** The operator shall submit a Technical Revision, with the required \$216 revision fee, to update and clarify the current approved mine plan to reflect existing and proposed activities by the corrective action date.

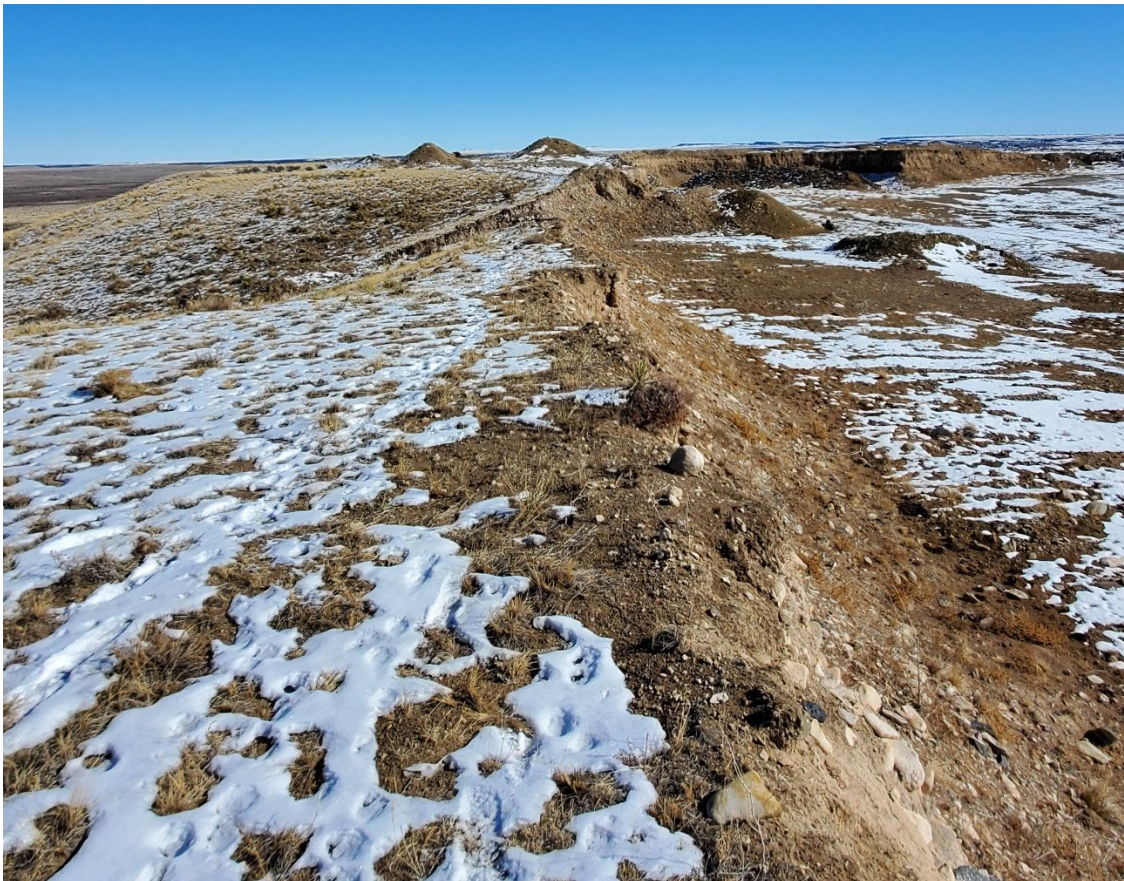
**Photo 8:** View of highwall along northern and eastern edges of the pit.

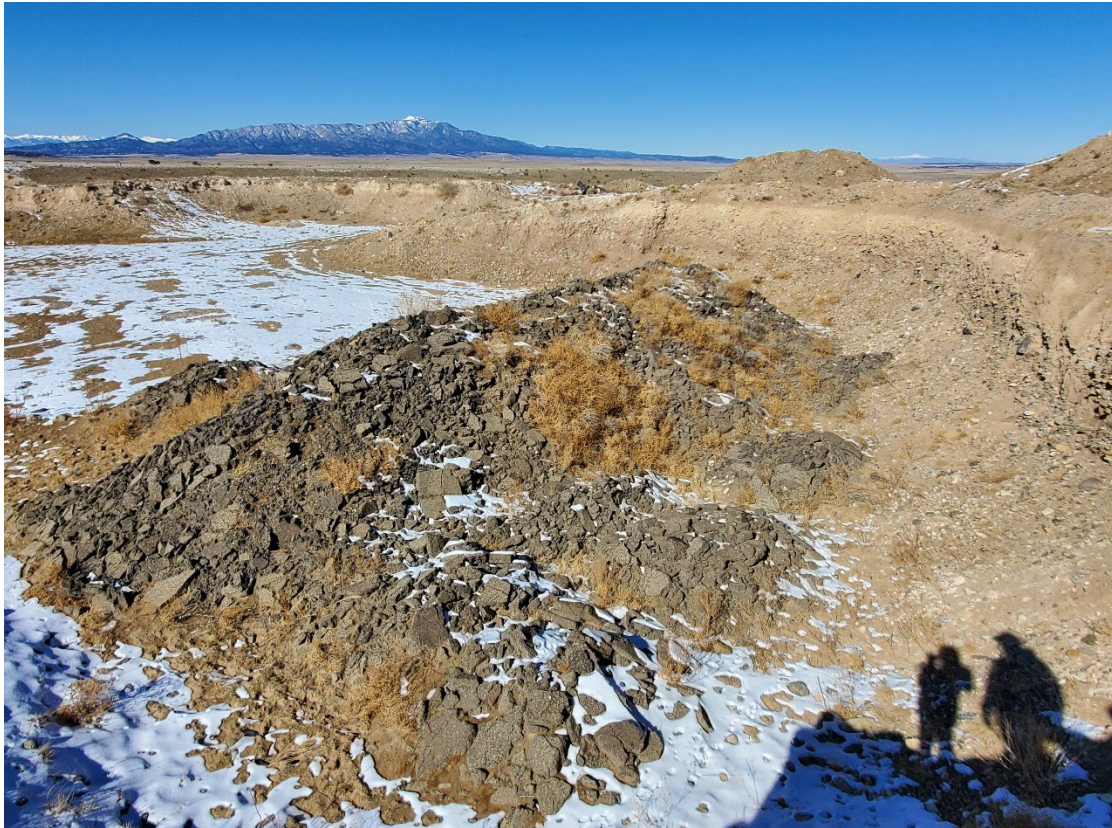
**Photo 9:** Looking down northwest across pit at asphalt stockpile.

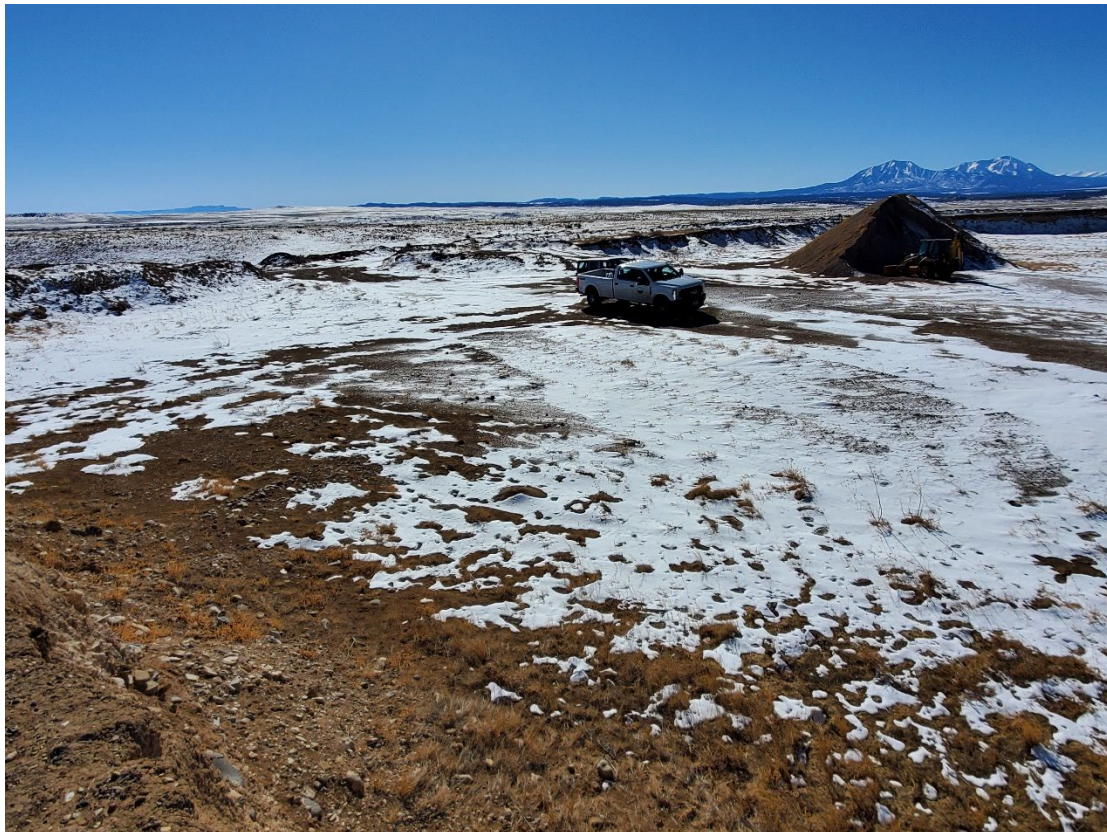
**Photo 10:** Looking southwest across pit at product stockpile near access road.

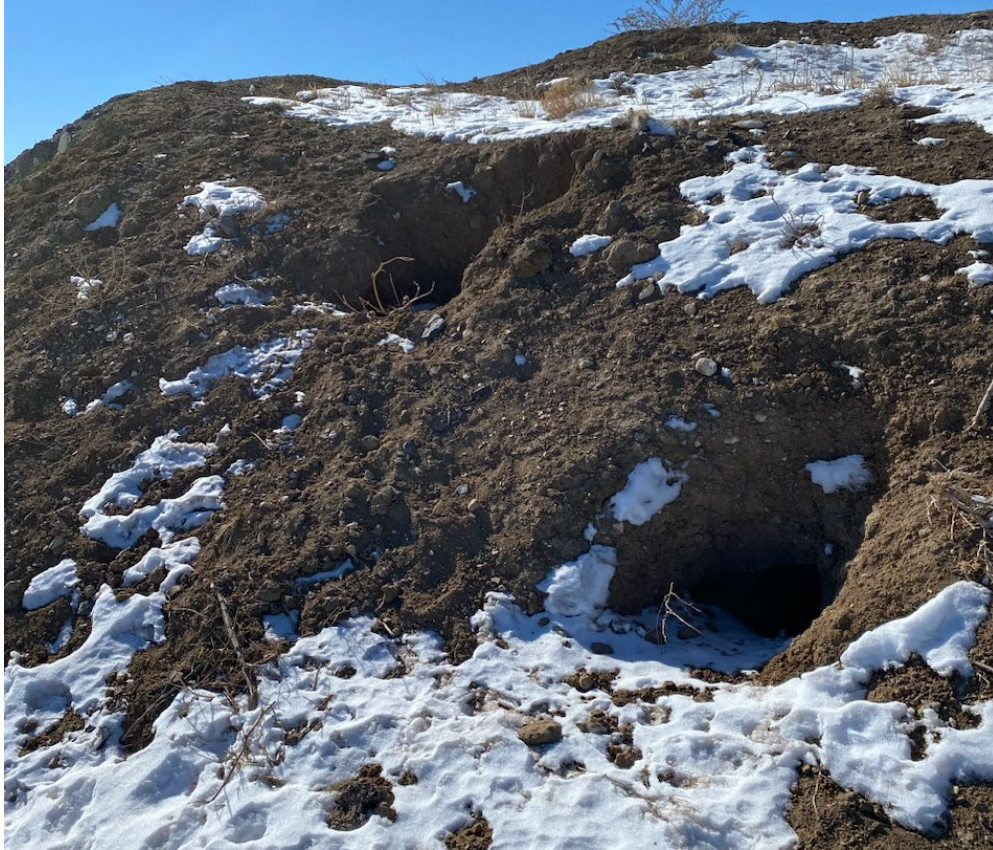
Topsoil stockpile is located on the western edge of Phase 2 and appears stable with some vegetation growing. We noticed some animal boreholes on the east facing side on the south end of the stockpile.

**Photo 11:** Animal burrows in east-facing side of southern portion of topsoil pile.

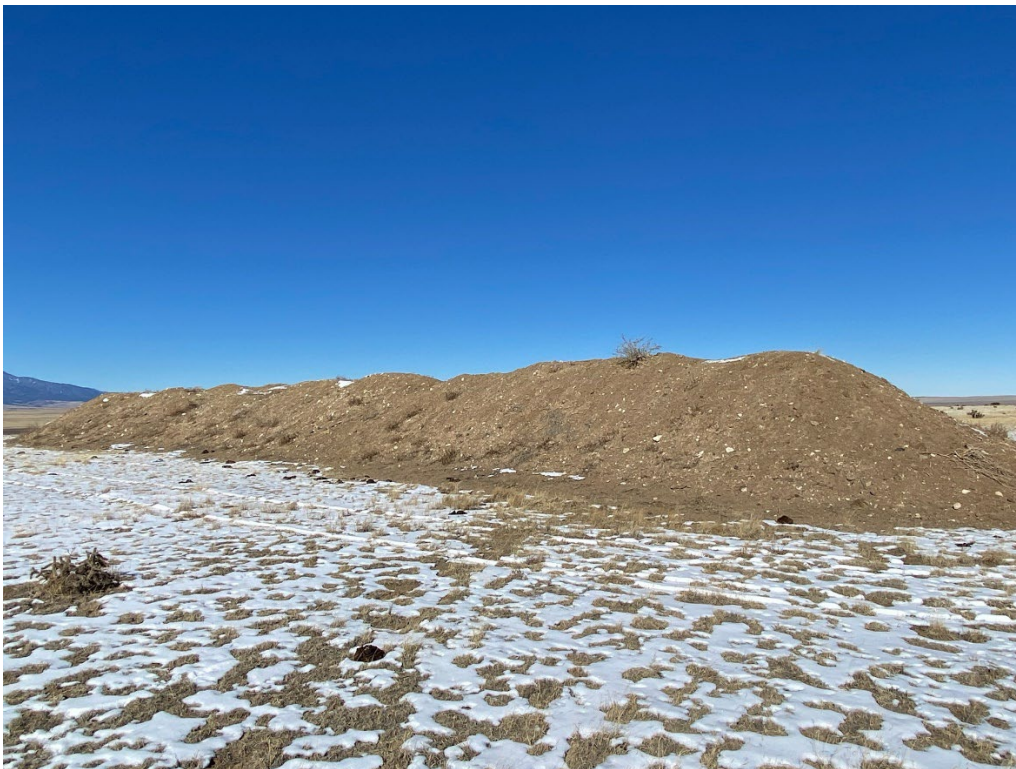
**Photo 12:** Looking east at west-facing side of topsoil stockpile. Pile has sparse vegetation.

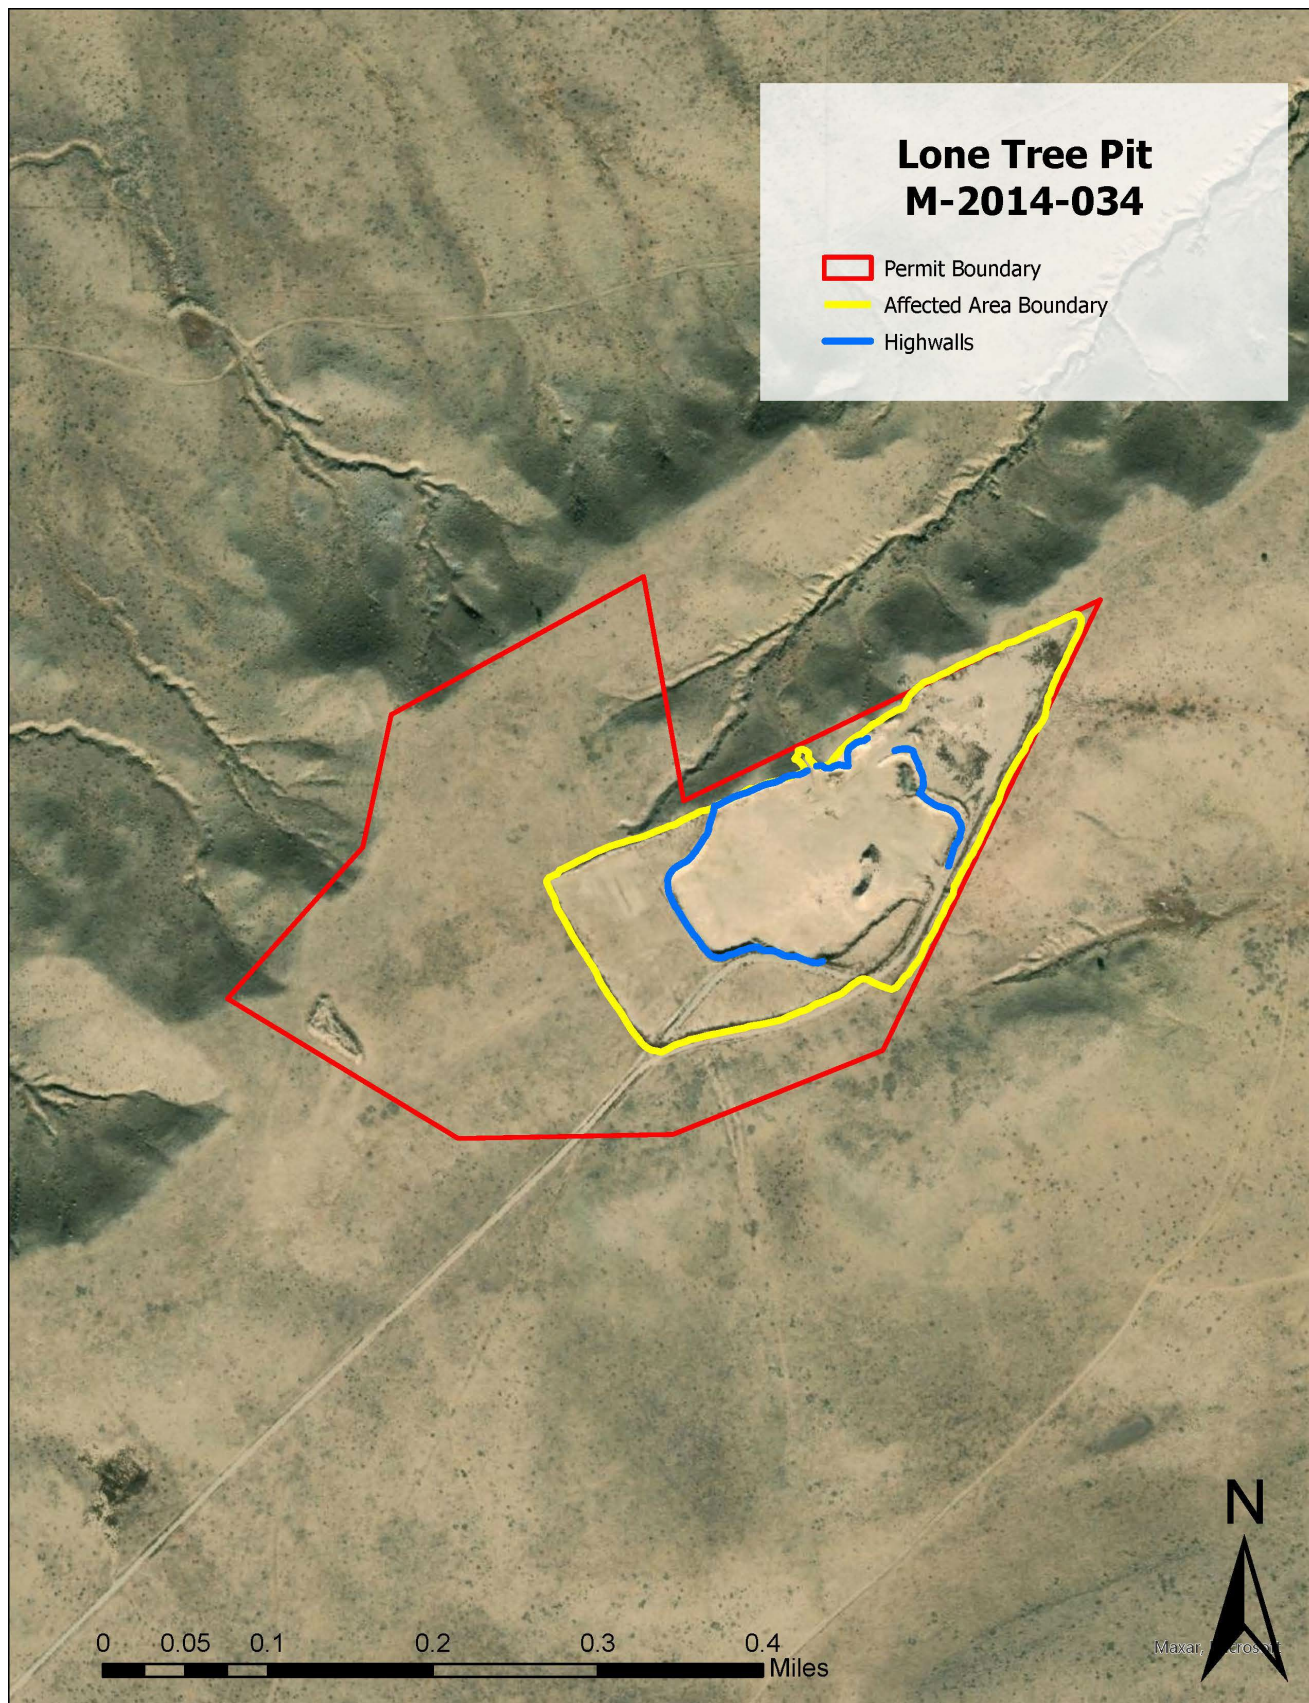
**Map:** Map showing permit boundary, extent of highwalls, and affected area.
