Attachment D

SPCC C-1 Diesel and Gas Storage & Filling Station

Date of Inspection	2022-01-19
Inspection Frequency	Monthly

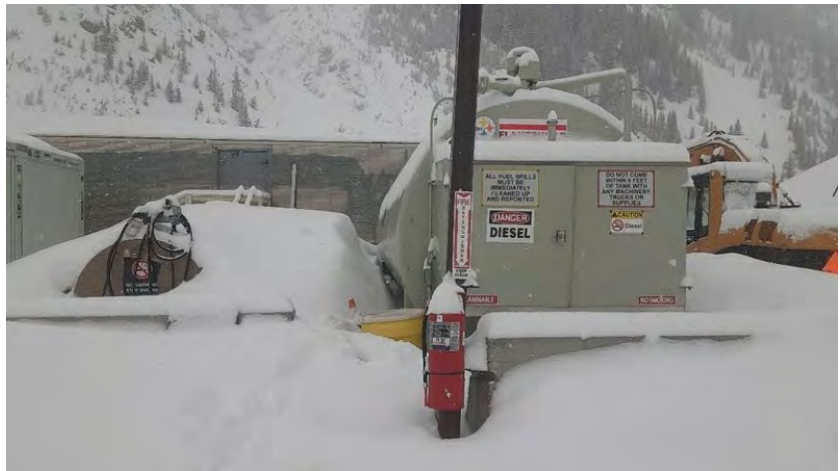
Tank photos (both tanks)

Do gas tank surfaces show signs of leakage?	No
Is gas tank damaged, rusted or otherwise deteriorating?	No
Are gas tank supports damaged, rusted or otherwise deteriorating?	No
Are gas tank foundations eroded or settled?	No
Gas tank fill level gauge functional?	Yes
Note gas fill level (inches)	15
Are gas vents free of obstruction?	No
Is gas secondary containment damaged?	No
Is any maintenance required for gas tank?	No
Note corrective action needed for gas tank	Tank buried in snow. Vents need to be cleared

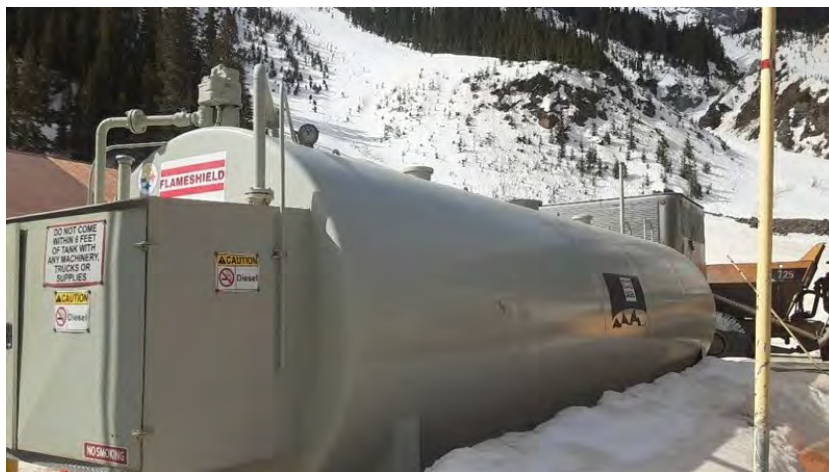
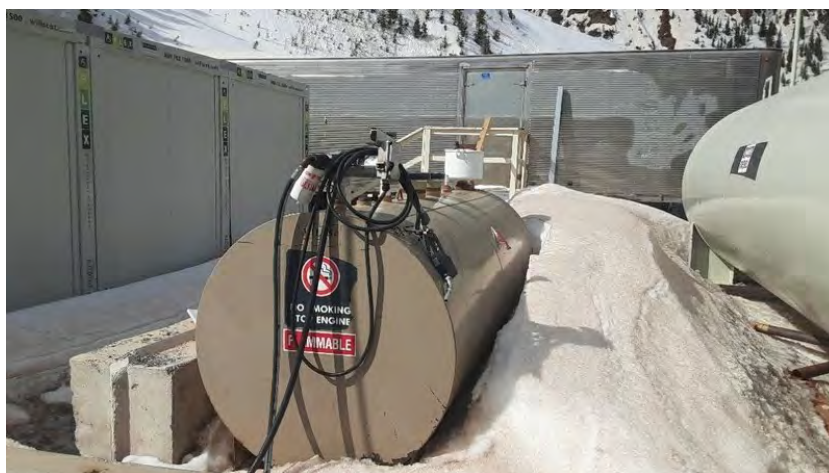
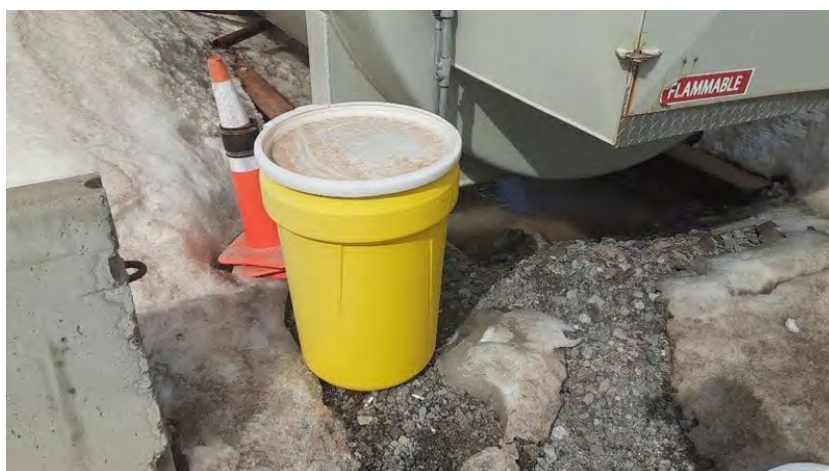
Tank photos (both tanks)

Do gas tank surfaces show signs of leakage?	No
Is gas tank damaged, rusted or otherwise deteriorating?	No
Are gas tank supports damaged, rusted or otherwise deteriorating?	No
Are gas tank foundations eroded or settled?	No
Gas tank fill level gauge functional?	No
Note gas fill level (inches)	8
Are gas vents free of obstruction?	Yes
Is gas secondary containment damaged?	No
Is any maintenance required for gas tank?	No
Note corrective action needed for gas tank	Gauge was broken during snow removal. Needs to be replaced. Level of fuel in tank estimated.

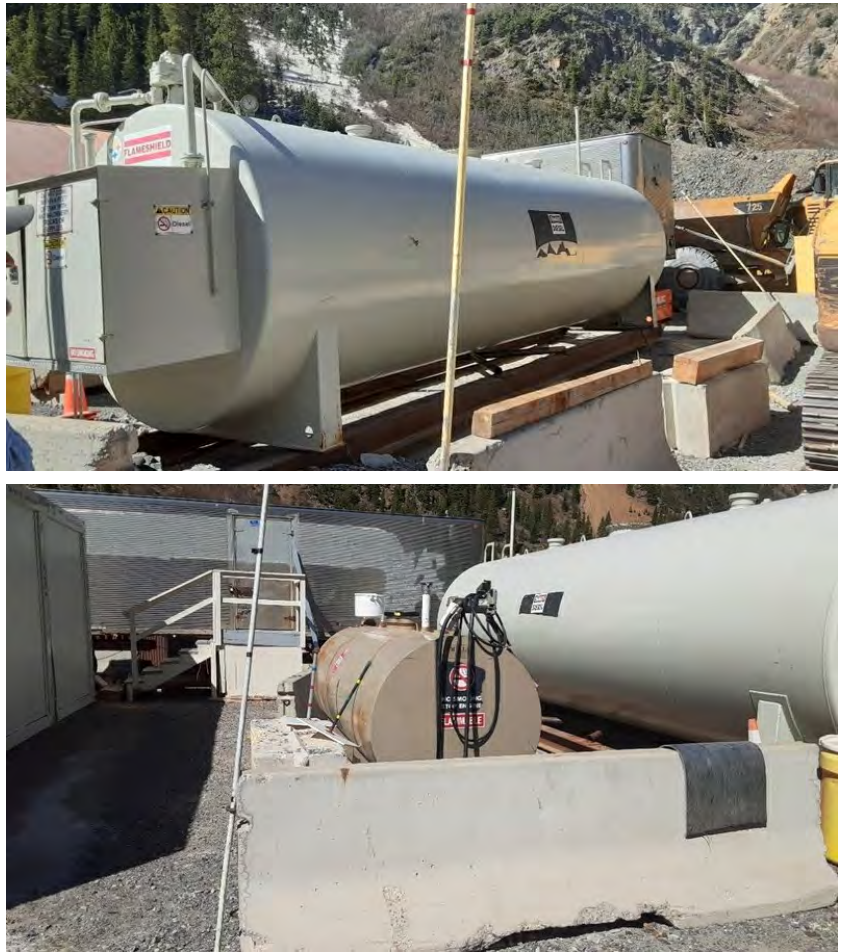
Tank photos (both tanks)

Do gas tank surfaces show signs of leakage?	No
Is gas tank damaged, rusted or otherwise deteriorating?	No
Are gas tank supports damaged, rusted or otherwise deteriorating?	No
Are gas tank foundations eroded or settled?	No
Gas tank fill level gauge functional?	No
Note gas fill level (inches)	-99
Are gas vents free of obstruction?	Yes
Is gas secondary containment damaged?	No
Is any maintenance required for gas tank?	Yes
Note corrective action needed for gas tank	Gauge needs to be fixed. Kelly says there is 2 feet of gas there

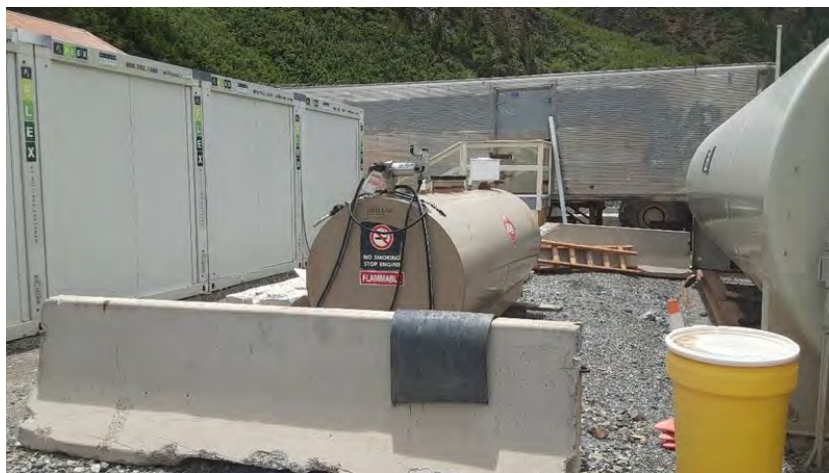
Tank photos (both tanks)

Do gas tank surfaces show signs of leakage?	No
Is gas tank damaged, rusted or otherwise deteriorating?	No
Are gas tank supports damaged, rusted or otherwise deteriorating?	No
Are gas tank foundations eroded or settled?	No
Gas tank fill level gauge functional?	No
Note gas fill level (inches)	24
Are gas vents free of obstruction?	Yes
Is gas secondary containment damaged?	No
Is any maintenance required for gas tank?	Yes
Note corrective action needed for gas tank	Level of tank is approximate. Gauge/bis broken.

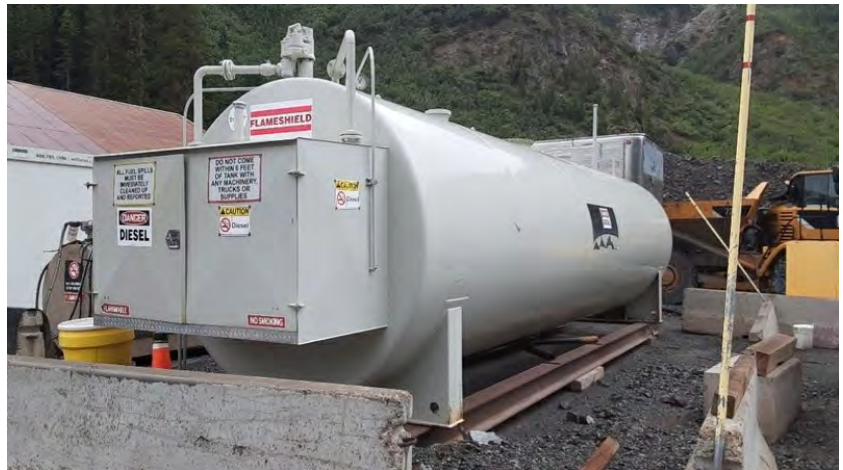
Tank photos (both tanks)

Do gas tank surfaces show signs of leakage?	No
Is gas tank damaged, rusted or otherwise deteriorating?	No
Are gas tank supports damaged, rusted or otherwise deteriorating?	No
Are gas tank foundations eroded or settled?	No
Gas tank fill level gauge functional?	No
Note gas fill level (inches)	3
Are gas vents free of obstruction?	Yes
Is gas secondary containment damaged?	No
Is any maintenance required for gas tank?	No
Note corrective action needed for gas tank	Gauge needs to be fixed

Are gas pipelines or supports damaged, rusted or otherwise deteriorating?	Yes
Do gas joints, valves, valve seals, gaskets or other appurtenances show signs of leakage?	No
Loading/unloading gas connections are capped or blank flanged?	Yes
Is any maintenance required on gas connections?	No
Note corrective action needed for gas transfer and connections	NA

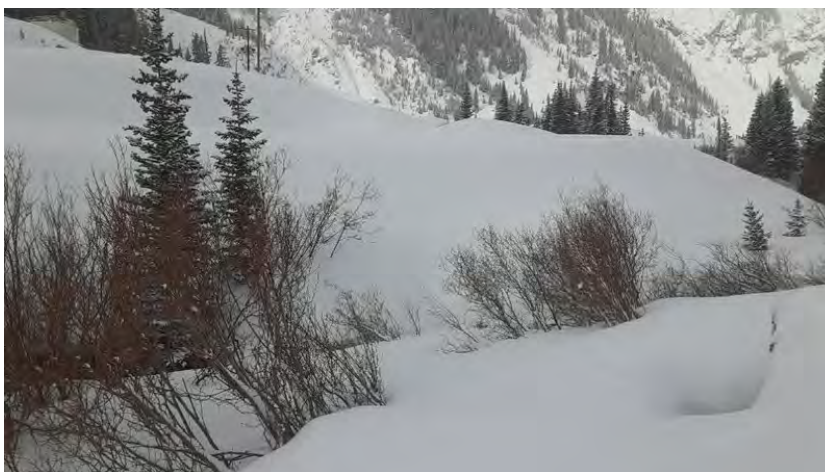
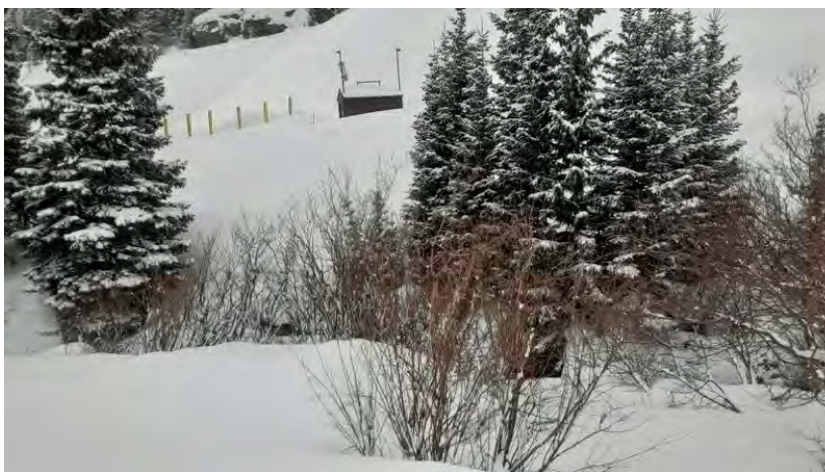
Created	2022-03-29 09:20:16 MDT by Environmental Department
Updated	2022-03-29 10:27:16 MDT by Environmental Department
Location	37.9742177, -107.749309
Date	2022-03-29
Time	09:20
Weather Conditions	Snowing
Water Present?	No
Notes	Area snow covered. No indication of leak
Photos

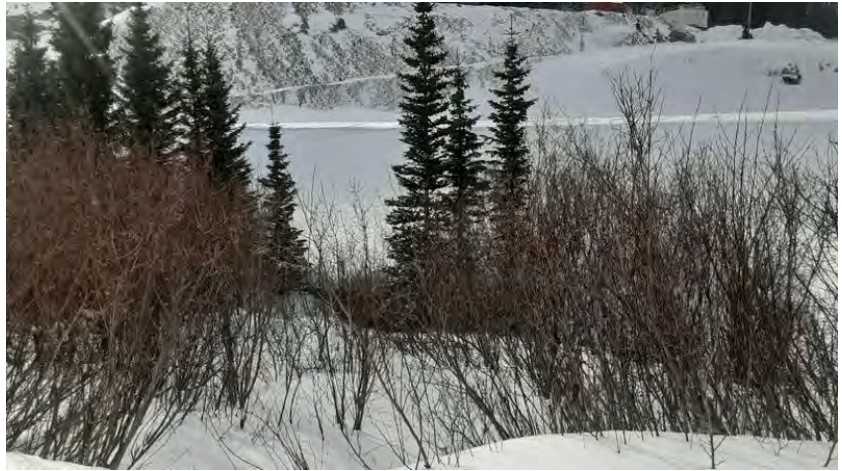
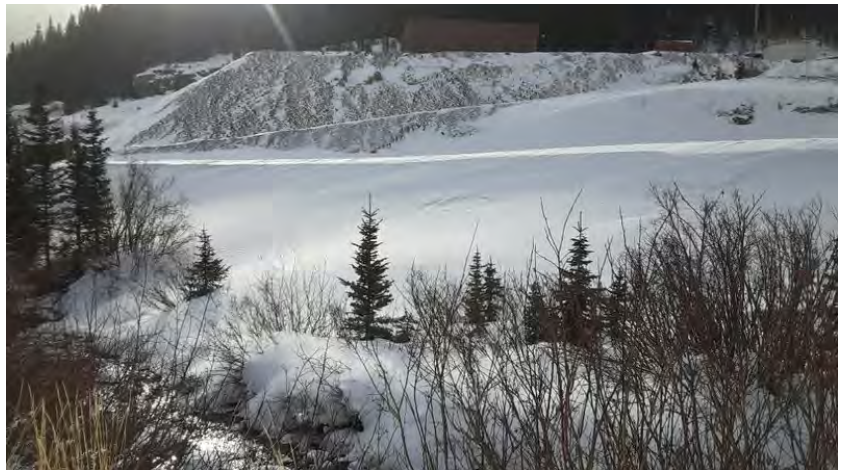
Created	2022-12-22 10:13:38 MST by Environmental Department
Updated	2022-12-22 10:15:35 MST by Environmental Department
Location	37.9756351, -107.748062
Date	2022-12-22
Time	10:13
Weather Conditions	Snowing
Water Present?	No
Notes	Banks covered in snow. No signs of leaks.
Photos
