MINERALS PROGRAM INSPECTION REPORT
PHONE: (303) 866-3567

MINE NAME: Bennett's Gravel Pit	MINE/PROSPECTING ID#: M-1979-166	MINERAL: Sand and gravel	COUNTY: Delta
INSPECTION TYPE: Surety-Related Inspection	WEATHER: Clear	INSP. DATE: January 25, 2023	INSP. TIME: 10:40
OPERATOR: Elam Construction, Inc.	OPERATOR REPRESENTATIVE: Jim Doody	TYPE OF OPERATION: 112c - Construction Regular Operation	
REASON FOR INSPECTION: Surety Related	BOND CALCULATION TYPE: None	BOND AMOUNT: \$237,024.00	
DATE OF COMPLAINT: NA	POST INSP. CONTACTS: None	JOINT INSP. AGENCY: None	
INSPECTOR(S): Robert Zuber, P.E.	INSPECTOR'S SIGNATURE:

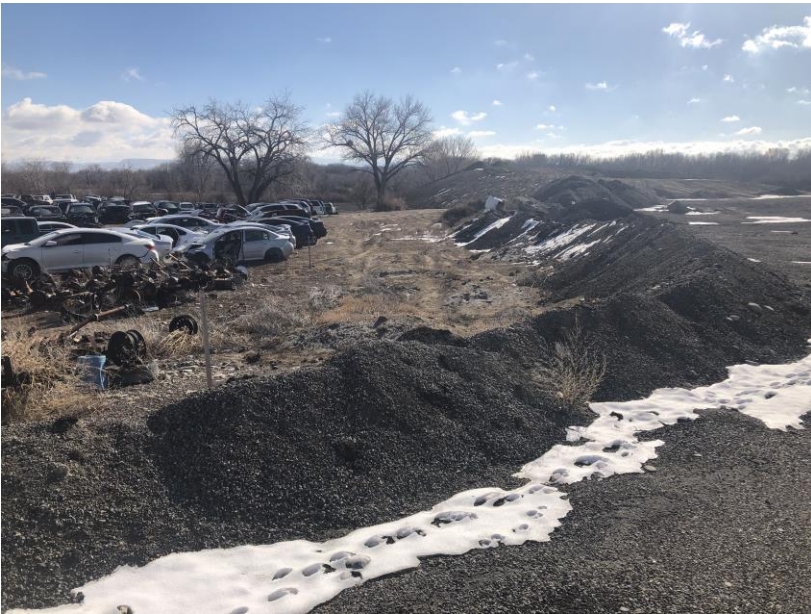
There was no indication that runoff from the site is causing problems in the Gunnison River, which is less than 30 feet from the mining area. Also, there is no sign of erosion of soil piles or loading of this material onto the adjacent property. However, these should be closely watched, and the Division recommends the use of berms or silt fence to preserve this resource.

Boundary marker near entrance and berm protecting adjacent property

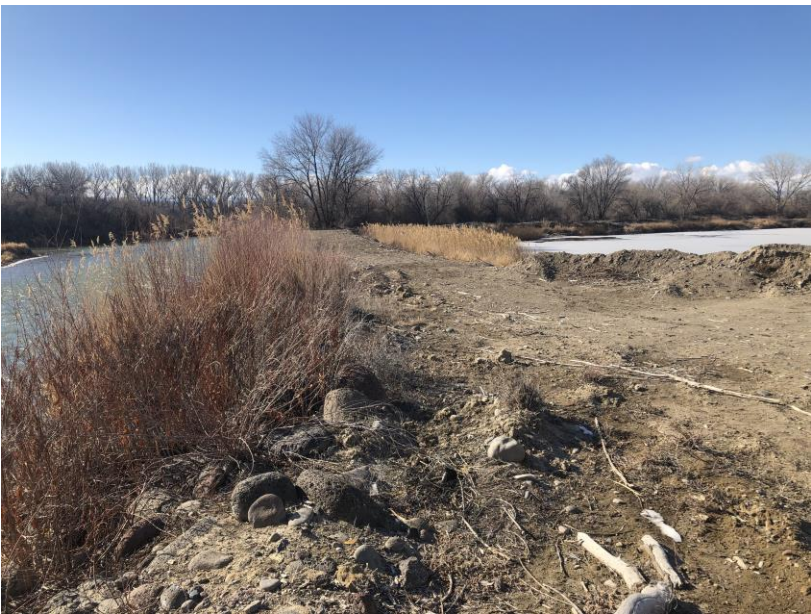
Road between river and pond (looking down river)

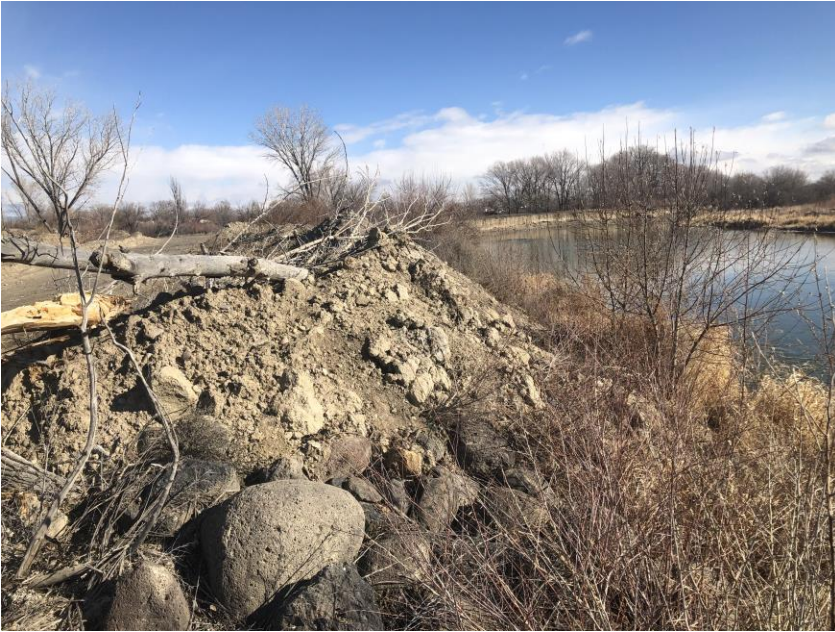
**Berm between river and mine site
(looking up river at bank erosion above the site)**

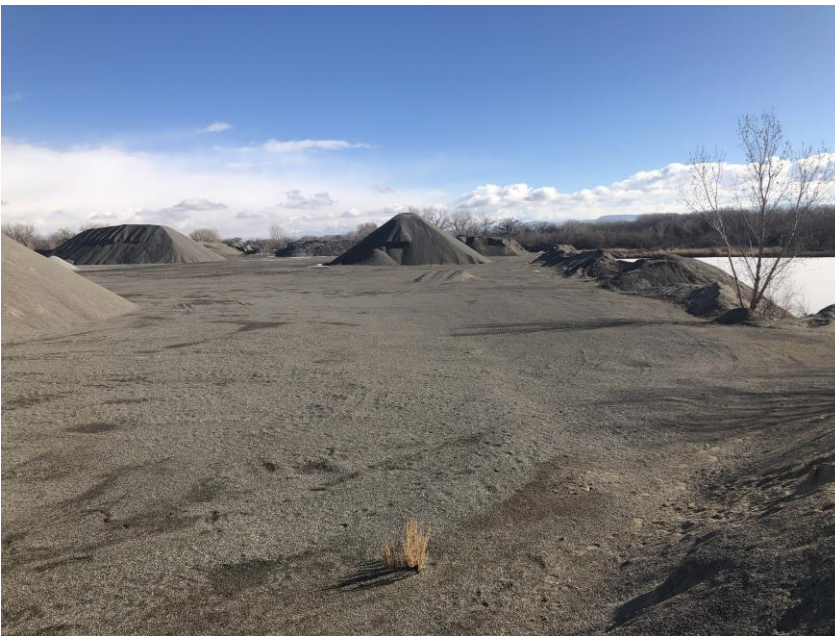
Large piles of processed material were seen at the process area.

Piles of product at process area

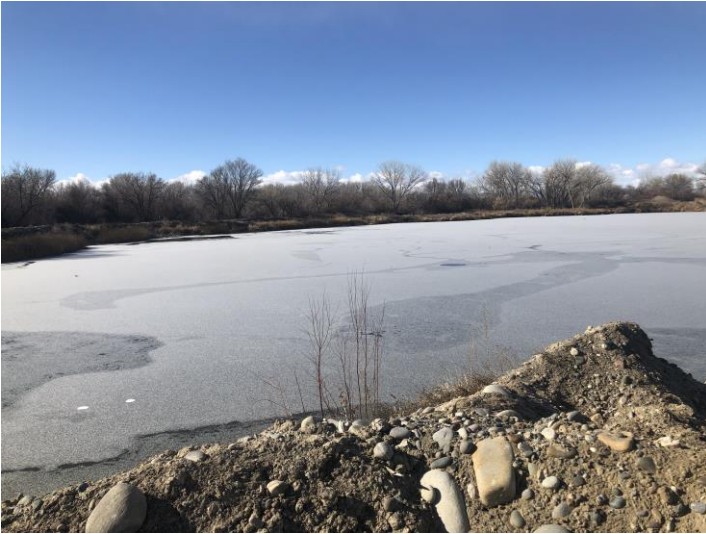
Pond, looking west at reclaimed bank

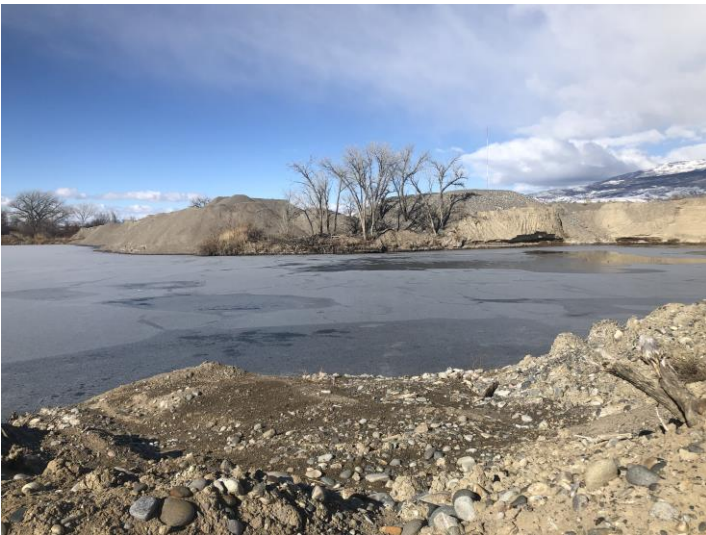
Using a laser measuring device and satellite imagery on a smart phone, it was determined that the total pond/pit area has not expanded in recent years. Also, the extent of un-reclaimed pit wall (aka pond banks) was estimated with Google Earth to be approximately 1,200 feet, well below the maximum of 2,000 feet.

Pond, looking north at un-reclaimed bank
