February 7, 2023  
Project No.: 19125

Regarding: Daniels Sand Pit 2, Permit No. M-1973-007-SG  
Slope Stability Monthly Monitoring Report

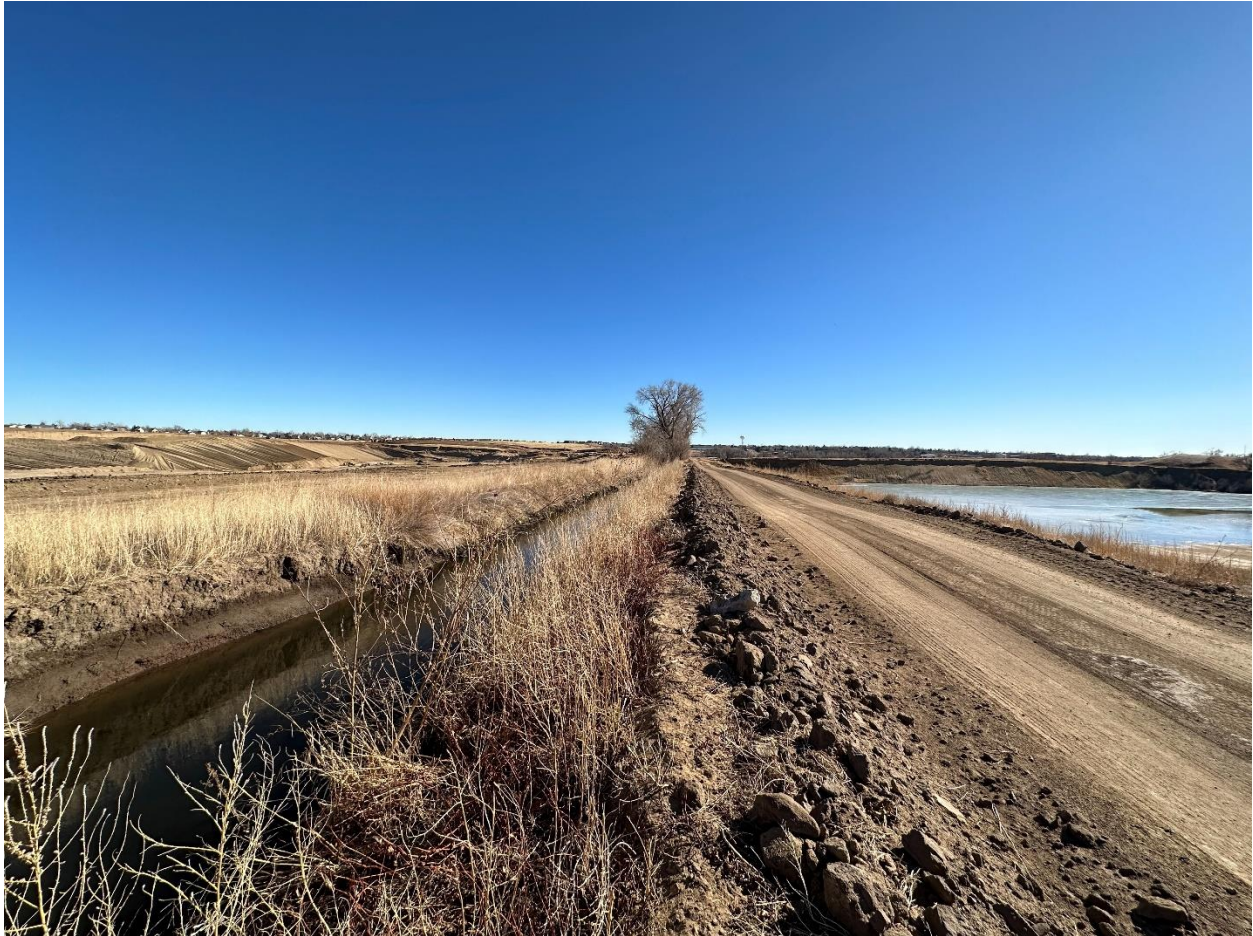
Photo 1. Fountain Mutual Ditch looking east with berm

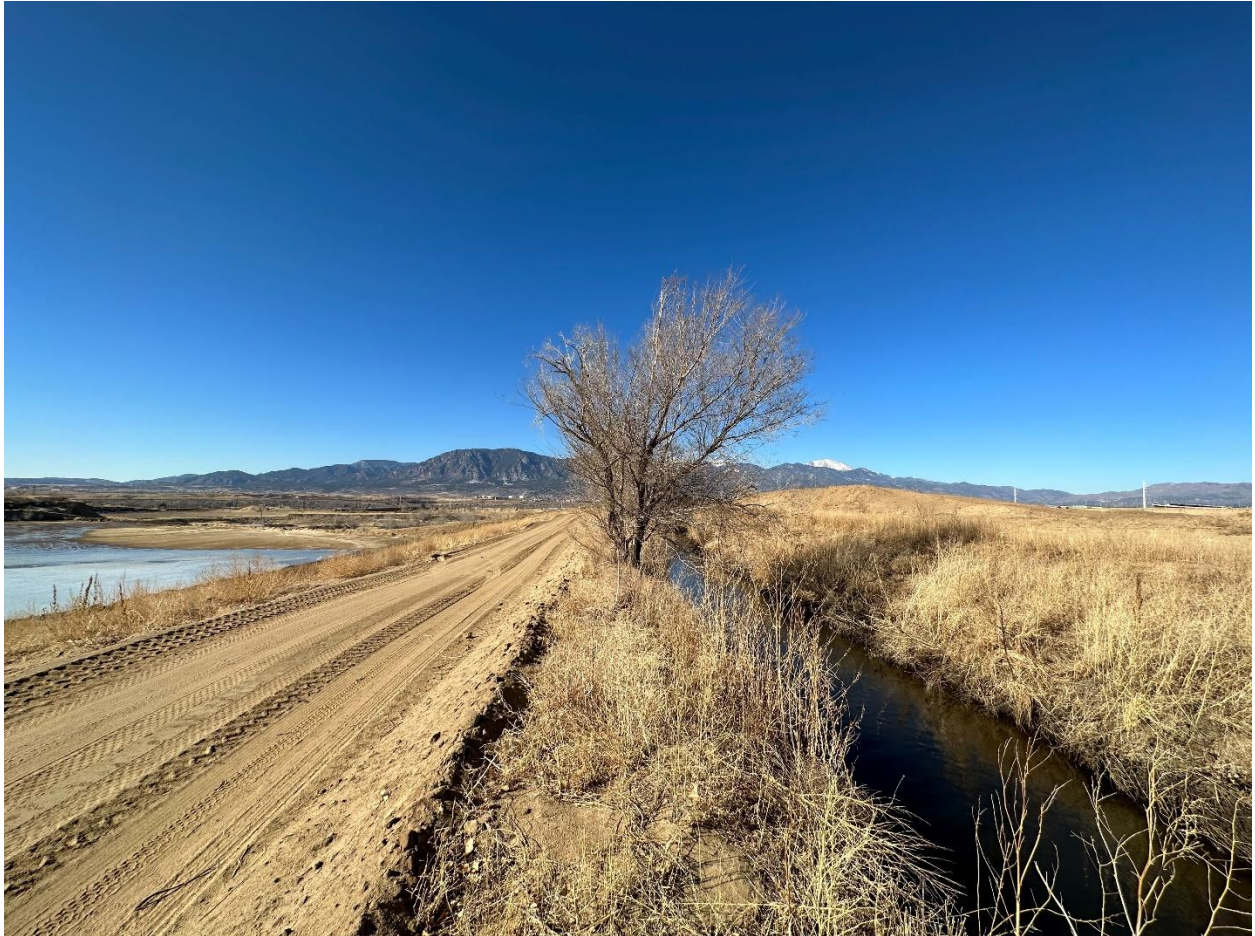
Photo 2. Fountain Mutual Ditch looking west with berm

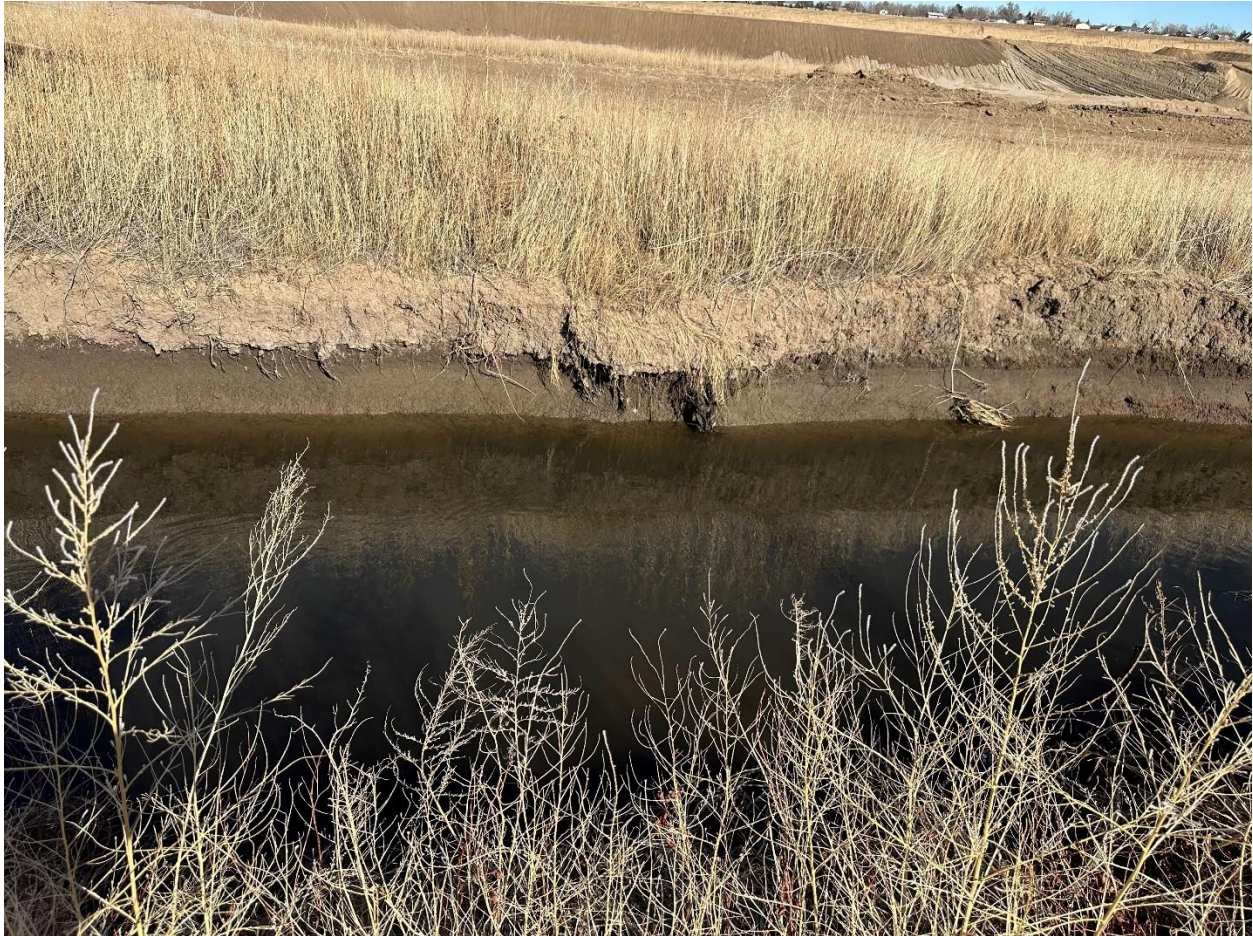
Photo 3. Fountain Mutual Ditch looking north

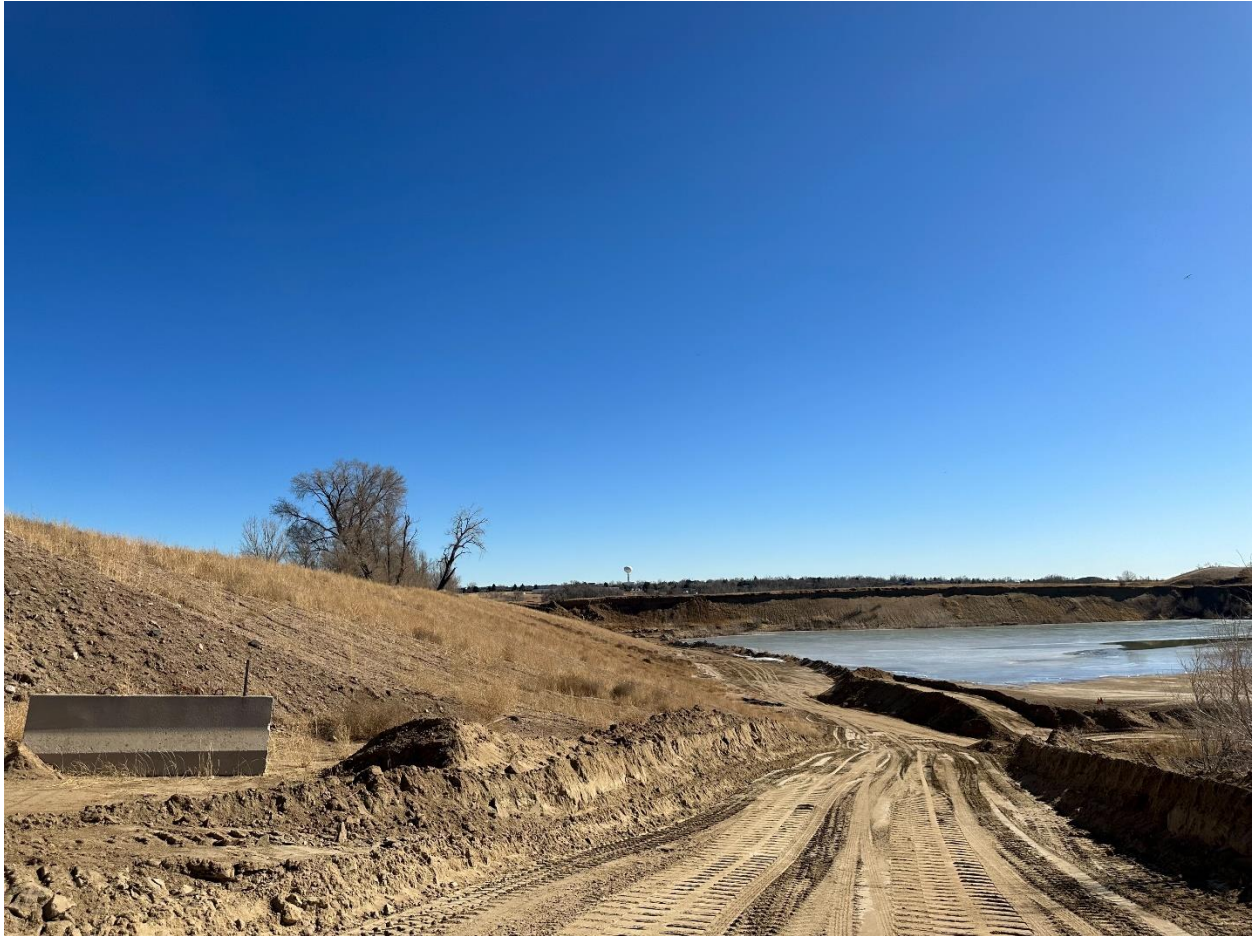
Photo 4. New access road west of the buttress slope

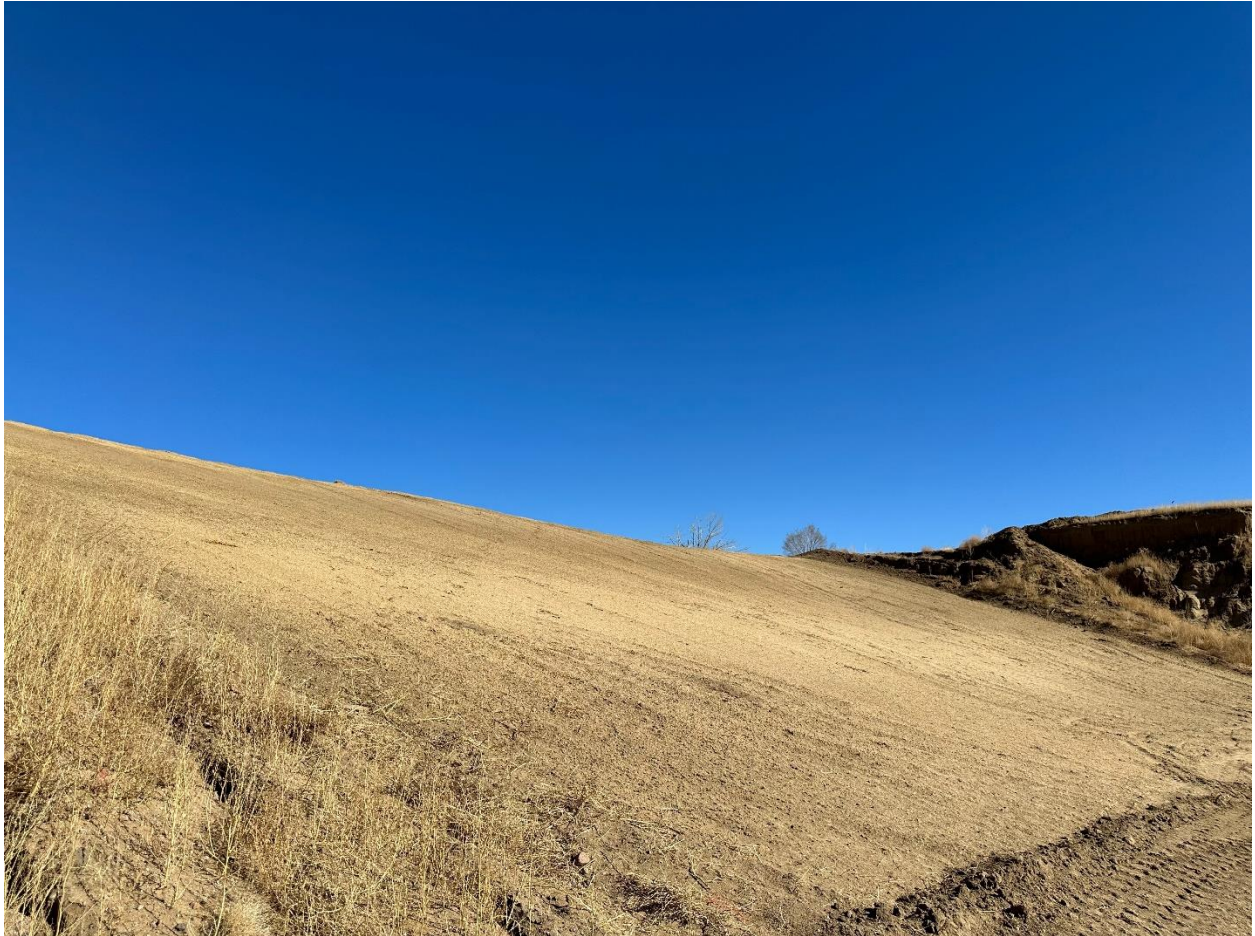
Photo 5. Buttress slope eastern portion with seed

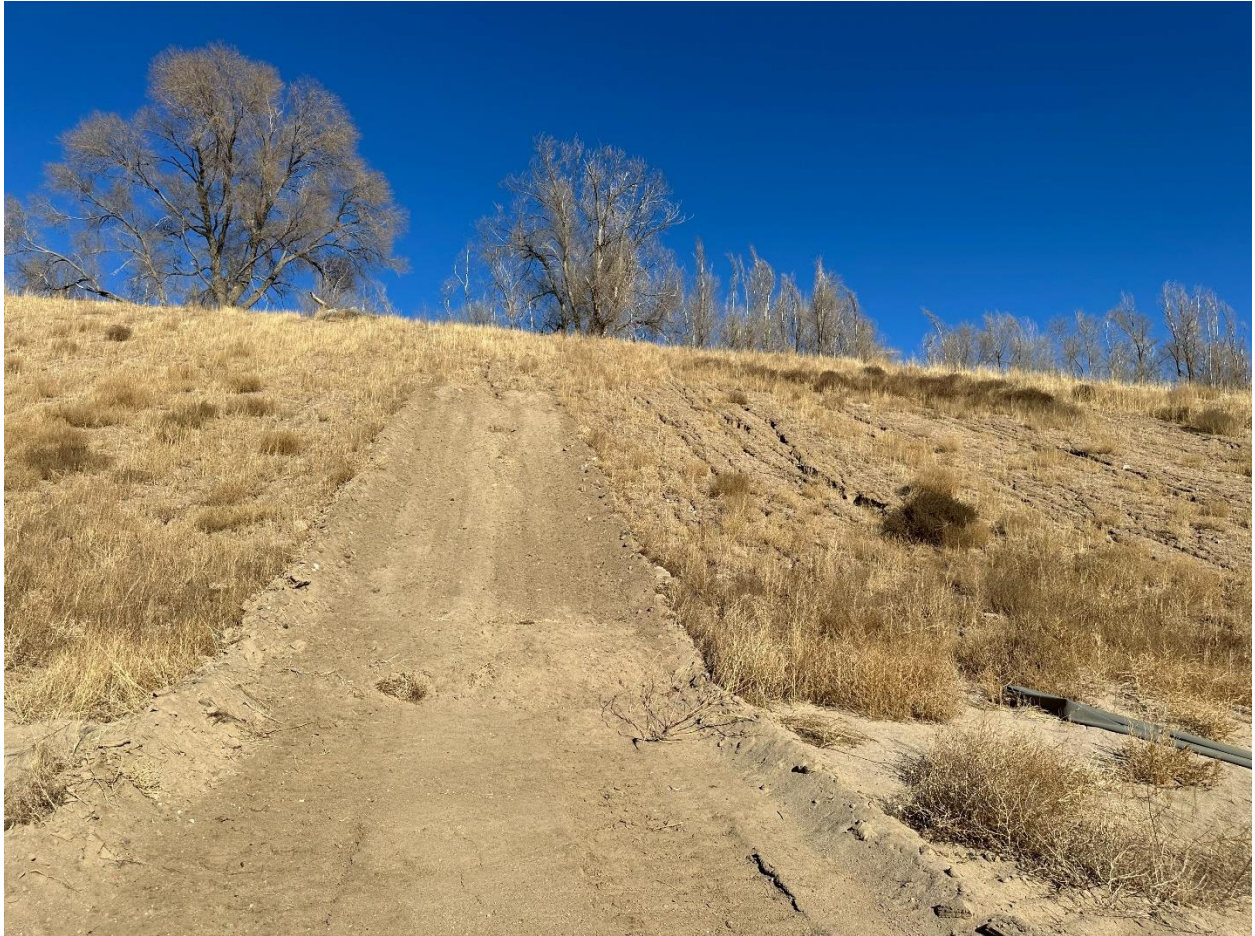
Photo 6. Buttress slope repair looking north from toe, erosion occurring around repair

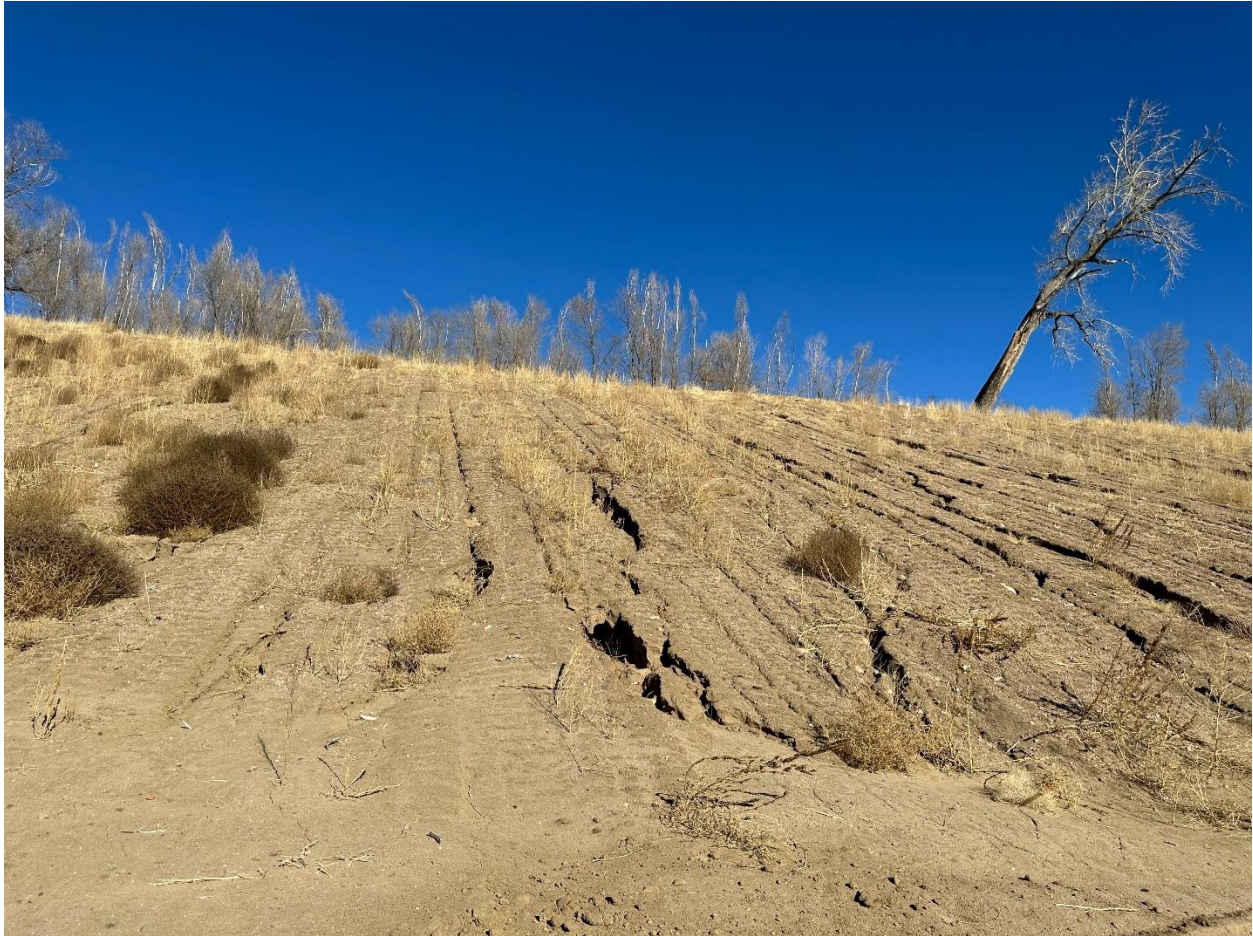
Photo 7. Buttress slope looking north, note evidence of drainage/erosion gullies forming. More sediment near toe
