M1979155, Dotsero Cinder Pit, Inspection Report

MINERALS PROGRAM INSPECTION REPORT

MINE NAME: Dotsero Cinder Pit	MINE/PROSPECTING ID#: M-1979-155	MINERAL: Volcanic materials (ash, cinders)	COUNTY: Eagle
INSPECTION TYPE: Monitoring	WEATHER: Cloudy	INSP. DATE: November 28, 2022	INSP. TIME: 14:00
OPERATOR: Colorado Department of Transportation	OPERATOR REPRESENTATIVE: N/A	TYPE OF OPERATION: 110c - Construction Limited Impact

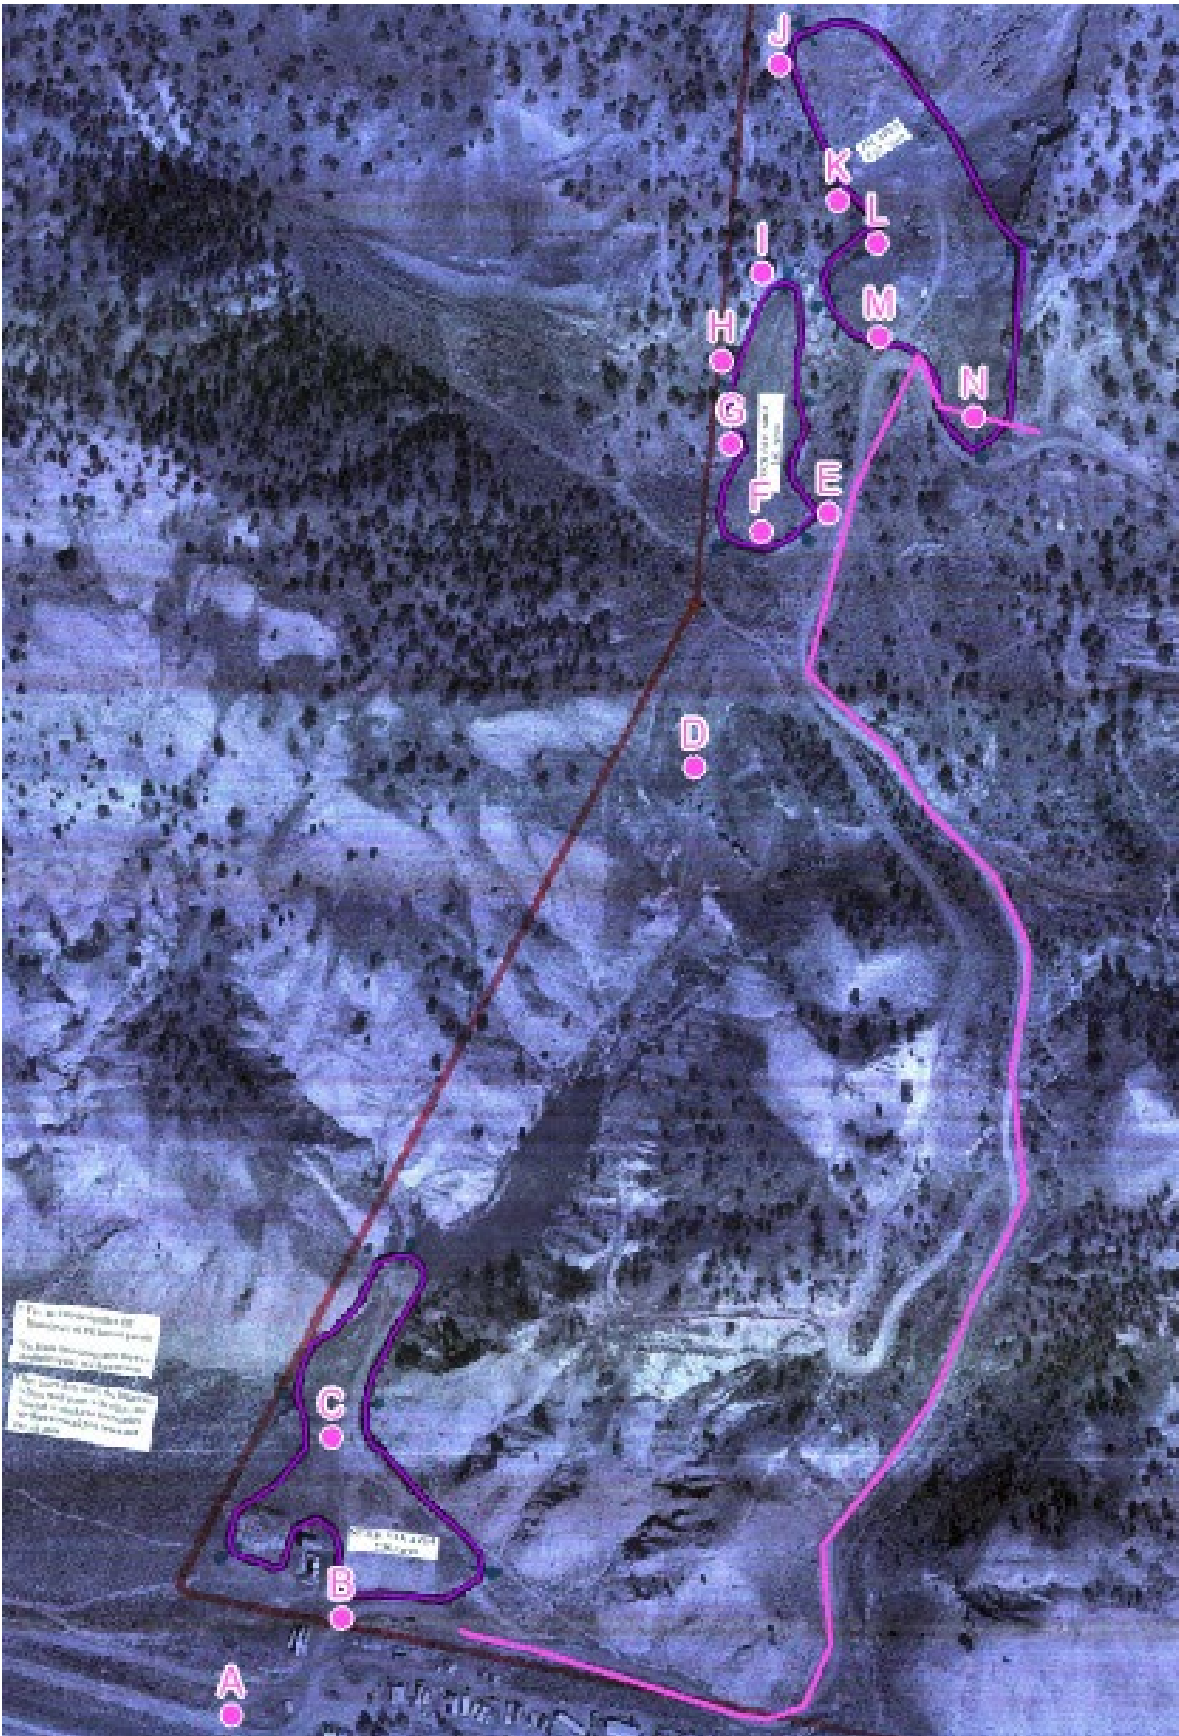
A site map was submitted on February 26, 2001 in response to the Division's October 19, 2000 inspection report. This map shows the permit boundary hand drawn onto an aerial image, and separated into three distinct parcels including a 4.03 acre pit area, a 1.03 acre stockpile area, and a lower 2.38 acre stockpile area. These stated acreages add up to a total of 7.44 acres. The map was georeferenced using physical features visible in the image, and the permit boundary was digitized. The total area of the three polygons was measured at 7.71 acres, which is 1.49 acres less than the approved 9.2 acres. (See Figure 1)

Figure 1: Screenshot of section of 2001 map, with digitized permit boundary (purple) and inspection features (pink)

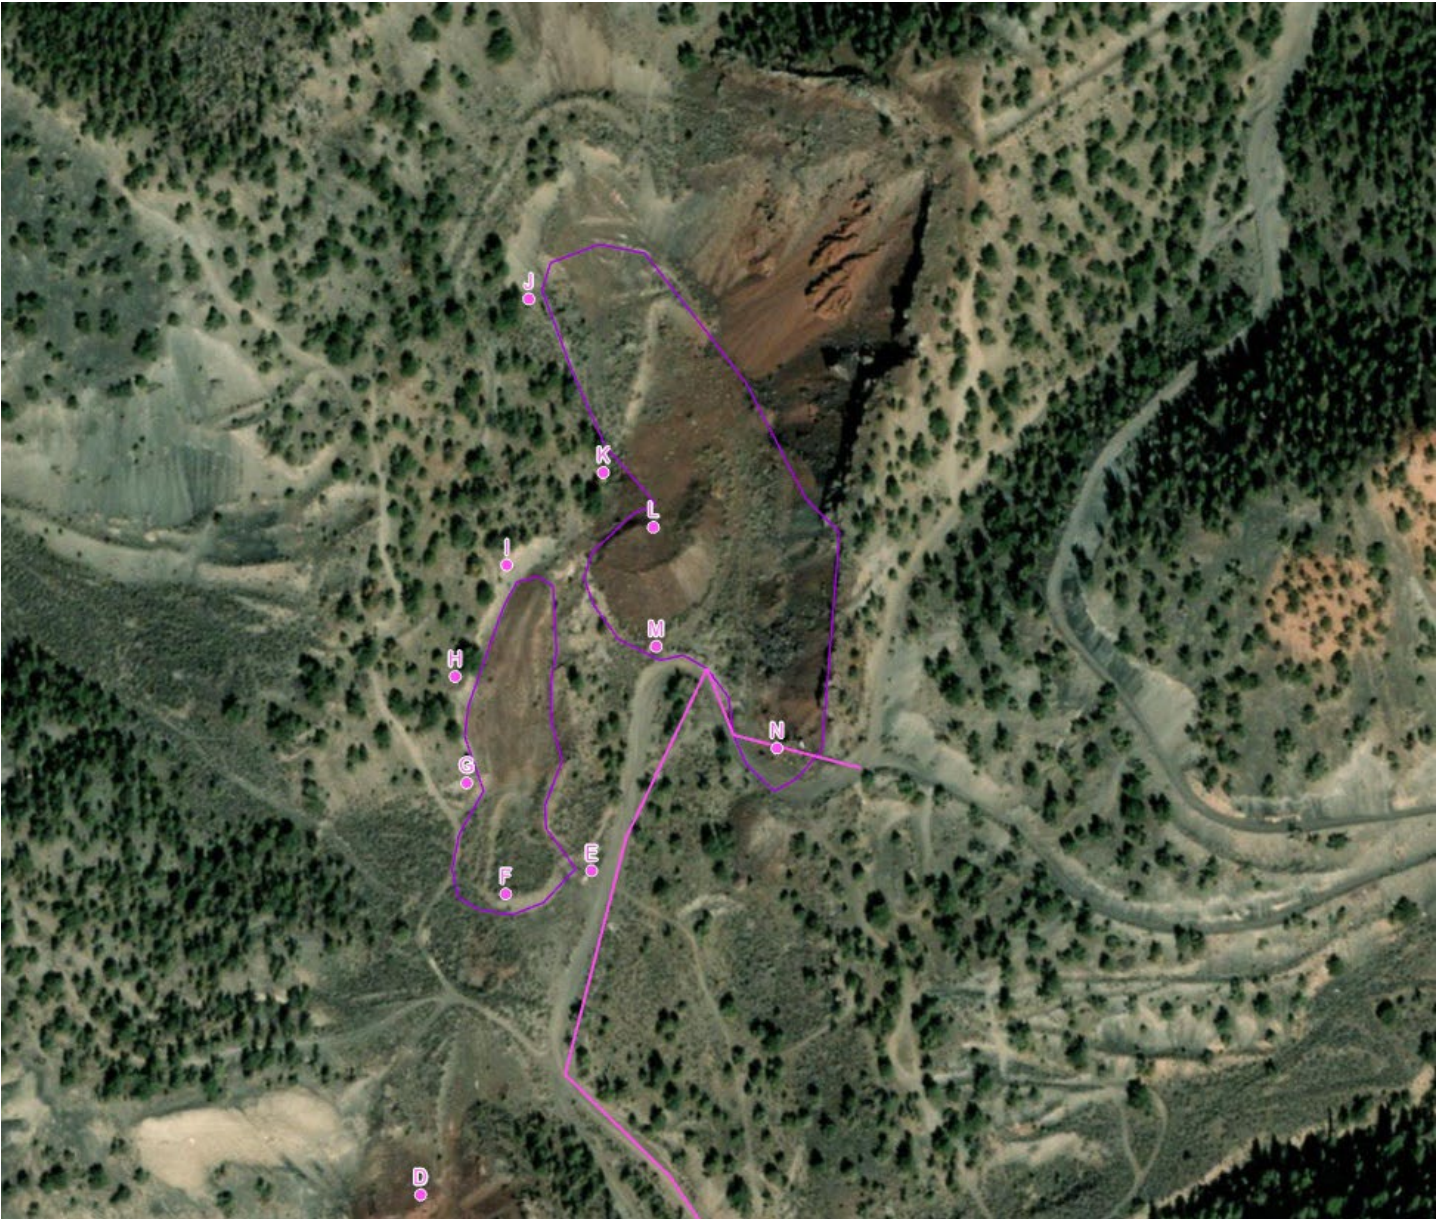
Figure 2 shows the northern-most parcel of the permit area (i.e. the "pit area"), overlaid on the aerial image, and Figure 3 shows the map submitted with annual reports from 2020-2023. It is clear that the red boundary line on the annual report map includes land that is outside of the approved boundary (purple polygon in Figure 2). Since the permit boundary cannot be revised with an Annual Report, there is either an error in the Annual Report map, or the operator has mined outside the permit boundary. In order to begin to resolve this issue, the operator should submit a Technical Revision to update the permit file with a Mining Plan Map and a Reclamation Plan Map that meet the requirements of Rules 6.2.1(2) and 6.3.5. Additionally, the Technical Revision must include updated mining and reclamation plans in accordance with Rules 6.3.3 and 6.3.4, which address the operational uses and reclamation procedures for each portion of the permit area.

Figure 2: Northern-most parcel of approved permit boundary, overlaid on aerial image

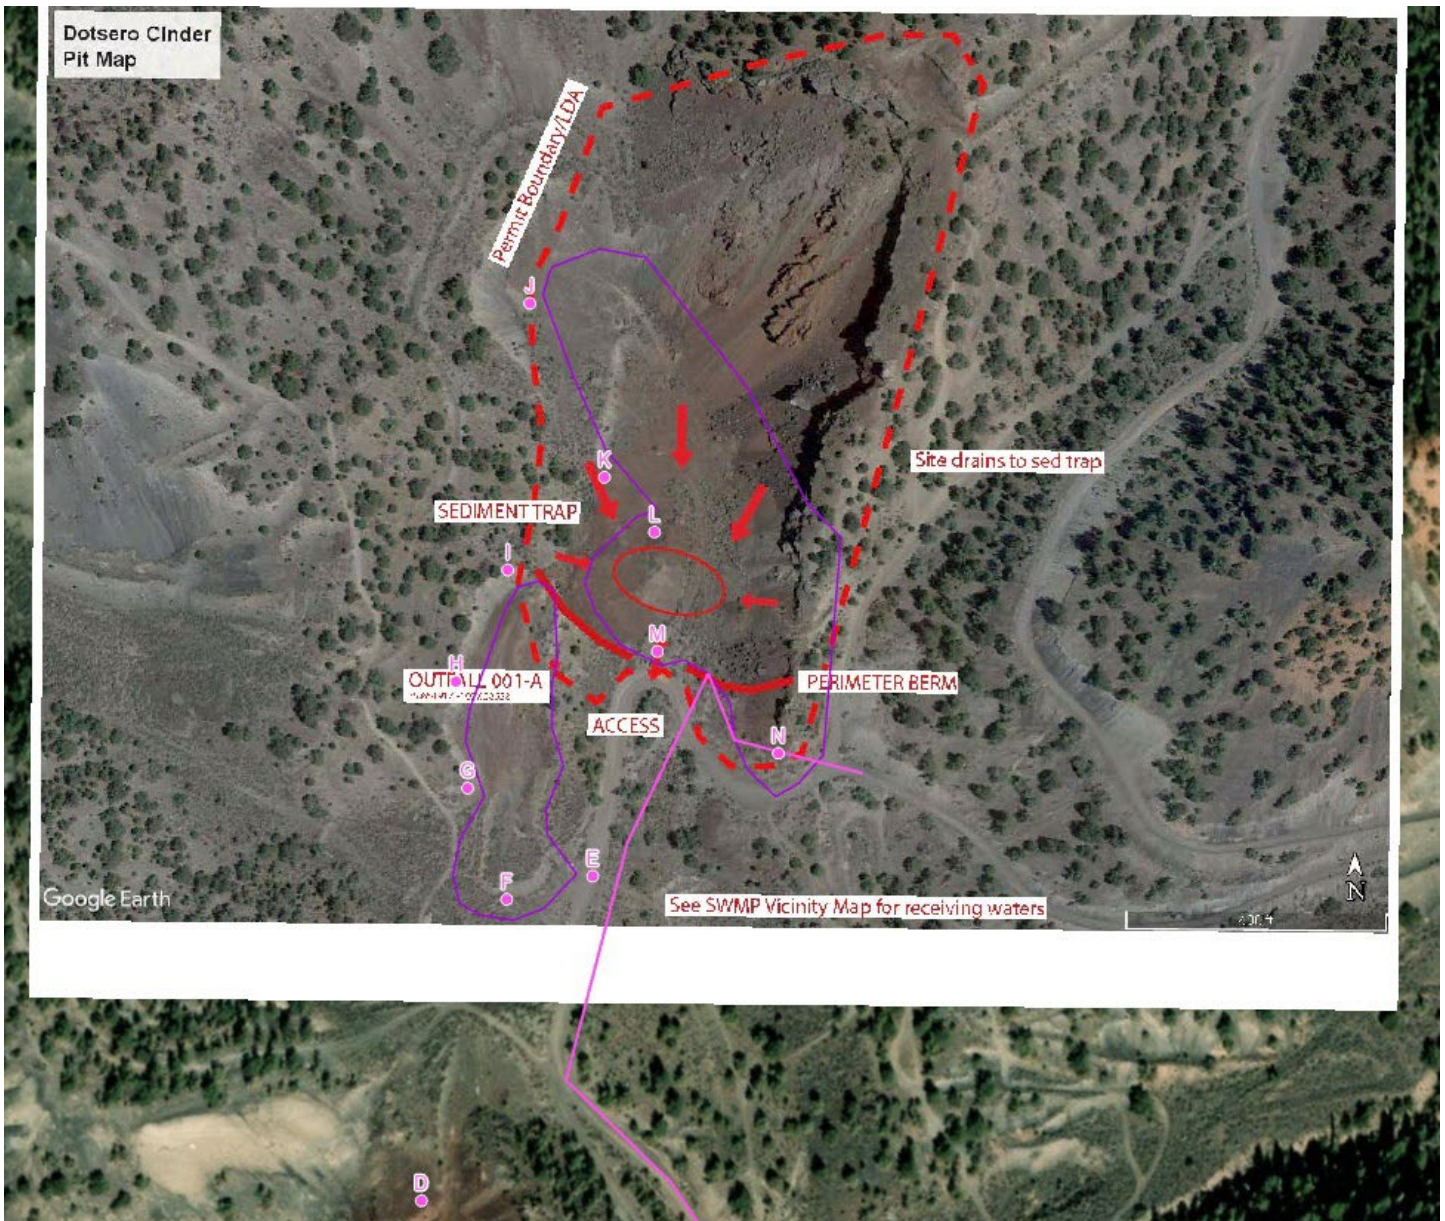
Figure 3: Northern-most parcel of approved permit boundary, overlaid on Annual Report Map from 2020-2023 and aerial image

CORRECTIVE ACTIONS: By the corrective action due date, the operator shall submit a Technical Revision, with the required \$216 revision fee, to update and clarify the current approved mining plan in accordance with Rule 6.3.3 to reflect existing and proposed activities. Additionally, the revision must include an updated mining plan map that meets the requirements of Rules 6.2.1(2) and 6.3.5(2). This map must unambiguously establish the location of the approved permit boundary. This will help to resolve any confusion caused by differences between the map submitted with the original application, a map submitted in response to a 2012 inspection (but never added to the permit through the appropriate revision), and maps submitted with recent annual reports.

CORRECTIVE ACTIONS: By the corrective action due date, the operator shall submit a Technical Revision, with the required \$216 revision fee, to update and clarify the current approved reclamation plan in accordance with Rule 6.3.4 to reflect existing and proposed activities. Additionally, the revision must include an updated reclamation plan map that meets the requirements of Rules 6.2.1(2) and 6.3.5(3). This map must unambiguously establish the location of the approved permit boundary. This corrective action may be submitted with the same Technical Revision required for Problem #1 of this report.

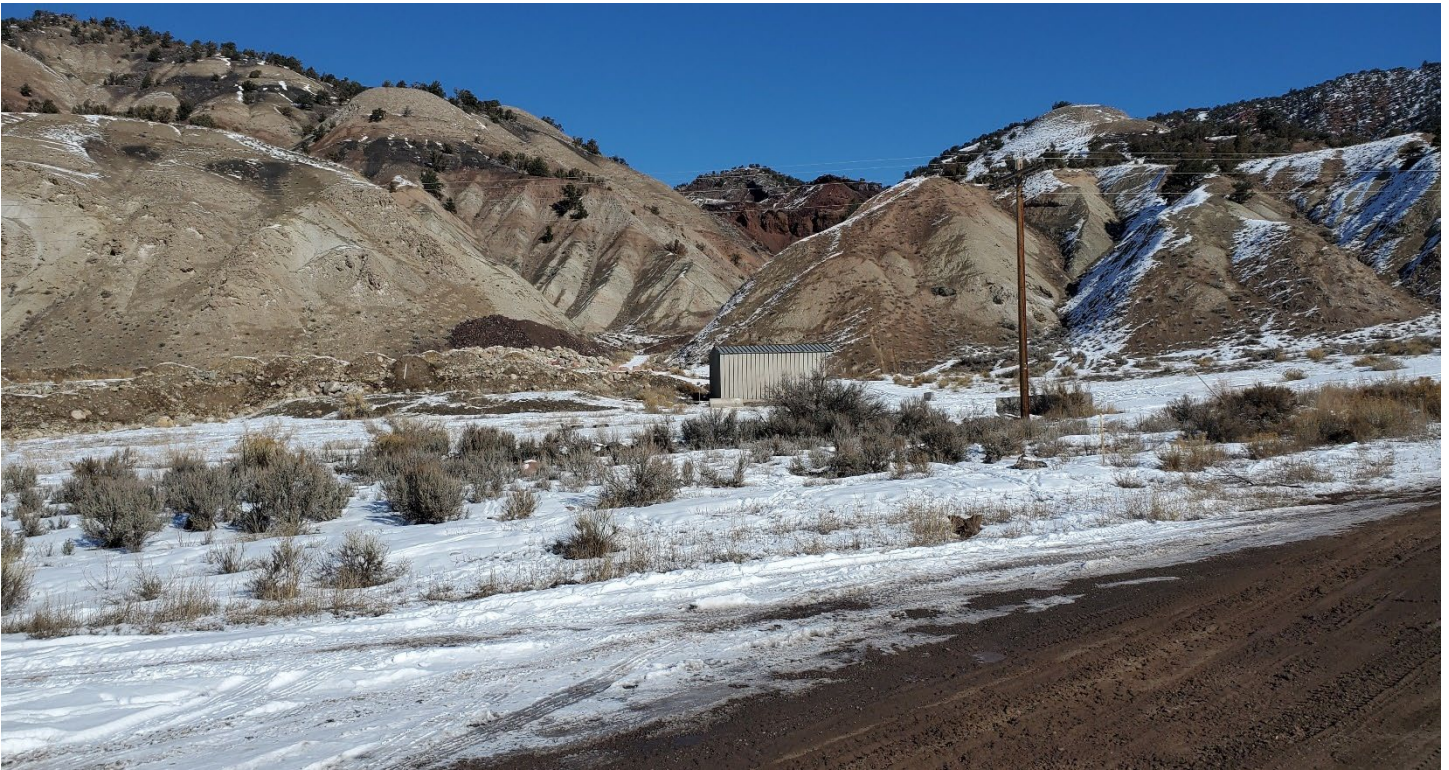
Figure 4: Entrance to Stock Pile Area from A

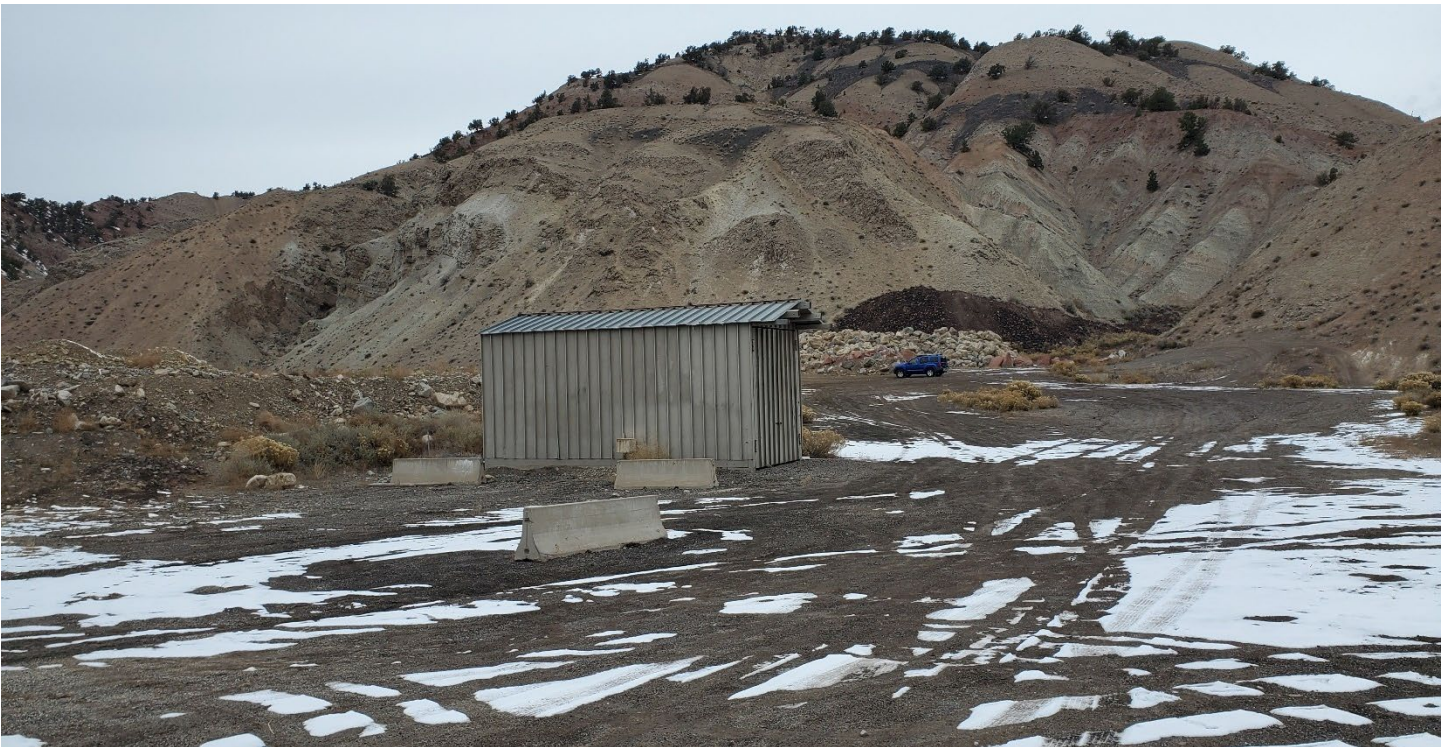
Figure 5: Stock Pile Area from B

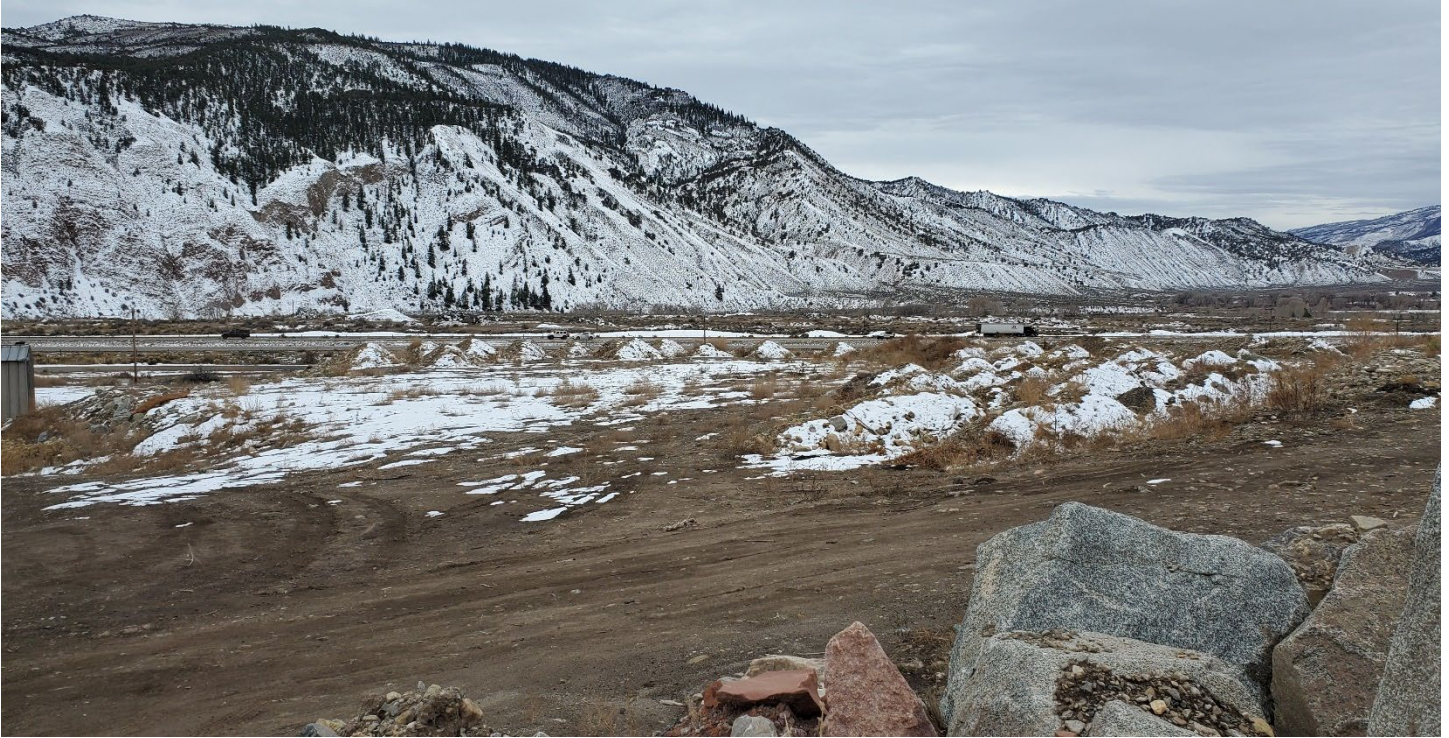
Off-site material had been stockpiled at the Stock Pile Area and on an adjacent area outside the permit area. The operator should be advised, the approved permit area shall not be used for temporary storage of material derived from off-site unless this activity is addressed in the approved mining and reclamation plans. Therefore, if the operator intends to continue using portions of the permit area for this purpose, the Division recommends the updated mining and reclamation plans submitted with the required Technical Revision reflect this activity. For example, the mining plan and map would need to specify which portions of the permit area will be used for this purpose, include a description of the materials, and specify the maximum volume of off-site material to be stored in these areas at any time. Additionally, the reclamation plan would need to address any lands disturbed by this activity. If the operator plans to use any such material for reclamation of the affected lands, details on this proposal shall be included in the revised reclamation plan. The Division refers the operator to Rule 3.1.5(9) pertaining to material imported to the site for use in reclamation backfill.

Figure 6: Stockpiled material from off-site from C (1 of 2)

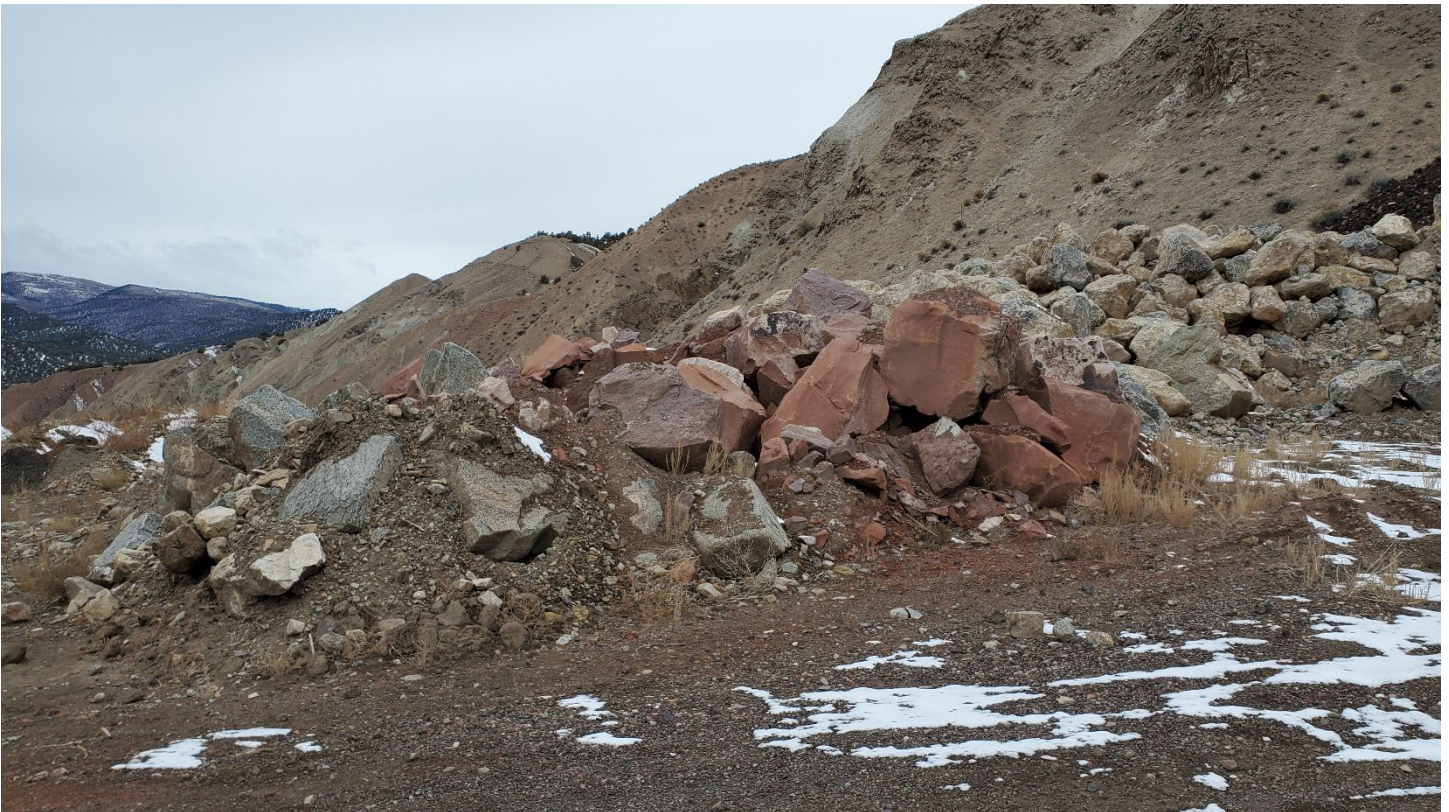
Figure 7: Stockpiled material from off-site from C (2 of 2)

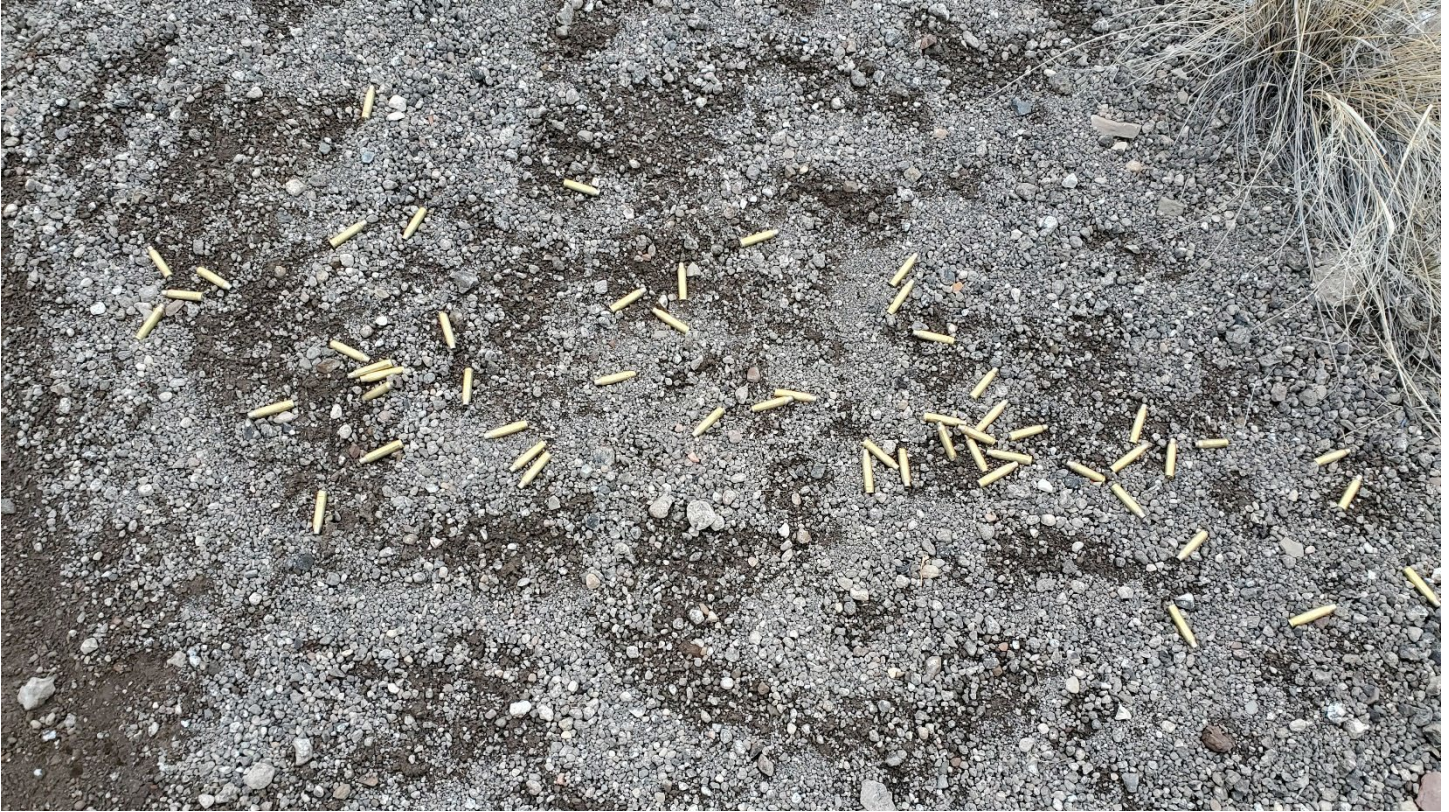
An initial inspection was made on November 28, 2022. The weather was overcast but dry, with patches of snow on the ground which was otherwise muddy. Following further review of the documentary archive a follow-up inspection was made on January 23, 2023. During the second inspection the sky was clear and the ground was frozen. The Esri Field Maps app was used with a Samsung Galaxy S10e cell phone during the inspection to navigate around the site and to record the location of observations. As is evident from the photographs below, the area is open to, and well used by, members of the public, with shell casings, dumped construction waste and tire tracks of off-road vehicles around the site.

Figure 9: Shell casings at E

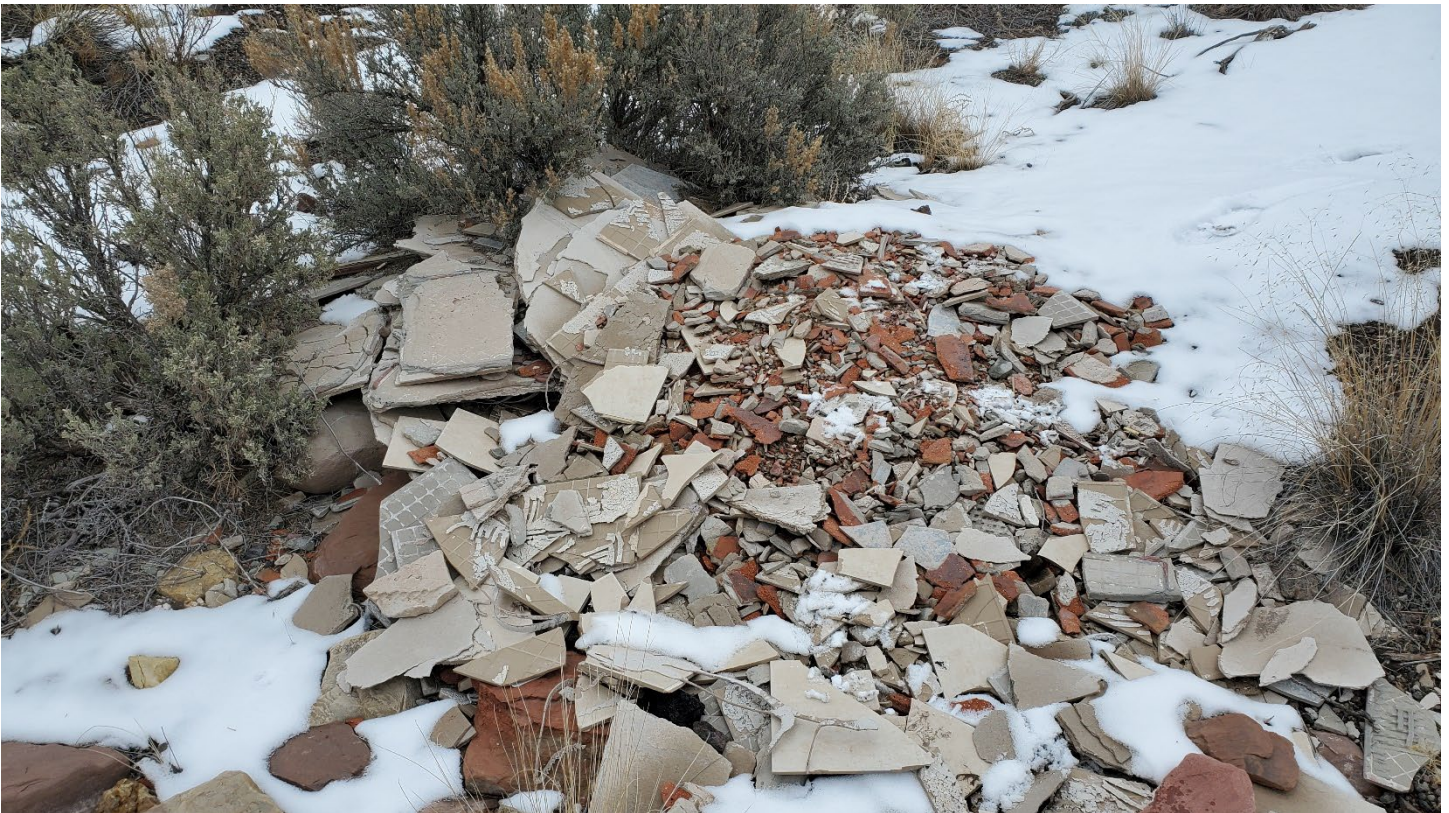
Figure 10: Construction waste at E

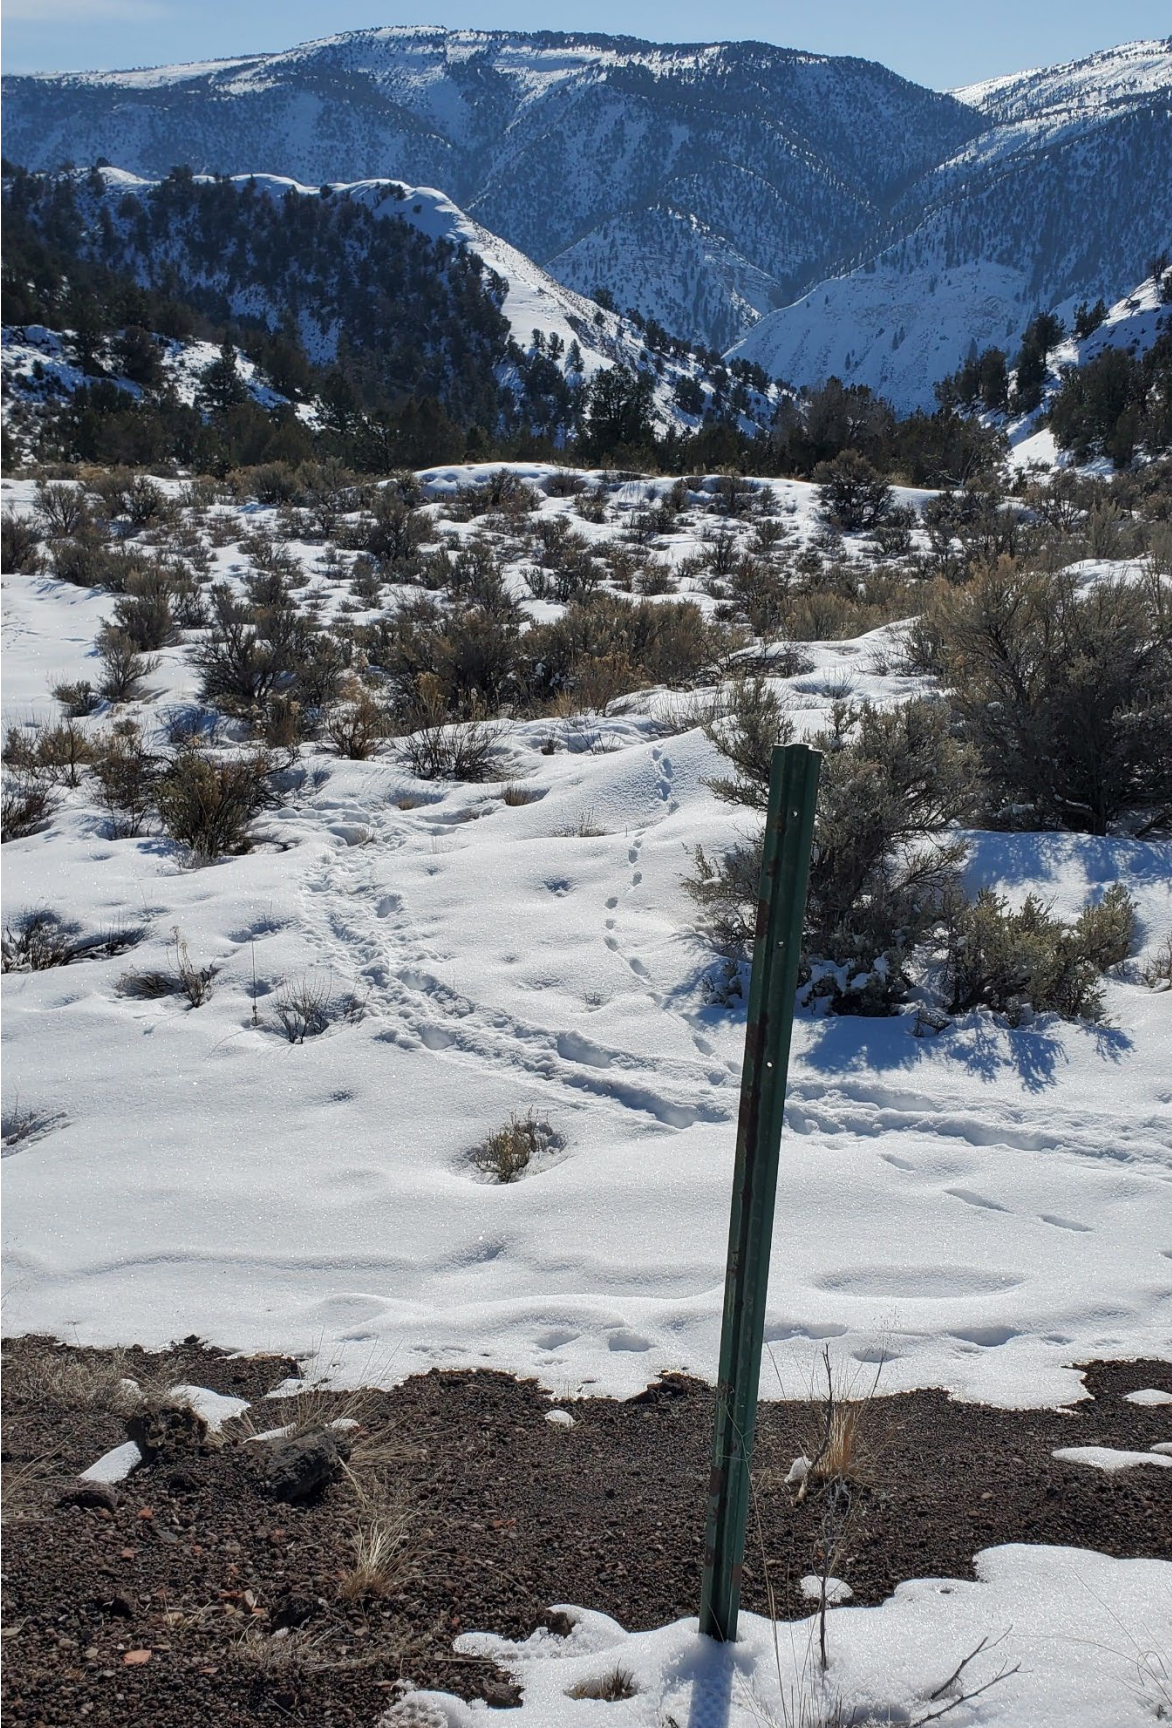
PROBLEM/POSSIBLE VIOLATION: Problem #3: The mine identification sign and affected area boundary markers were not observed per the requirements of Rule 3.1.12.

Two attempts were made during the inspection to locate a mine id sign and permit boundary markers. No sign could be located, and only a few unidentified t-posts were found. Under current conditions there is no way for members of the public to know that they are entering or leaving a permitted mine, or to know who to contact for further information. Given that the permit area is in three separate parcels, there should be three separate signs. Marker posts should be sufficient in number to clearly delineate the permit boundary.

Figure 13: T-post at G

CORRECTIVE ACTIONS: By the corrective action due date, the operator shall, at the entrance of the mine site post a sign in accordance with Rule 3.1.12(1), which is clearly visible from the access road, with a minimum size equaling one hundred and eighty-seven (187) square inches, such as eleven (11) inches in height and seventeen (17) inches in width, with appropriate font size, with the following: the name of the operator and the operation name; a statement that a reclamation permit for the operation has been issued by the Colorado Mined Land Reclamation Board; and the permit number. Additionally, the operator shall mark the boundaries of the affected area in accordance with Rule 3.1.12(2) by monuments or other markers that are clearly visible and adequate to delineate such boundaries, and provide sufficient evidence this has been done. The permit boundary delineated in the field with markers must correlate with the permit boundary shown on the revised mining and reclamation plan maps (submitted in the Technical Revision required for Problems #1 and #2). Please provide GPS coordinates for each boundary marker with this corrective action submittal.

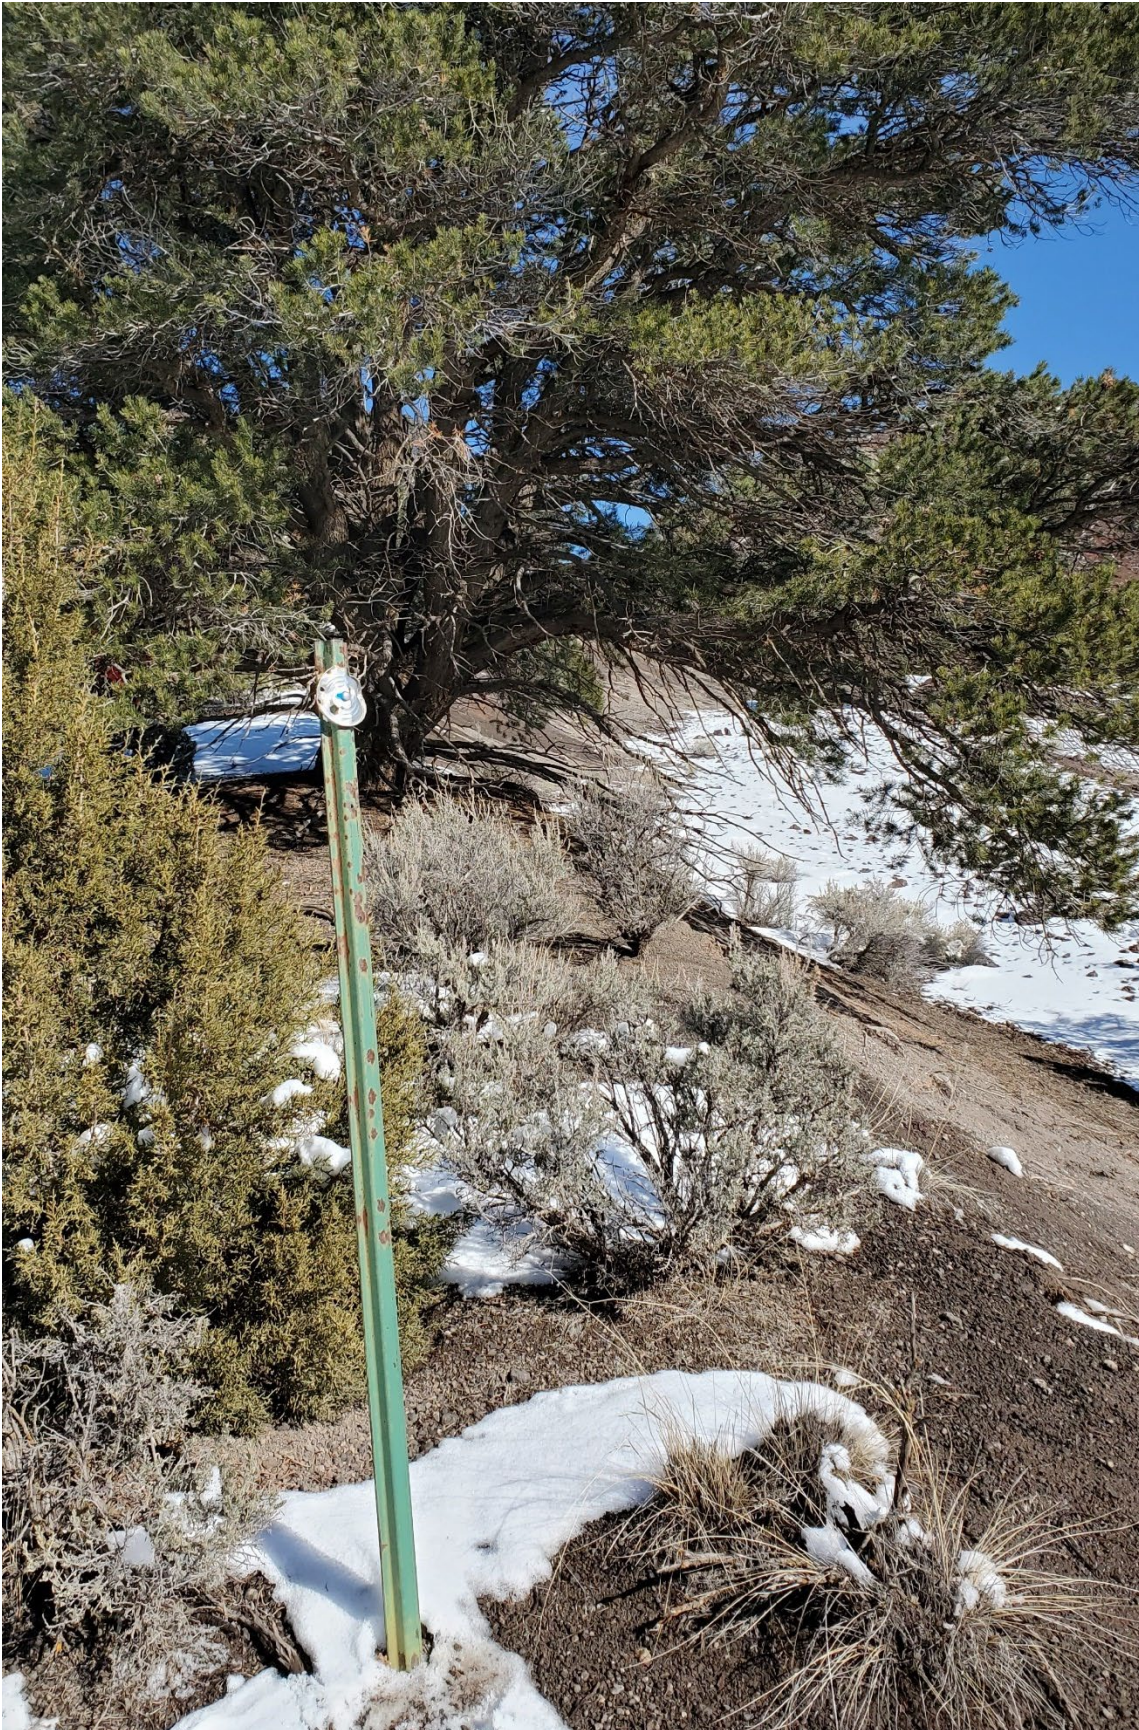
Figure 14: T-post at H

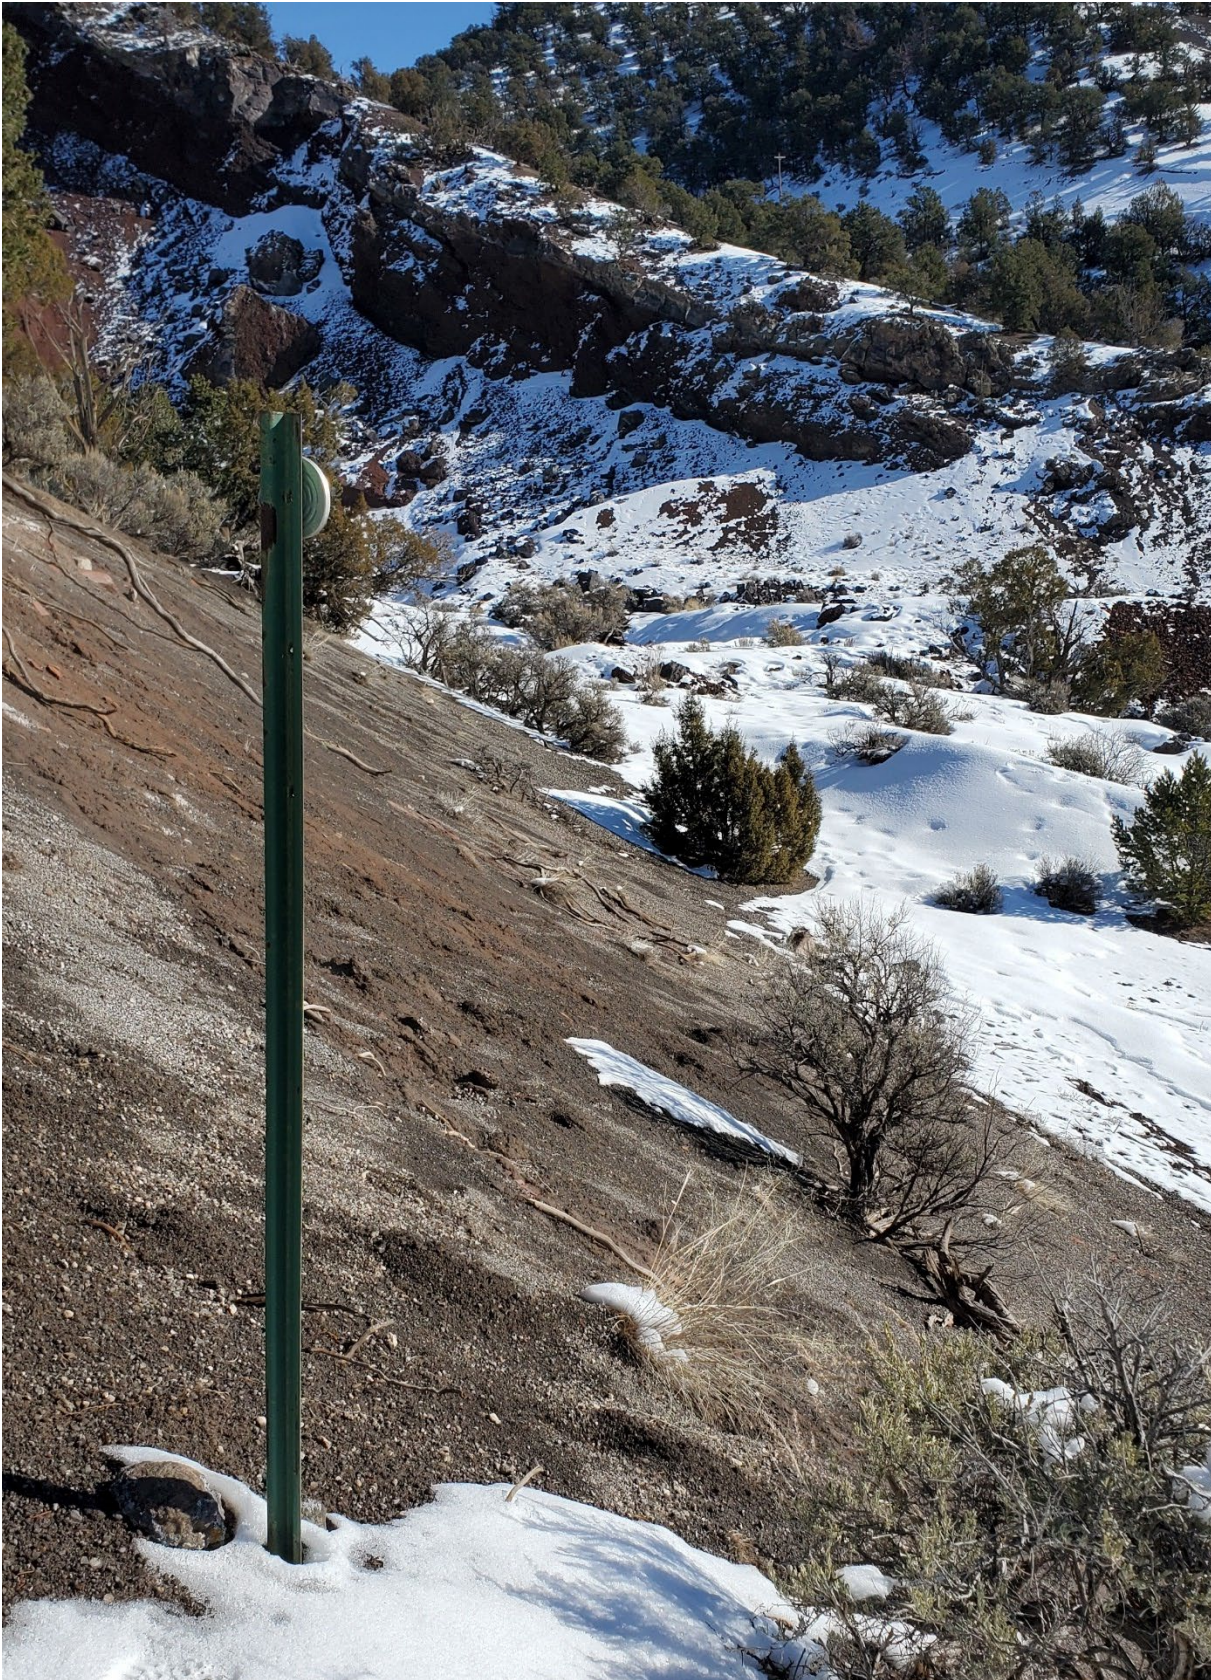
Figure 15: T-post at I

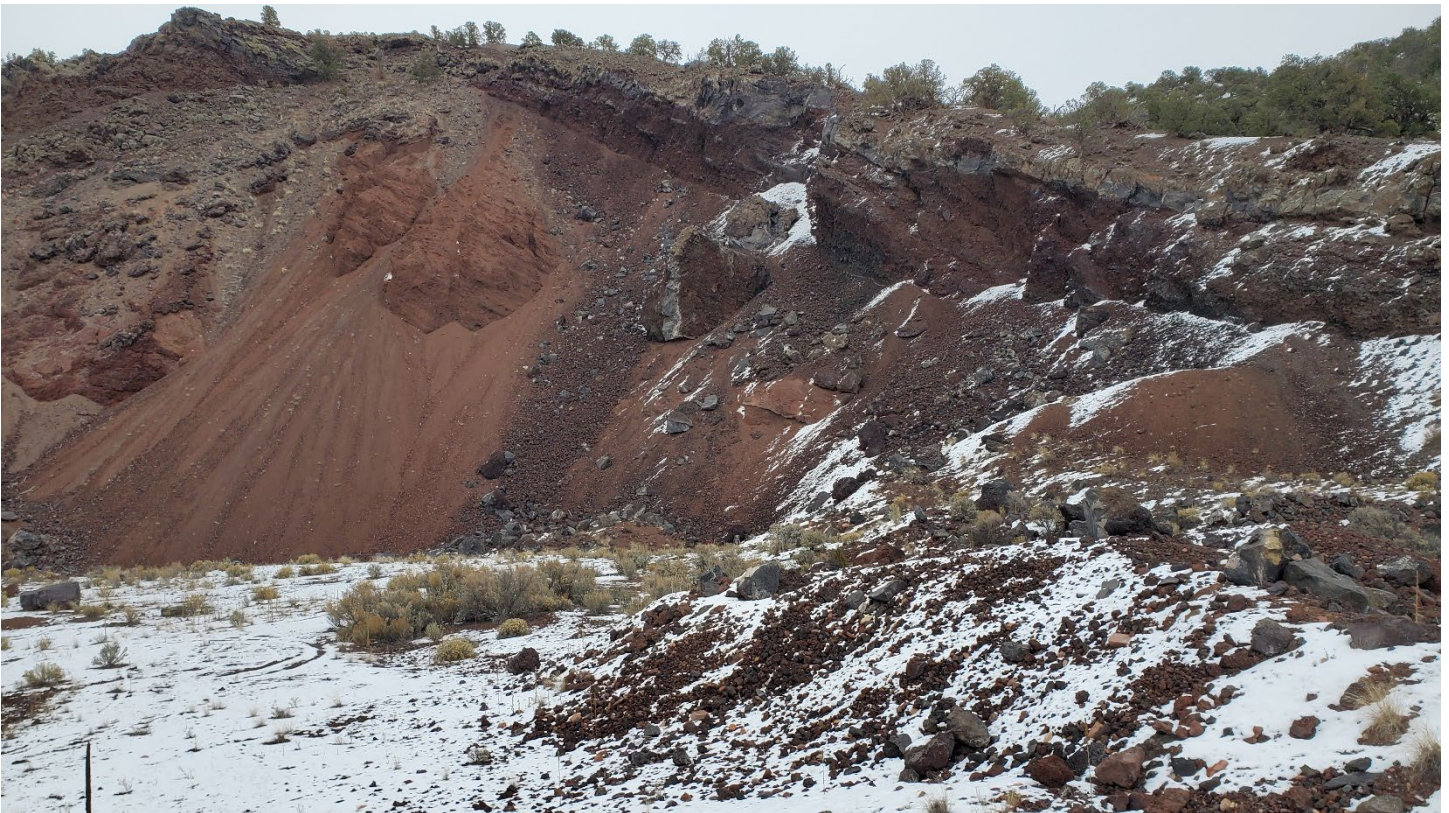
The site was graded so as to prevent uncontrolled runoff from the steep slopes in the pit. A flat area protected

by a substantial berm controlled sediment.

Figure 19: View north from L, showing sediment trap
