M1979155, Dotsero Cinder Pit, Inspection Report

MINERALS PROGRAM INSPECTION REPORT

MINE NAME: Dotsero Cinder Pit	MINE/PROSPECTING ID#: M-1979-155	MINERAL: Volcanic materials (ash, cinders)	COUNTY: Eagle
INSPECTION TYPE: Monitoring	WEATHER: Cloudy	INSP. DATE: November 28, 2022	INSP. TIME: 14:00
OPERATOR: Colorado Department of Transportation	OPERATOR REPRESENTATIVE: N/A	TYPE OF OPERATION: 110c - Construction Limited Impact

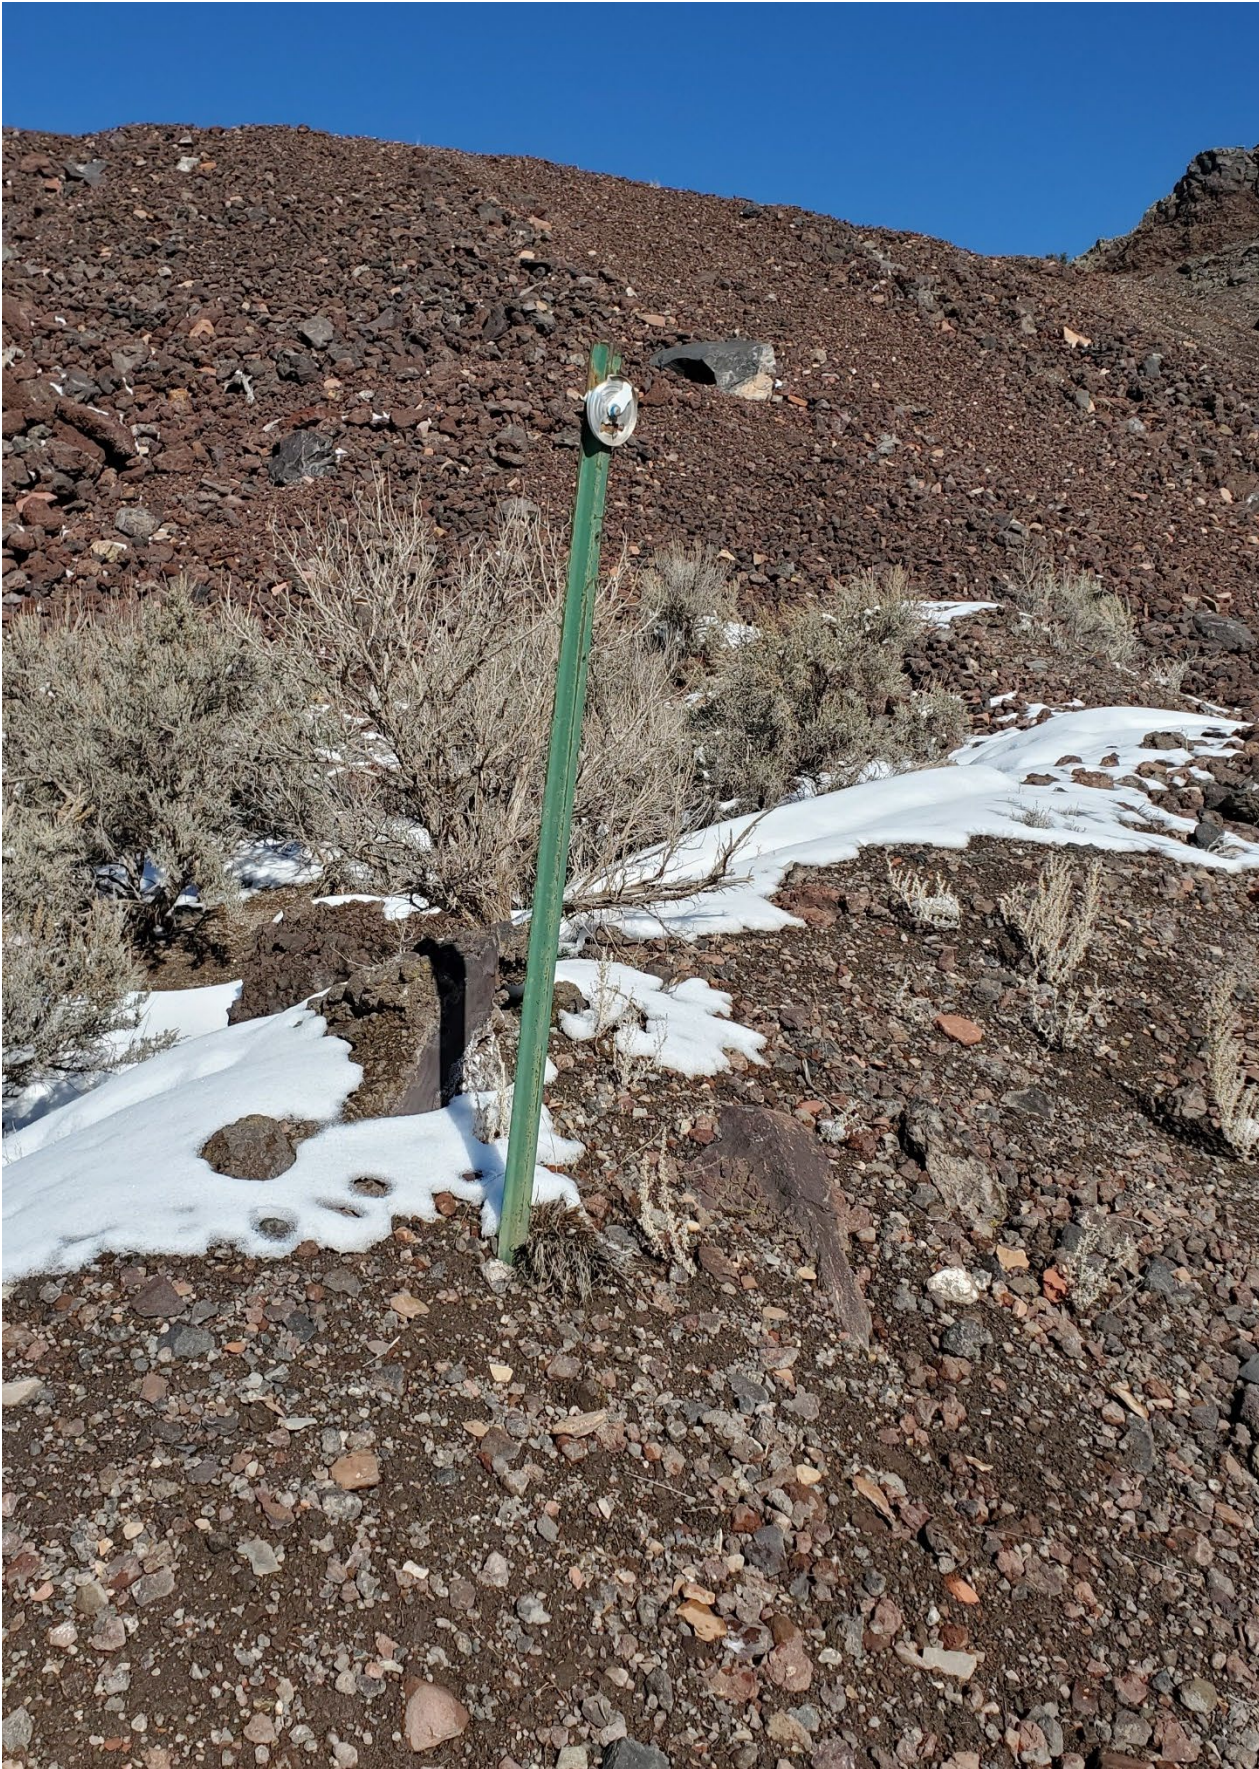
PROBLEM/POSSIBLE VIOLATION: Problem #3: The mine identification sign and affected area boundary markers were not observed per the requirements of Rule 3.1.12.

Two attempts were made during the inspection to locate a mine id sign and permit boundary markers. No sign could be located, and only a few unidentified t-posts were found. Under current conditions there is no way for members of the public to know that they are entering or leaving a permitted mine, or to know who to contact for further information. Given that the permit area is in three separate parcels, there should be three separate signs. Marker posts should be sufficient in number to clearly delineate the permit boundary.

Figure 20: T-post at M

CORRECTIVE ACTIONS: By the corrective action due date, the operator shall, at the entrance of the mine site post a sign in accordance with Rule 3.1.12(1), which is clearly visible from the access road, with a minimum size equaling one hundred and eighty-seven (187) square inches, such as eleven (11) inches in height and seventeen (17) inches in width, with appropriate font size, with the following: the name of the operator and the operation name; a statement that a reclamation permit for the operation has been issued by the Colorado Mined Land Reclamation Board; and the permit number. Additionally, the operator shall mark the boundaries of the affected area in accordance with Rule 3.1.12(2) by monuments or other markers that are clearly visible and adequate to delineate such boundaries, and provide sufficient evidence this has been done. The permit boundary delineated in the field with markers must correlate with the permit boundary shown on the revised mining and reclamation plan maps (submitted in the Technical Revision required for Problems #1 and #2). Please provide GPS coordinates for each boundary marker with this corrective action submittal.

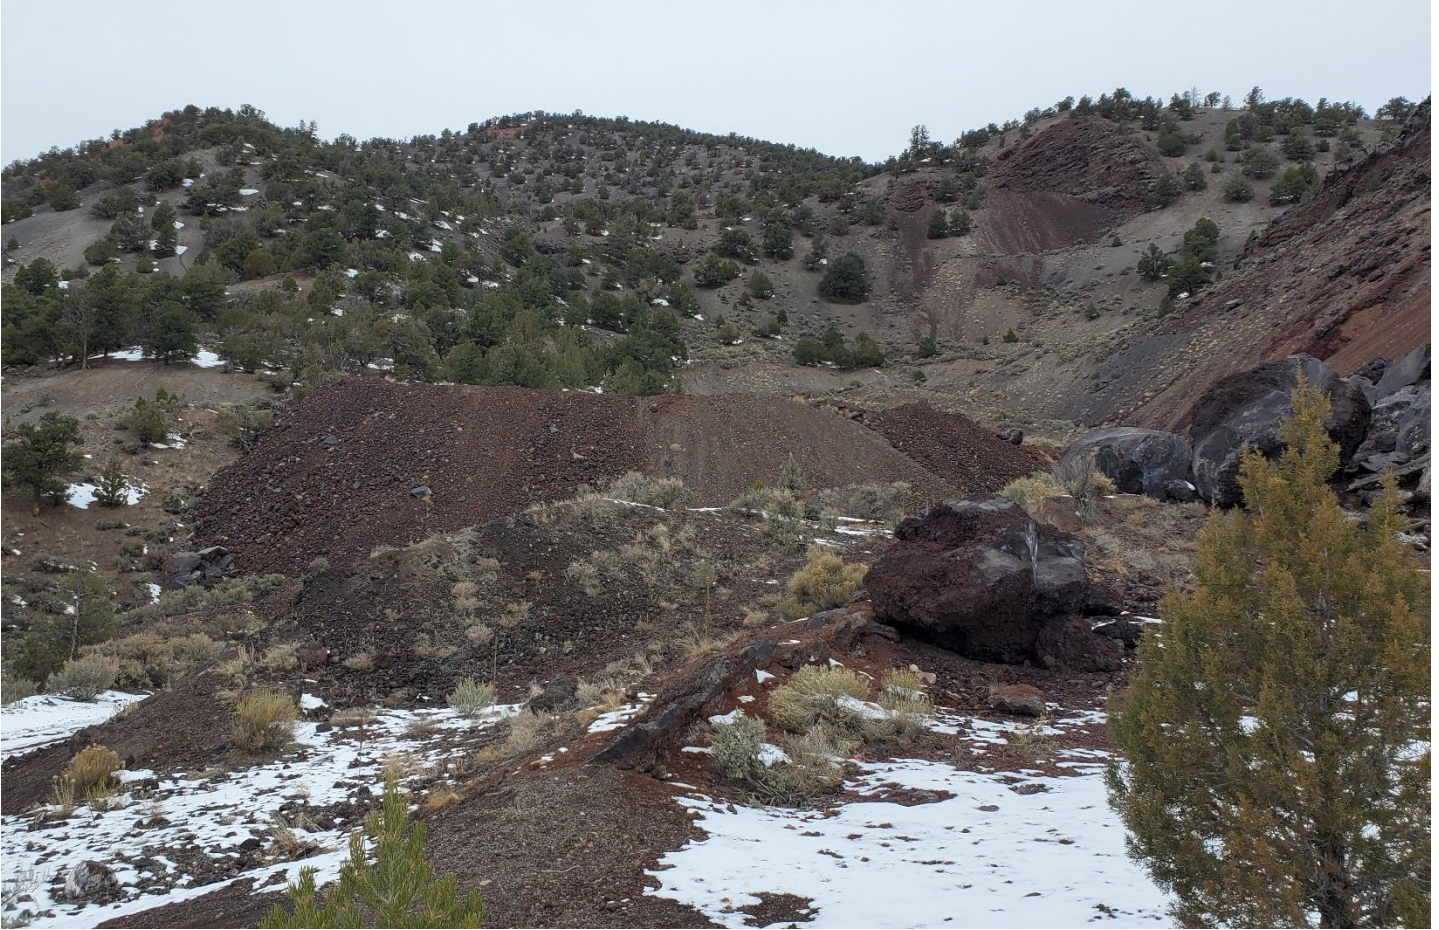
The site was graded so as to prevent uncontrolled runoff from the steep slopes in the pit. A flat area protected

by a substantial berm controlled sediment.

Figure 21: View north from N, showing perimeter berm
