PERMIT INFORMATION

Permit Number: C-1981-012 Mine Name: New Elk Mine Operator: New Elk Coal Company, LLC Operator Address: Mr. Mark Gray 12250 Highway 12 Weston, CO 81091	County: Las Animas Operation Type: Underground Permit Status: Active Ownership: Private
	Operator Representative Present: Nick Mason
Operator Representative Signature: (Field Issuance Only)

INSPECTION INFORMATION

Inspection Start Date: January 26, 2023 Inspection Start Time: 09:30 Inspection End Date: January 26, 2023 Inspection End Time: 12:00	Inspection Type: Coal Partial Inspection Inspection Reason: Normal I&E Program Weather: Clear
Joint Inspection Agency: None	Joint Inspection Contacts:
Post Inspection Agency: None	Post Inspection Contacts:
Inspector(s): Brock Bowles	Inspector's Signature:

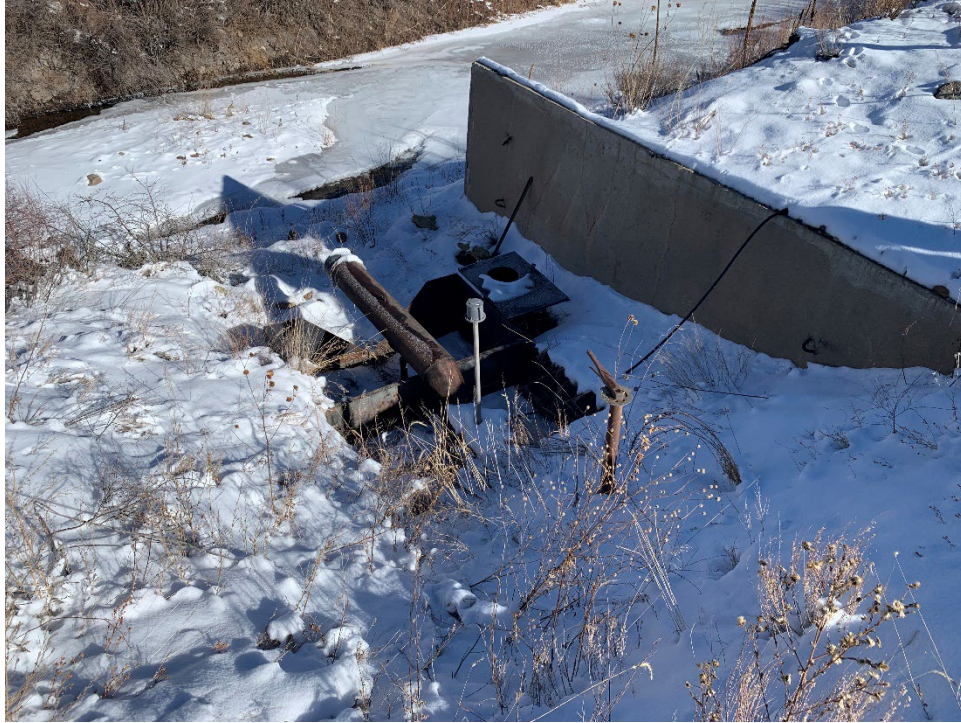
Photo 1 – Outfall #1

NPDES outfall #1 was free and clear of obstructions and appeared to be in working order. Pond 1 contain a small amount of water which was frozen. No water was discharging (photo 1).

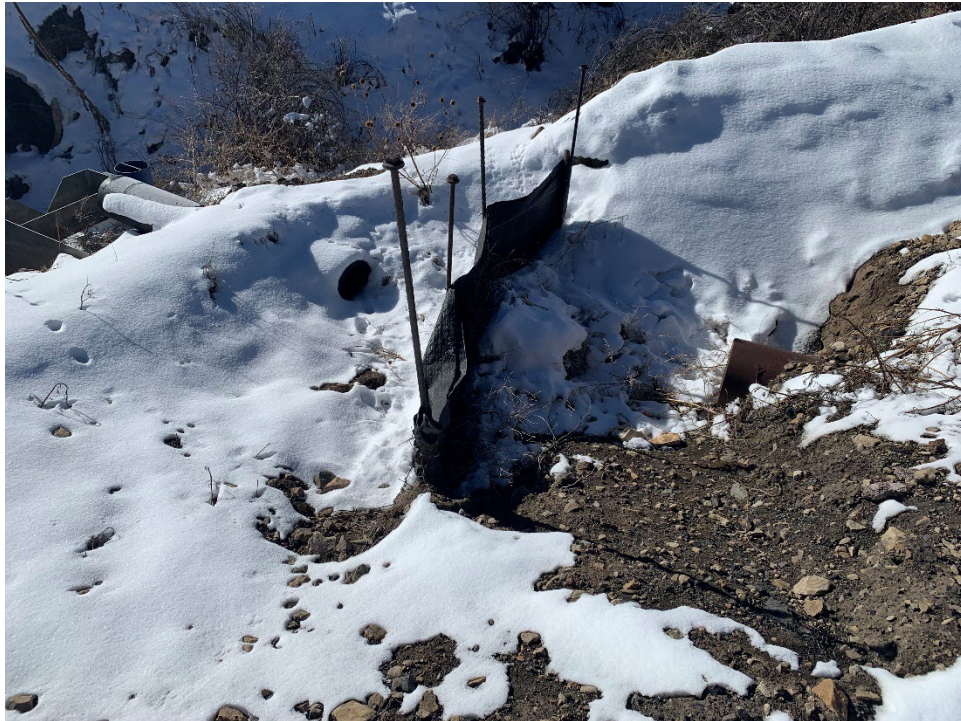
Photo 2 – Outfall #10

NPDES outfall #10 is a stormwater discharge and is a SAE for the east staging/material storage area (CDPS permit #CO0000906 fact sheet). #10 consists of a series of silt fence catchments basins on either side of the access road which were all in working order. No water was discharging but a couple of tumble weeds were in the catchments basins that need to be cleared (photo 2).

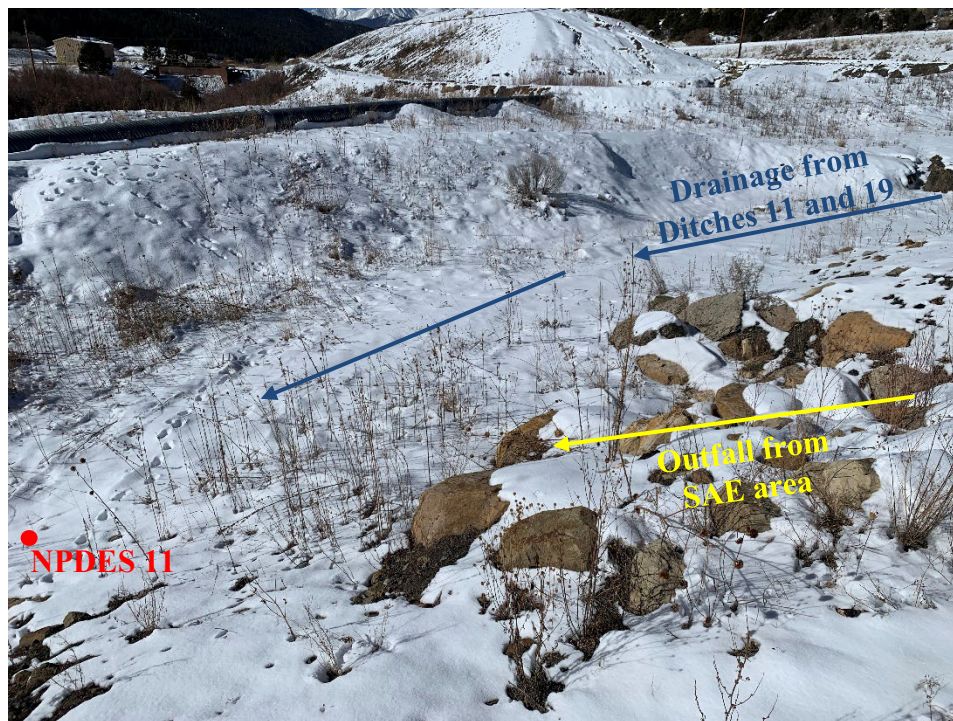
Photo 3 – Outfall #11

NPDES outfall #11 is approved to discharge the runoff from the north topsoil SAE (topsoil stockpile #2) as per the CDPS permit #CO0000906 fact sheet. Ditches D11 and D19 collect runoff from mine related disturbed areas outside of the approved SAE area and directs the runoff to outfall #11. The runoff collected in ditches D11 and D19 does not pass through a sediment control structure(s) before it is discharged to the Purgatoire River (photo 3).

All surface drainage from disturbed areas need to pass through some kind of treatment facility before leaving the permit area as per Rule 4.05.2(1). A sediment control structure(s) needs to be installed above discharged #11, be appropriately sized to effectively treat the area between the RDA access road, ditch D11 and ditch D19, and meet the standards of Rule 4.05.5, 4.05.6, and 4.05.9. Please consult with CDPHE regarding proposed changes to the NPDES permit for outfall #11 before installing any structures. NECC must submit a Technical Revision to address this issue within 60 days of this inspection report.

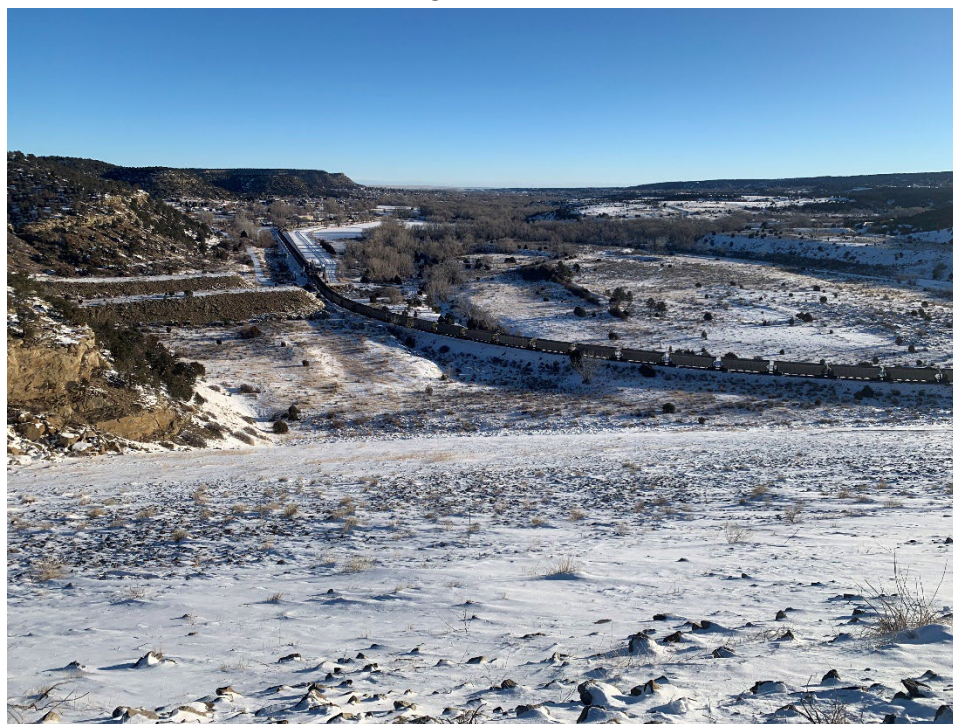
A train was being loaded at the Jansen Loadout (photo 4).

Photo 4 – Train being loaded at the Jansen load-out
