**MINERALS PROGRAM INSPECTION REPORT**  
**PHONE: (303) 866-3567**

| <b>MINE NAME:</b><br>Climax Mine | <b>MINE/PROSPECTING ID#:</b><br>M-1977-493 | <b>MINERAL:</b><br>Molybdenum | <b>COUNTY:</b><br>Lake, Summit |
| <b>INSPECTION TYPE:</b><br>Monitoring | <b>WEATHER:</b> Clear | <b>INSP. DATE:</b><br>February 9, 2023 | <b>INSP. TIME:</b><br>09:45 |

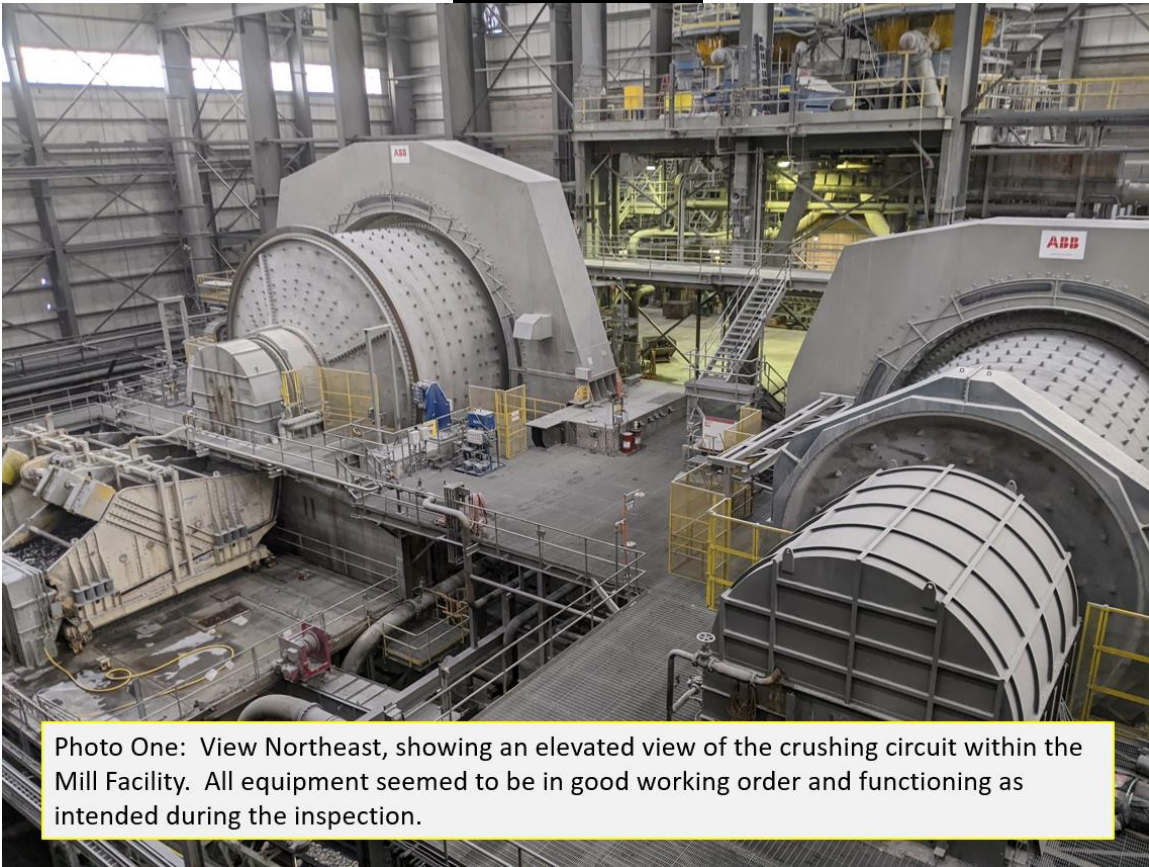
Photo One: View Northeast, showing an elevated view of the crushing circuit within the Mill Facility. All equipment seemed to be in good working order and functioning as intended during the inspection.

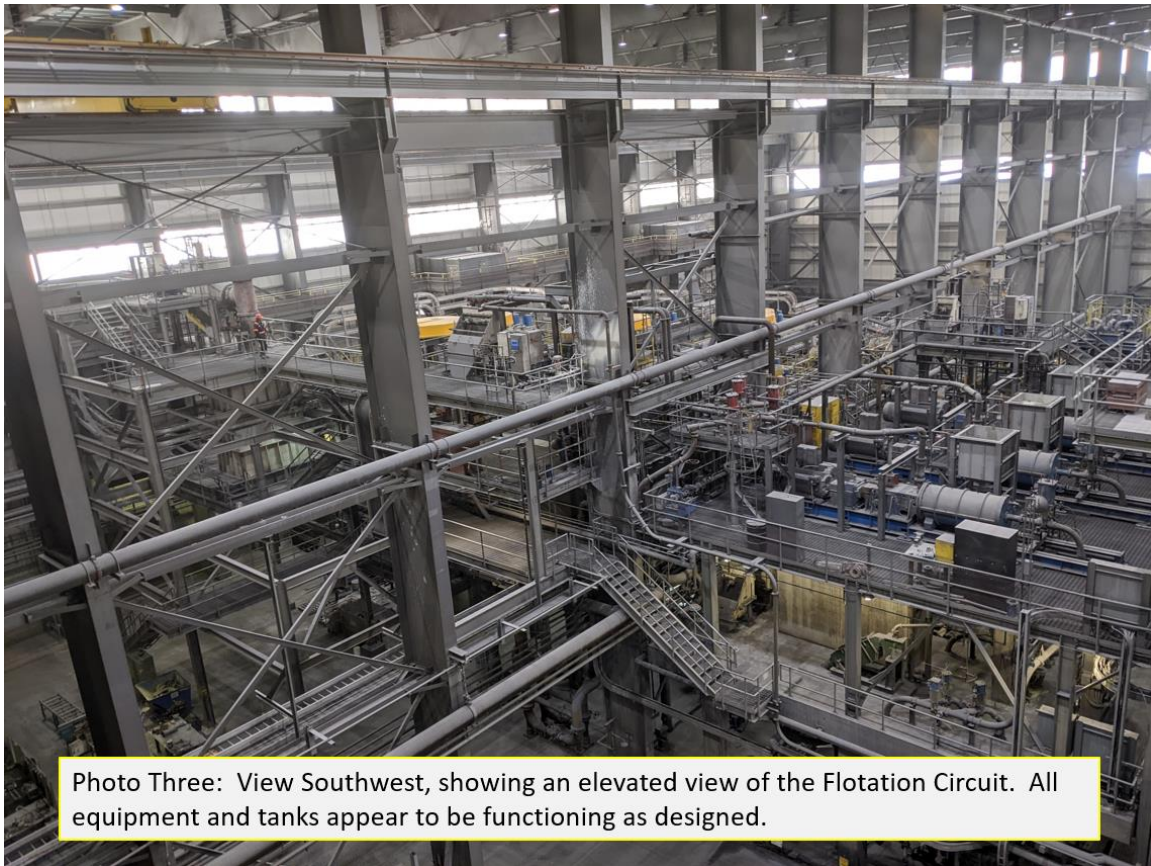
The flotation circuit was also active at the time of the inspection. The rougher, cleaner and scavenger tanks with associated equipment were operational and appeared to be functioning as designed. No evidence of significant spillage or disrepair was observed. An elevated view of the flotation circuit can be seen in Photo Three. As is the case with the crushing circuit, the floor serves as the secondary containment structure for the flotation circuit. The containment structure was in excellent condition, having recently been cleaned. All sumps observed were free from obstruction and able to function as designed with sprayers directing materials into the sumps. An example of the containment structure for the flotation circuit can be seen in Photo Four.

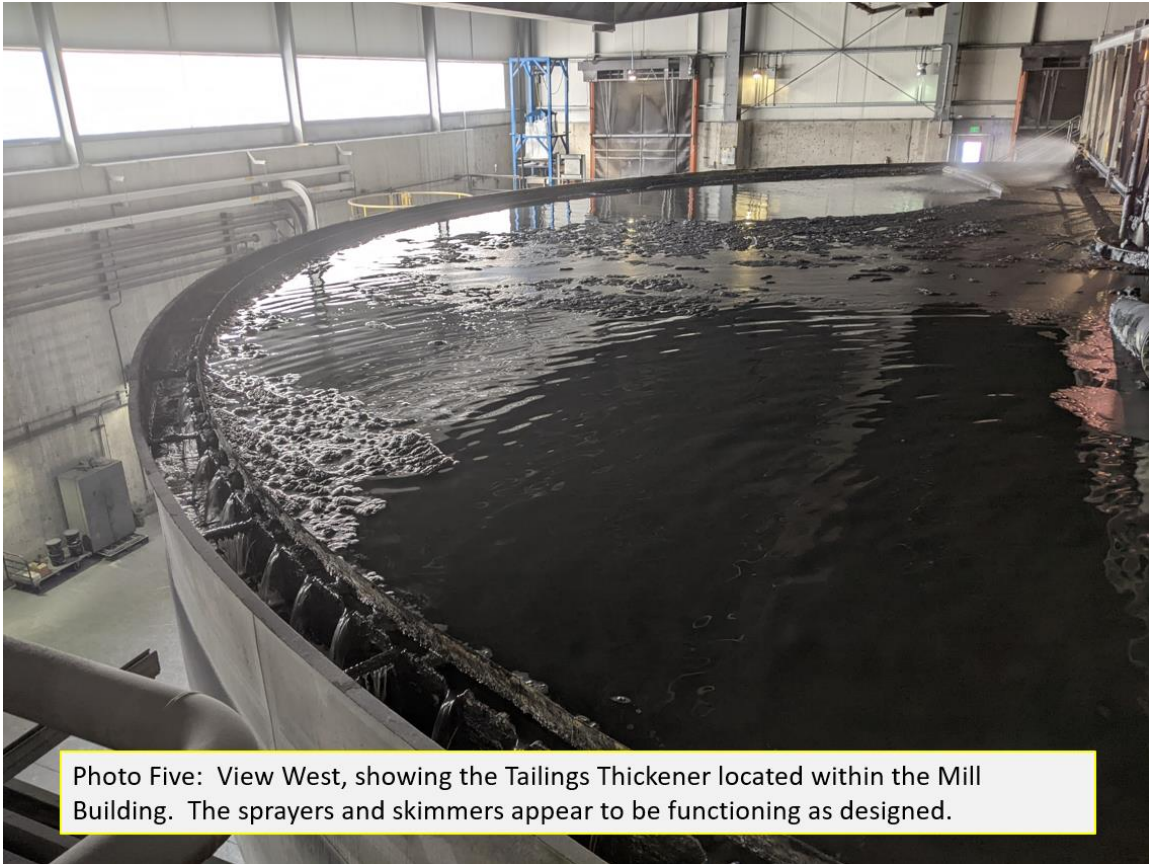
The Tailings Thickener area was also observed to be in good condition. The thickener was actively processing tailings prior to their exit of the facility via the Tailings Delivery Line (TDL). Photo Five shows the thickener as observed. The area underneath the thickener serves as the secondary containment, and is in excellent condition. All observed sumps are free from obstruction and able to function as designed. The containment structure for the Tailings Thickener can be seen in Photo Six.

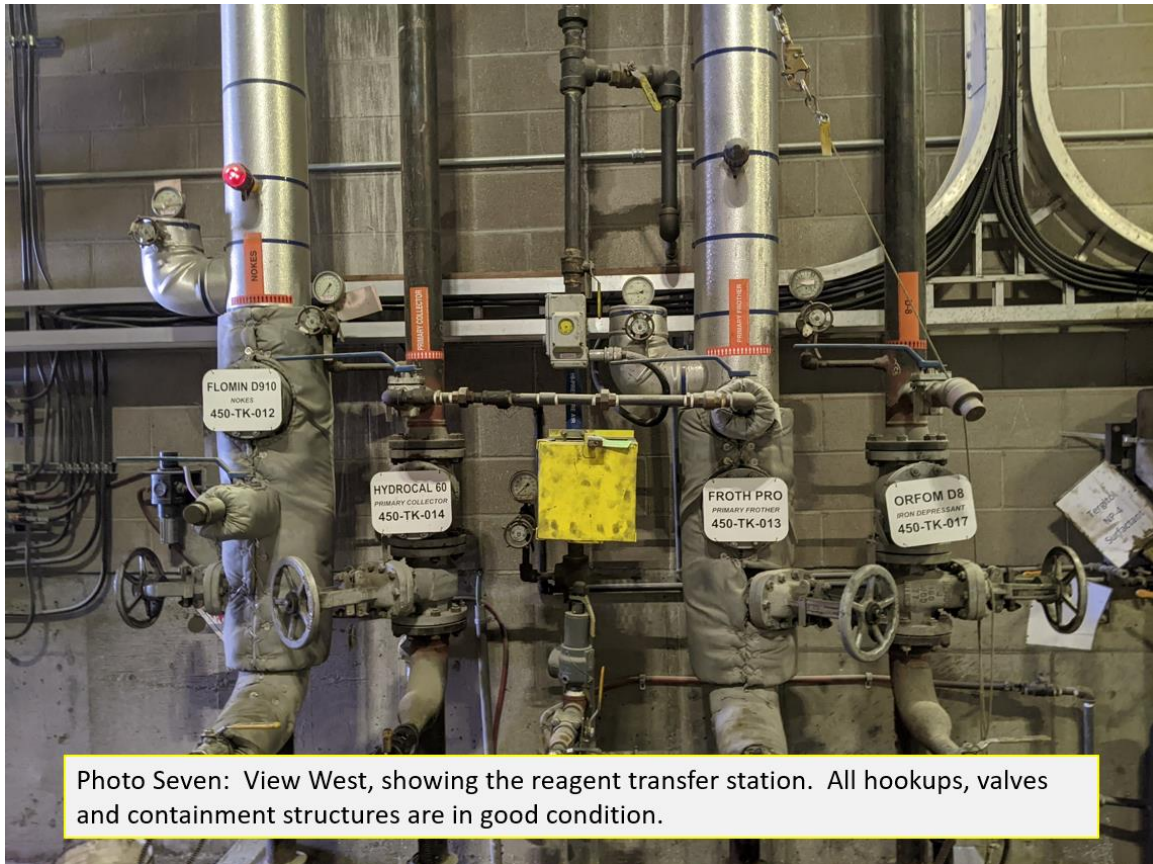
Chemical Storage and Transfer Area: The Mill Facility Chemical storage is concentrated in three areas, the Reagent Storage Room, bulk storage under the flotation cells, and the internal and external lime storage areas. The Reagent Storage Room and transfer bay were observed to be in excellent condition. The transfer bay was clean, neat and well kept. The actual transfer station can be seen in Photo Seven. All pipes and delivery

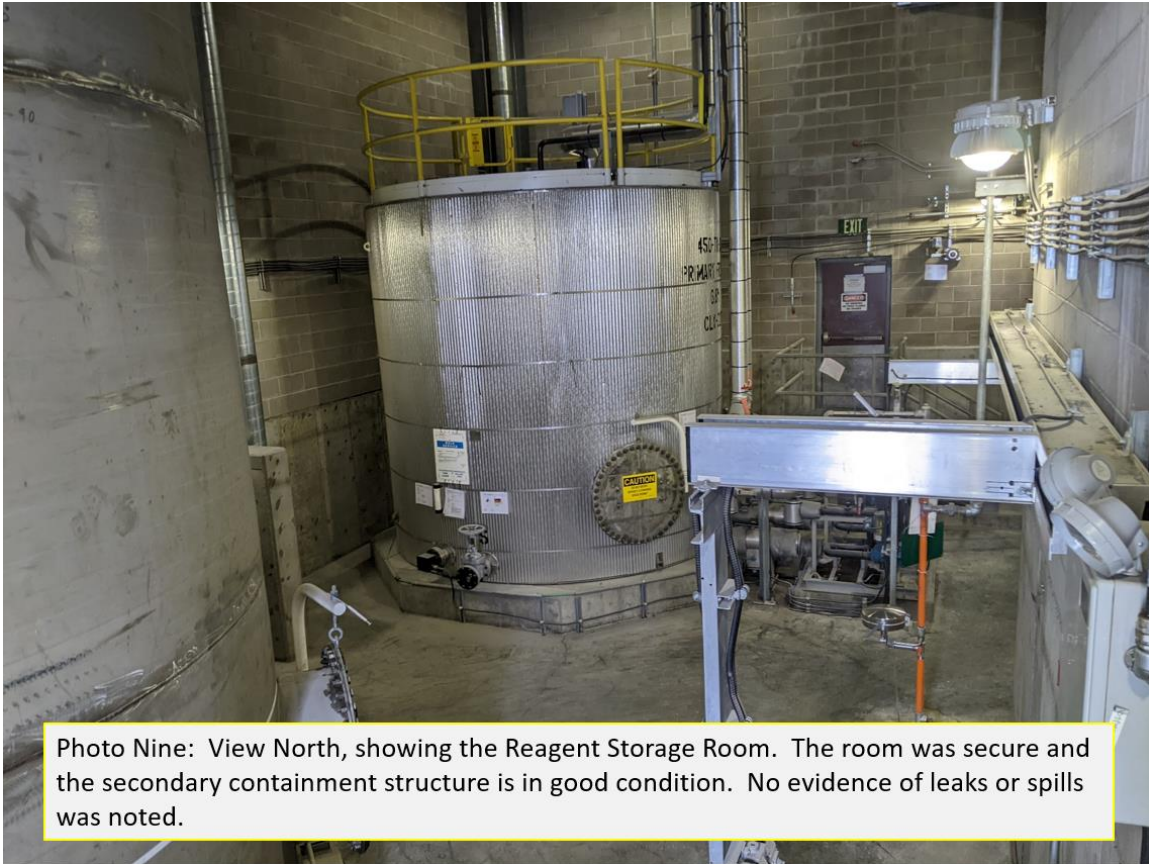
systems appeared to be in good working order and no evidence of spillage during transfer was noted. The sump associated with the transfer station was clean and free from obstruction. The transfer bay is sloped towards the interior of the mill facility providing for secondary containment should any spillage occur. The bay can be seen in Photo Eight. The Reagent Storage room is a separate room attached to the Mill Facility to provide containment of the chemicals and is accessed from an exterior man door. The interior of the room is in excellent condition and can be seen in Photo Nine. No evidence of spillage or containment concerns was observed, the sump is clean and clear from obstructions providing more than adequate containment for all materials stored in the room.

Photo Nine: View North, showing the Reagent Storage Room. The room was secure and the secondary containment structure is in good condition. No evidence of leaks or spills was noted.

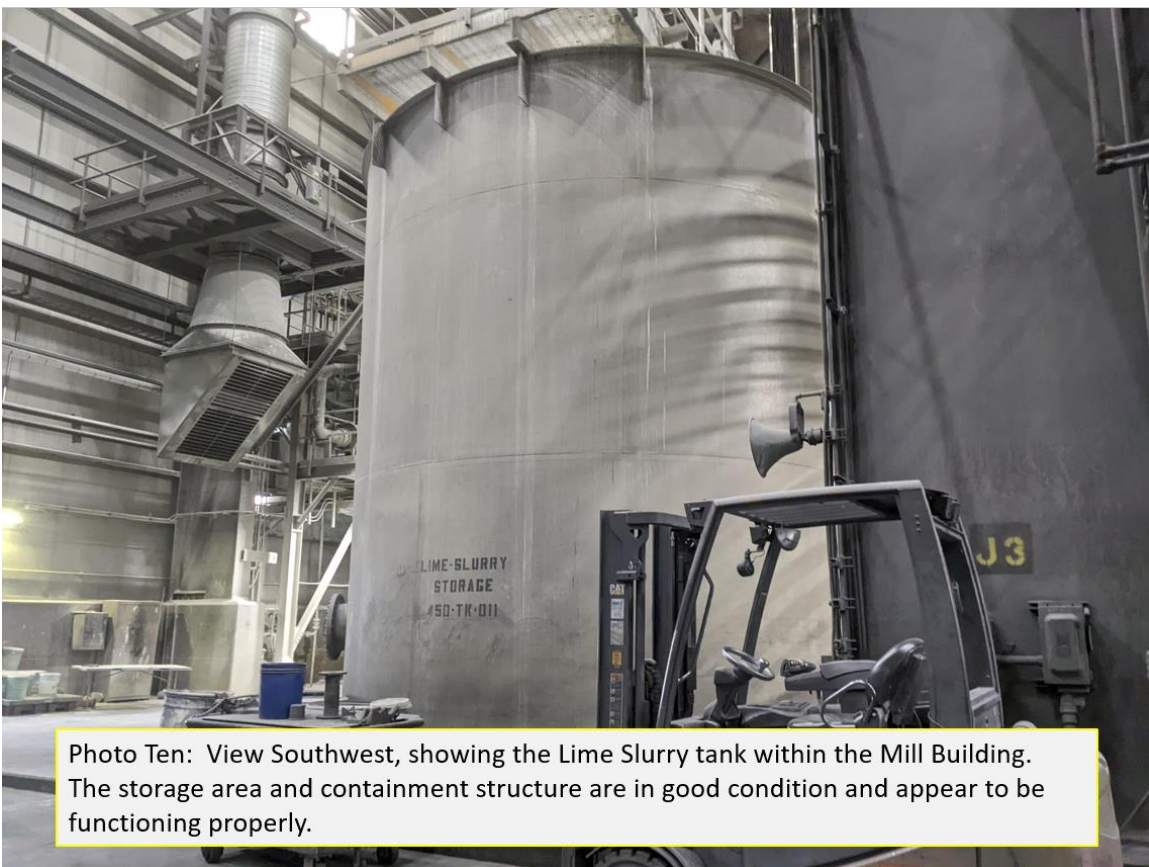
Concentrated lime storage is achieved in two locations of the Mill Facility. The internal lime storage tank which is connected to the mill feed lines, and the bulk lime storage silo located just outside the Mill Building. The internal lime storage tank can be seen in Photo Ten. Evidence of use and lime scaling was observed around the tank, which is consistent with normal operations. No evidence of significant spillage was observed, and because the tank is located within the Mill Facility, secondary containment is achieved through the greater secondary containment of the Mill Facility. The external lime storage silo was also observed to be in excellent condition and can be seen in Photo Eleven. No evidence of spillage or lime scaling was observed on or around the silo. Secondary containment for the silo is achieved by the pads surrounding the Mill Facility that would contain any possible spillage.

Photo Ten: View Southwest, showing the Lime Slurry tank within the Mill Building. The storage area and containment structure are in good condition and appear to be functioning properly.

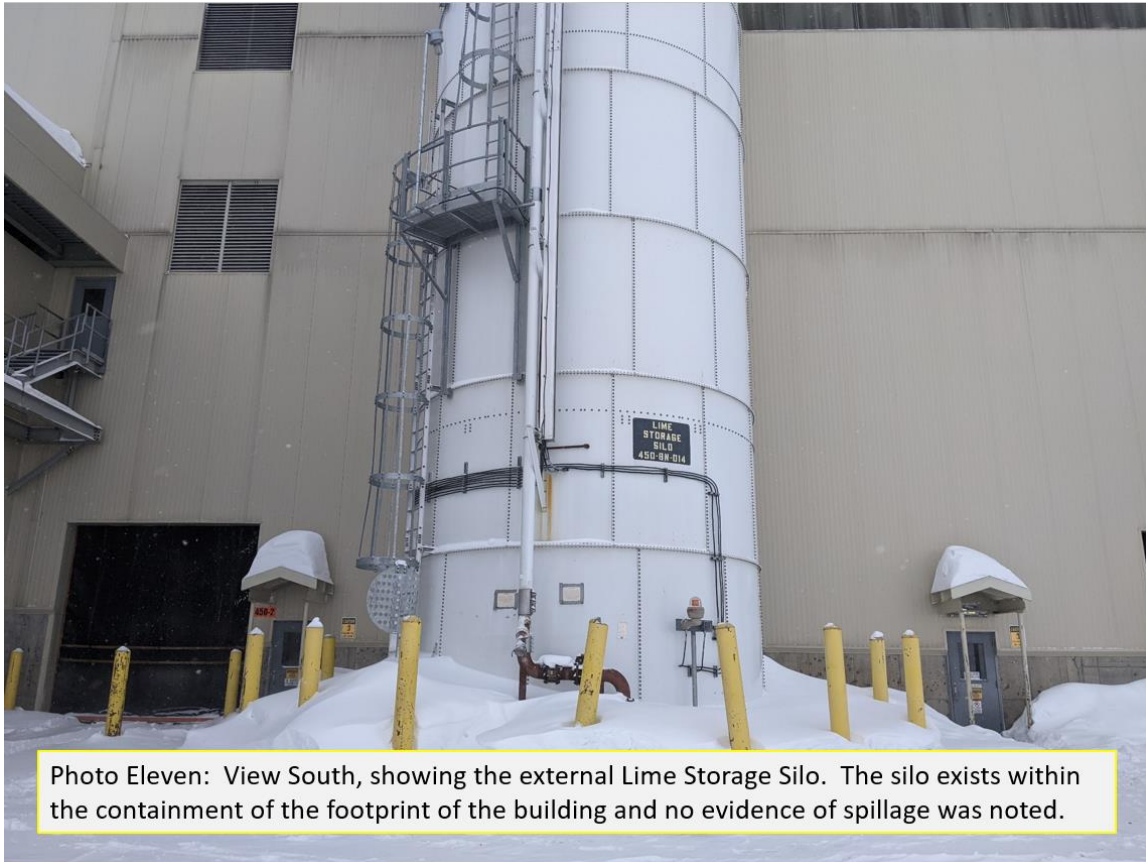
Photo Eleven: View South, showing the external Lime Storage Silo. The silo exists within the containment of the footprint of the building and no evidence of spillage was noted.

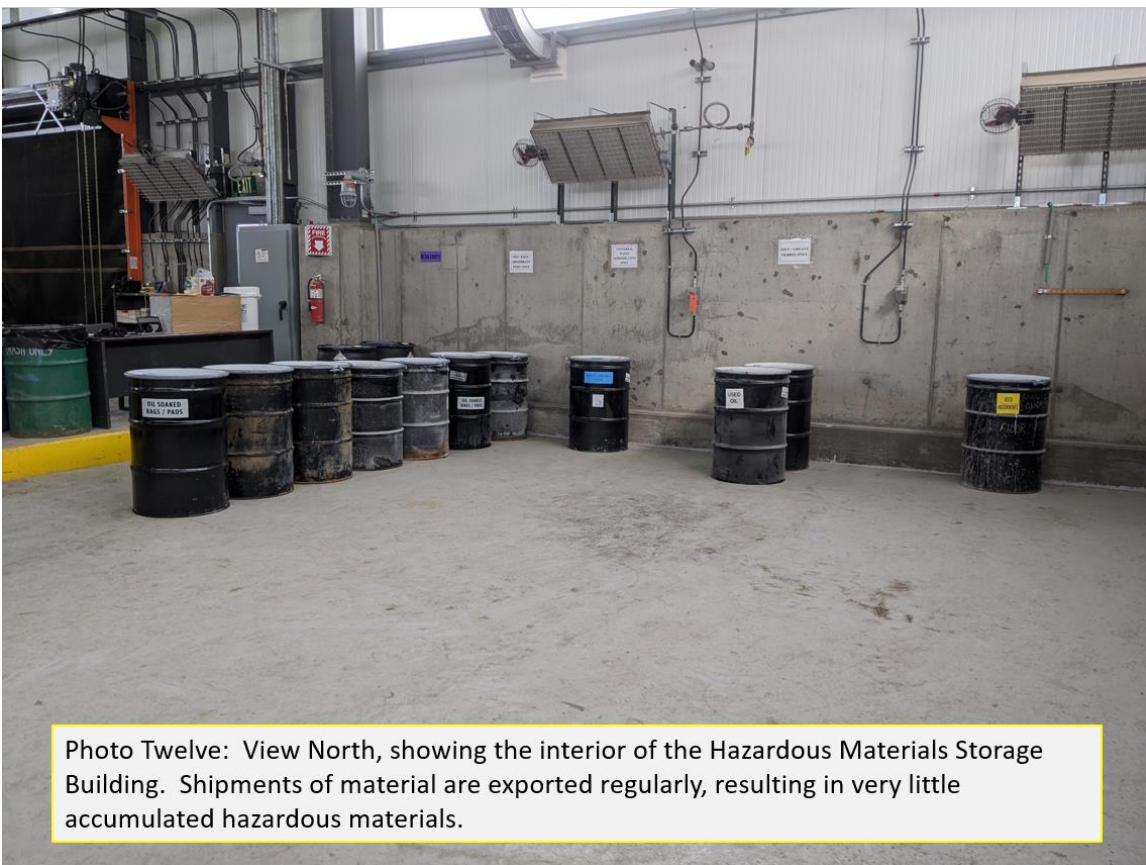
Hazardous Waste Storage Building: The Climax Mine facility is registered as a small quantity generator in compliance with all rules and regulations under the Resource Conservation and Recovery Act (RCRA). All hazardous waste that is generated by the site is stored in the Hazardous Waste Storage Building. The Hazardous Waste Storage Facility is a small building located near the Main Building on site that includes an internal secondary containment system. All manner of hazardous materials are stored there for disposal including used oils, oily rags, various electronics and other materials that are regulated as hazardous materials. The building was constructed in a way that the storage area acts as secondary containment for any and all items stored there. The storage area can be seen in Photos Twelve and Thirteen. All materials being stored in the facility are well kept and organized.

Photo Twelve: View North, showing the interior of the Hazardous Materials Storage Building. Shipments of material are exported regularly, resulting in very little accumulated hazardous materials.

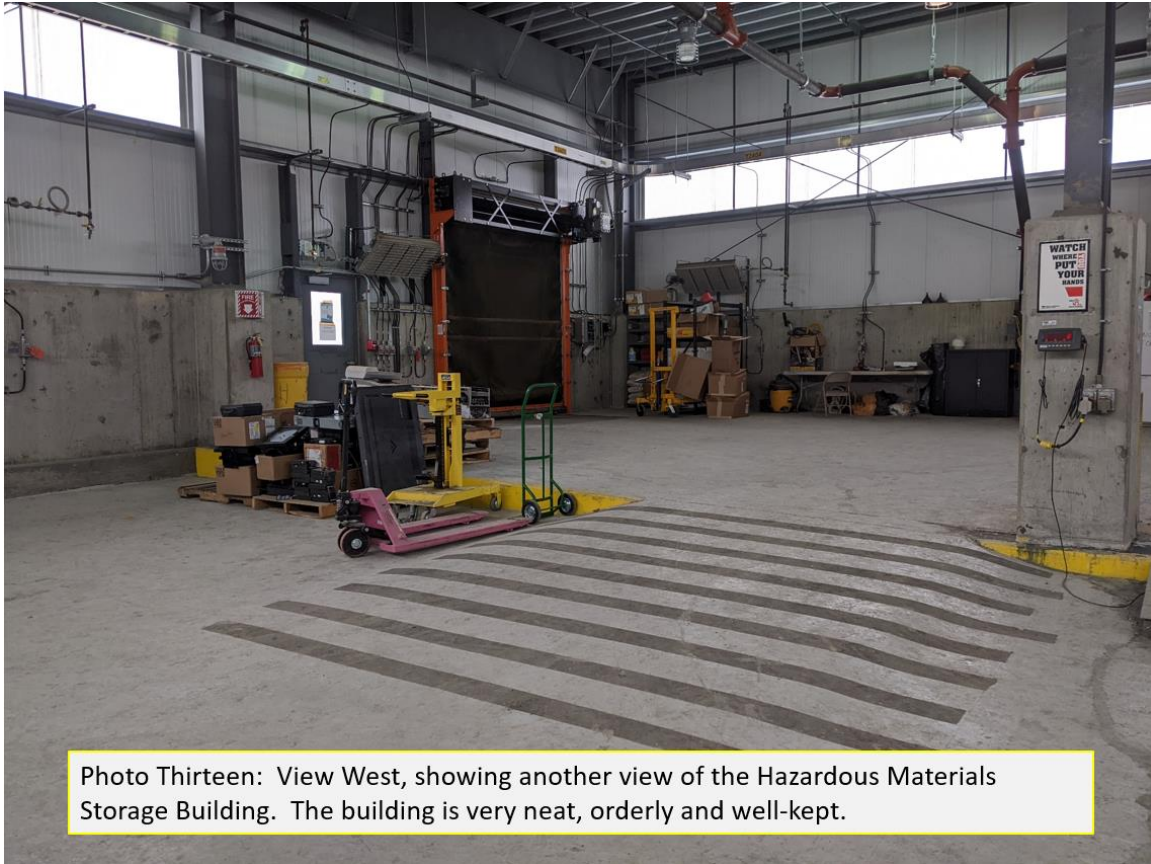
Photo Thirteen: View West, showing another view of the Hazardous Materials Storage Building. The building is very neat, orderly and well-kept.
