MINERALS PROGRAM INSPECTION REPORT
PHONE: (303) 866-3567

MINE NAME: Windsor East Mine	MINE/PROSPECTING ID#: M-2022-042	MINERAL: Sand and gravel	COUNTY: Weld
INSPECTION TYPE: Pre-Operation Inspection	WEATHER: Clear	INSP. DATE: November 28, 2022	INSP. TIME: 10:00
OPERATOR: Martin Marietta Materials, Inc.	OPERATOR REPRESENTATIVE: Julie Mikulas	TYPE OF OPERATION: 112c - Construction Regular Operation	
REASON FOR INSPECTION: Pre-Operation Inspection	BOND CALCULATION TYPE:	BOND AMOUNT: No Bond Held	
DATE OF COMPLAINT: NA	POST INSP. CONTACTS: None	JOINT INSP. AGENCY: None	
INSPECTOR(S): Peter Hays Amber Michels	INSPECTOR'S SIGNATURE:

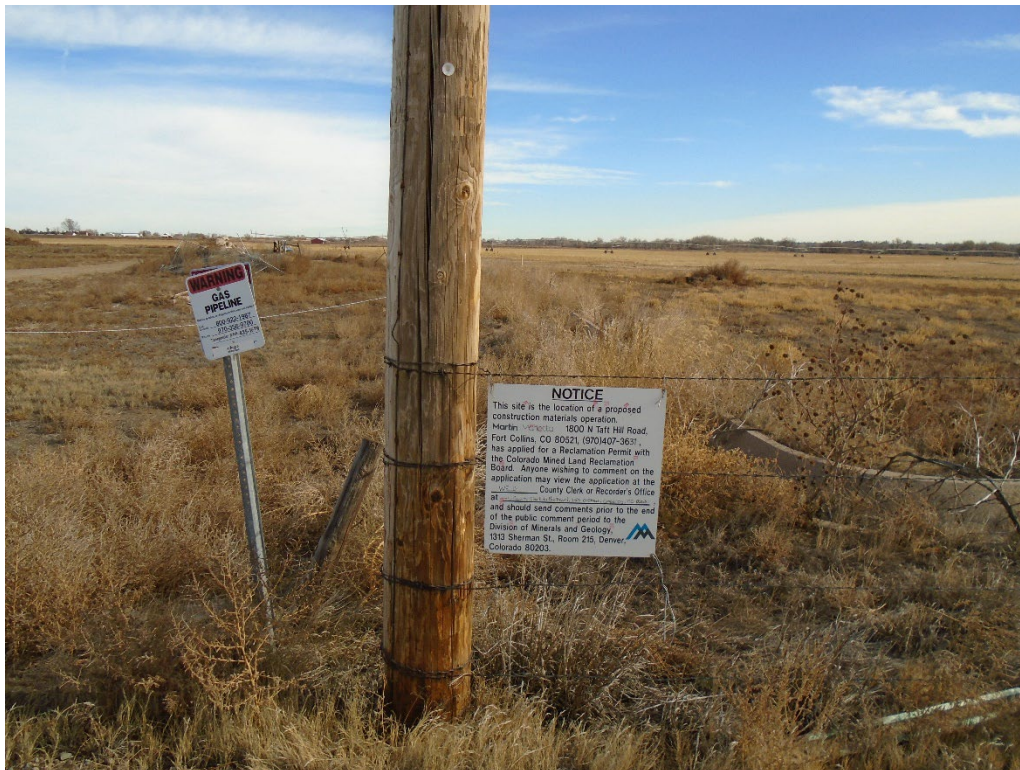
View of the notice sign posted at the site entrance from WCR 23

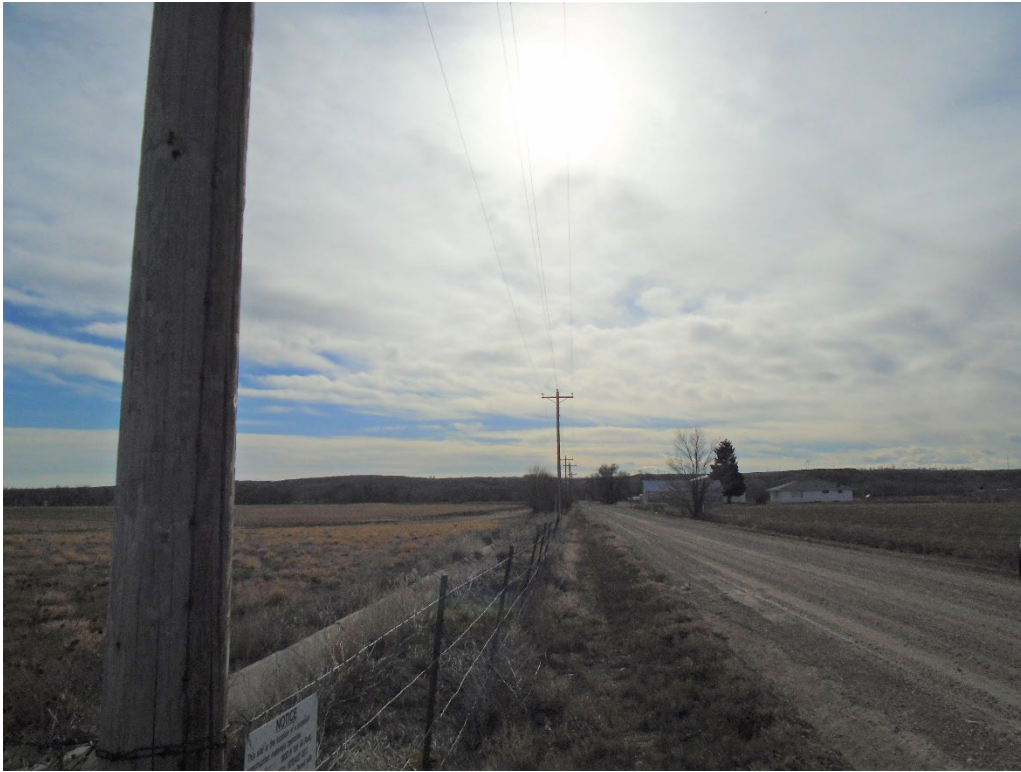
View of WCR 23 from the site entrance looking south

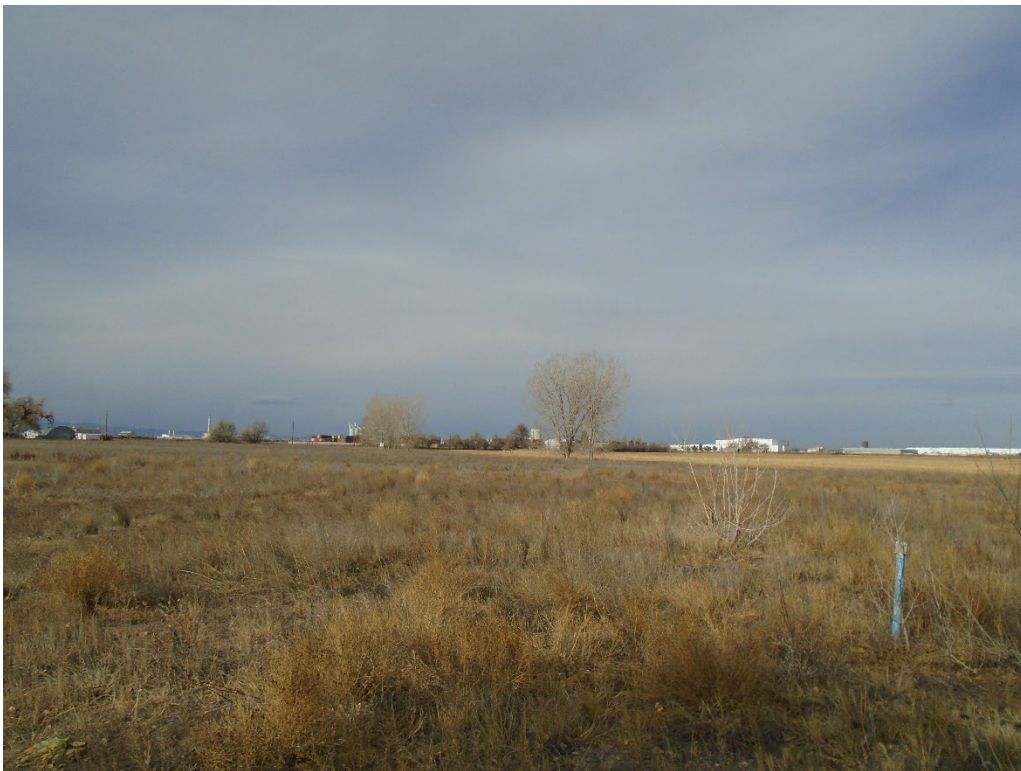
View of the site from the southwest corner looking northeast

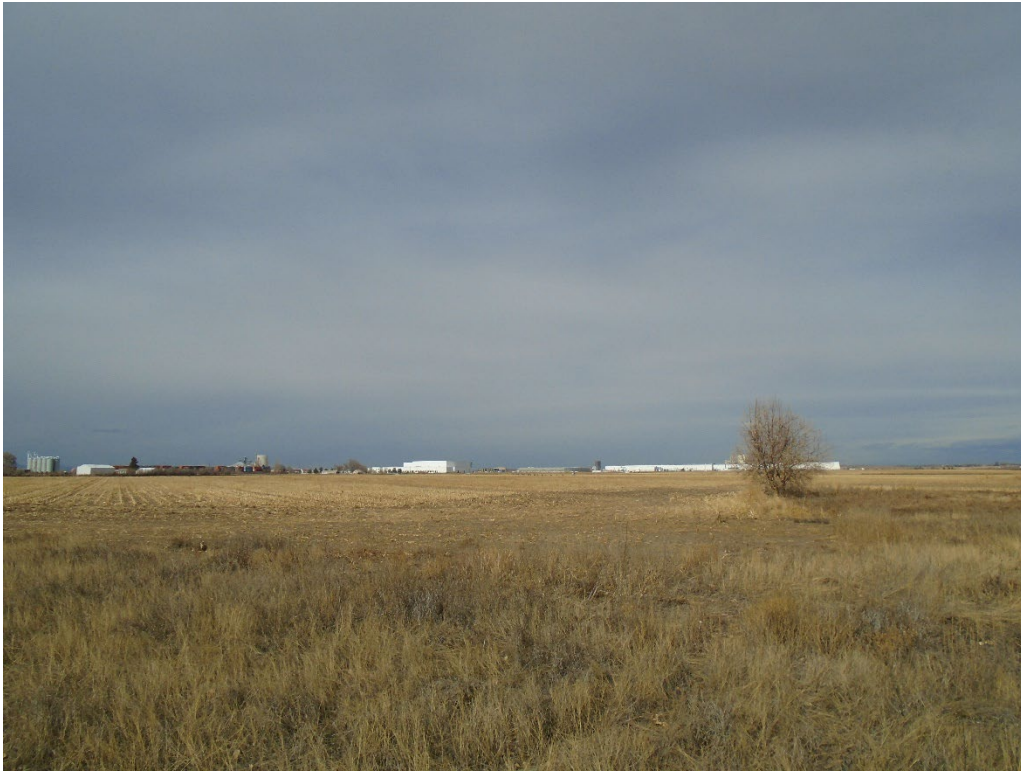
View of the site from the south boundary looking north

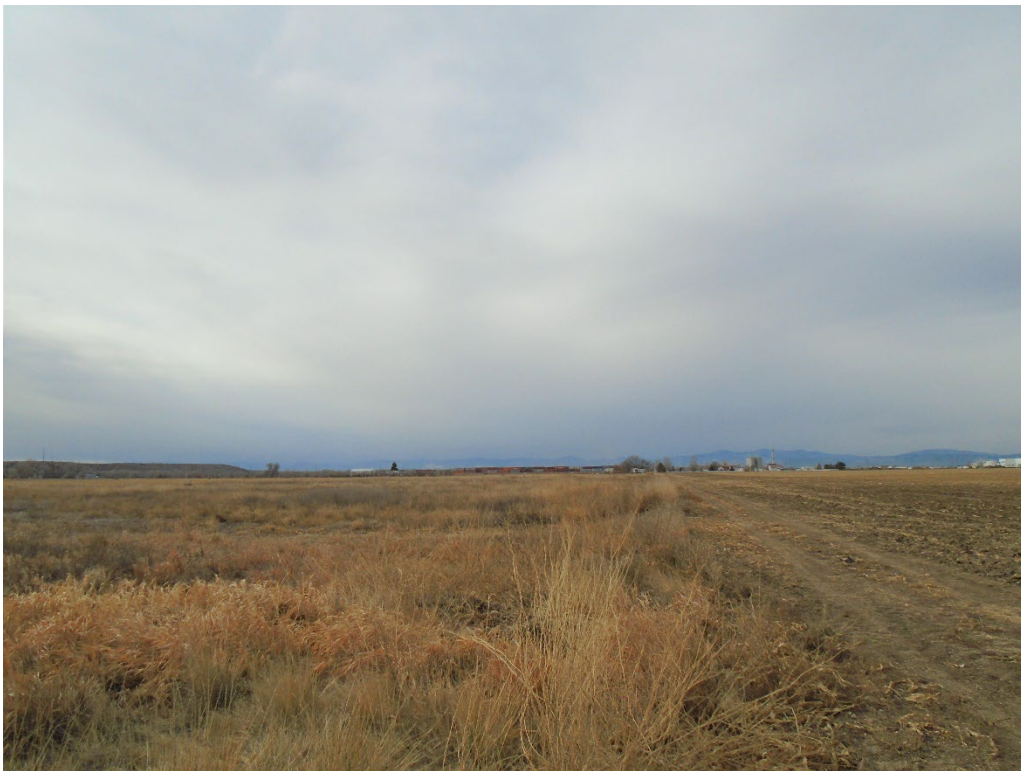
View of the site from the west boundary looking west

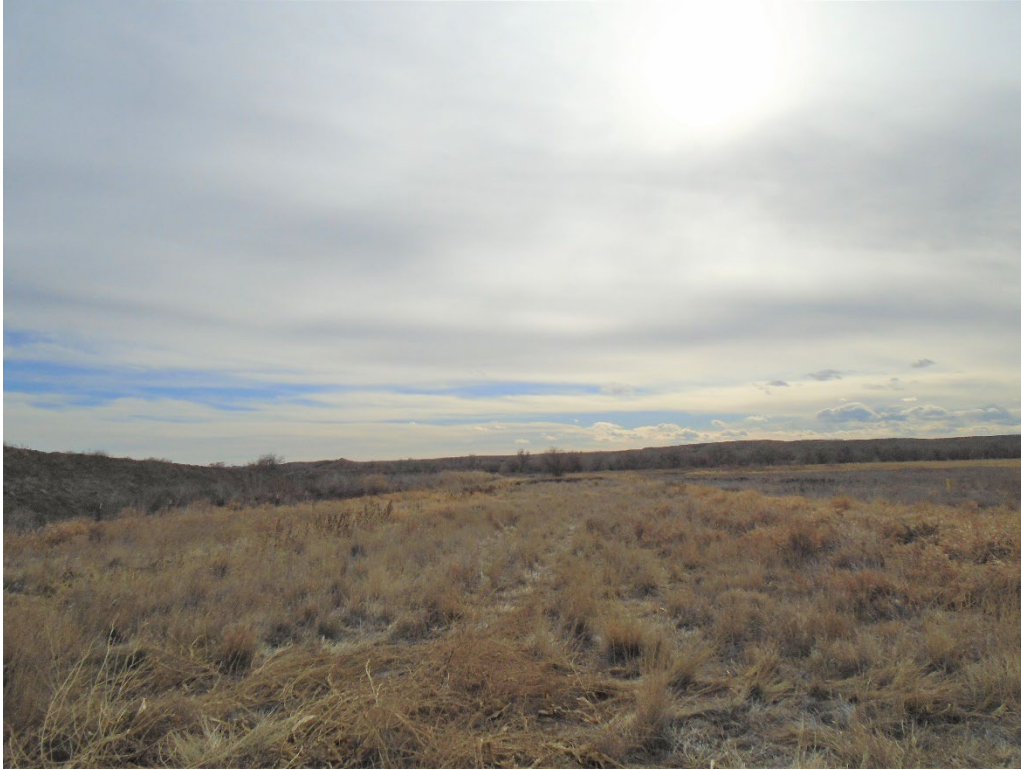
View of the site from the northwest boundary corner looking south

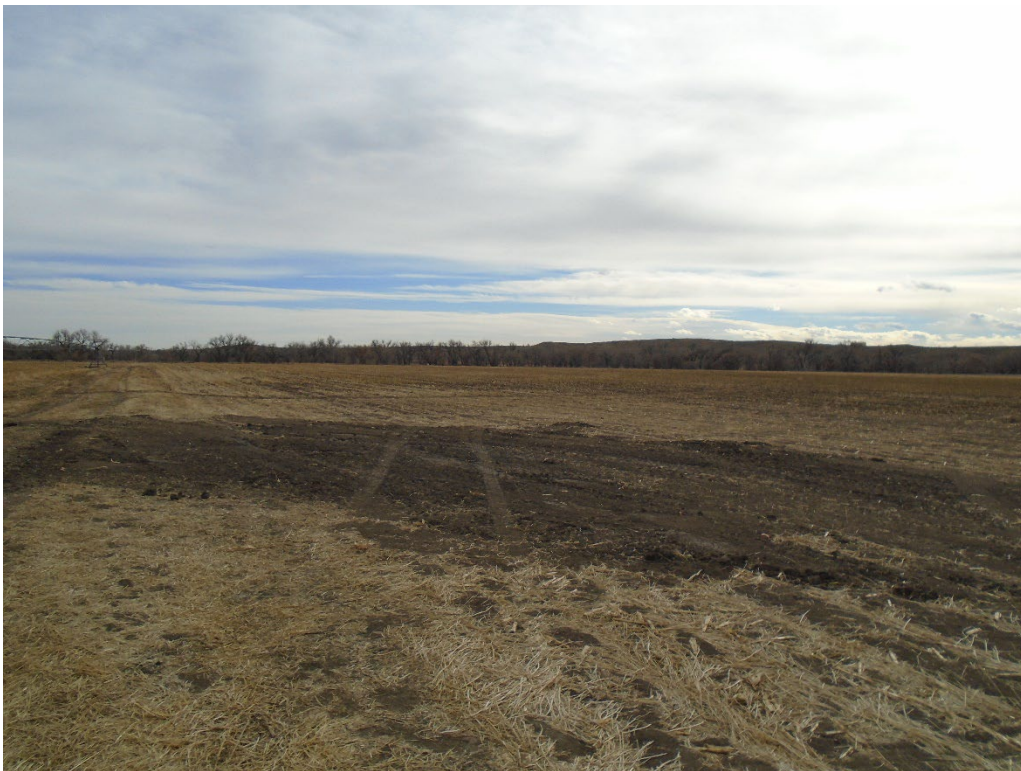
View of the plugged oil and gas well reclamation
