MINERALS PROGRAM INSPECTION REPORT PHONE: (303) 866-3567

| MINE NAME: | MINE/PROSPECTING ID#: | MINERAL: | COUNTY: |
|---|---|---|---|
| Milliken Resource | M-2000-087 | Sand and gravel and | Weld |
| Monitoring | | December 7, 2022 | 13:00 |
| Holcim - WCR, Inc. | Wyatt Webster | 112c - Construction Regular Operation | |

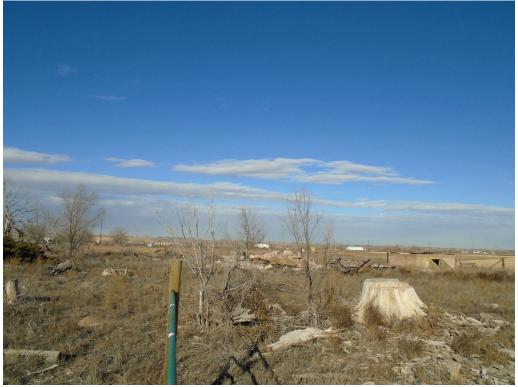
View of the site from the entrance gate off of Hwy 60 looking north

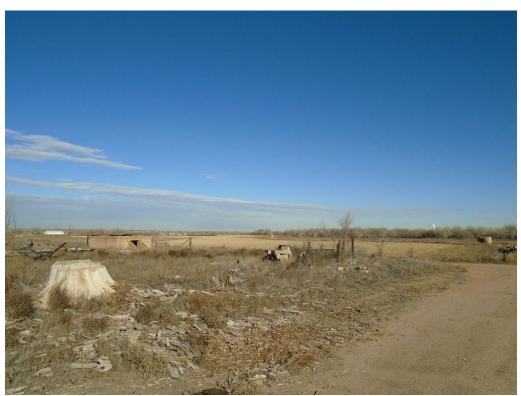
View of the site from the entrance gate off of Hwy 60 looking northeast

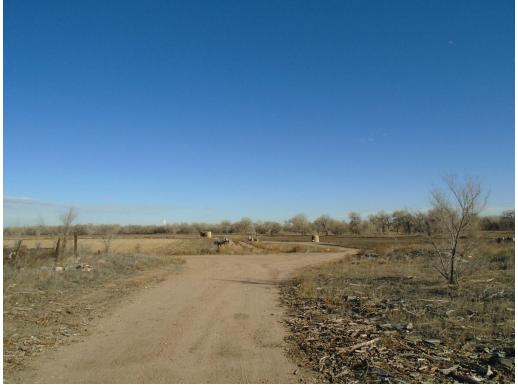
View of the site from the entrance gate off of Hwy 60 looking east
