**MINERALS PROGRAM INSPECTION REPORT**  
**PHONE: (303) 866-3567**

<b>MINE NAME:</b> Longmont Distel Operations	<b>MINE/PROSPECTING ID#:</b> M-1989-029	<b>MINERAL:</b> Sand and gravel	<b>COUNTY:</b> Weld
<b>INSPECTION TYPE:</b> Monitoring	<b>WEATHER:</b> Snowing, Windy	<b>INSP. DATE:</b> December 13, 2022	<b>INSP. TIME:</b> 10:00
<b>OPERATOR:</b> Holcim - WCR, Inc.	<b>OPERATOR REPRESENTATIVE:</b> Wyatt Webster	<b>TYPE OF OPERATION:</b> 112c - Construction Regular Operation

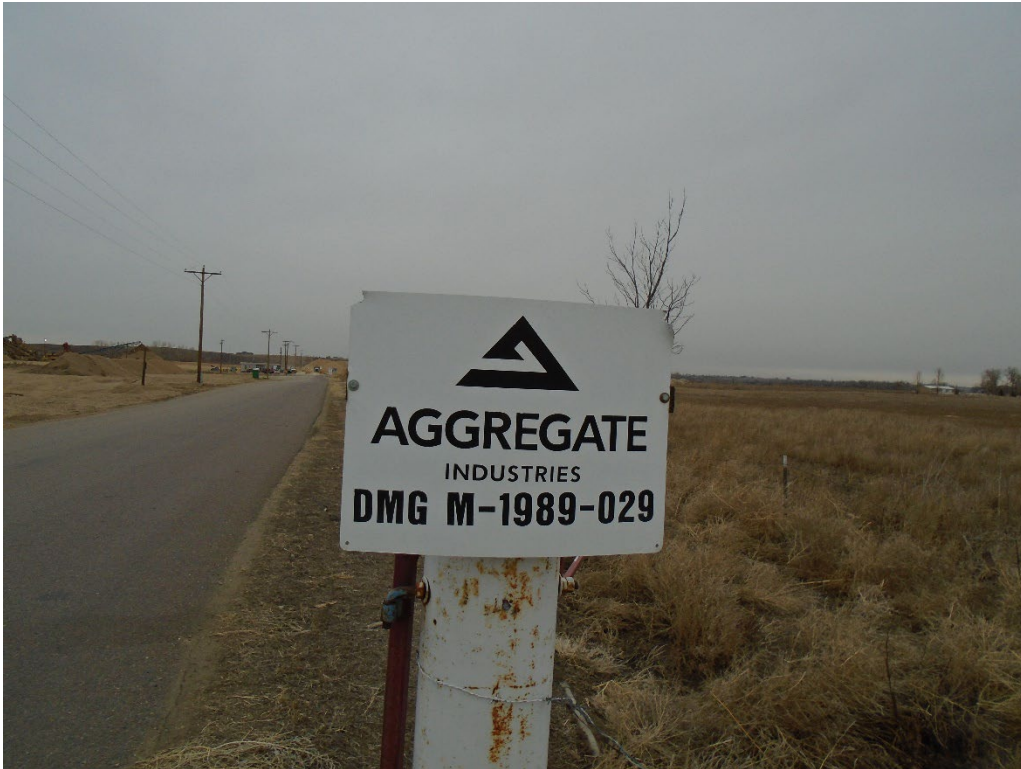
**PROBLEM:** The mine identification sign was not posted at the entrance of the mine site. This is a problem for failure to post a mine identification sign as required by Rule 3.1.12(1). The Operator shall, at the entrance of the mine site post a sign, which shall be clearly visible from the access road, with a minimum size equaling one hundred and eighty-seven (187) square inches, such as eleven (11) inches in height and seventeen (17) inches in width, with appropriate font size, with the following: the name of the Operator, a statement that a reclamation permit for the operation has been issued by the Colorado Mined Land Reclamation Board; and the permit number.

View of the mine sign for the Longmont Distel Operations

**CORRECTIVE ACTIONS:** The Operator shall, at the entrance of the mine site, post a sign which shall be clearly visible from the access road with the following: the name of the operator, a statement that a reclamation permit for the operation has been issued by the Colorado Mined Land Reclamation Board; and the permit number. The Operator shall submit photo documentation that a proper sign has been posted by the corrective action date.

**CORRECTIVE ACTION DUE DATE:** 3/31/23

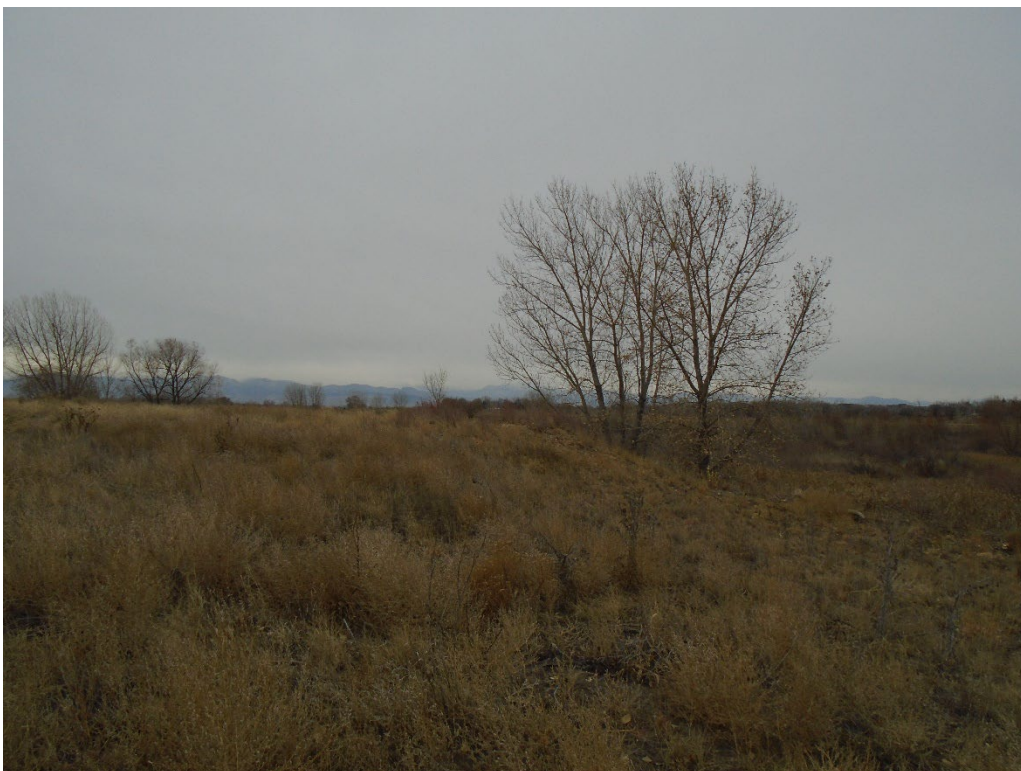
View of the site from the Bigelow property looking west

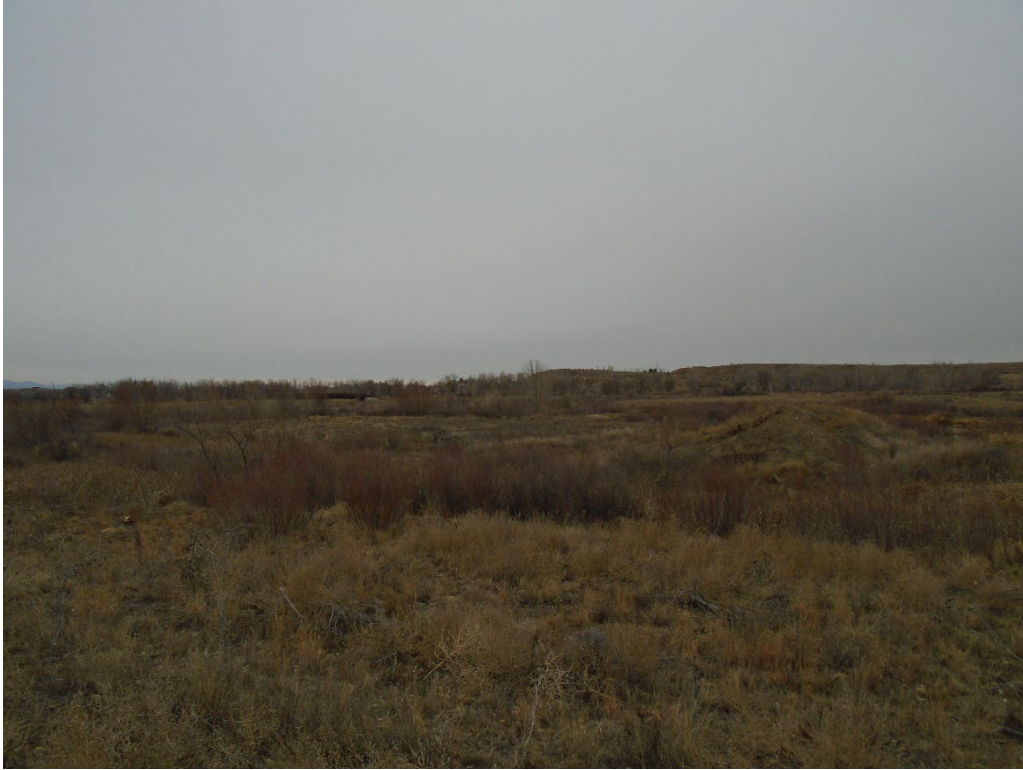
View of the site from the Bigelow property looking northwest

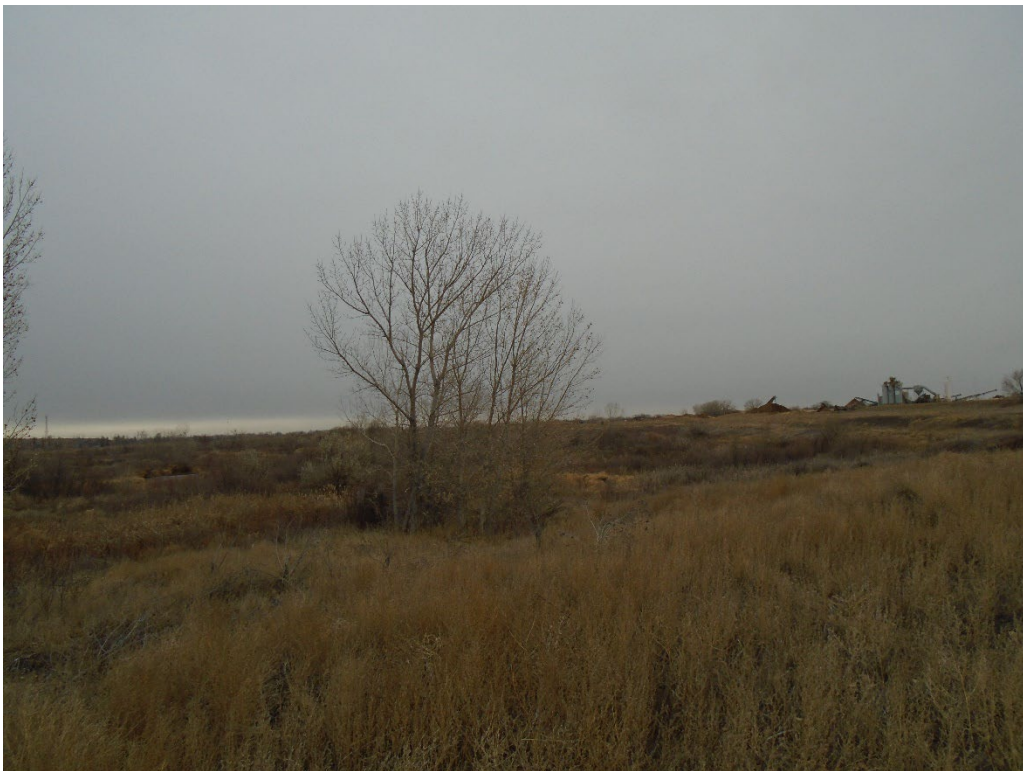
View of the site from the Bigelow property looking east

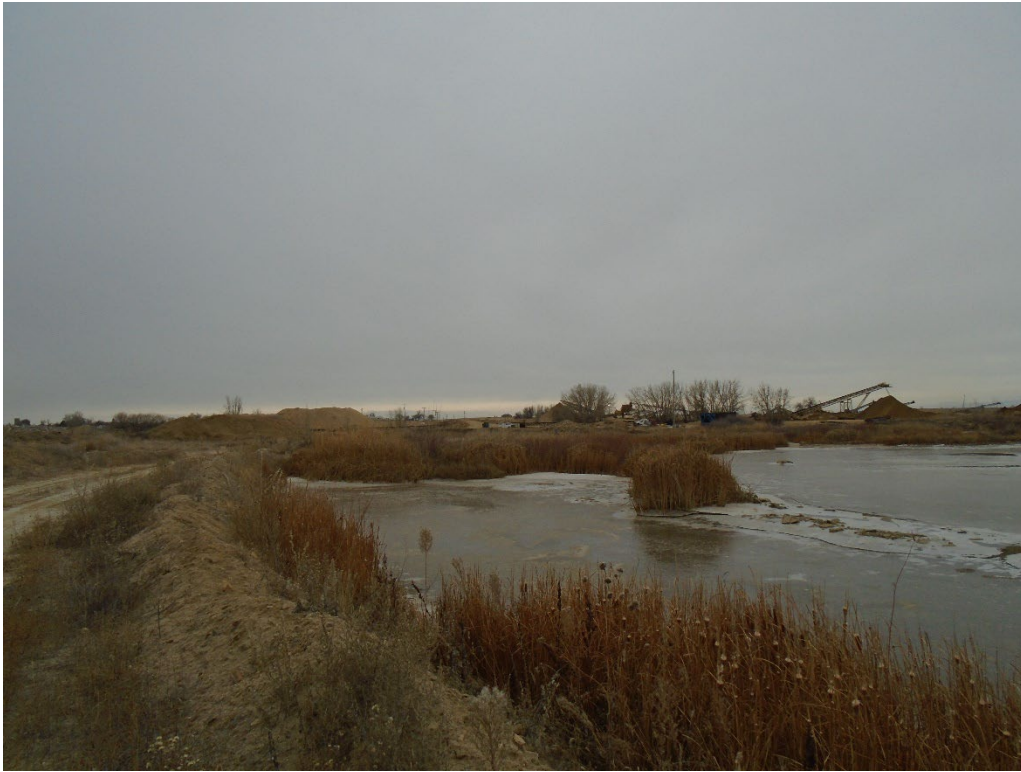
View of the processing plant area from the Bigelow property looking east
