**MINERALS PROGRAM INSPECTION REPORT**  
**PHONE: (303) 866-3567**

<b>MINE NAME:</b> Longmont Operation	<b>MINE/PROSPECTING ID#:</b> M-1994-027	<b>MINERAL:</b> Sand and gravel	<b>COUNTY:</b> Weld
<b>INSPECTION TYPE:</b> Monitoring	<b>WEATHER:</b> Snowy, Windy	<b>INSP. DATE:</b> December 13, 2022	<b>INSP. TIME:</b> 11:00
<b>OPERATOR:</b> Holcim - WCR, Inc.	<b>OPERATOR REPRESENTATIVE:</b> Wyatt Webster	<b>TYPE OF OPERATION:</b> 112c - Construction Regular Operation

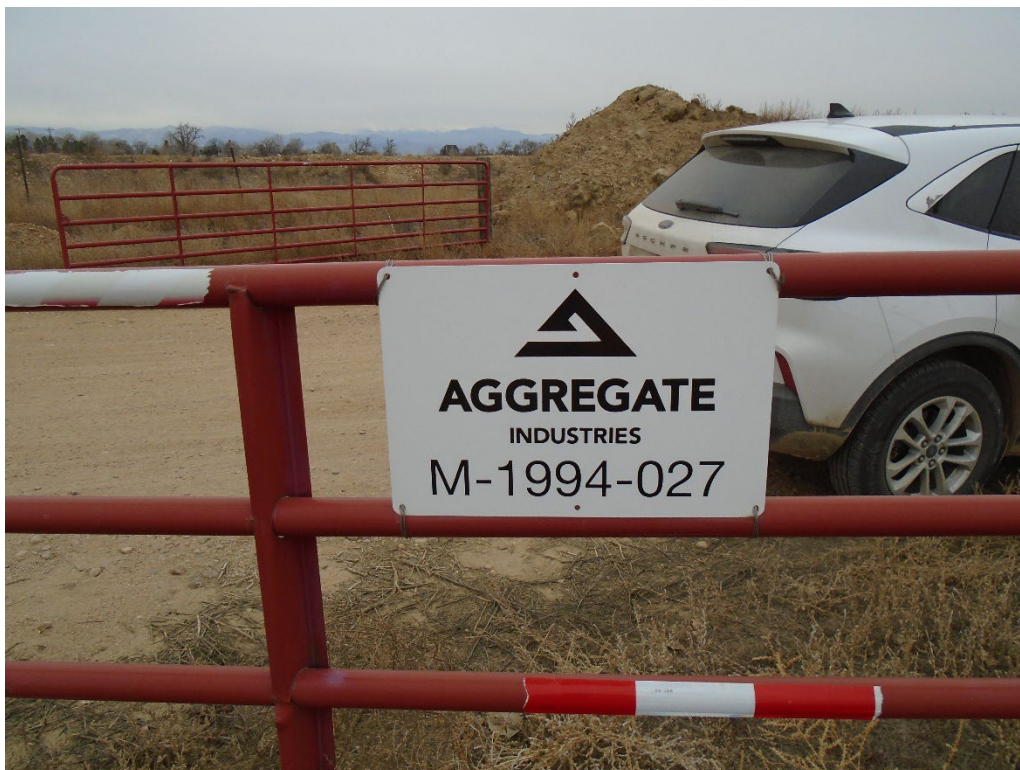
**PROBLEM:** The mine identification sign was not posted at the entrance of the mine site. This is a problem for failure to post a mine identification sign as required by Rule 3.1.12(1). The Operator shall, at the entrance of the mine site post a sign, which shall be clearly visible from the access road, with a minimum size equaling one hundred and eighty-seven (187) square inches, such as eleven (11) inches in height and seventeen (17) inches in width, with appropriate font size, with the following: the name of the Operator, a statement that a reclamation permit for the operation has been issued by the Colorado Mined Land Reclamation Board; and the permit number.

Inaccurate Longmont Operations mine sign

**CORRECTIVE ACTIONS:** The Operator shall, at the entrance of the mine site, post a sign which shall be clearly visible from the access road with the following: the name of the operator, a statement that a reclamation permit for the operation has been issued by the Colorado Mined Land Reclamation Board; and the permit number. The Operator shall submit photo documentation that a proper sign has been posted by the corrective action date.

**CORRECTIVE ACTION DUE DATE:** 3/31/23

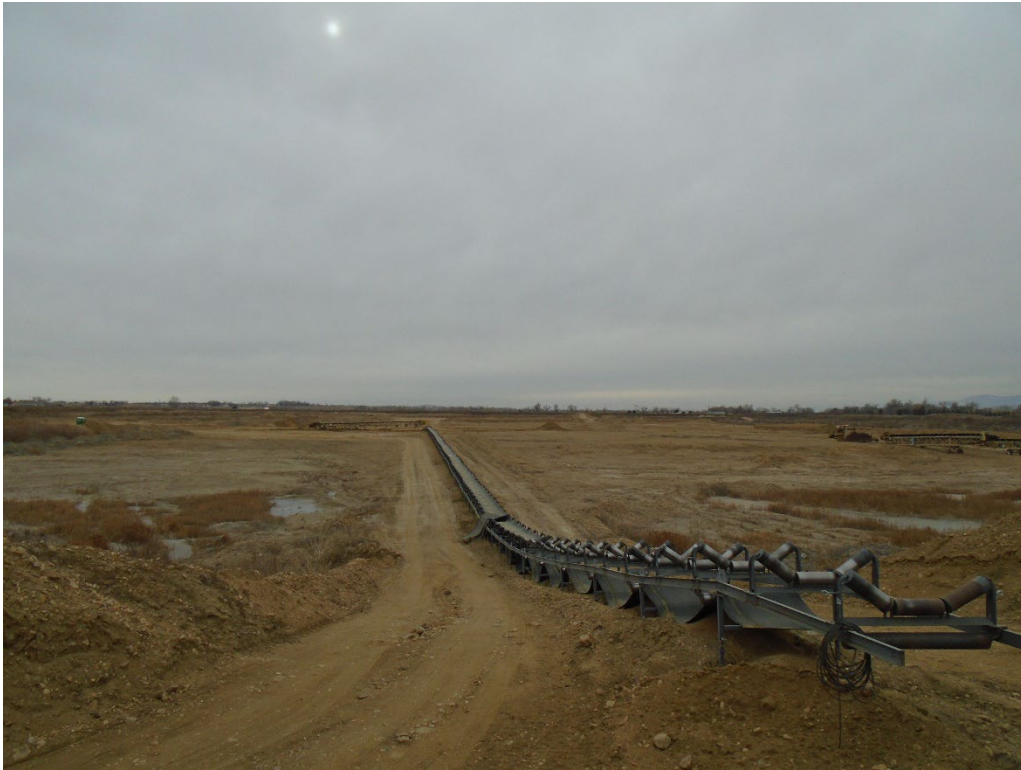
View of the site from the northeast corner looking east

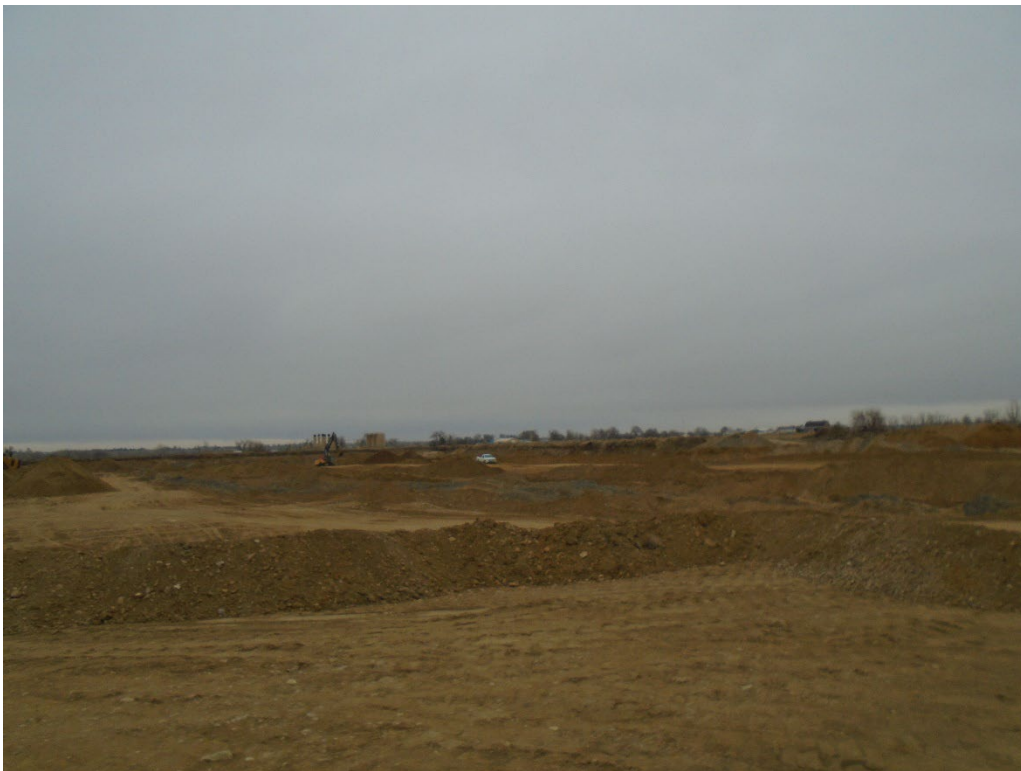
View of the active mining operations from the southwest corner of block F looking northeast

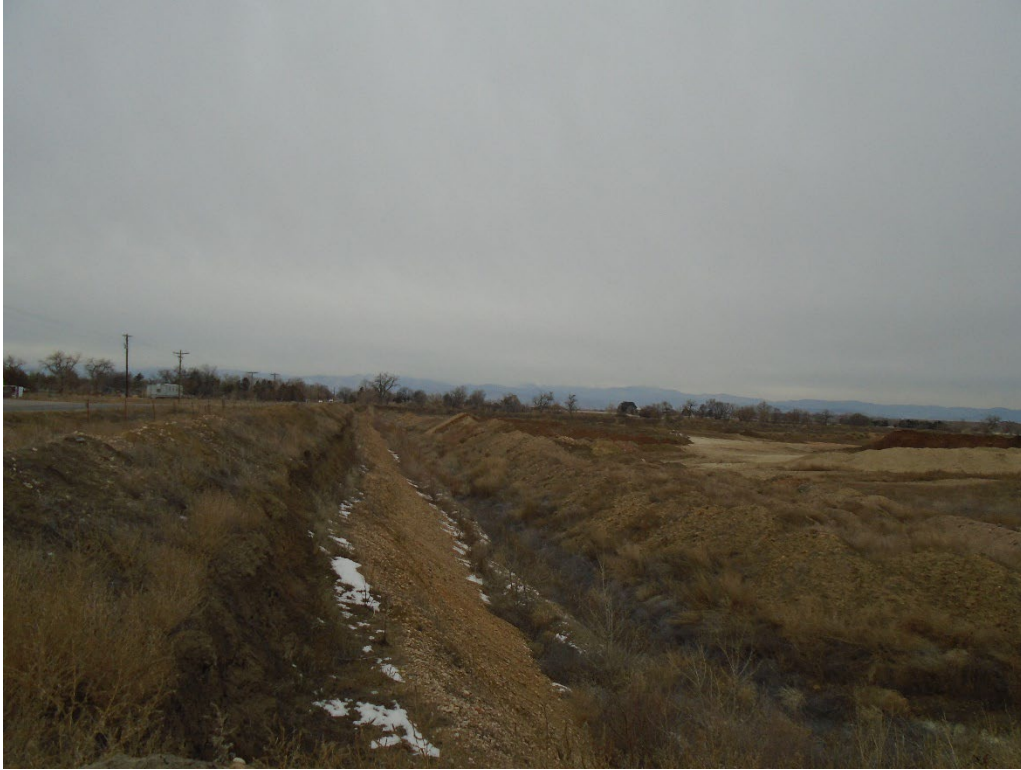
View of the southern highwall along WCR 20.5 looking west

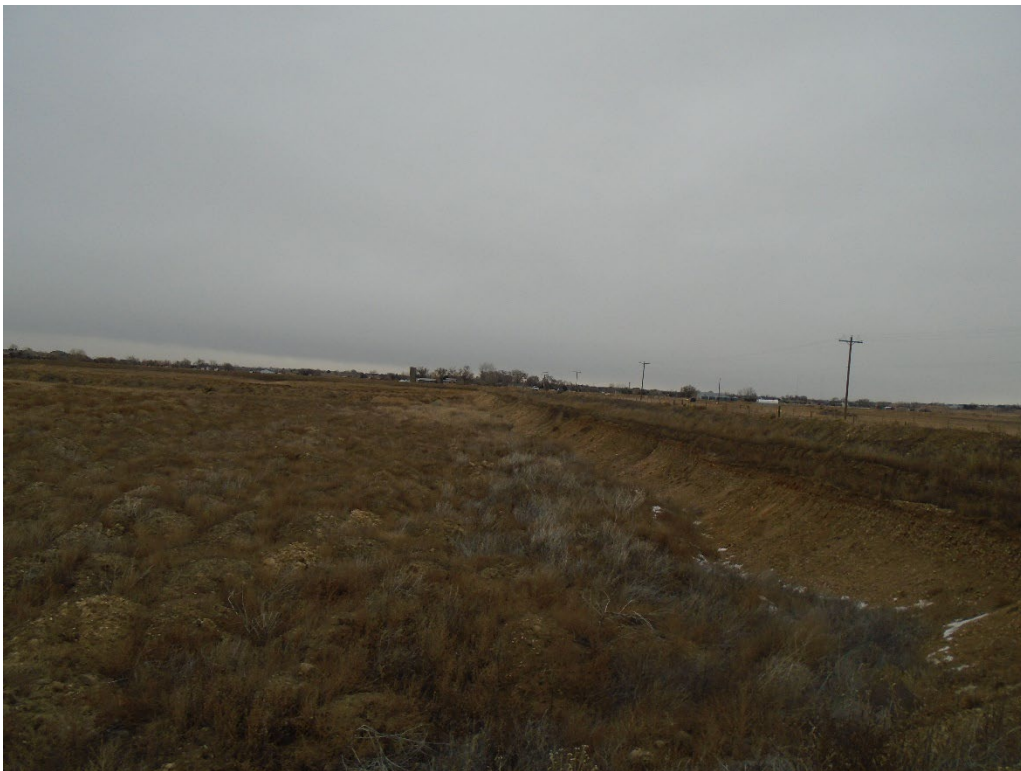
View of the southern highwall along WCR 20.5 looking east

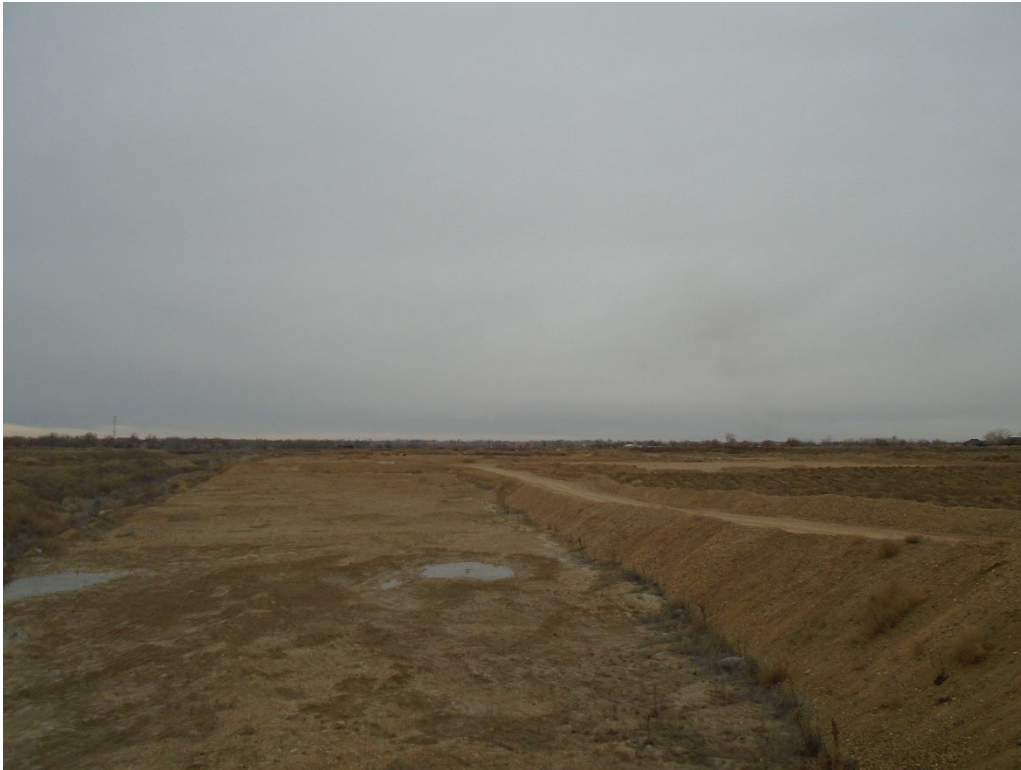
View of the site from the south entrance looking north

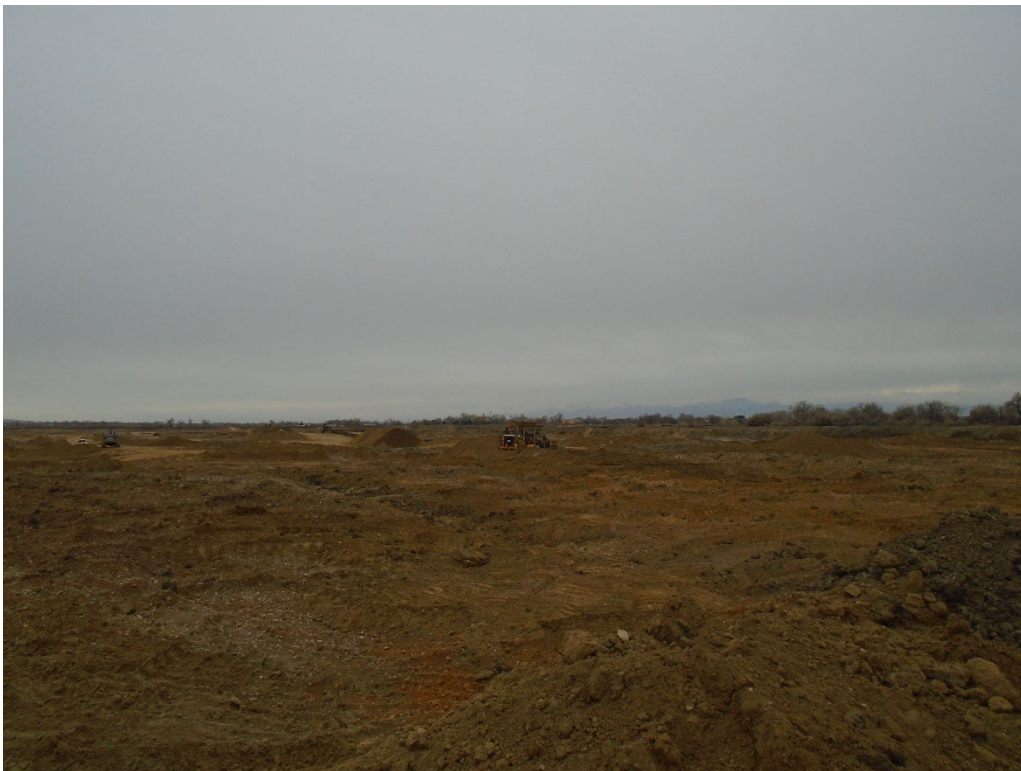
View of the active mining operations from the northeast corner of block F looking southwest

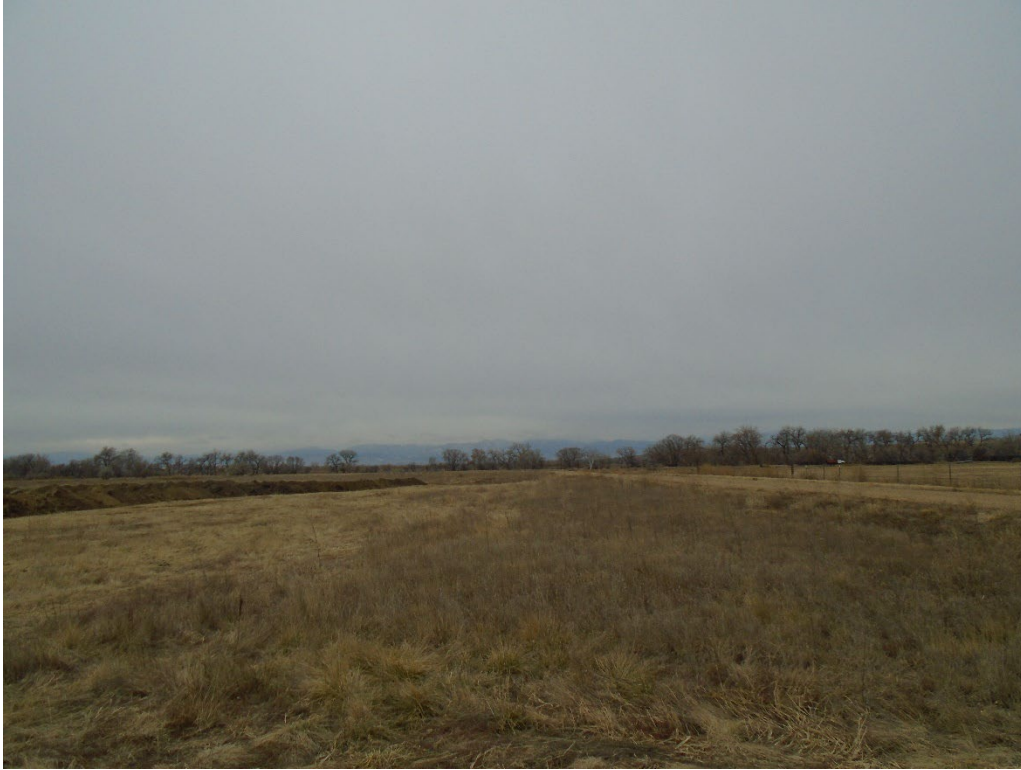
View of the last unstripped mining area at the north end of block F
