MINERALS PROGRAM INSPECTION REPORT
PHONE: (303) 866-3567

MINE NAME: CEMEX Sandstone Quarry	MINE/PROSPECTING ID#: M-1977-361	MINERAL: Sandstone	COUNTY: Boulder
INSPECTION TYPE: Monitoring	WEATHER: Clear	INSP. DATE: February 13, 2023	INSP. TIME: 11:45
OPERATOR: CEMEX, Inc.	OPERATOR REPRESENTATIVE: Cita Cisse, Robin Bay	TYPE OF OPERATION: 110c - Construction Limited Impact	
REASON FOR INSPECTION: Normal I&E Program	BOND CALCULATION TYPE: Complete Bond	BOND AMOUNT: \$409,366.00	
DATE OF COMPLAINT: NA	POST INSP. CONTACTS: None	JOINT INSP. AGENCY: None	
INSPECTOR(S): Patrick Lennberg	INSPECTOR'S SIGNATURE:

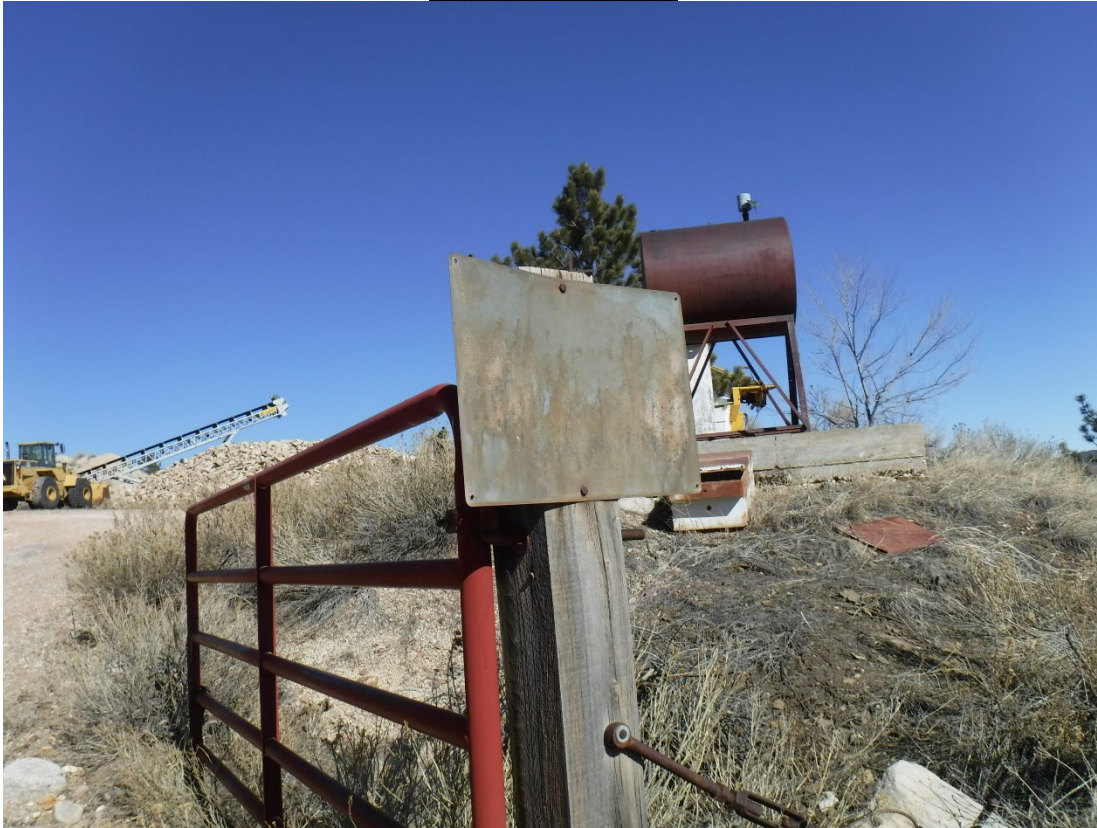
Photo 1: Faded mine sign at the primary mine entrance needing replacement

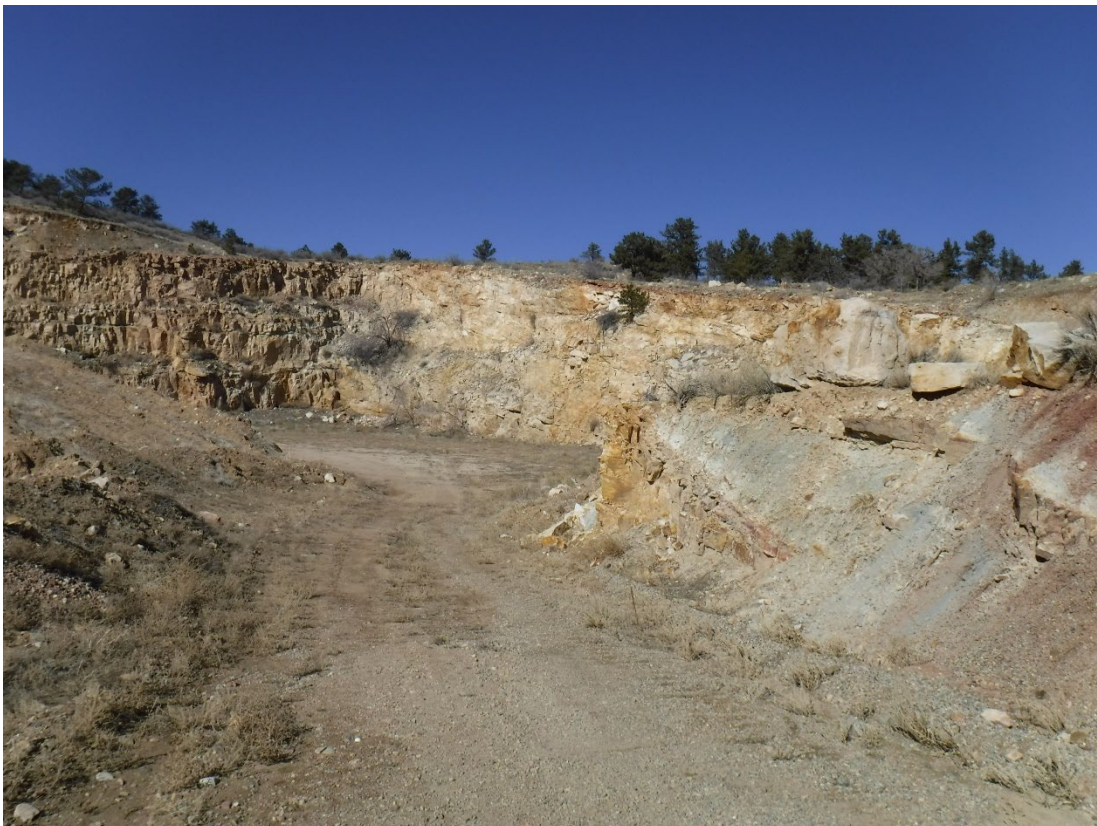
Photo 2: Road leading into quarry area

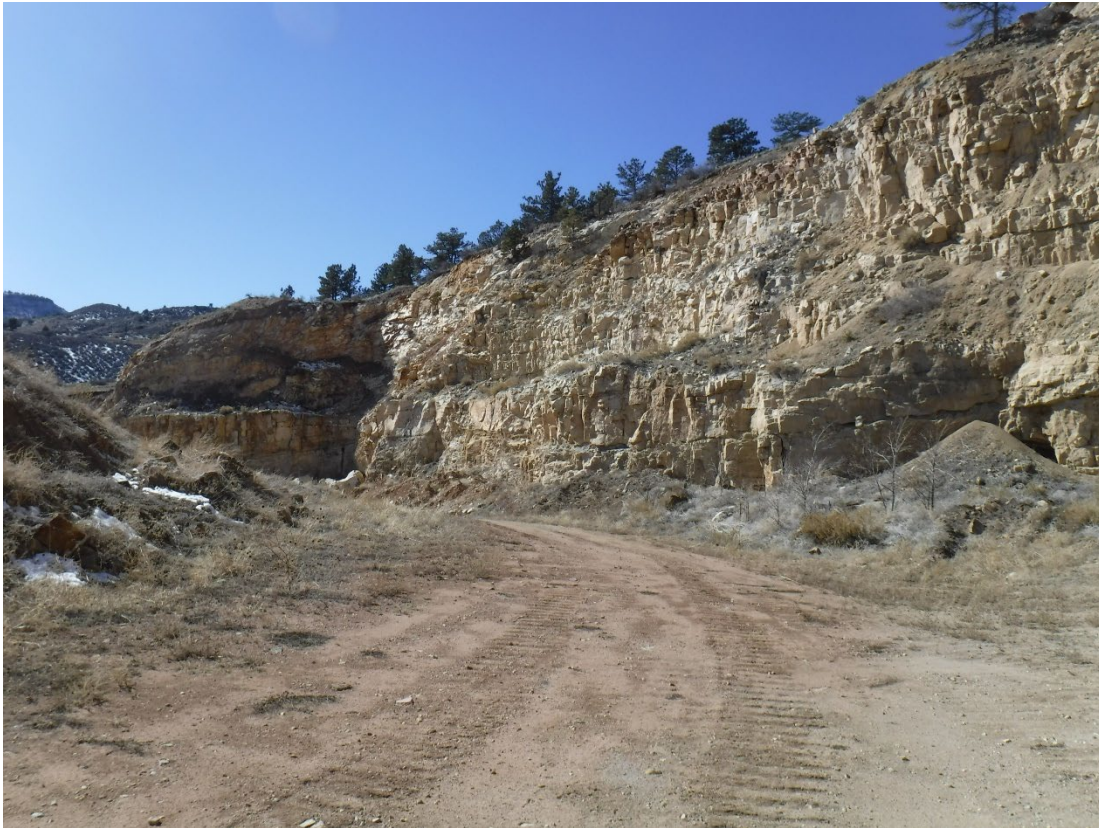
Photo 3: Typical highwalls of quarry

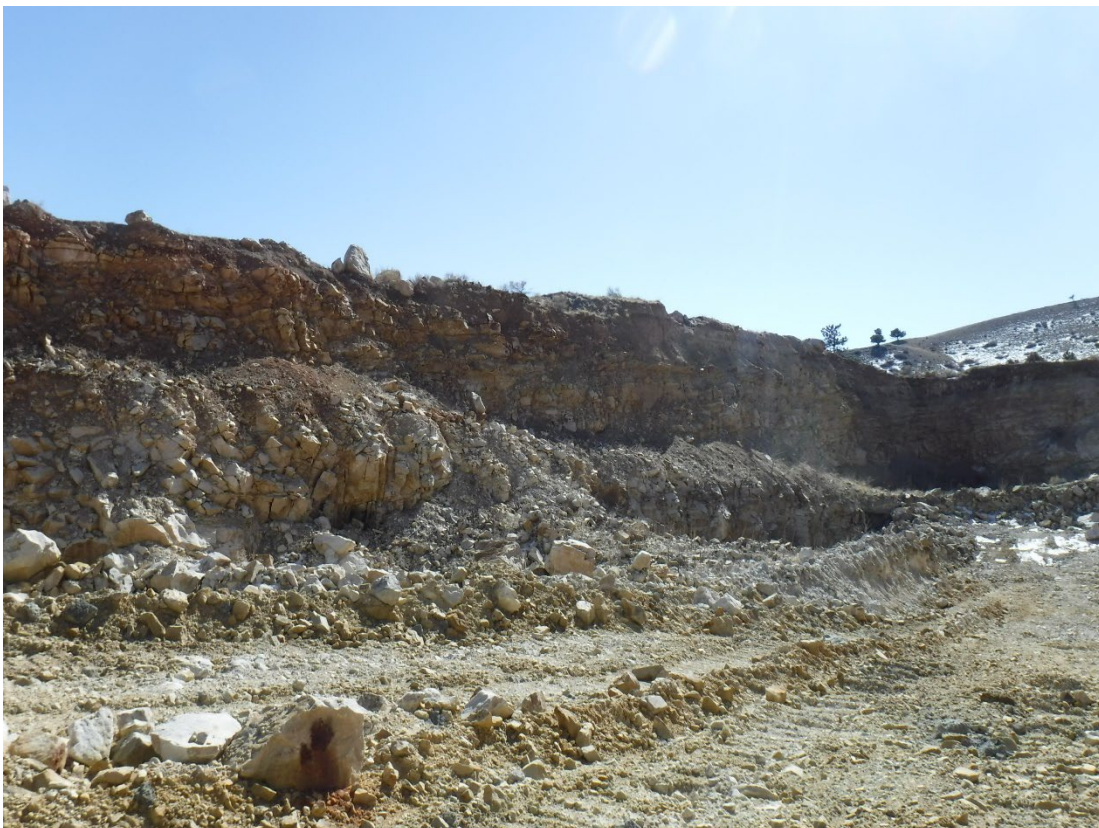
Photo 4: Active quarry area in the southeastern portion of permit area

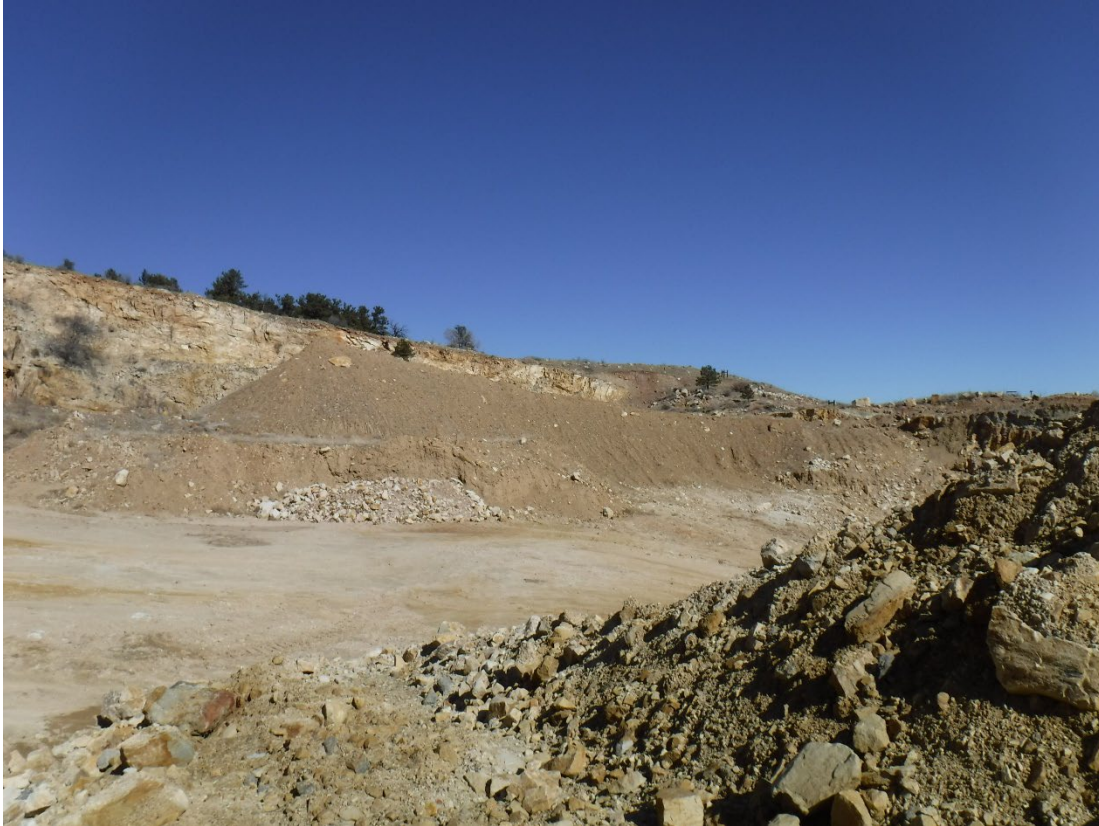
Photo 5: Approved imported backfill material for use during reclamation

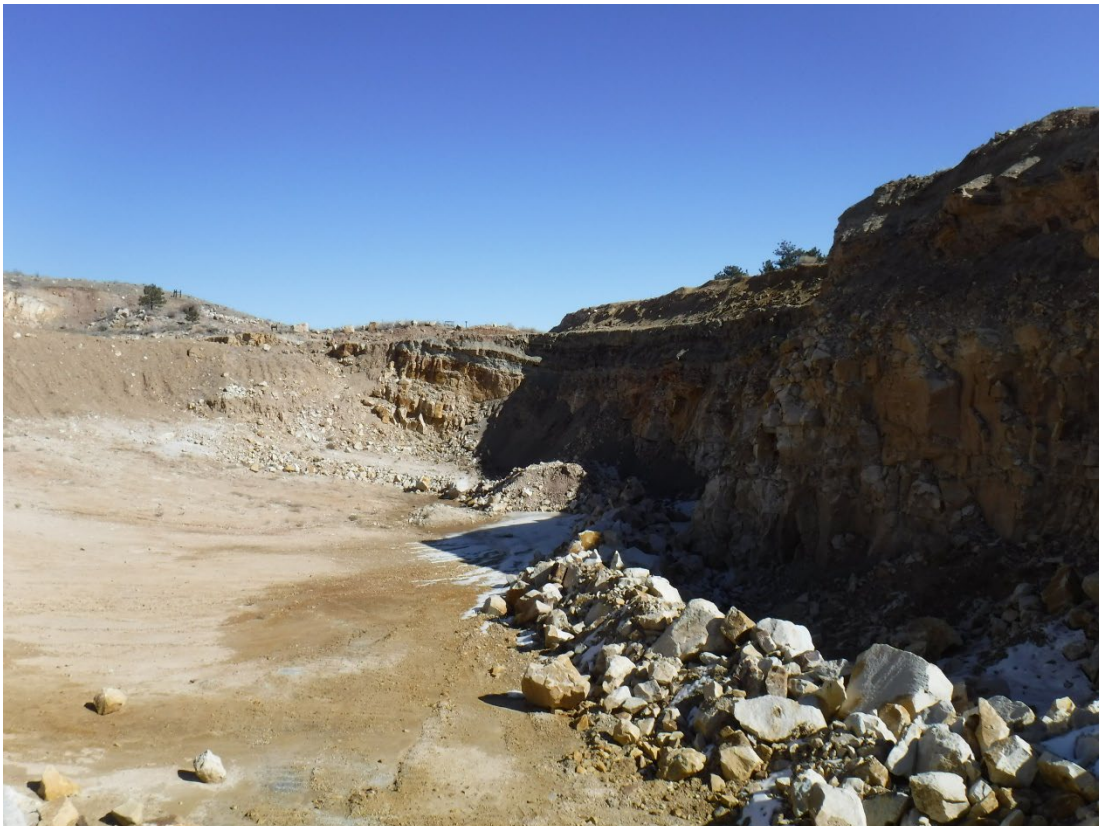
Photo 6: Pit floor area along the eastern portion of the permit

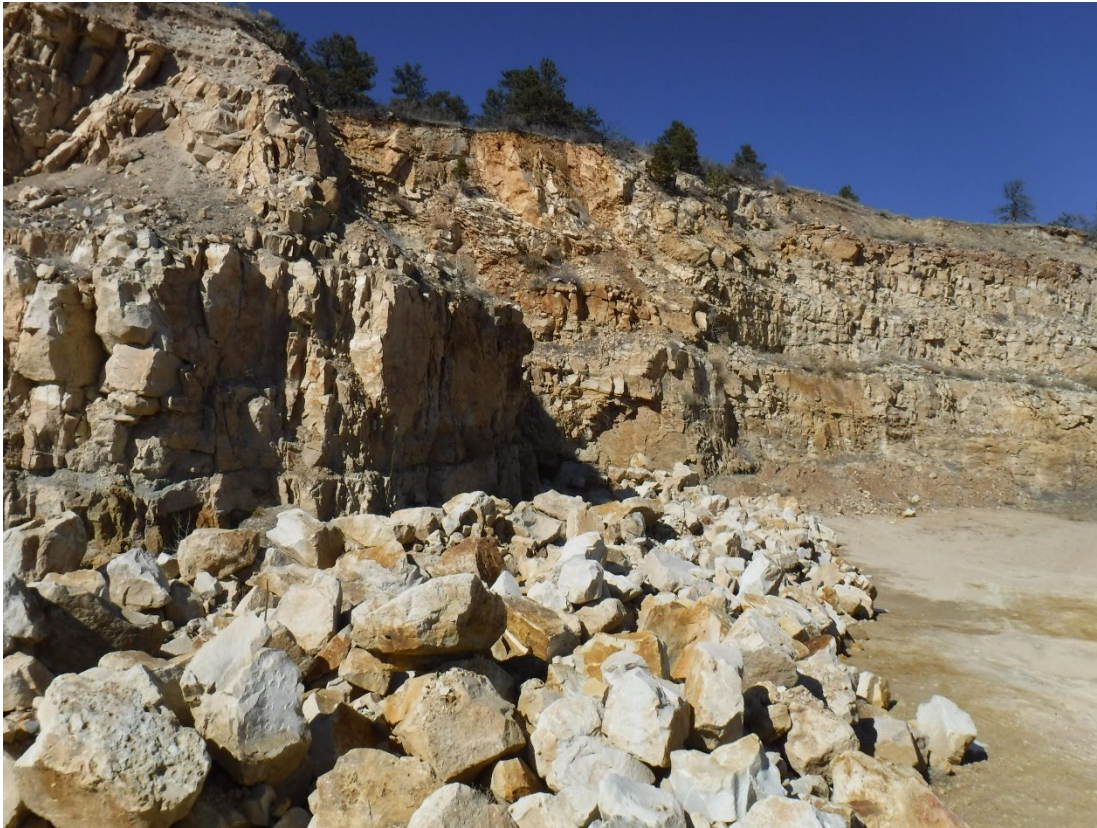
Photo 7: Highwalls along the western boundary of the permit area

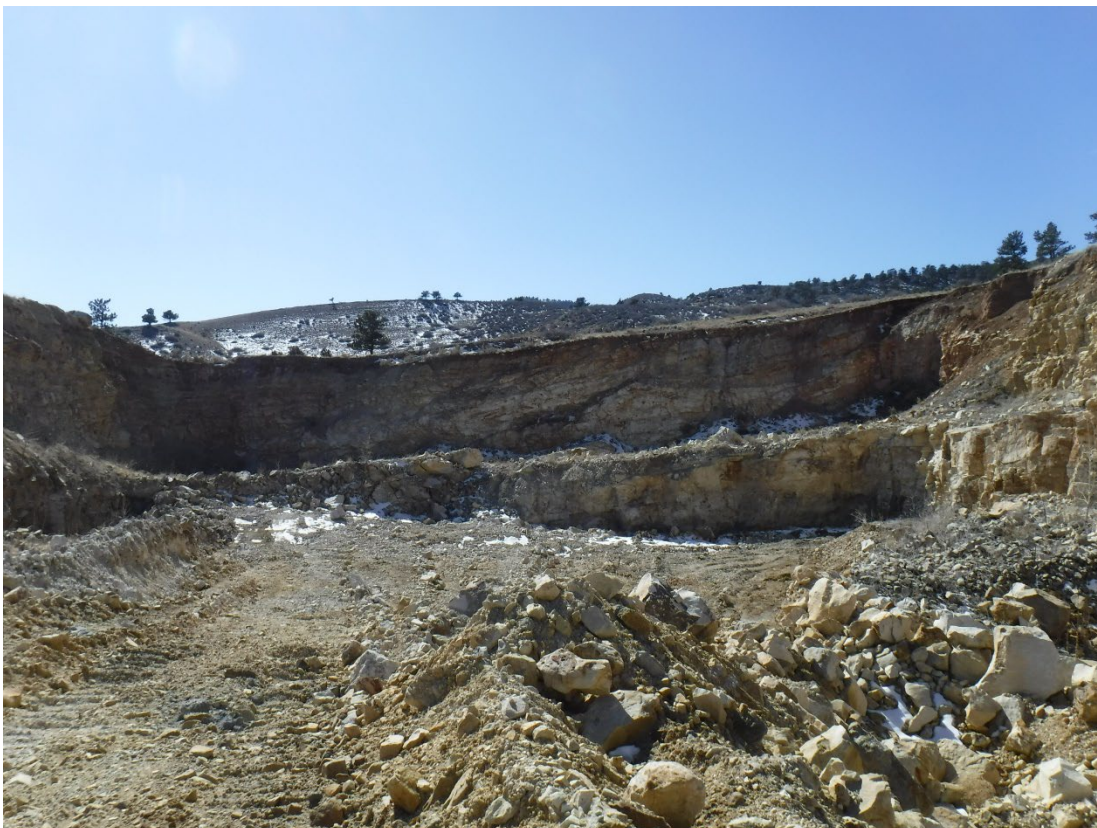
Photo 8: Highwalls along the southern boundary of the permit area
