**Reference: January 2023 Geotechnical Monitoring Summary Pikeview Quarry**

Client/Project  
CONTINENTAL MATERIALS  
CORP.  
PIKEVIEW QUARRY SLOPE  
MONITORING

OBSERVATIONS FROM  
JANUARY INSPECTION

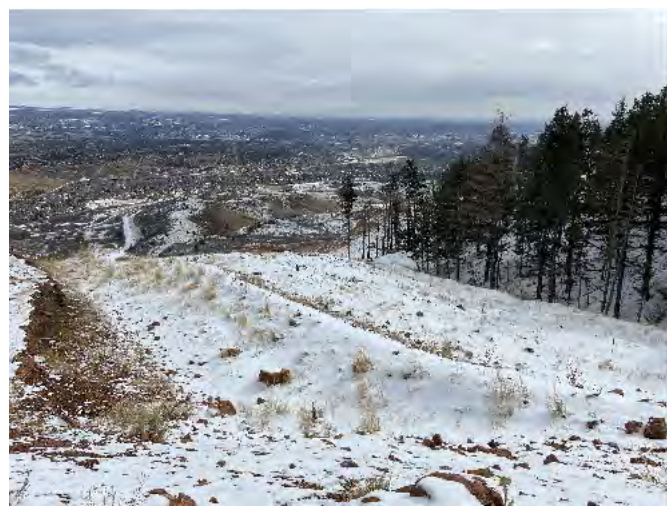
- Known cracks were monitored for changes. Currently the cracks are not growing in any of the areas on the slopes of the site. The hummocky field in the area immediately above the southern extent of the slide shows evidence of cracking, but they are not fresh or active. No new or open cracks were found immediately inside or next to the slide area. (Photo 6)

6. Hummocky area on south end of the site.

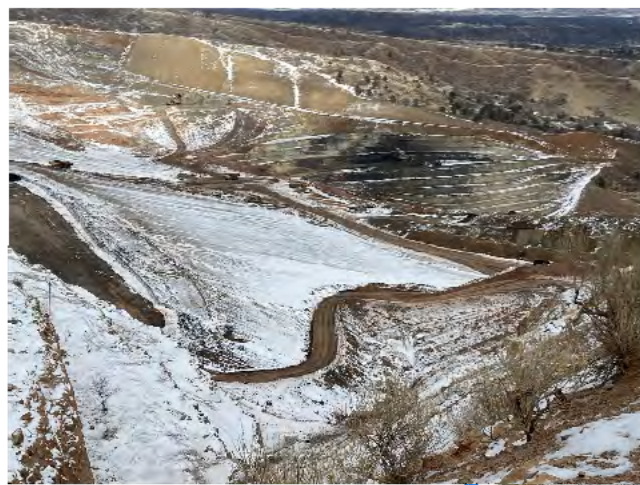
5. NBA benches in the northeast from haul road

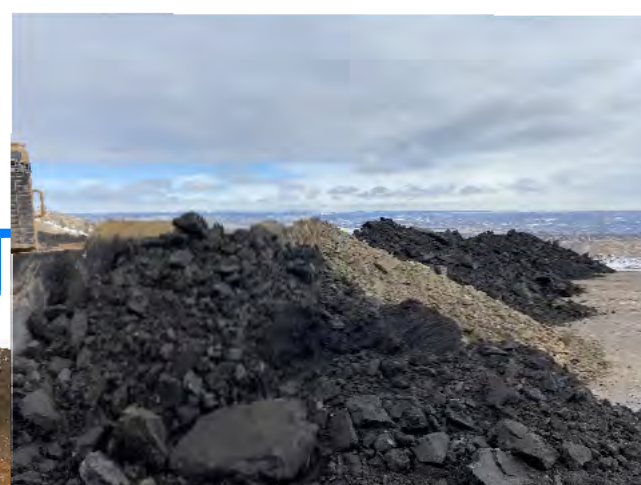
- Compaction testing continues at the rate of at least one test per 5,000 cubic yards of fill placed in the buttress area. (Photos 3 and 4)
- Offsite topsoil was stockpiled at the base of the buttress area with the additional topsoil and growth medium.

4. Material types are mixed before compaction.

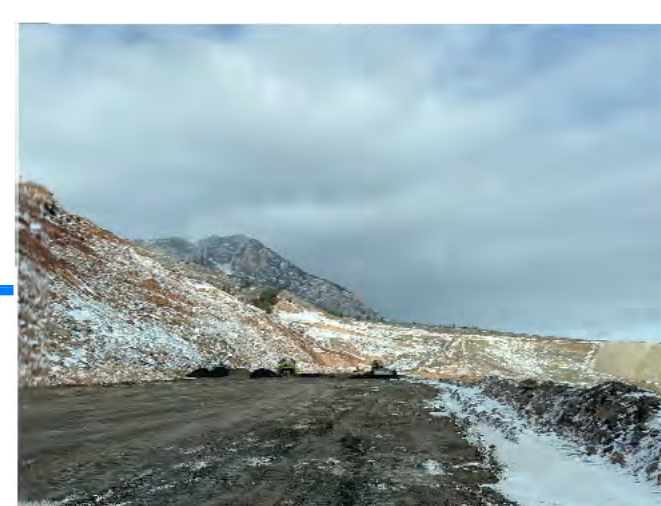
3. View north from compaction area on bench.

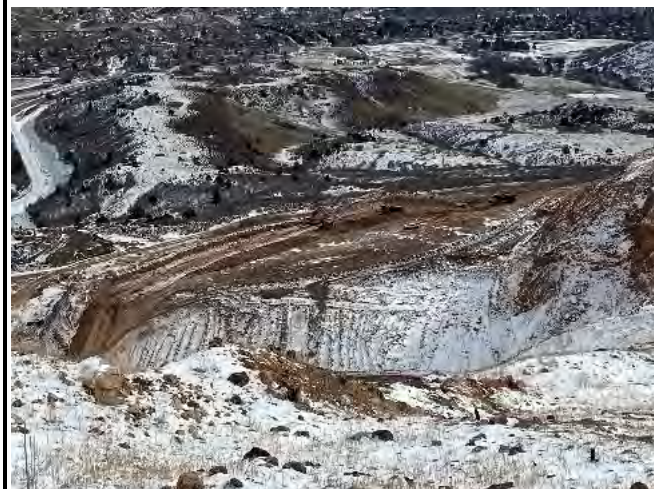
- Material is being excavated from the South Borrow Area and hauled to the bench for spreading and compaction. (Photo 7)
- The culvert remains cleared but mostly blocked inside. CMC has partially cleared the debris, but access limitations and supports within the culvert inhibit clearing all the debris. CMC has procured a pump and will begin pumping operations if any water collects behind the culvert. CMC inspects the culvert for ponded water following rain events, and should any water be observed, it will be removed using pumps. To date, no ponding has been observed.

7. Material is hauled from the SBA

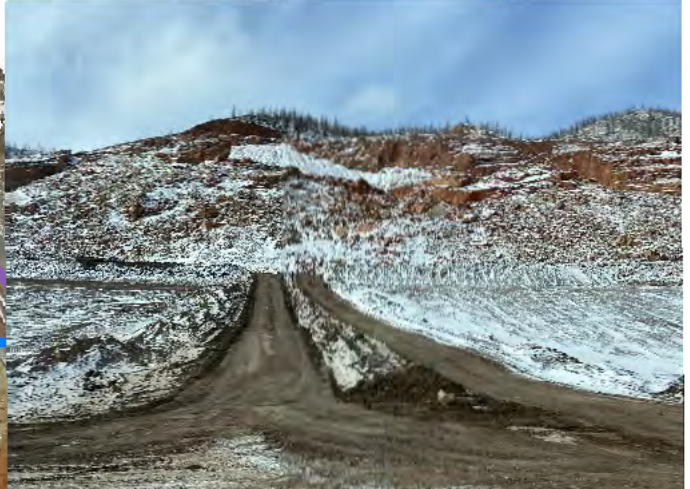
- The slope below the first bench has been placed to the final grade, and this slope was traversed on foot and examined for cracks or signs of instability by Stantec engineers. No cracks or signs of instability were identified. (Photo 2)

2. Haul road leading to bench work area.

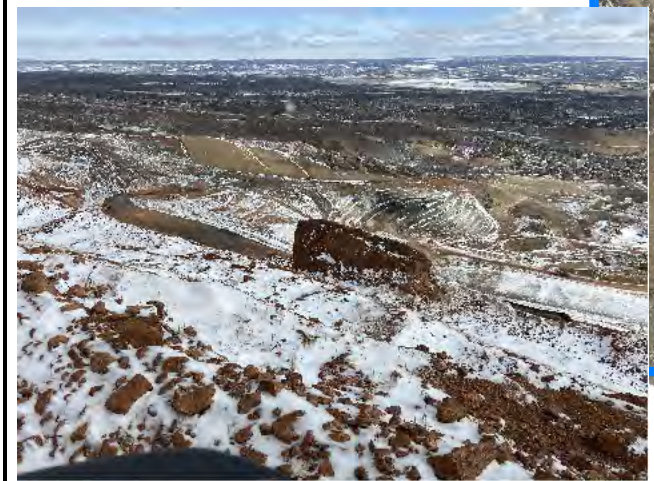
8. View to the north from haul road.

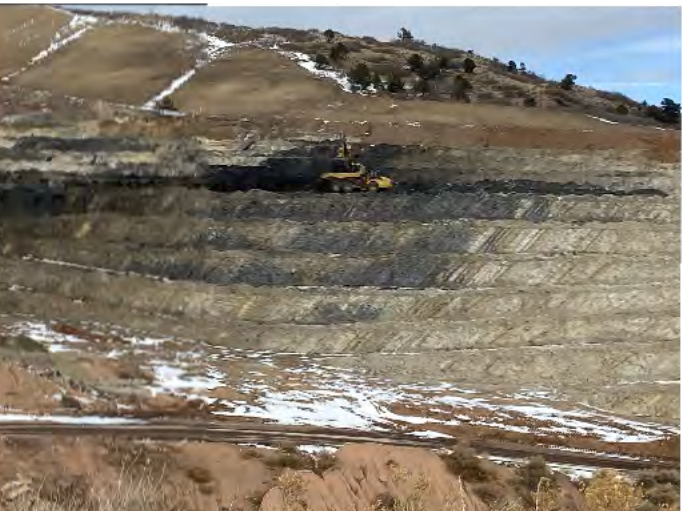
- Operators continue to place compacted material in the buttress zone. Material is excavated from the North and South Borrow Areas. Material is initially excavated in benches for the majority of the excavation to efficiently remove the material; these benches are removed for final grading (Photo 1)

1. Benches in the north borrow area.

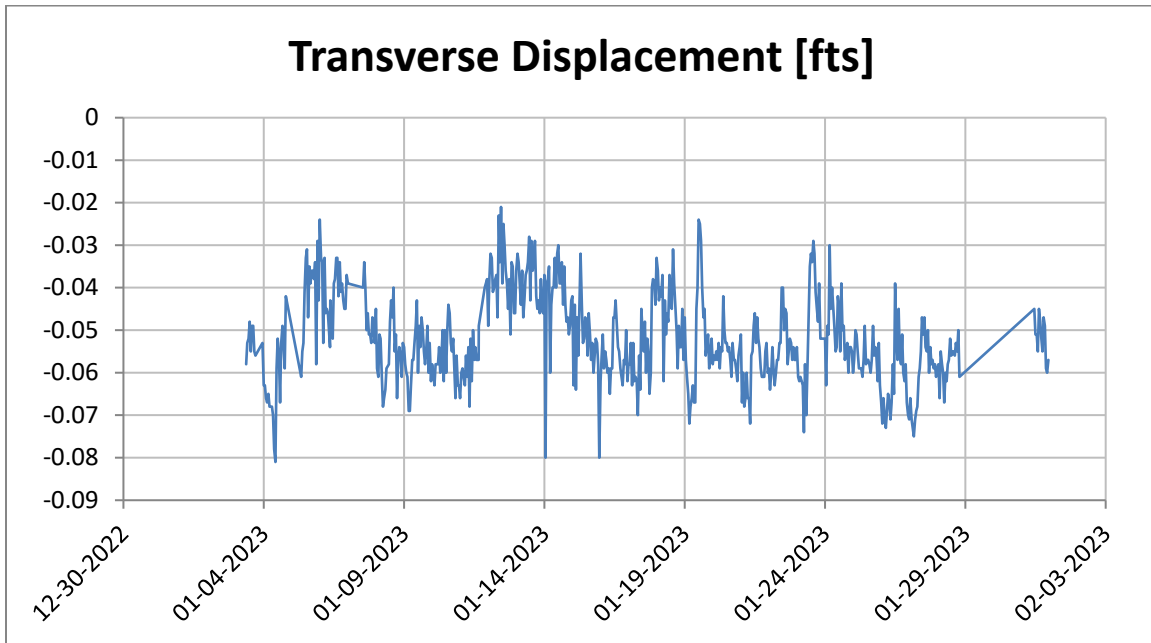
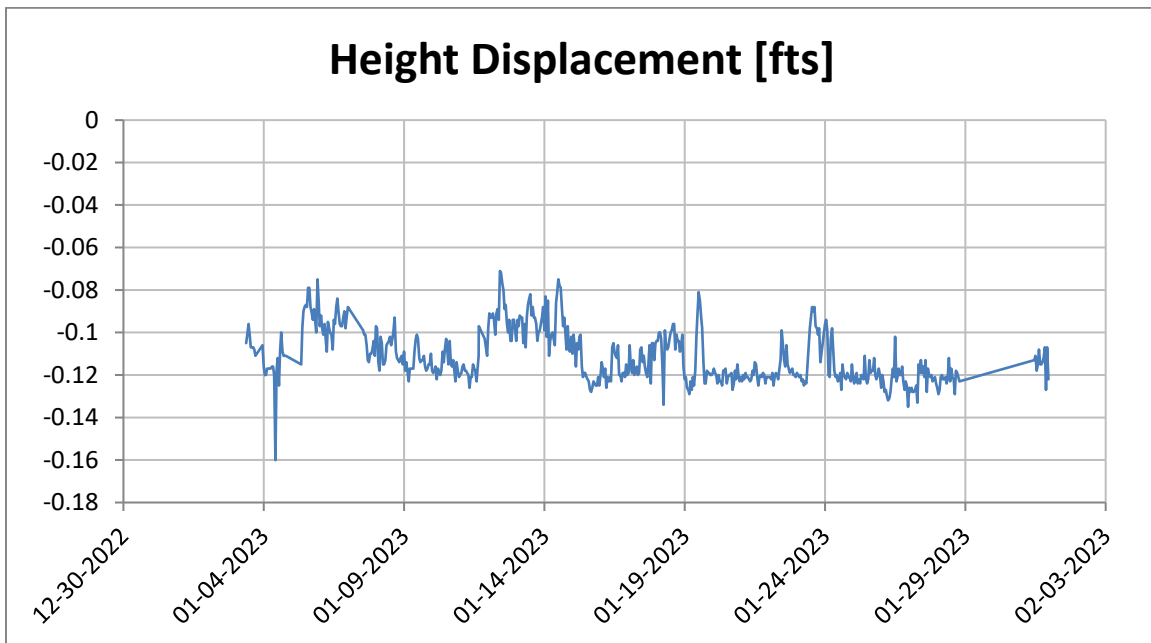
## Prism BR1

| Prism ID | Cumulative Transverse Displacement (ft) | Cumulative Height Displacement (ft) | Monthly Delta (ft) | Cumulative Delta (ft) | Notes / Recommendations |
|---|---|---|---|---|---|
| BR1 | -0.057 | -0.122 | 0.0144 | 0.1935 | Slope creep movements. |

1. Survey accuracy is +/-0.016 feet.
2. Alarm threshold is +/-0.35 feet.
3. Transverse displacement is in the horizontal direction. Positive direction means closer to the robotic station.
4. Height displacement is in the vertical direction. Positive direction means higher in elevation.
5. Prism records slope creep movements with slow velocity.

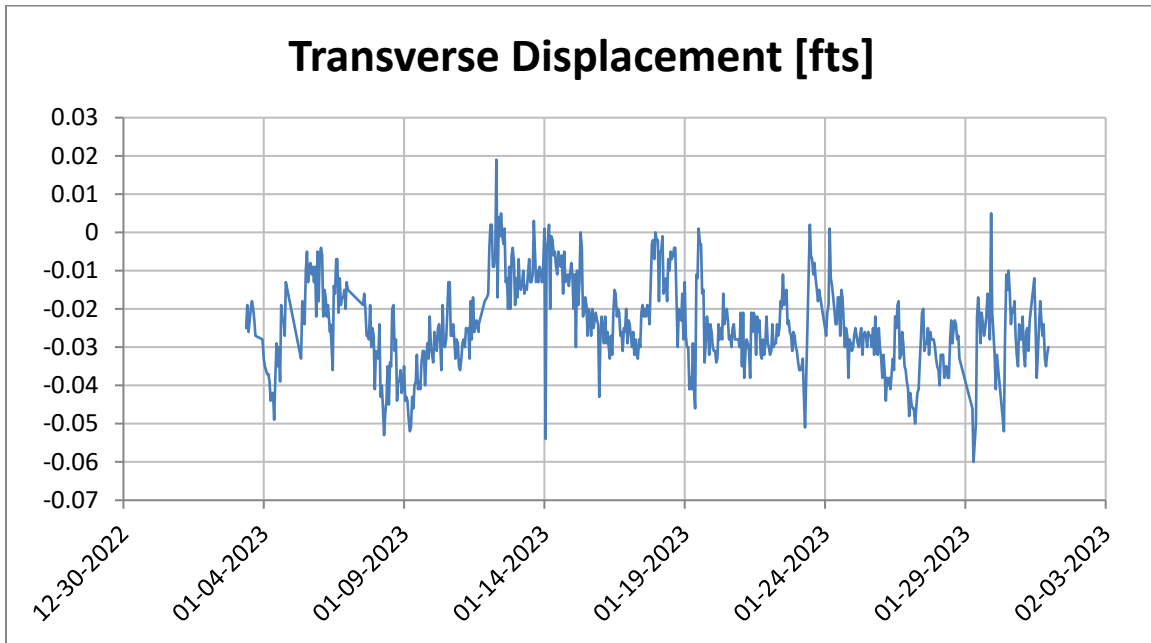
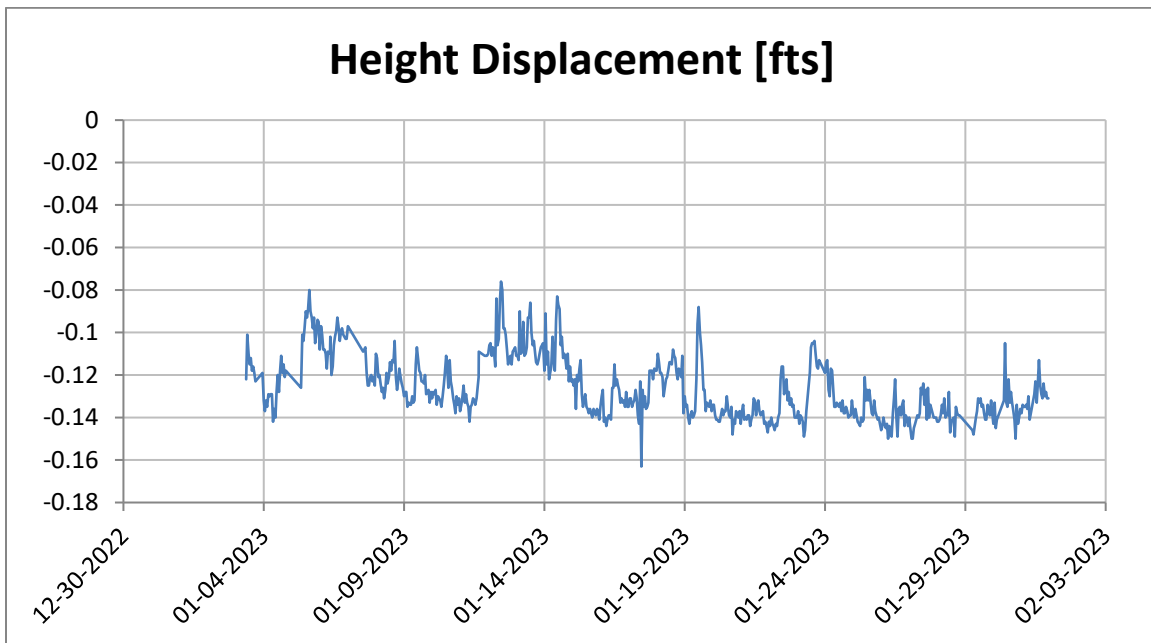
## Prism BR2

| Prism ID | Cumulative Transverse Displacement (ft) | Cumulative Height Displacement (ft) | Monthly Delta (ft) | Cumulative Delta (ft) | Notes / Recommendations |
|---|---|---|---|---|---|
| BR2 | -0.030 | -0.131 | 0.0062 | 0.2082 | Slope creep movements. |

1. Survey accuracy is  $\pm 0.016$  feet.
2. Alarm threshold is  $\pm 0.35$  feet.
3. Transverse displacement is in the horizontal direction. Positive direction means closer to the robotic station.
4. Height displacement is in the vertical direction. Positive direction means higher in elevation.
5. Prism records slope creep movements with slow velocity.

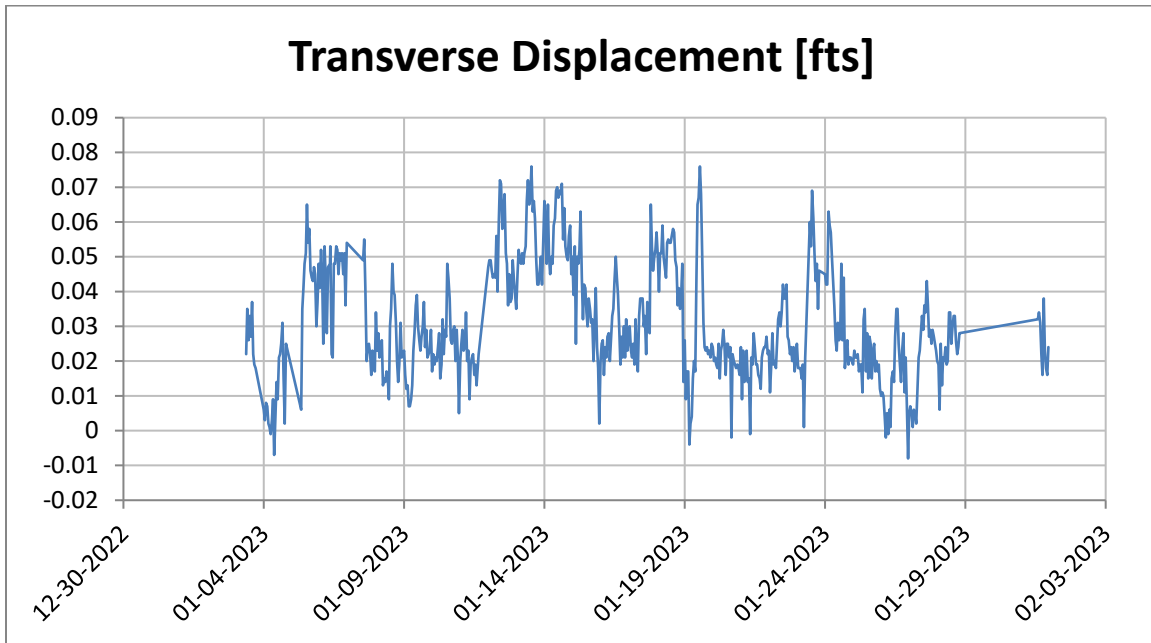
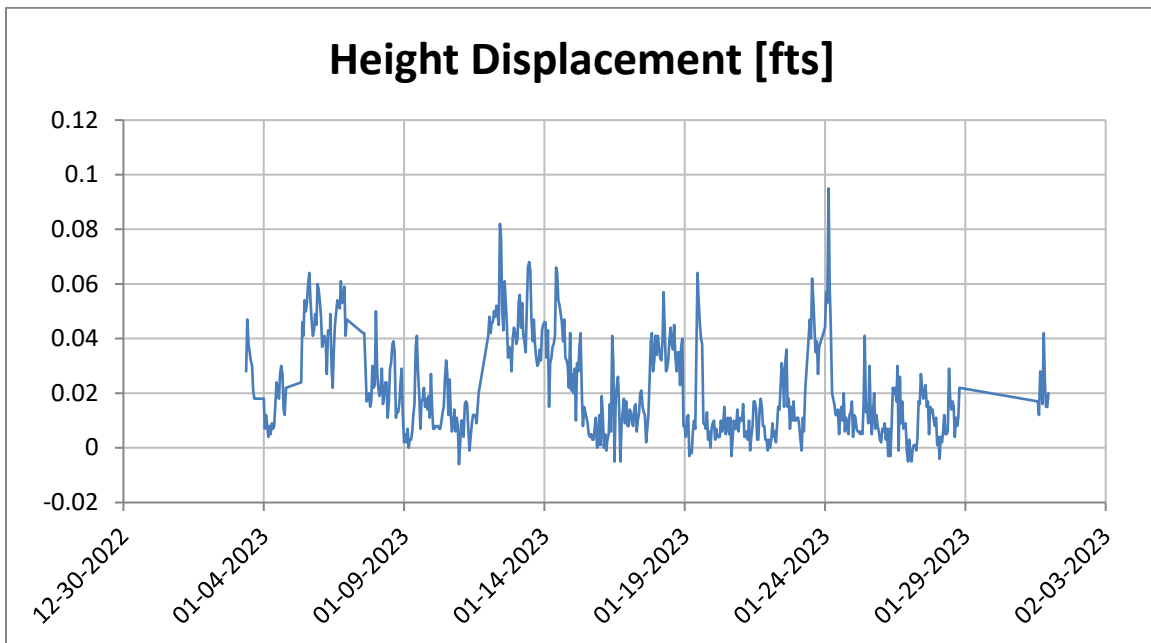
## Prism NP2

1. Survey accuracy is  $\pm 0.016$  feet.
2. Alarm threshold is  $\pm 0.35$  feet.
3. Transverse displacement is in the horizontal direction. Positive direction means closer to the robotic station.
4. Height displacement is in the vertical direction. Positive direction means higher in elevation.
5. Exceedance alerts were received on 1/16 and 1/19.

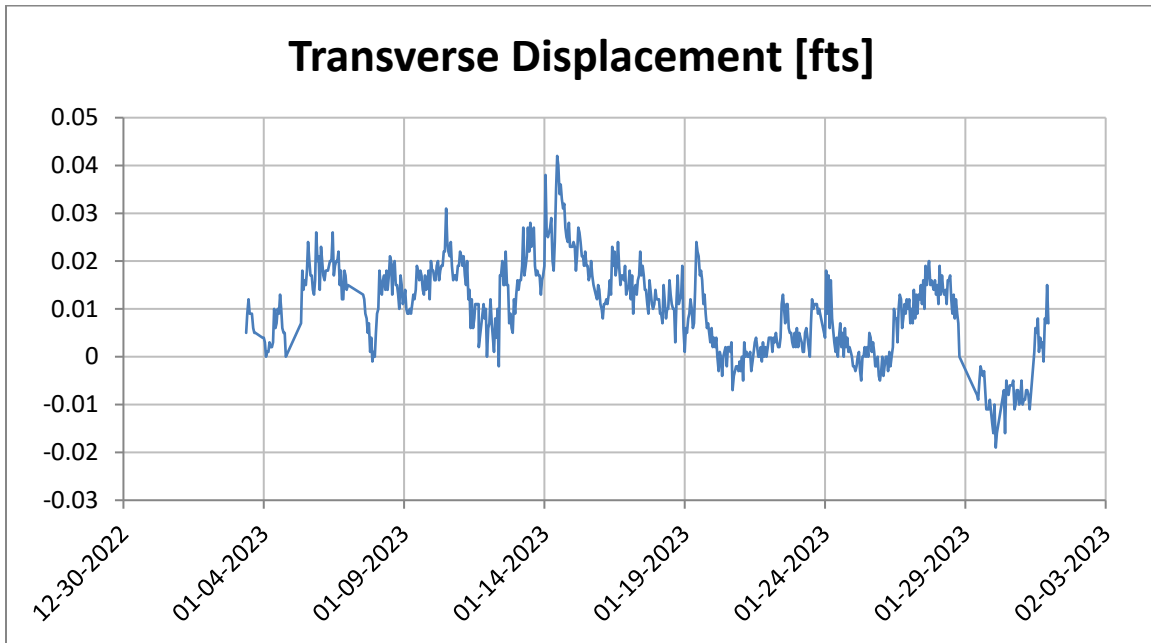
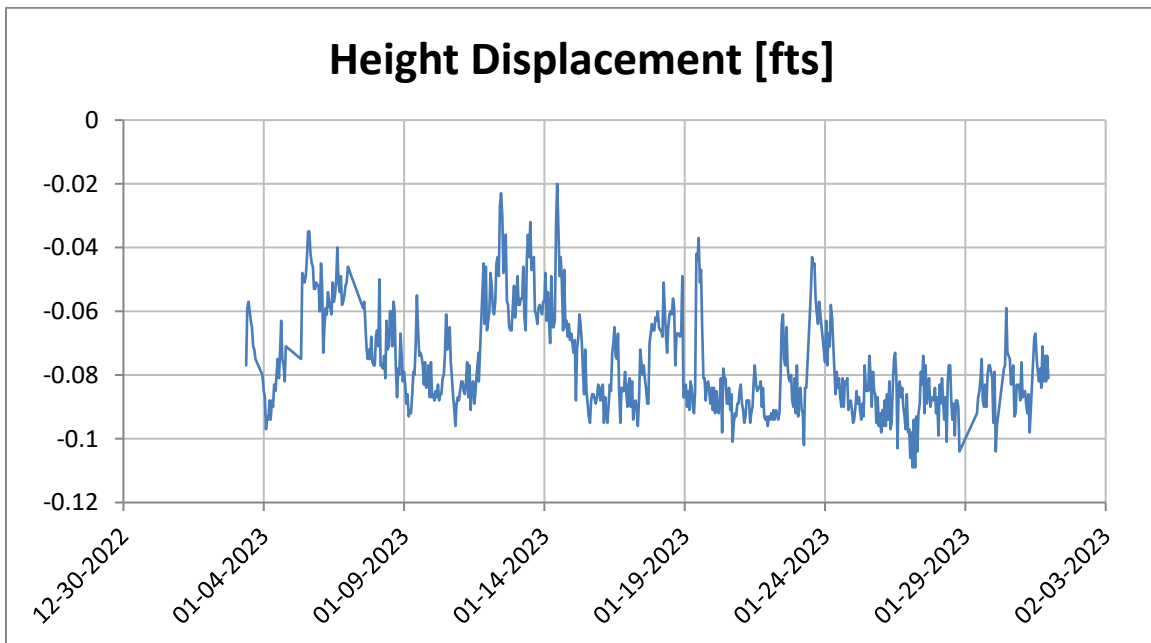
## Prism NP66

| Prism ID | Cumulative Transverse Displacement (ft) | Cumulative Height Displacement (ft) | Monthly Delta (ft) | Cumulative Delta (ft) | Notes / Recommendations |
|---|---|---|---|---|---|
| NP66 | 0.007 | -0.081 | 0.0067 | 0.0971 | Slope creep movements. |

1. Survey accuracy is  $\pm 0.016$  feet.
2. Alarm threshold is  $\pm 0.35$  feet.
3. Transverse displacement is in the horizontal direction. Positive direction means closer to the robotic station.
4. Height displacement is in the vertical direction. Positive direction means higher in elevation.
5. Prism records slope creep movements with slow velocity.

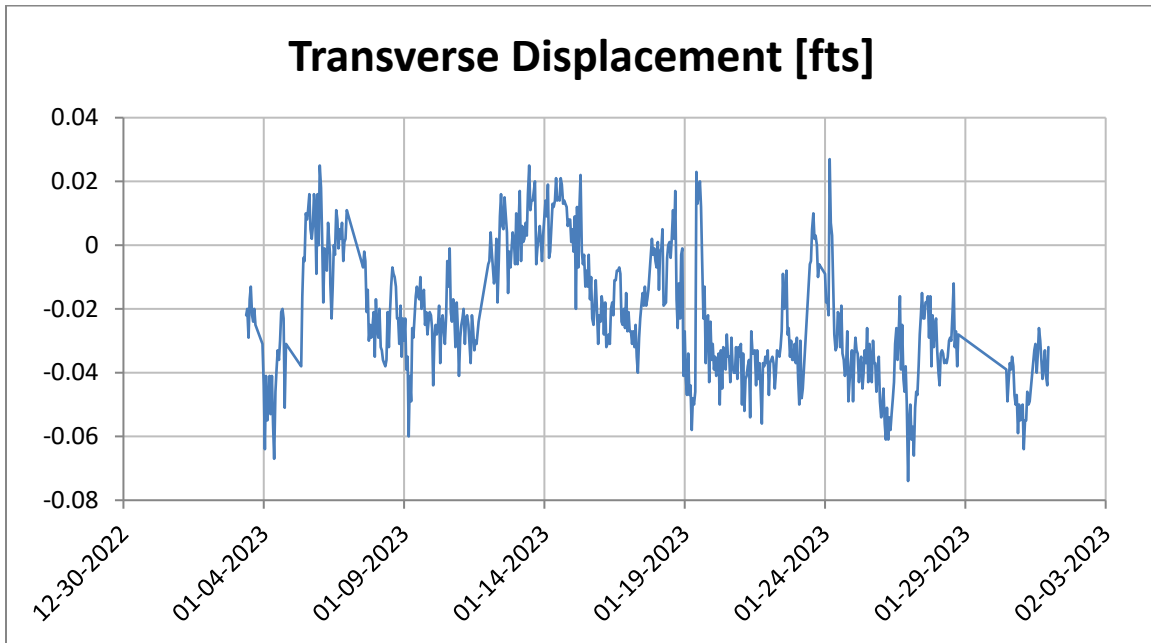
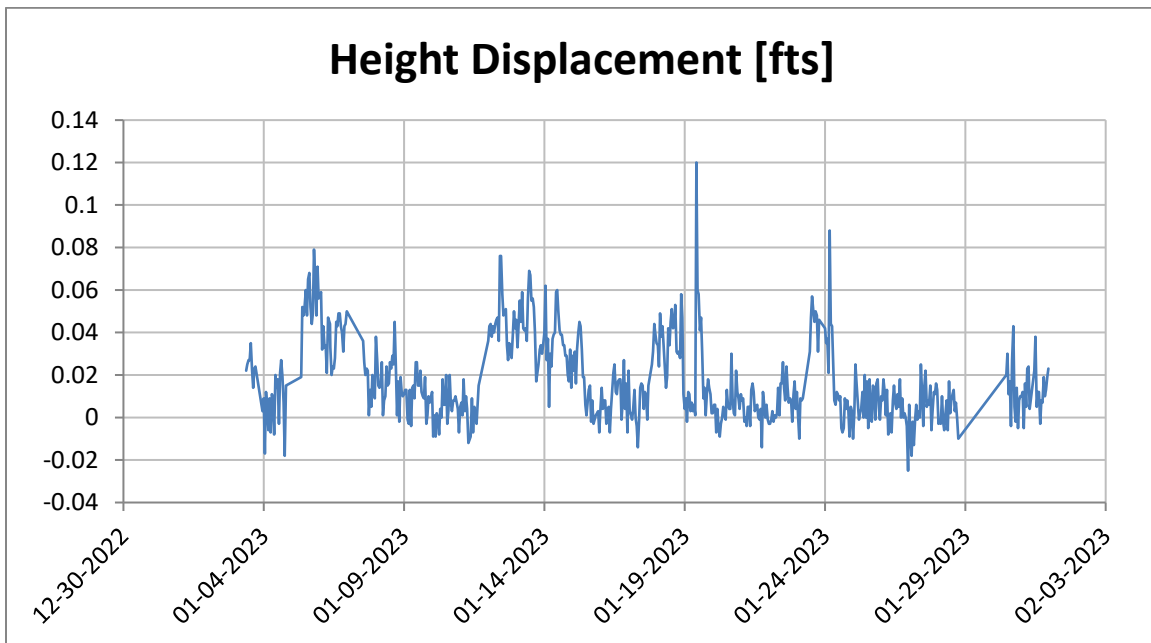
## Prism P32

1. Survey accuracy is +/-0.016 feet.
2. Alarm threshold is +/-0.35 feet.
3. Transverse displacement is in the horizontal direction. Positive direction means closer to the robotic station.
4. Height displacement is in the vertical direction. Positive direction means higher in elevation.
5. Exceedance alerts were received on 1/19.

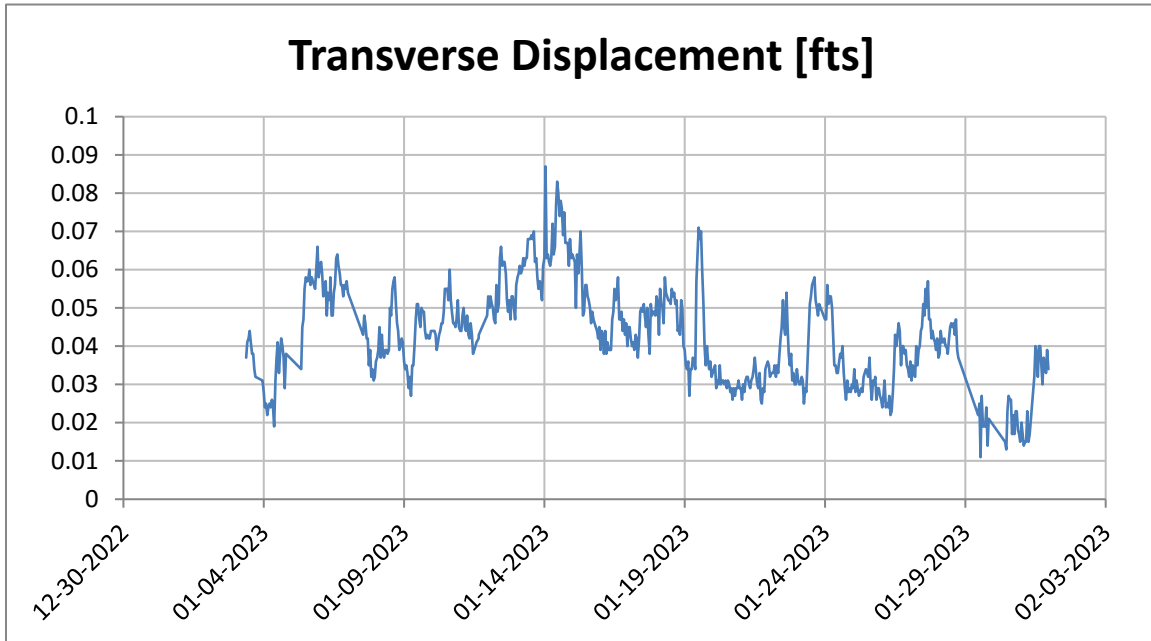
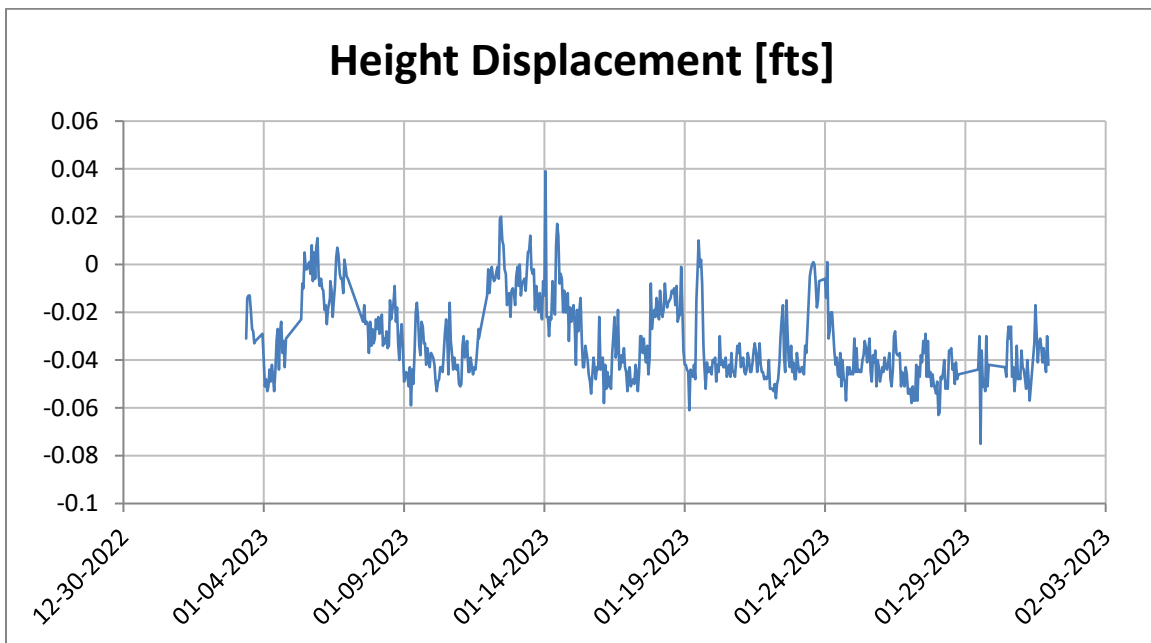
## Prism P69A

1. Survey accuracy is  $\pm 0.016$  feet.
2. Alarm threshold is  $\pm 0.35$  feet.
3. Transverse displacement is in the horizontal direction. Positive direction means closer to the robotic station.
4. Height displacement is in the vertical direction. Positive direction means higher in elevation.
5. Exceedance alerts were received on 1/19.
