**COLORADO****Division of Reclamation,  
Mining and Safety**

**PERMIT INFORMATION**

<b>Permit Number:</b> C-1981-012 <b>Mine Name:</b> New Elk Mine <b>Operator:</b> New Elk Coal Company, LLC <b>Operator Address:</b> Mr. Mark Gray 12250 Highway 12 Weston, CO 81091	<b>County:</b> Las Animas <b>Operation Type:</b> Underground <b>Permit Status:</b> Active <b>Ownership:</b> Private
	<b>Operator Representative Present:</b>  Nick Mason
<b>Operator Representative Signature: (Field Issuance Only)</b>

<b>Inspection Start Date:</b> February 23, 2023 <b>Inspection Start Time:</b> 11:00 <b>Inspection End Date:</b> February 23, 2023 <b>Inspection End Time:</b> 14:30		<b>Inspection Type:</b> Coal Complete Inspection <b>Inspection Reason:</b> Normal I&E Program <b>Weather:</b> Cloudy	
<b>Joint Inspection Agency:</b>  None		<b>Joint Inspection Contacts:</b>  	
<b>Post Inspection Agency:</b>  None		<b>Post Inspection Contacts:</b>  	
<b>Inspector(s):</b>  Brock Bowles	<b>Inspector's Signature:</b>

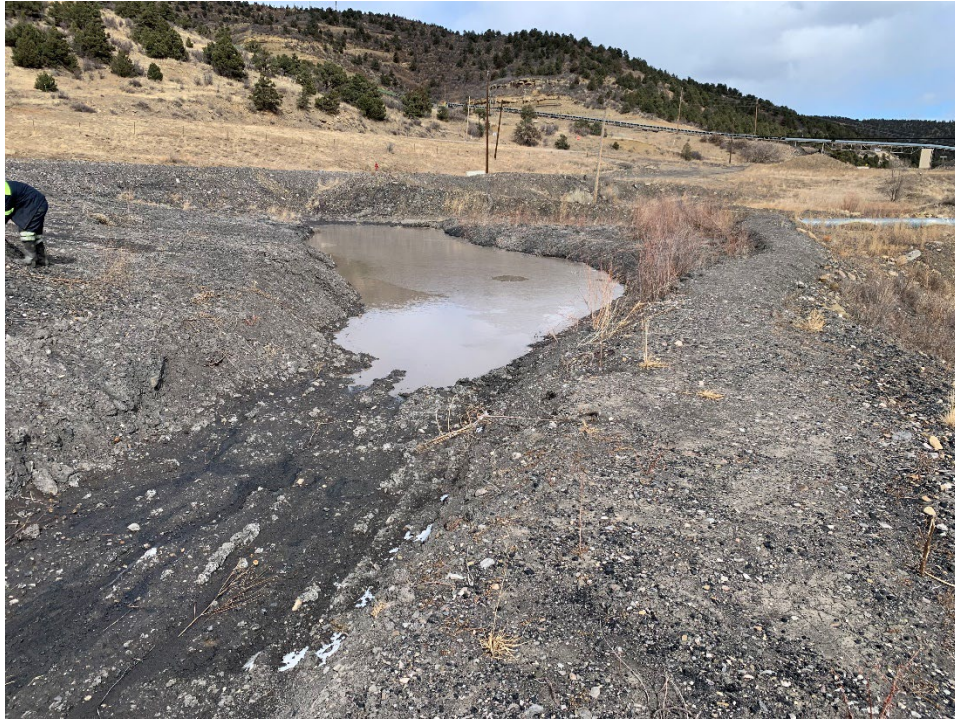
The DWDA #2 appeared to be stable. The length of ditch D14 was inspected and was in good condition. Some water was contained in the catchment basin on the east side (photo 1).

Photo 1 – DWDA #2 catchment on east side

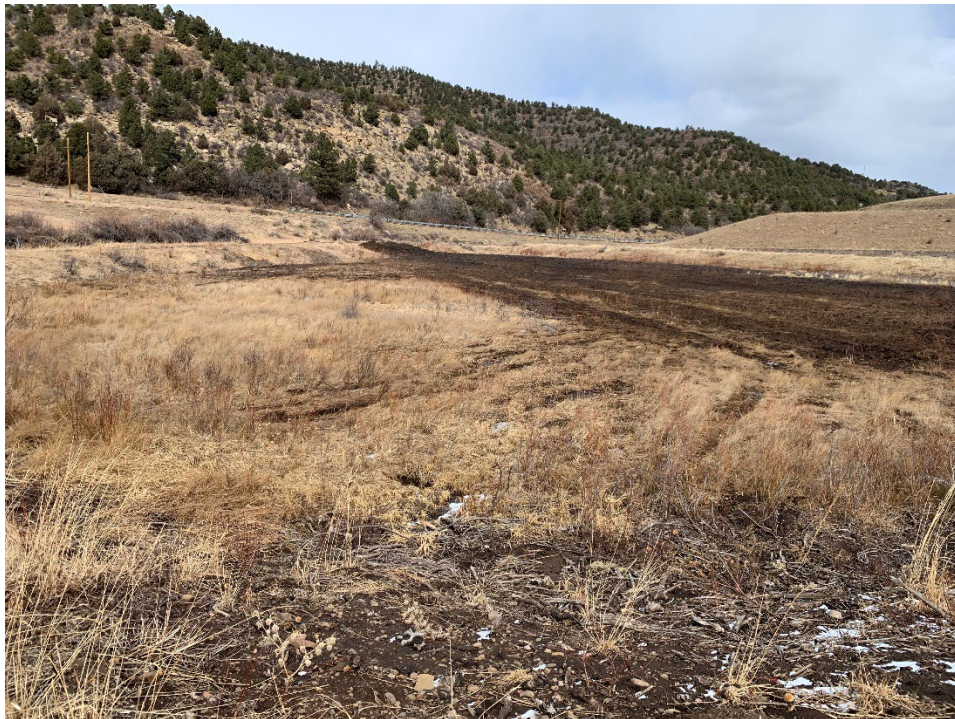
Pond 4 did not contain water and the discharge structures were clear of obstructions. Some of the vegetation was cleaned from the bottom of the pond (photo 2). The embankment was inspected. It was well vegetated with grasses and appeared to be stable. There were no signs of animal burrows or erosion.

Photo 2 – Pond 4 had some willows and vegetation removed

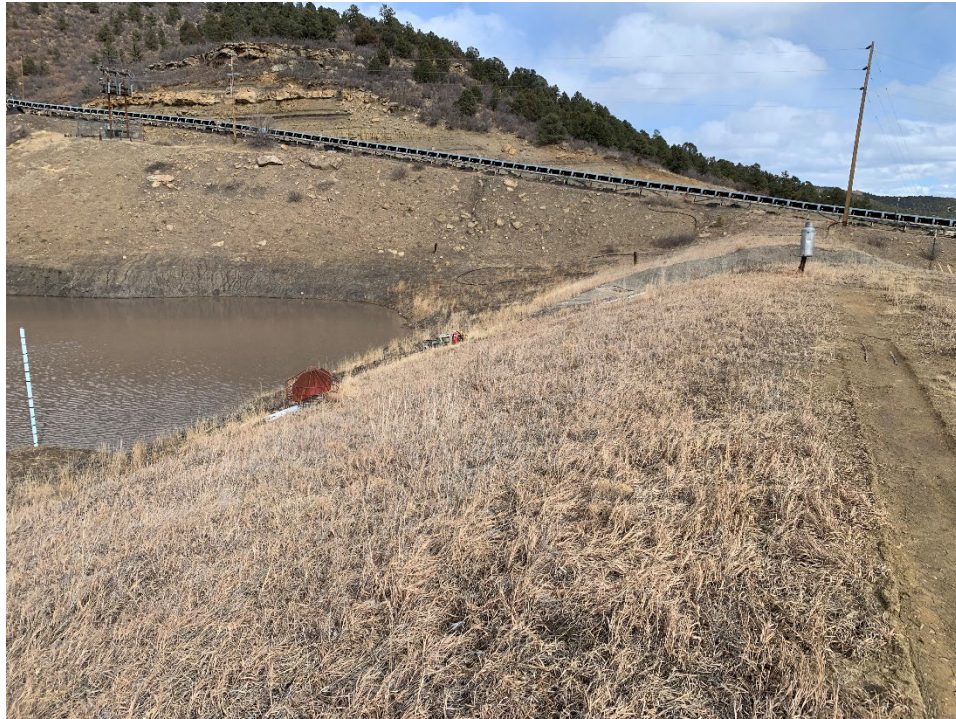
Pond 8 contained water but was not discharging (photo 3). The spillways were free and clear of obstructions.

Photo 3 – Pond 8 and embankment facing east

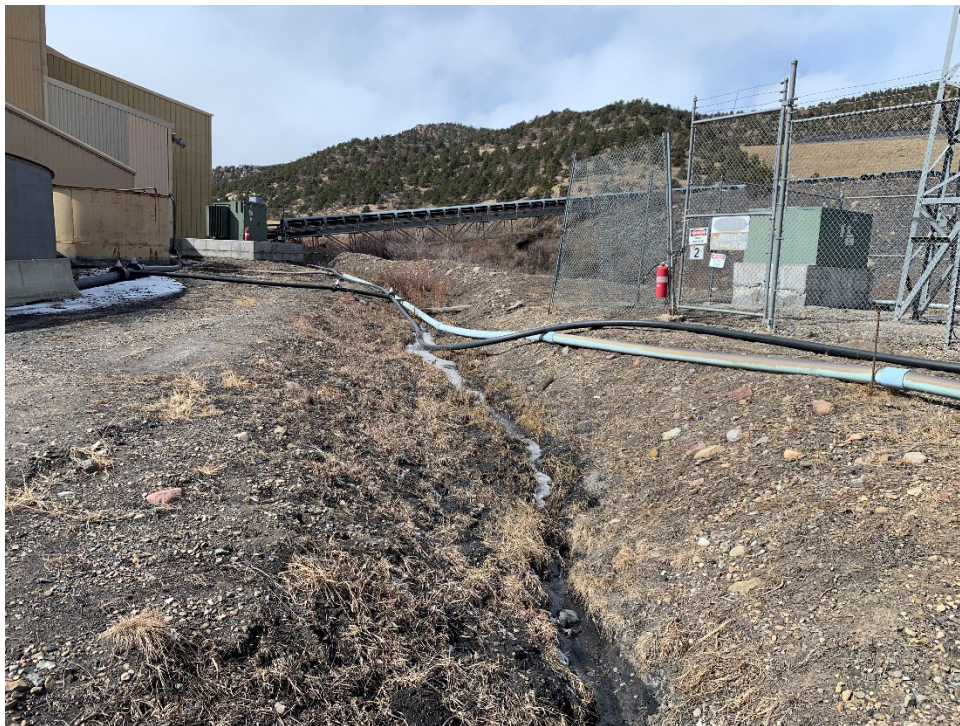
Ditches 32A and 32B around the prep plant were in working order (photo 4).

Photo 4 – Ditch 32A by prep plant

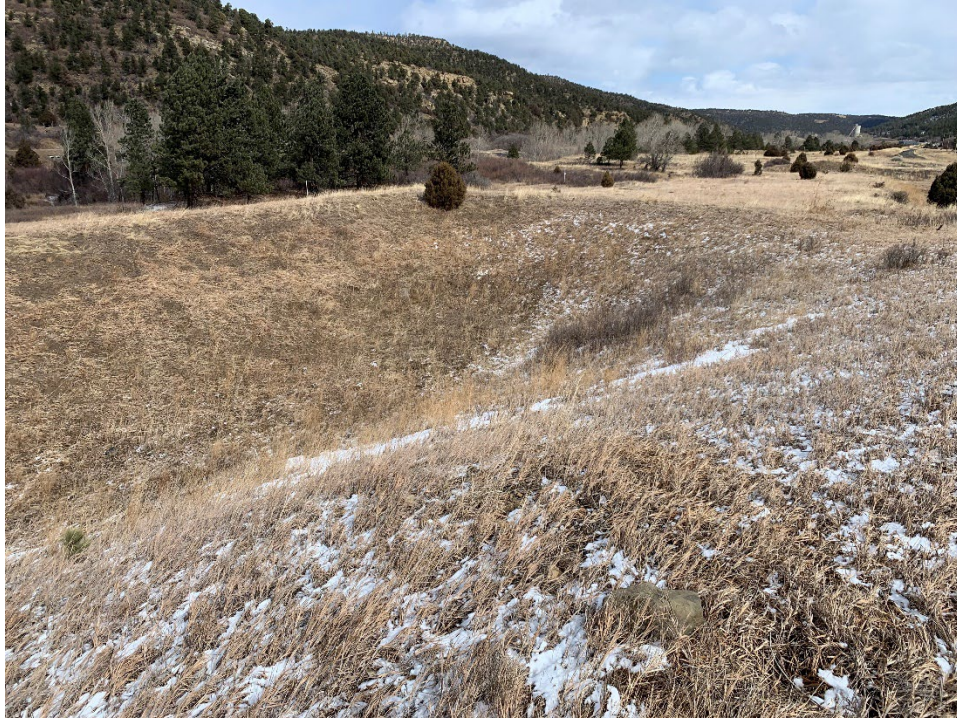
Containment 2 did not contain water (photo 5). It was well vegetated and appeared to be stable.

Photo 5 – Containment 2

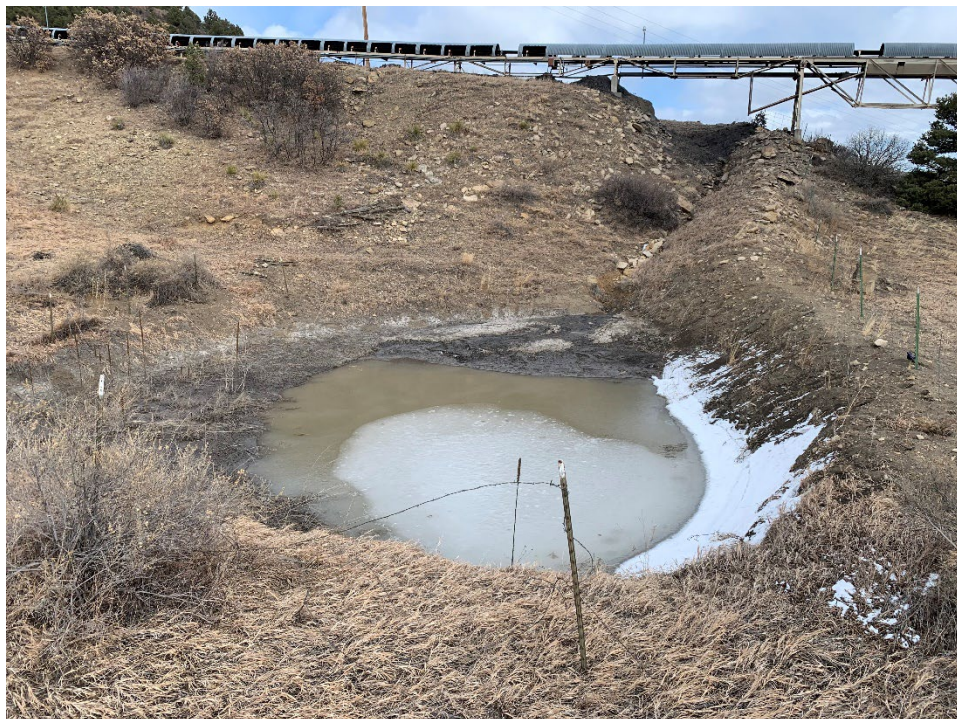
Containment 5 had some water and ice (photo 6).

Photo 6 – Containment 5

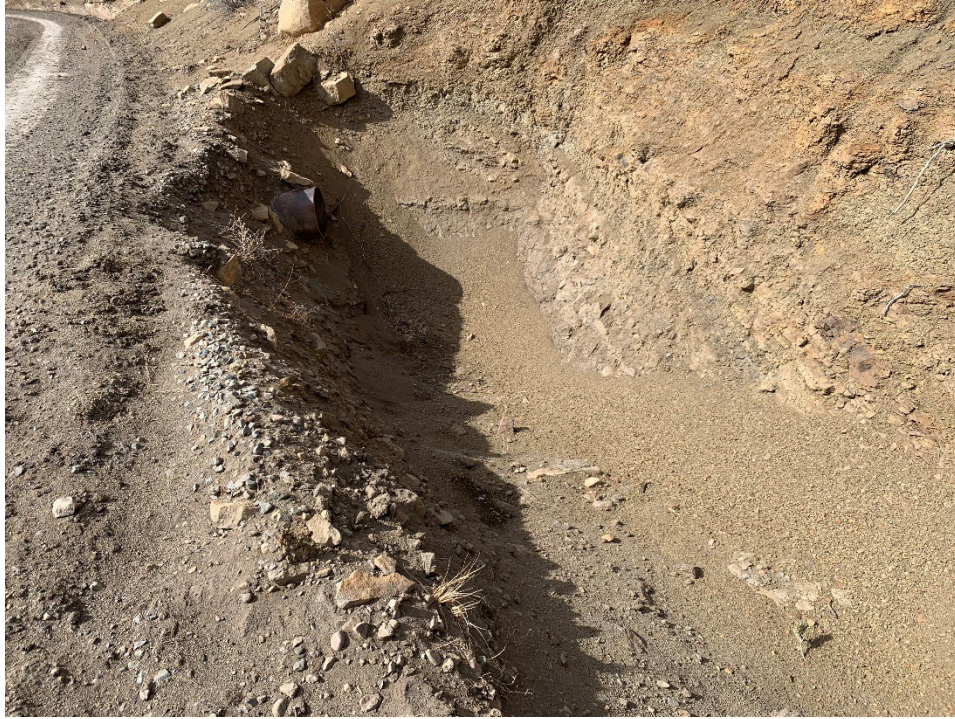
The catchment basins along the RDA haul road did not contain water and were clean (photo 7).

Photo 7 – Catchment basin along RDA haul road
