**PERMIT INFORMATION**

**INSPECTION INFORMATION**

**EXCESS SPOIL and DEVELOPMENT WASTE – Rule 4.09**

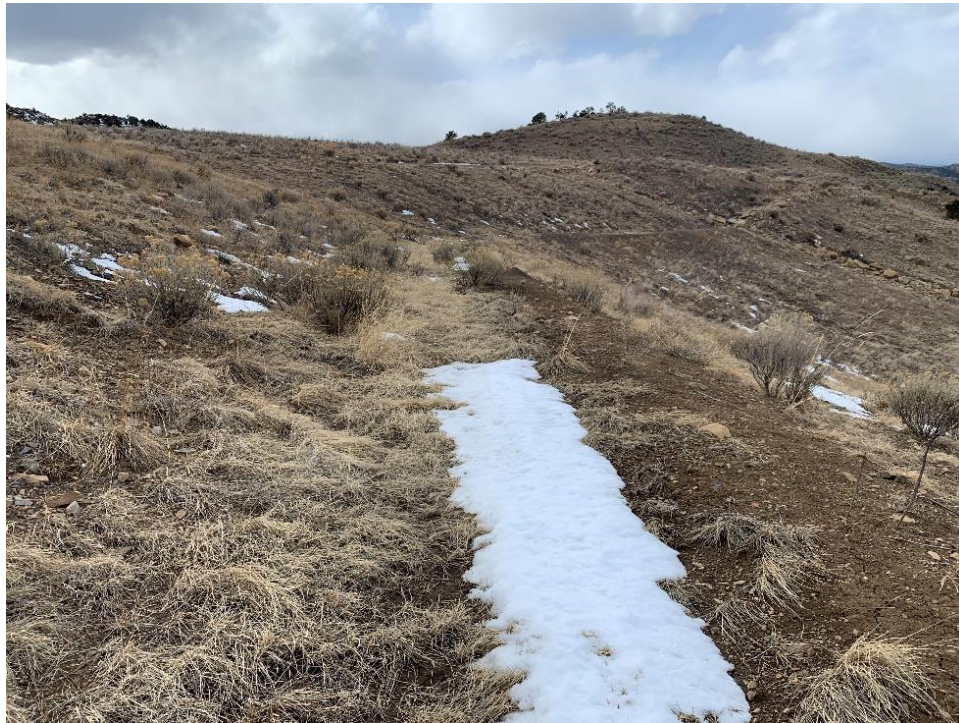
Top level and first contour ditch (top) were walked. The ground was damp and soft with patchy snow. No water puddles, rills or signs of erosion were seen. The vegetation was winter dormant and well established with a mixture of grasses and shrubs (photo 1).

Photo 1 – Fill 8, top contour ditch facing west

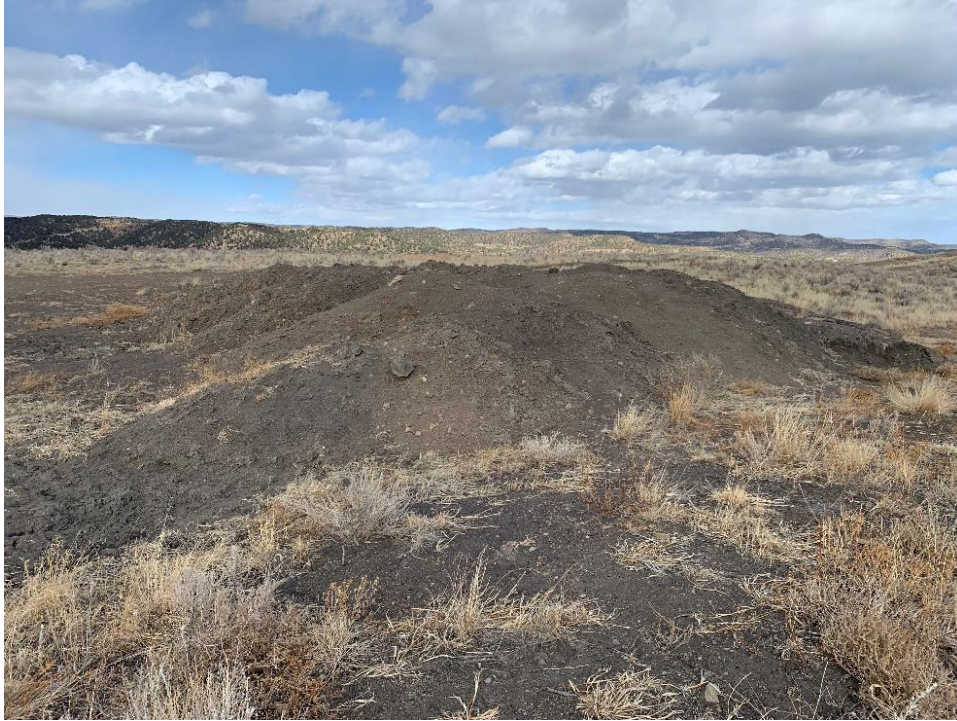
The sediment drying area above Fill 8 contained several loads of sediment. No erosion was seen and the sediment appeared stable in this location (photo 2).

Photo 2 – Sediment drying area above Fill 8

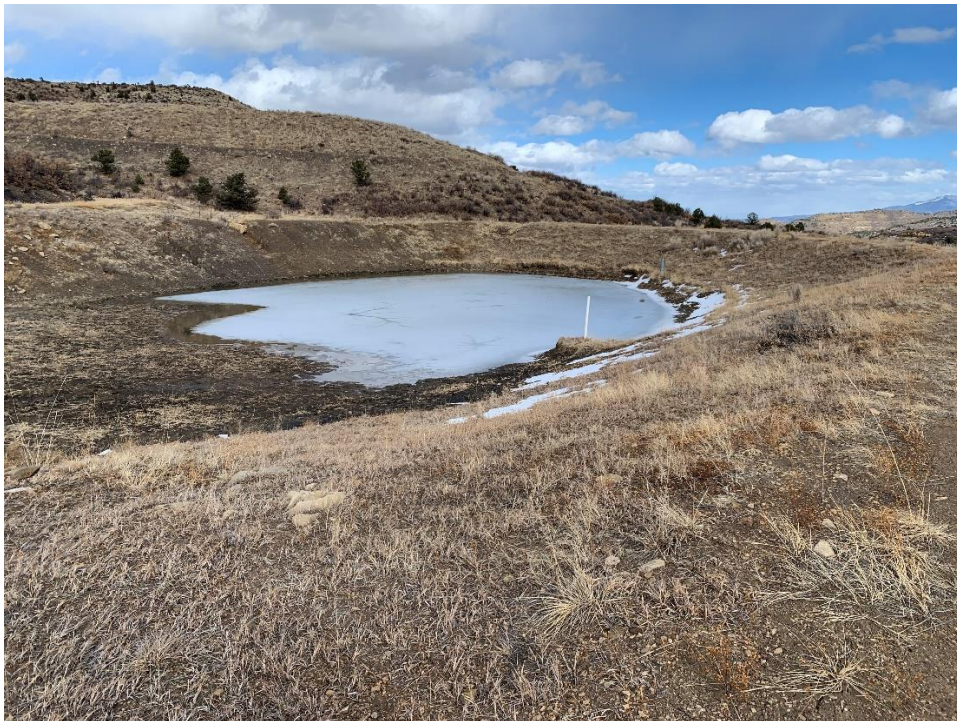
Photo 3 – Pond 6

Pond 6 contained water and some ice (photo 3). The water level was well below the discharge level. The embankment appeared stable.

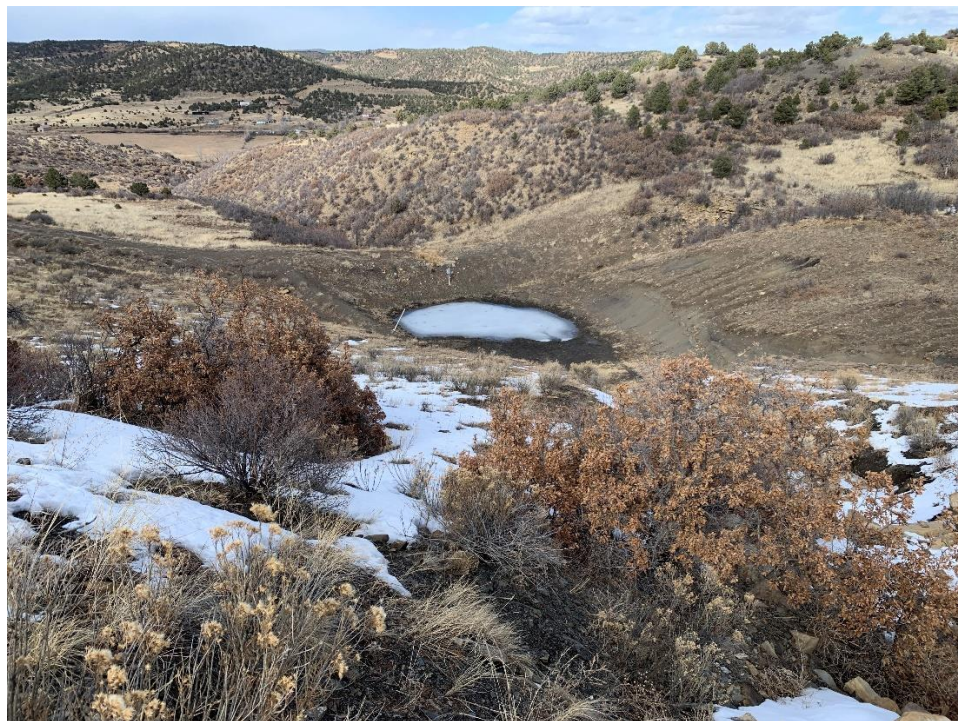
Pond 9 contained ice and was well below the discharge level as viewed from the road above the pond (photo 4). The access road to the pond was snowy and muddy making it inaccessible.

Pond 9 – Viewed from the access road south of pond
