**MINERALS PROGRAM INSPECTION REPORT**  
**PHONE: (303) 866-3567**

<b>MINE NAME:</b> Deer Creek Quarry	<b>MINE/PROSPECTING ID#:</b> M-1997-014	<b>MINERAL:</b> Granite, gneiss, crushed stone	<b>COUNTY:</b> Jefferson
<b>INSPECTION TYPE:</b> Surety-Related Inspection	<b>WEATHER:</b> Cloudy	<b>INSP. DATE:</b> March 1, 2023	<b>INSP. TIME:</b> 08:30
<b>OPERATOR:</b> Aggregate Industries - WCR, Inc.	<b>OPERATOR REPRESENTATIVE:</b> Jessica Walker	<b>TYPE OF OPERATION:</b> 112c - Construction Regular Operation	
<b>REASON FOR INSPECTION:</b> Surety Related	<b>BOND CALCULATION TYPE:</b>	<b>BOND AMOUNT:</b> \$334,400.00	
<b>DATE OF COMPLAINT:</b> NA	<b>POST INSP. CONTACTS:</b> None	<b>JOINT INSP. AGENCY:</b> None	
<b>INSPECTOR(S):</b> Eric Scott	<b>INSPECTOR'S SIGNATURE:</b>

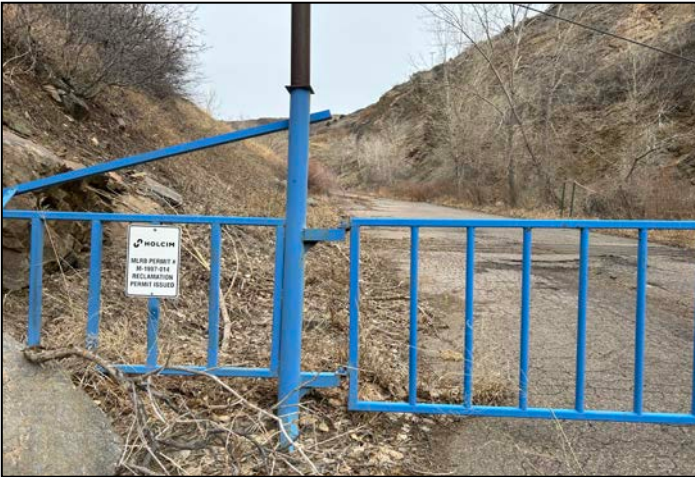
**Photo 1 – Locked access gate and site ID sign at entrance from Deer Creek Road.**

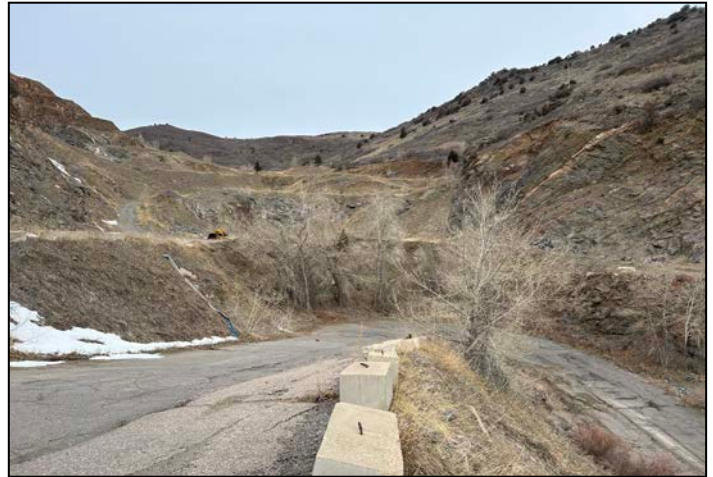
**Photo 2 – Looking north into mined area from site access road.**

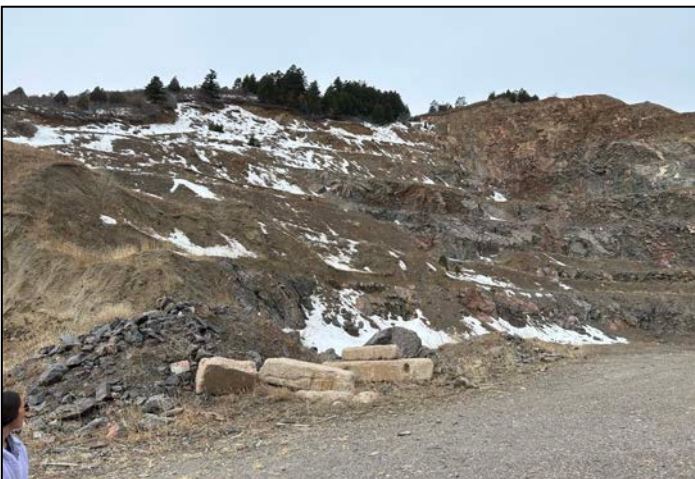
As shown in Photos 3 and 4, the benched mine face area remains largely stable. Only minor localized raveling/sliding was noted and this was being fully contained by the existing benches.

**Photo 3 – Looking west at benched mine face.**

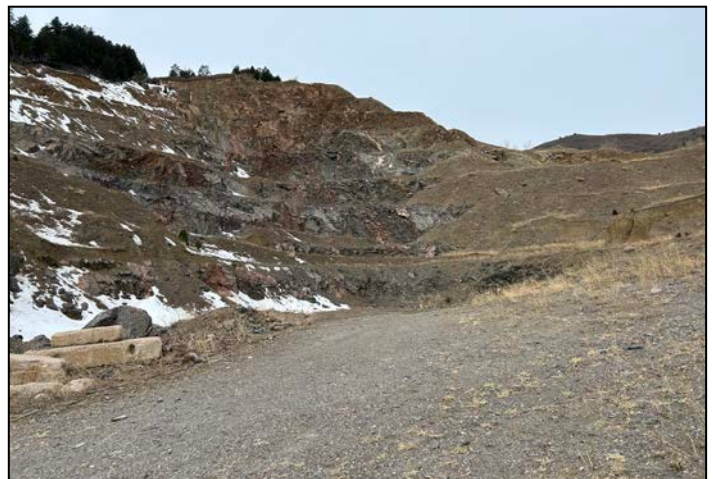
**Photo 4 – Looking northwest at benched mine face.**

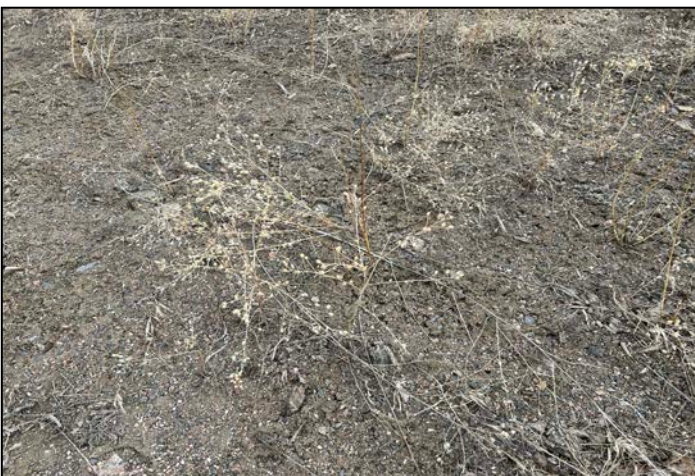
**Photo 5 - Knapweed observed on-site at base of active face area. Holcim will need to conduct weed control activity at this site.**

Holcim will need to continue with site maintenance, erosion control, and weed control activity (knapweed observed on site – Photo 5) despite the low level of mining activity taking place at this permit.
