**MINERALS PROGRAM INSPECTION REPORT**  
**PHONE: (303) 866-3567**

<b>MINE NAME:</b> Morrison Quarry	<b>MINE/PROSPECTING ID#:</b> M-1973-021	<b>MINERAL:</b> Granite, gneiss	<b>COUNTY:</b> Jefferson
<b>INSPECTION TYPE:</b> Surety-Related Inspection	<b>WEATHER:</b> Cloudy	<b>INSP. DATE:</b> March 1, 2023	<b>INSP. TIME:</b> 09:30
<b>OPERATOR:</b> Aggregate Industries - WCR, Inc.	<b>OPERATOR REPRESENTATIVE:</b> Jessica Walker	<b>TYPE OF OPERATION:</b> 112c - Construction Regular Operation	
<b>REASON FOR INSPECTION:</b> Surety Related	<b>BOND CALCULATION TYPE:</b>	<b>BOND AMOUNT:</b> \$7,847,335.00	
<b>DATE OF COMPLAINT:</b> NA	<b>POST INSP. CONTACTS:</b> None	<b>JOINT INSP. AGENCY:</b> None	
<b>INSPECTOR(S):</b> Eric Scott	<b>INSPECTOR'S SIGNATURE:</b>

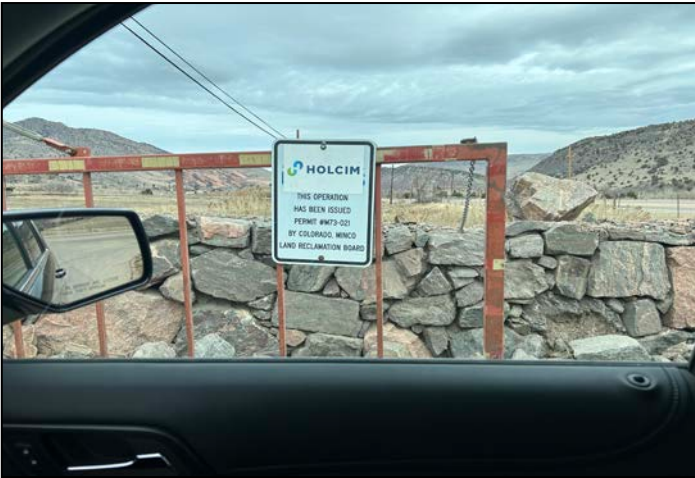
**Photo 1 – Updated site identification sign at site entrance.**

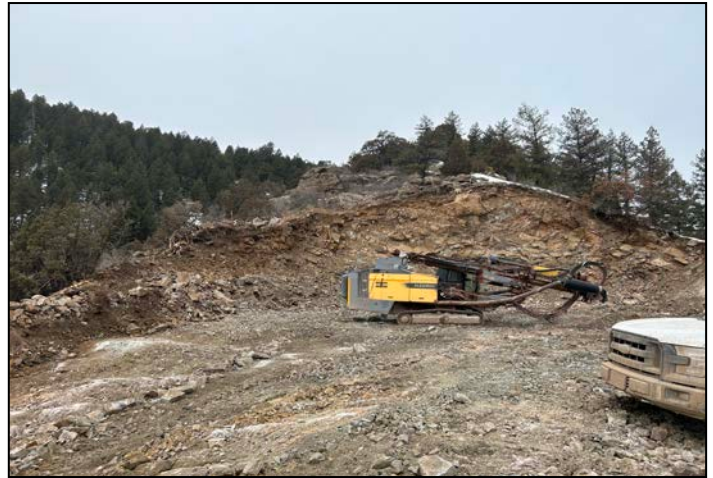
Significant improvements to the site have taken place since the approval of AM7 in November of 2021. The most notable change is the extension of the of the new haul road approved in TR7 which now accesses the West Quarry and the upper South Quarry areas. This new haul road is currently being utilized to access the upper face of the South Quarry area to import material for reclamation(Photo 4), and to access the upper portion of the West Quarry where mine development is just beginning (photos 2- 3).

**Photo 2 – Top of West Quarry area looking west. Area just starting mining development.**

As a significant haul traffic structure on-site, DRMS will expect to see this haul road constructed as designed and approved, and as-built documentation submitted to DRMS verifying the construction meets the approved design specifications.

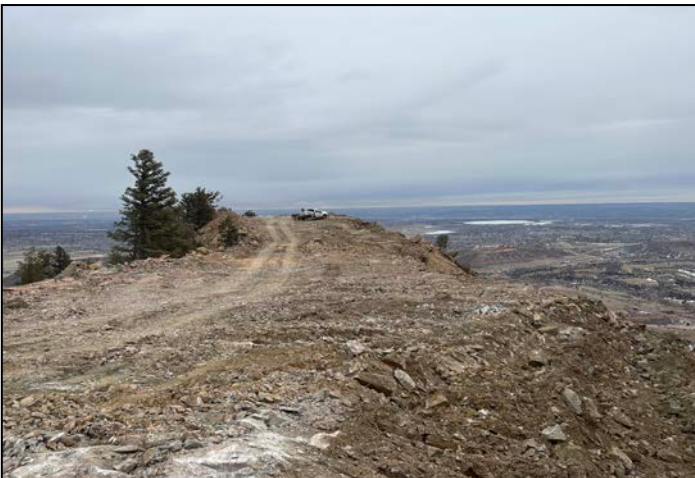
**Photo 3 – Top of West Quarry area looking east. Area just starting mining development.**

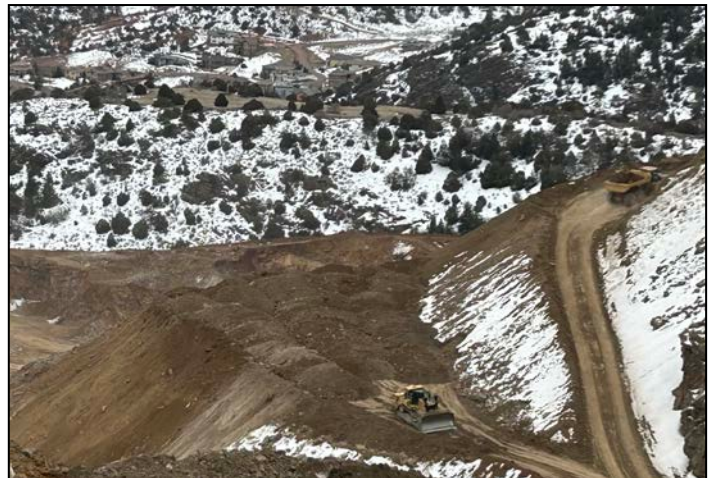
**Photo 4 – Looking South to South Quarry from top of West Quarry at dozer and haul truck placing material for reclamation of mined face.**

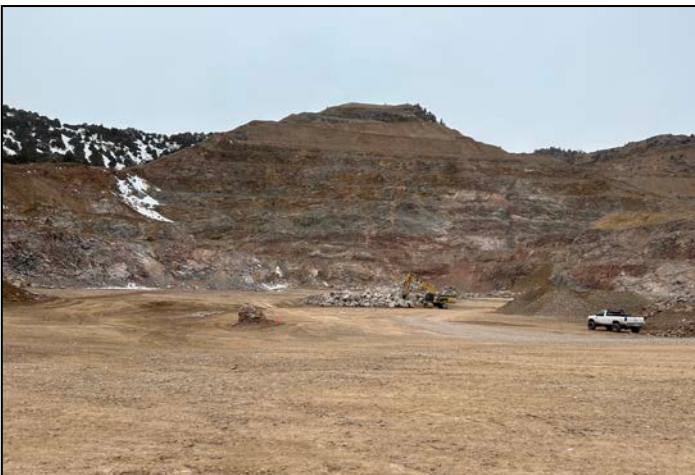
It was noted that the base area of the South Quarry, previously divided into multiple working areas, has been consolidated in to a single working area, and all previously retained water has been discharged (Photo 5). The South Quarry pit floor was observed to be dry at the time of this inspection. The "temporary" road base plant observed during the previous inspections and located adjacent to the South Quarry was still in place and operating. The central portion of the site is still serving as a product stockpile and fueling area (Photo 6). Mining operations at the site appear to be in compliance with the approved mining and reclamation plans as updated in AM7

**Photo 5 – Base of South Quarry looking west at working face at middle of photo and reclamation face at top of photo. Quarry floor is consolidated and dry.**

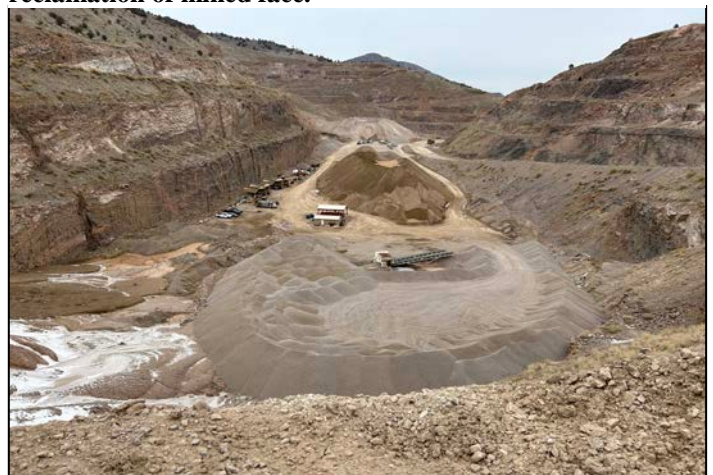
**Photo 6 – Looking North into Central Quarry fueling and product stockpile area from haul road.**
