MINERAL MATERIALS INSPECTION REPORT

Pike and San Isabel National Forest
Pikes Peak Ranger District Forest
Phone: 719-636-1602

MINERAL MATERIAL OPERATING PLAN					
MINE NAME:		CLAIM NUMBER(S):		INSPECTOR(S):	
Pikeview Quarry		CMC256219		Amy Titterington	
TOWNSHIP:	RANGE:	SECTION(S):	COUNTY:	TYPE OF OPERATION:	
13 S	67 W	9	El Paso	Negotiated Sale Contract	
OPERATOR(S):		OPERATOR(S) PRESENT:		INSP. DATE:	INSP. TIME:
Riverbend Industries		Yes		January 26, 2023	10:00
REASON FOR INSPECTION:		DATE OF LAST INSPECTION:		JOINT INSP. AGENCY:	
New Operation		1/11/2023		DRMS	
STATUS:	PLAN EXPIRATION DATE:	MINERAL:		BOND AMOUNT:	
Authorized	12/31/2023	Placer		DRMS: \$13,389,784 (2020)	
USFS PLAN NUMBER:		COUNTY SUP (Y/N):		DRMS PERMIT NUMBER:	
2850-021209-RP-2022-001		Yes		M-1977-211	
VOLUME PERMITTED:	VOLUME DISTURBED:	NEPA DATE:	CONTACT:		
197,500 LCY	132,642 LCY	CE: 07/28/22	Jerry Schnabel		
FOLLOW UP REQUIRED:	INSPECTOR'S SIGNATURE:			SIGNATURE DATE:	
Yes

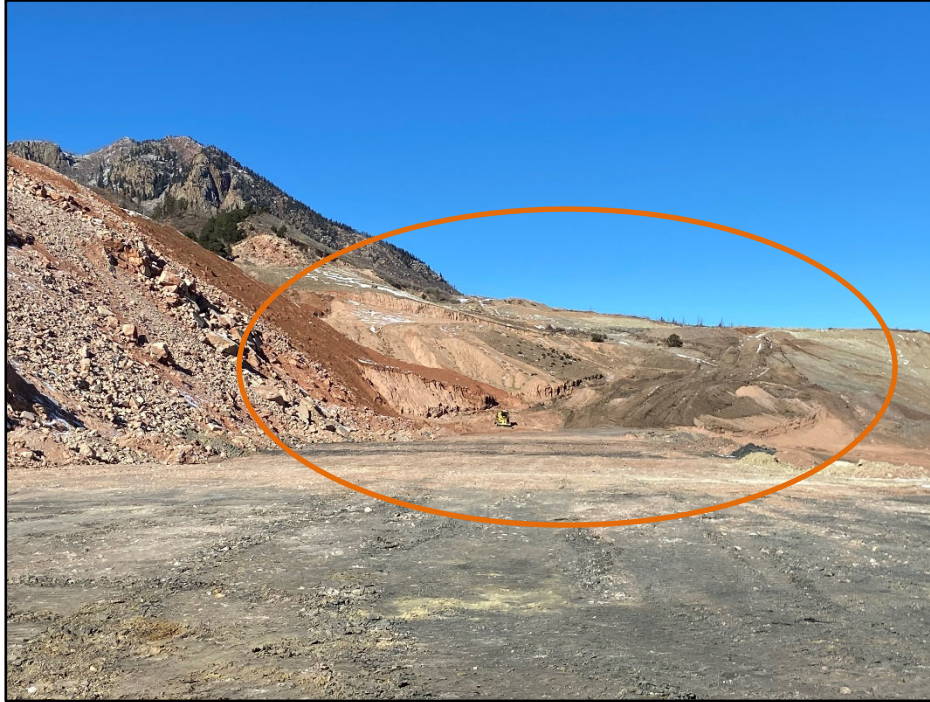
The site is actively being excavated from the north (Photo 1) and south borrow areas (Photos 4) and placed in lifts to build up the 2H:1V outslope portion of the backfill in the main pit.

Photo 1 – Material is being mined from North Borrow Area.

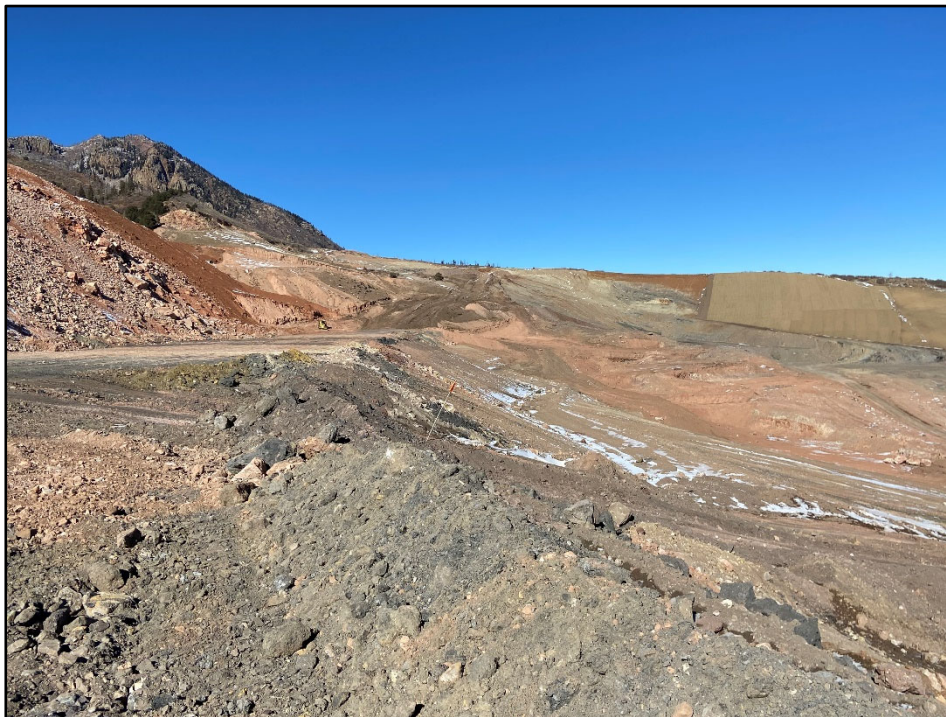
I visited the site in coordination with DRMS to conduct a monthly compliance inspection of the Pikeview Negotiated Sale contract. To date, Riverbend Industries has removed approximately 132,642 loose cubic yards of NFS fill material for use in the backfill of the main pit area (Photo 2).

Photo 2 – Fill material is being actively placed in main backfill area.

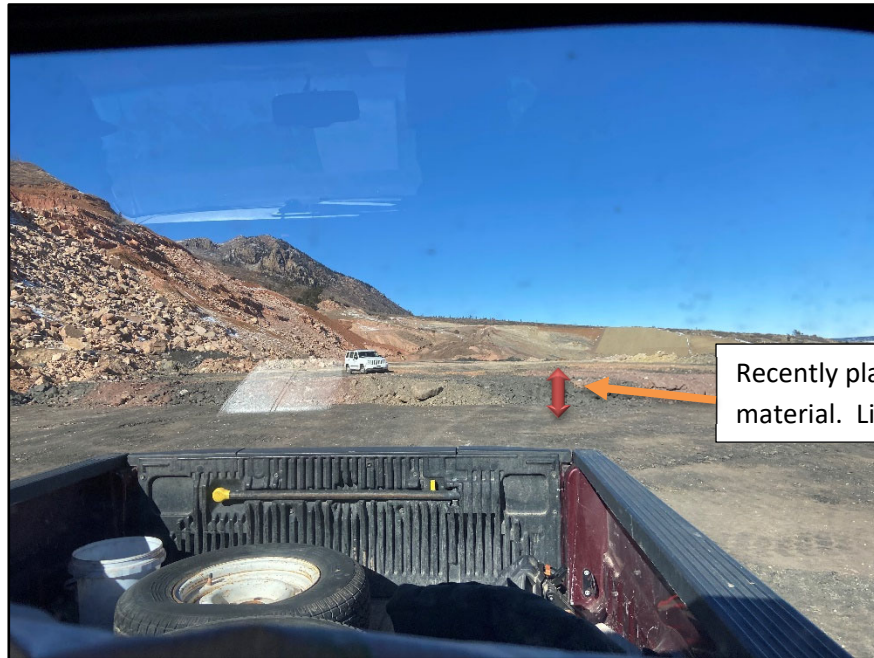
Photo 3 – Main backfill area. Showing one of the lifts of material that the contractor has placed.

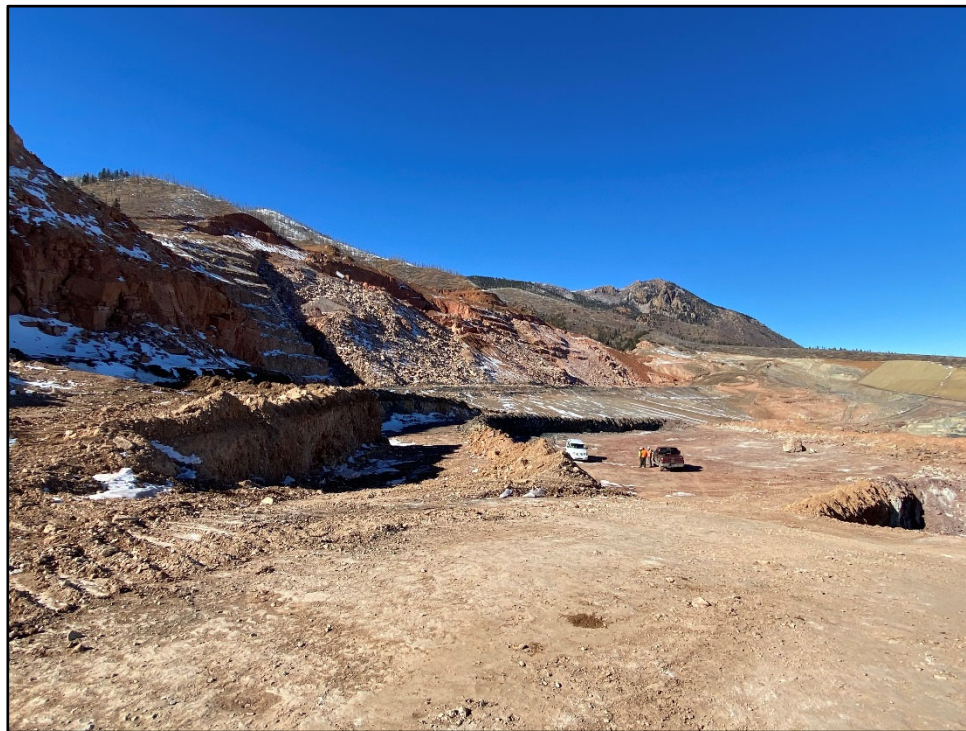
Photo 4 – Overview of the site from the USFS South Borrow Area looking north.

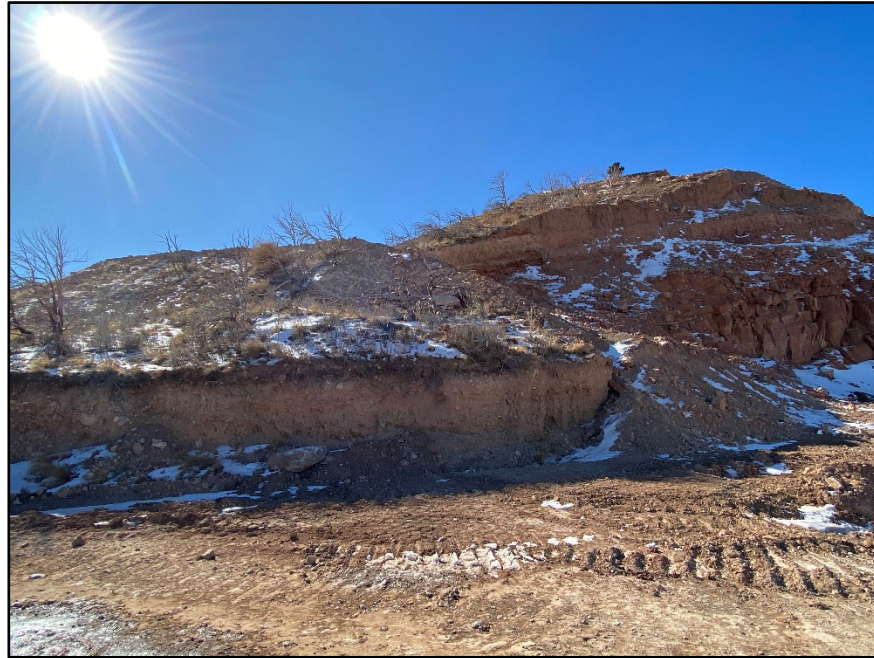
Photo 5 – Overview photo of South Borrow Area on NFS lands looking west.

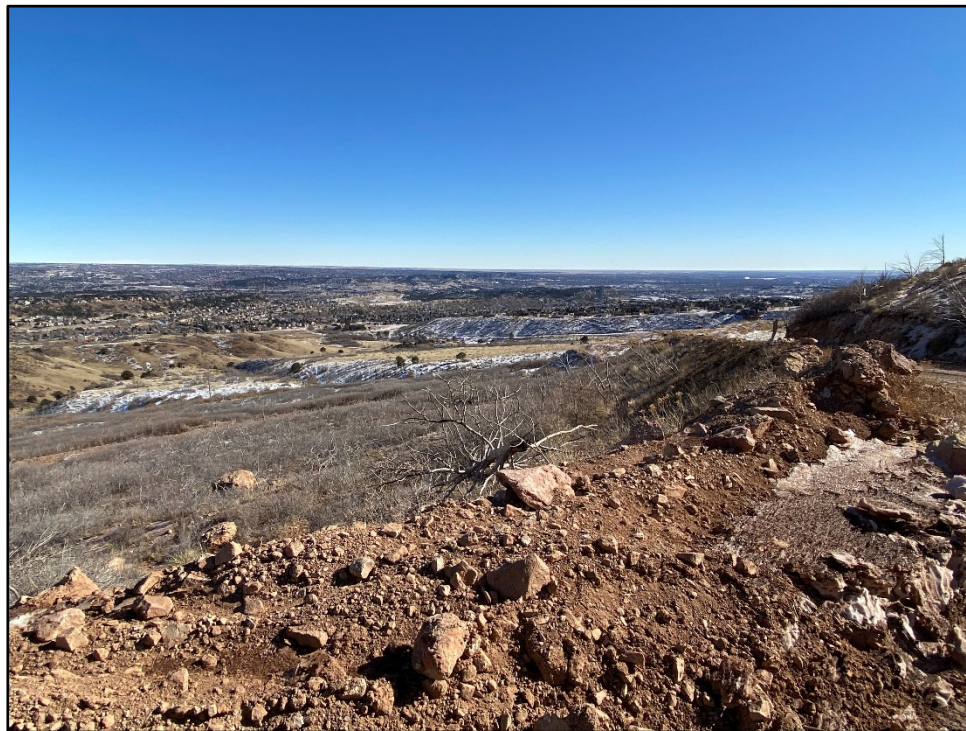
Photo 6 – Overview photo of South Borrow area looking south. Native vegetation below the road is scrub oak.
