RE: 2022 Annual Report, Henderson Mine and Mill, Permit No M-1977-342

Climax Molybdenum Company (Climax) is submitting its 2022 Colorado Division of Reclamation, Mining and Safety (DRMS) Annual Report and DRMS Annual Report Form for the Henderson Mine and Mill (Permit No. M-1977-342), along with payment for the required annual fee of \$1,150.00.

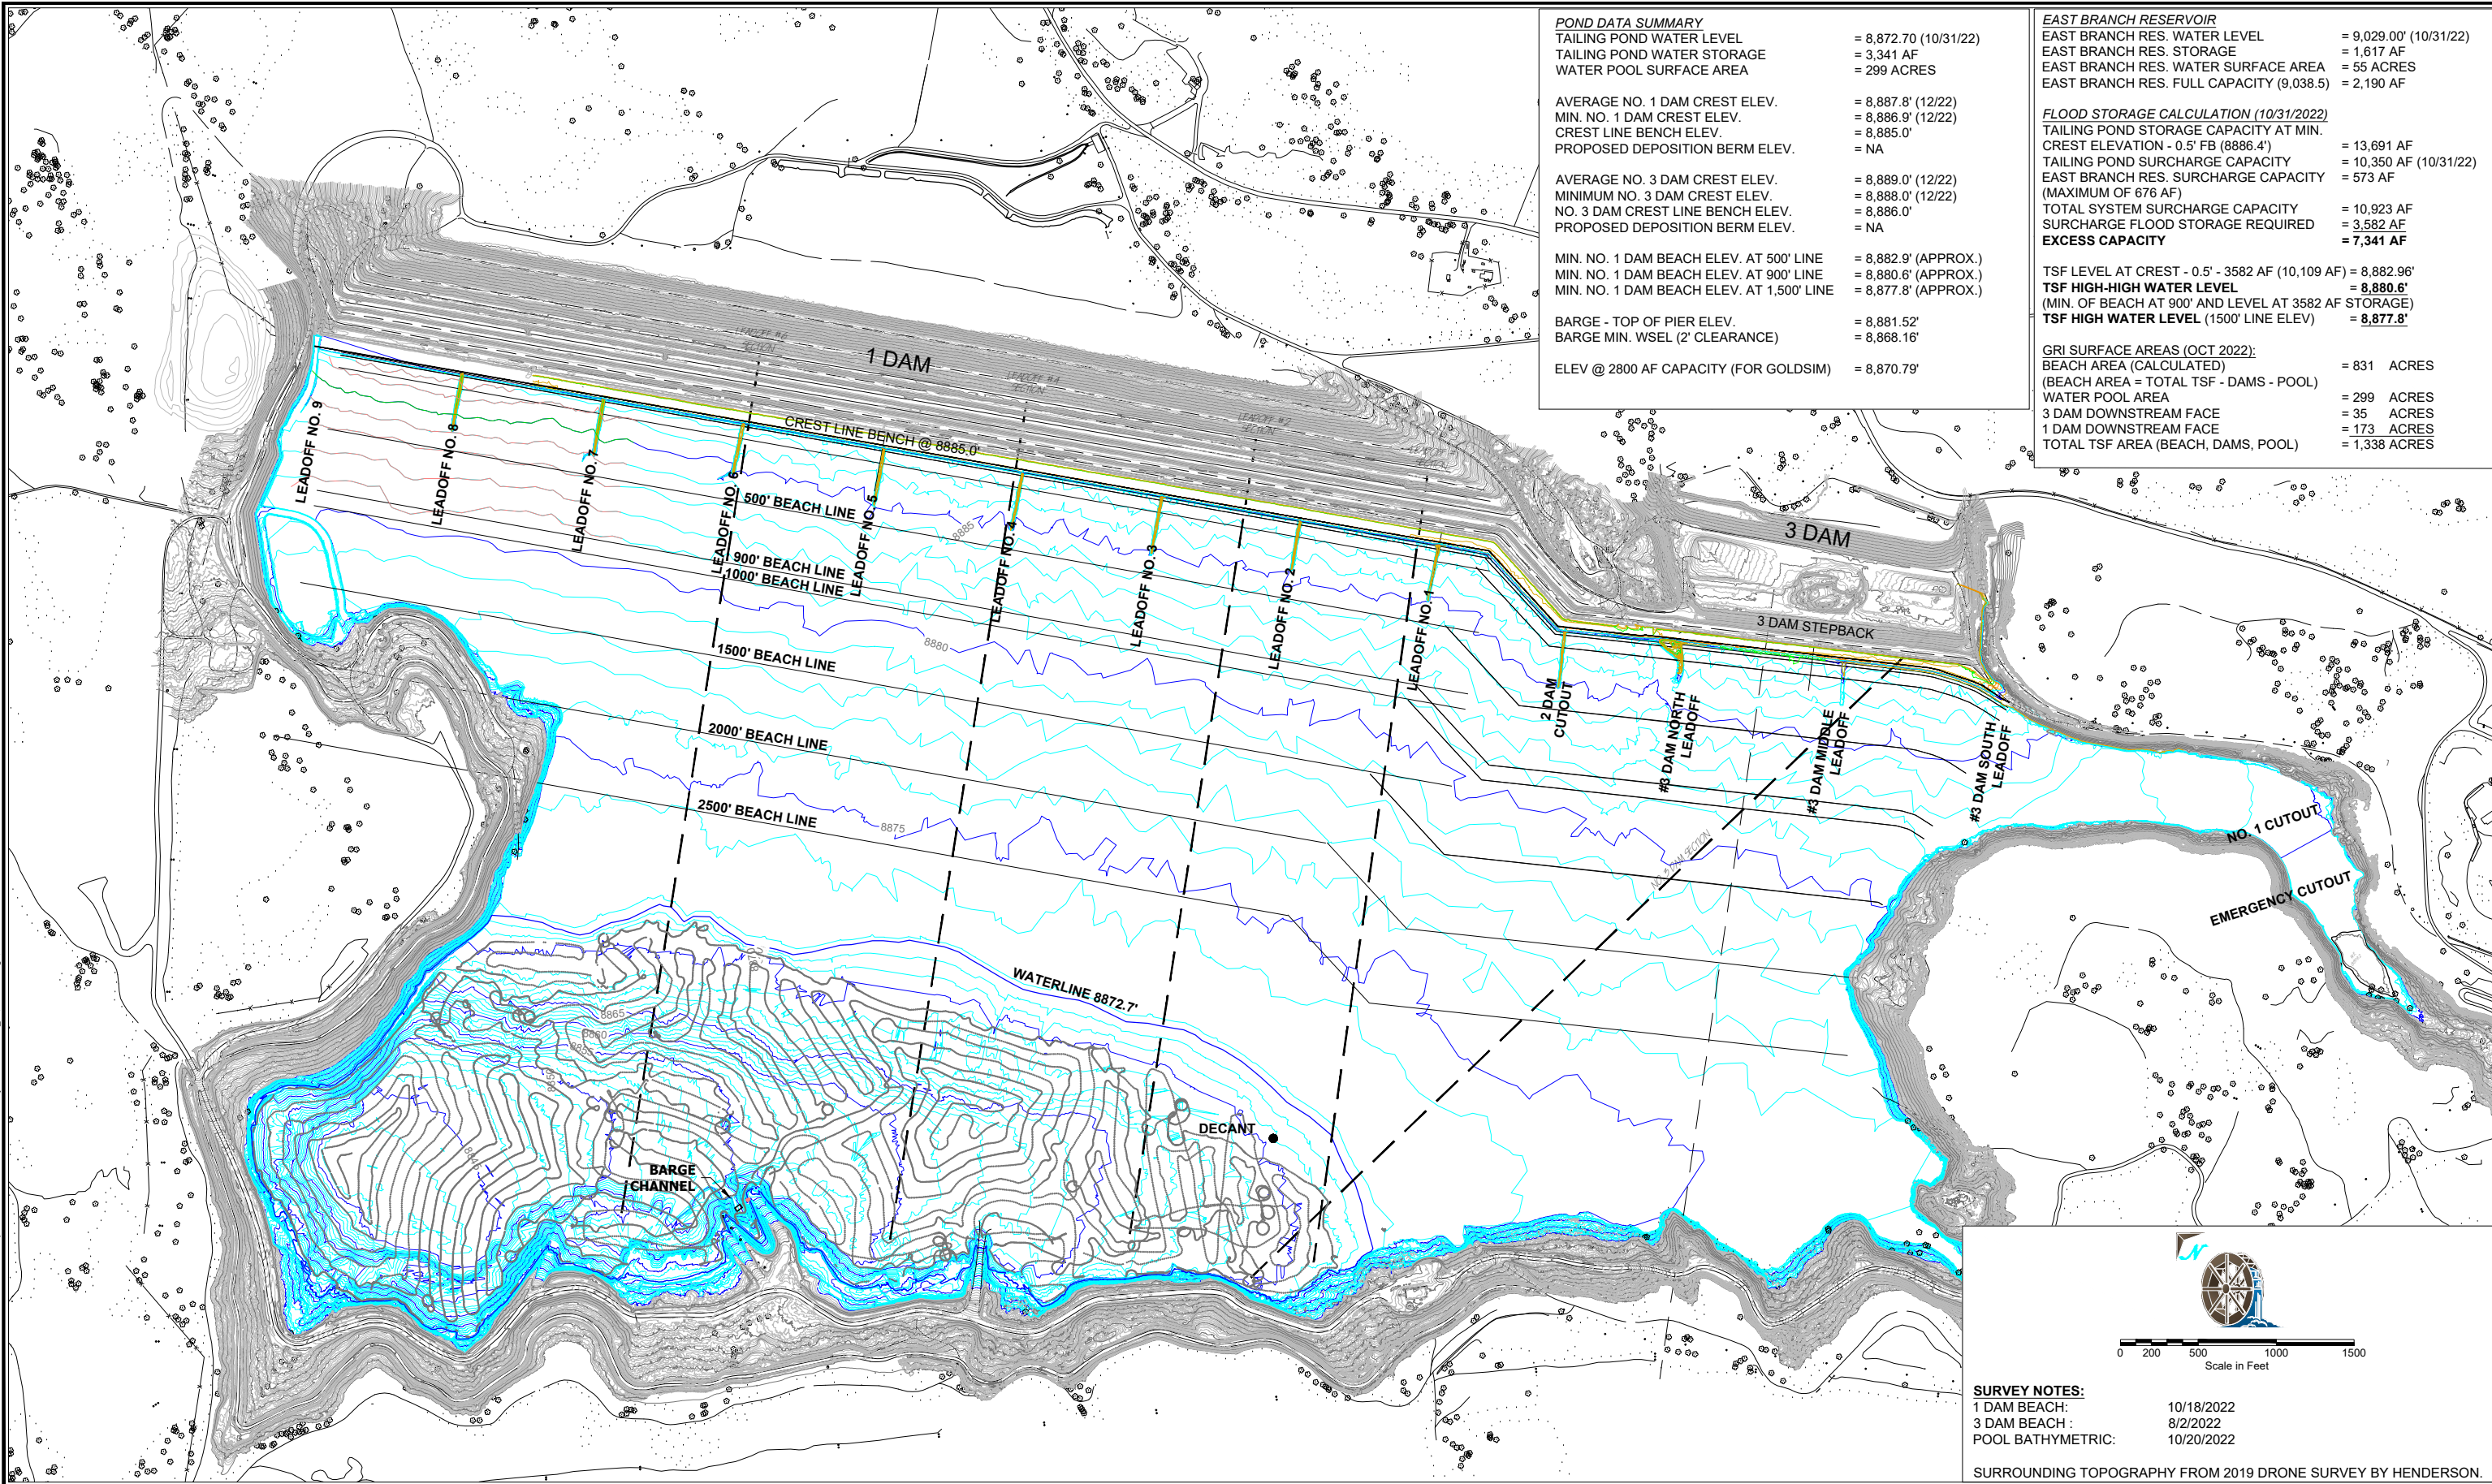
HENDERSON MILL TAILINGS STORAGE FACILITY		Climax Molybdenum Henderson Mill Parshall, CO	
BEACH AND POND SURVEY	SAA	10/22	SCALE AS NOTED
FALL 2022 SURVEY	CHECKED BY SMM	10/22	DRAWING NO.
DATES: SEE SURVEY NOTES	ACCEPTED BY ...		FIGURE 1

One of the primary uses of the survey data is to evaluate the flood storage capacity conditions in the water system. As summarized on Figure 1, at the approximate time of the fall survey there was a total system surcharge storage capacity of about **10,923 acre-feet** in the system. This capacity includes both the TSF and East Branch Reservoir and is based on 0.5 feet of residual freeboard below the minimum dam crest elevation of 8,886.9' and a October 31st water level of 8,872.7 feet. The flood storage requirement for the system is **3,582 acre-feet**. This requirement is based on hydrologic modeling of the probable maximum precipitation (PMP) event. The available flood storage capacity in the system at

the time of the survey significantly exceeds the storage requirement. However, this excess capacity will decrease throughout the coming year as additional inflows to the system occur and a portion of the storage space is filled with deposited tailing.
