**MINERALS PROGRAM INSPECTION REPORT**  
**PHONE: (303) 866-3567**

<b>MINE NAME:</b> Speer Mining Resource	<b>MINE/PROSPECTING ID#:</b> M-1983-176	<b>MINERAL:</b> Gravel	<b>COUNTY:</b> Adams
<b>INSPECTION TYPE:</b> Monitoring	<b>WEATHER:</b> Cold, Windy	<b>INSP. DATE:</b> February 9, 2023	<b>INSP. TIME:</b> 10:00
<b>OPERATOR:</b> Asphalt Specialties Co., Inc.	<b>OPERATOR REPRESENTATIVE:</b> Greg Geras	<b>TYPE OF OPERATION:</b> 112c - Construction Regular Operation	
<b>REASON FOR INSPECTION:</b> Normal I&E Program		<b>BOND CALCULATION TYPE:</b> Calculated in Technical Revision 5	
<b>DATE OF COMPLAINT:</b> NA		<b>BOND AMOUNT:</b> \$678,169.00	
<b>INSPECTOR(S):</b> Nikie Gagnon		<b>POST INSP. CONTACTS:</b> None	
<b>INSPECTOR'S SIGNATURE:</b>

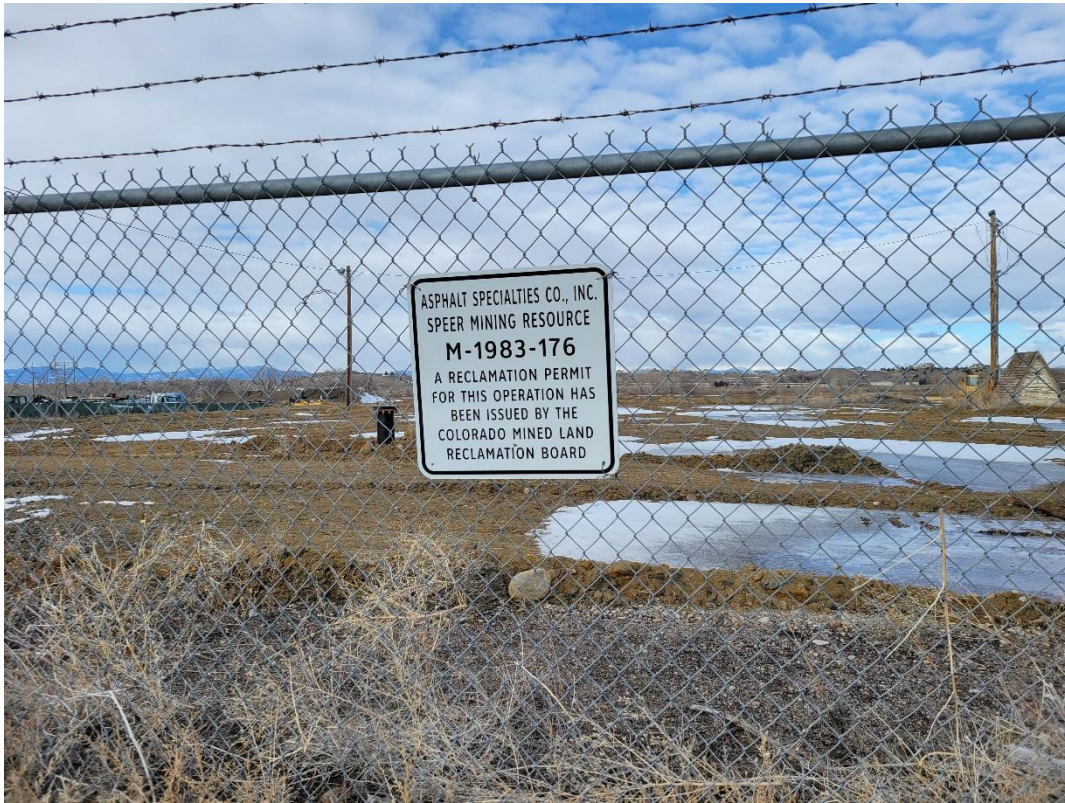
Photo 1. Mine sign posted near front entrance.

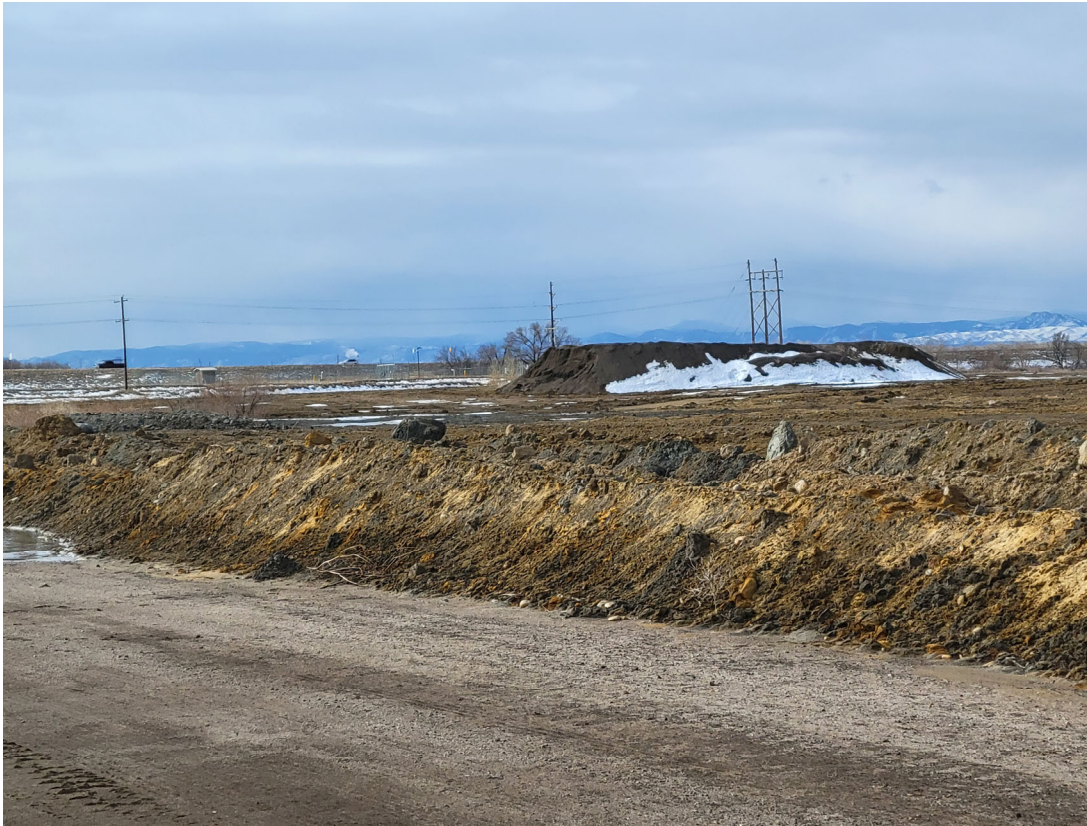
Per the settlement agreement with the County, ASCI is required to remove or use the stockpiles leftover from the recycling operations. During the inspection, Mr. Geras indicated this material will be utilized for reclamation. Once the final stockpiles of material have been moved or utilized, the operator will need to spread the required 1½ feet of topsoil/growth media and revegetate the site in accordance with the approved reclamation plan described in AM-4 (approved on January 29, 2010).

Photo 3. Inert fill stockpile leftover from recycling activities in 2018.

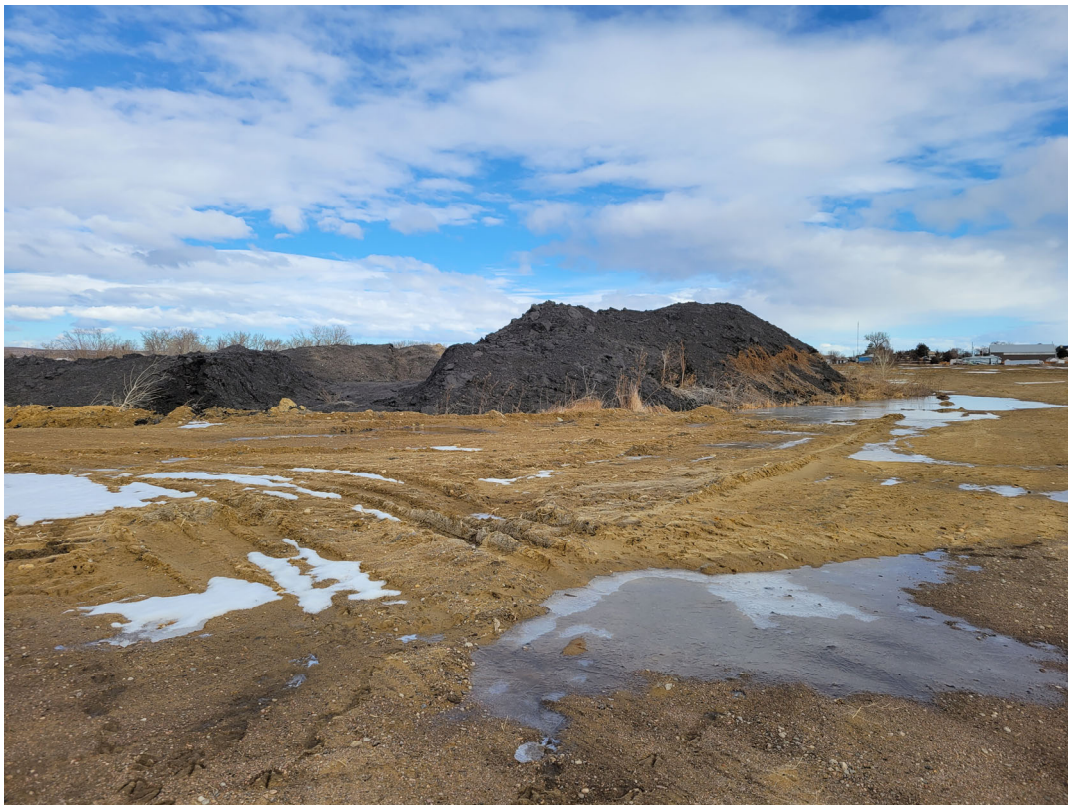
Photo 4. Inert fill stockpile (recycled roofing tiles) leftover from recycling activities in 2018.

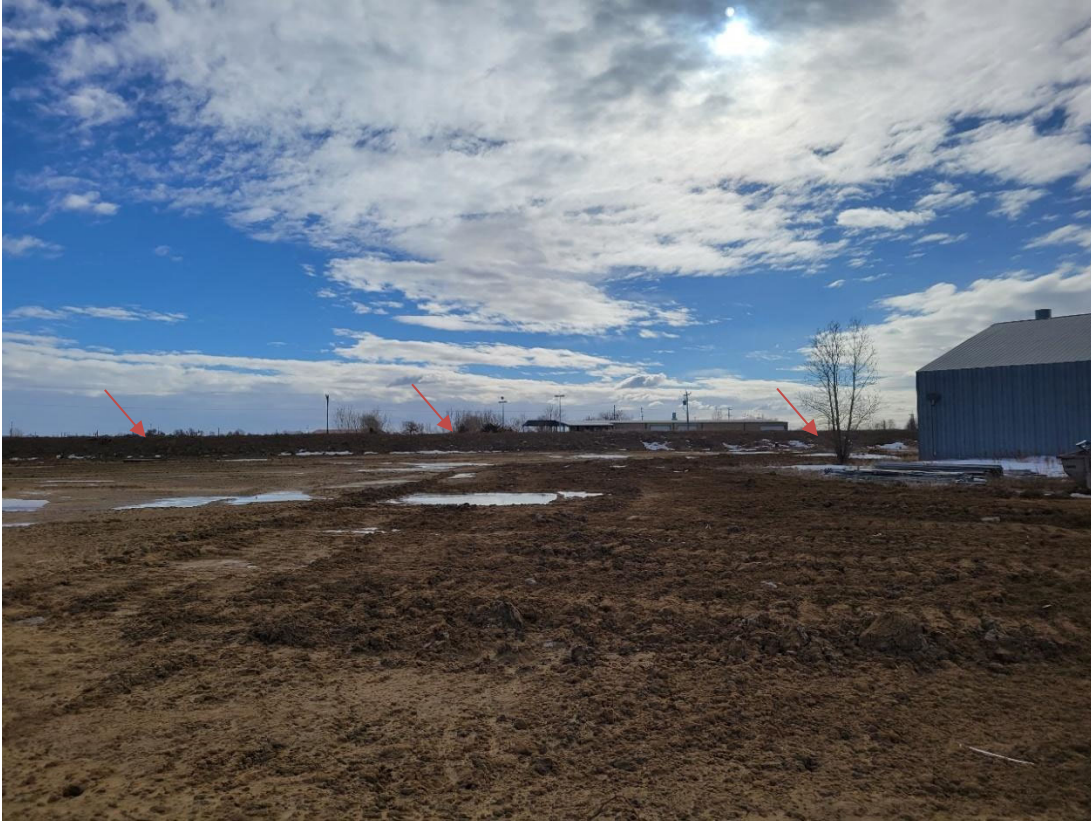
Photo 5. Looking east at graded area. Topsoil berm runs along eastern edge of the permit area (red arrows).

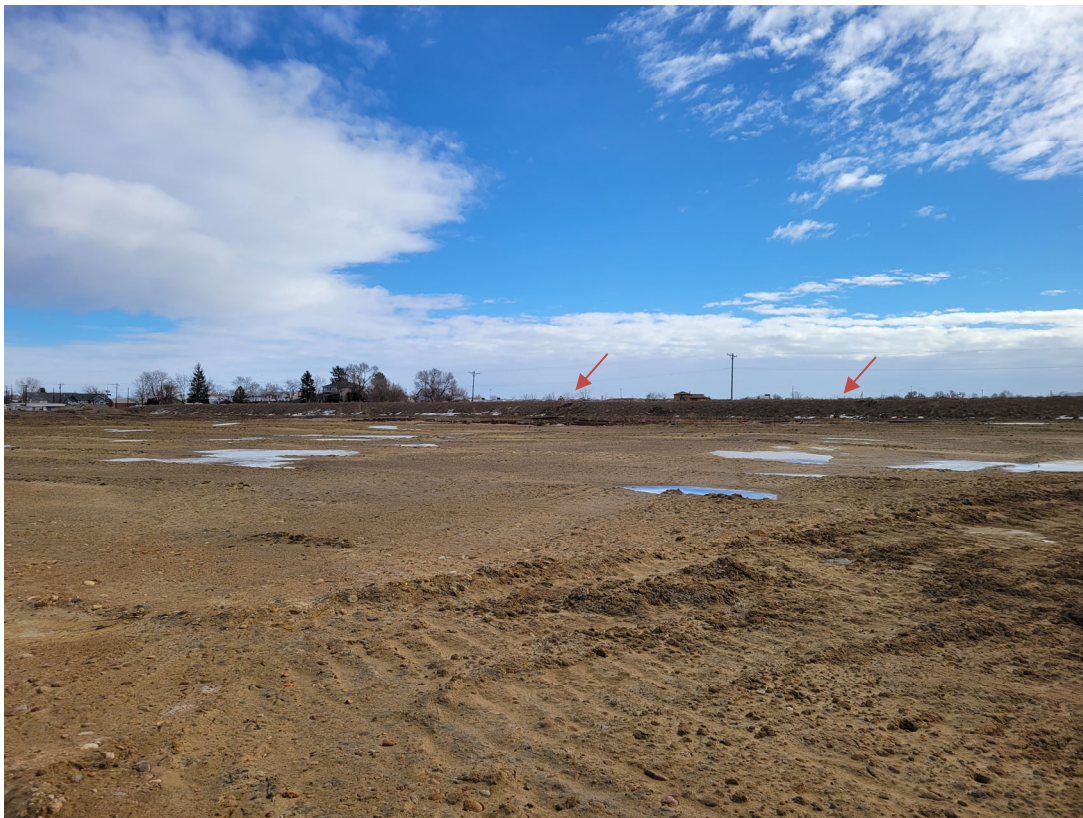
Photo 6. Looking northeast. Graded area and topsoil berm along eastern edge (red arrows).

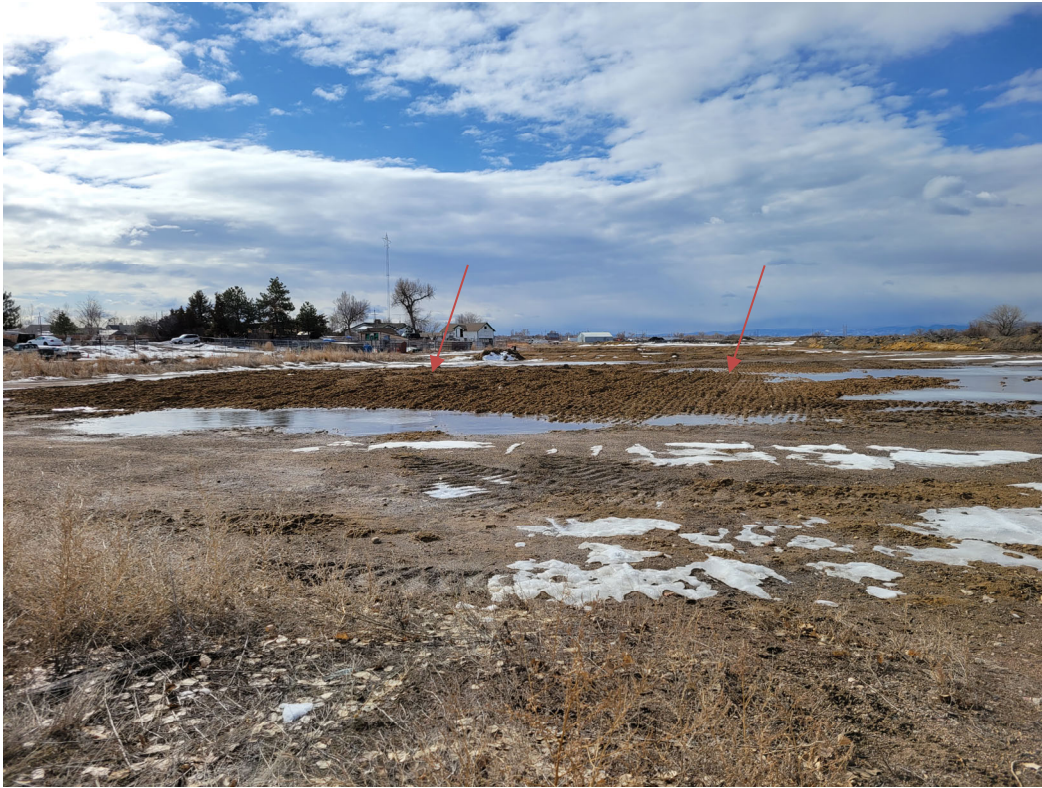
The Division's inspection report signed on March 11, 2022 noted a 0.5 acre depression in the northern part of the permit area that was retaining stormwater. During this inspection, the Division observed material placed in the center of this area, partially backfilling the depression, however, more material is needed and the area should be graded to ensure stormwater is not detained for longer than 72 hours, and flows naturally across the surface.

Photo 13. Area of standing water noted in the 2018 inspection report. Arrows points to backfill placed in center.

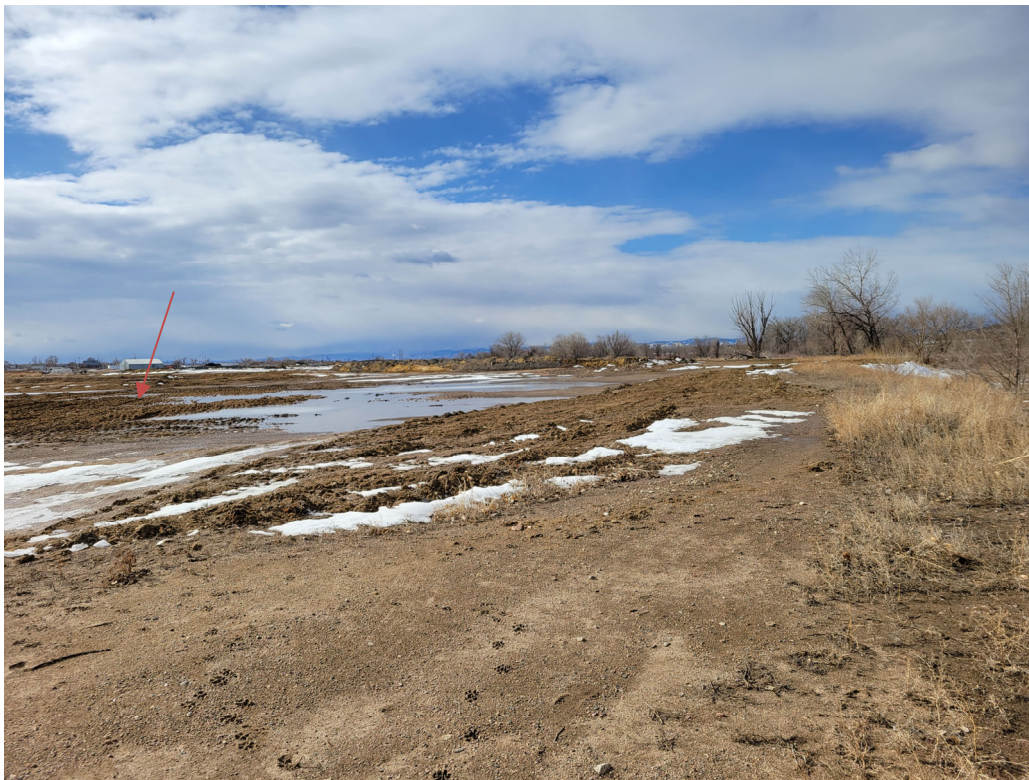
Photo 14. Edge of 0.5 acre depression area noted in the 2018 inspection report.  
Arrow points to material placed recently.

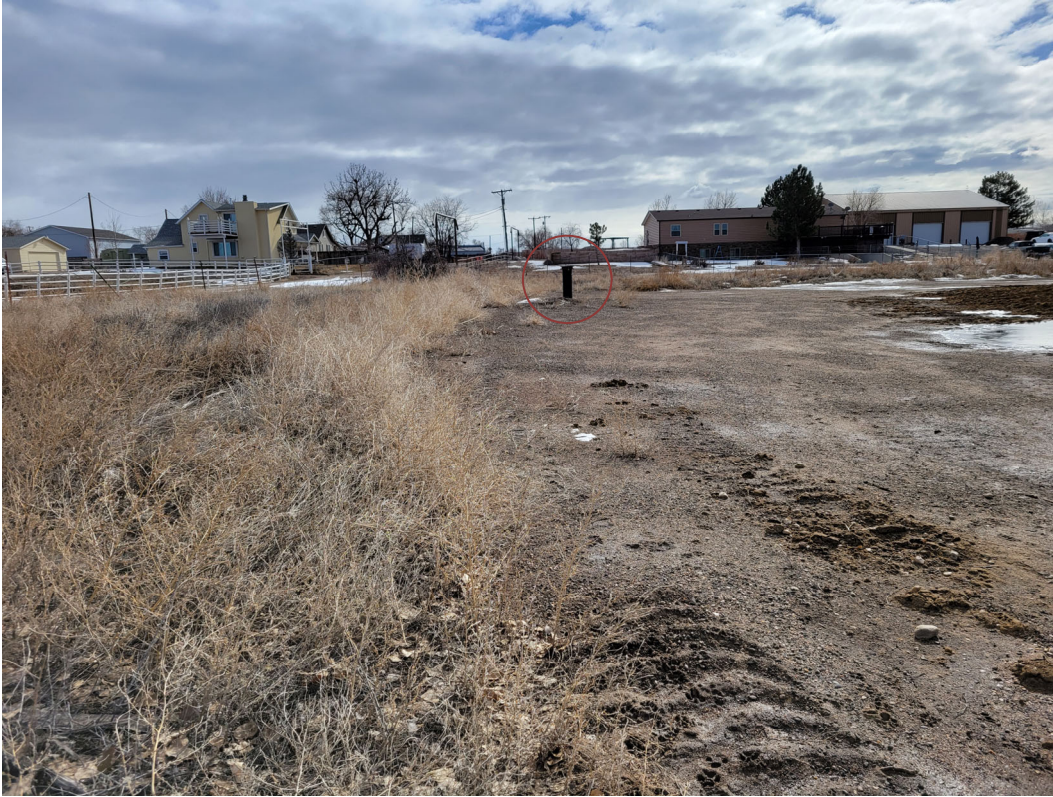
The Division observed two sections of the Phase I French drain operating. Water from the east flows into the drain that runs along the eastern edge of the permit boundary and discharges into the south end of the open groundwater pond on Mr. Crom's property. Water flows out of the northern side of the pond into a French drain that discharges into the South Platte River in the northwestern corner of the permit area. The Division observed the stand pipes and outlet discharge point. Water was flowing from the French drain into the South Platte River and a few feet of water was observed in the unlined pond. The French drain around the pond is still incomplete. ASCI provided a copy of the engineering certification and as-built drawing for the completed portion of this drain on February 23, 2023. During the inspection, Mr. Geras confirmed the French drain receives regular clean out maintenance.

Photo 15. Stand pipe (circled) for French drain in the northwestern corner of the permit area.

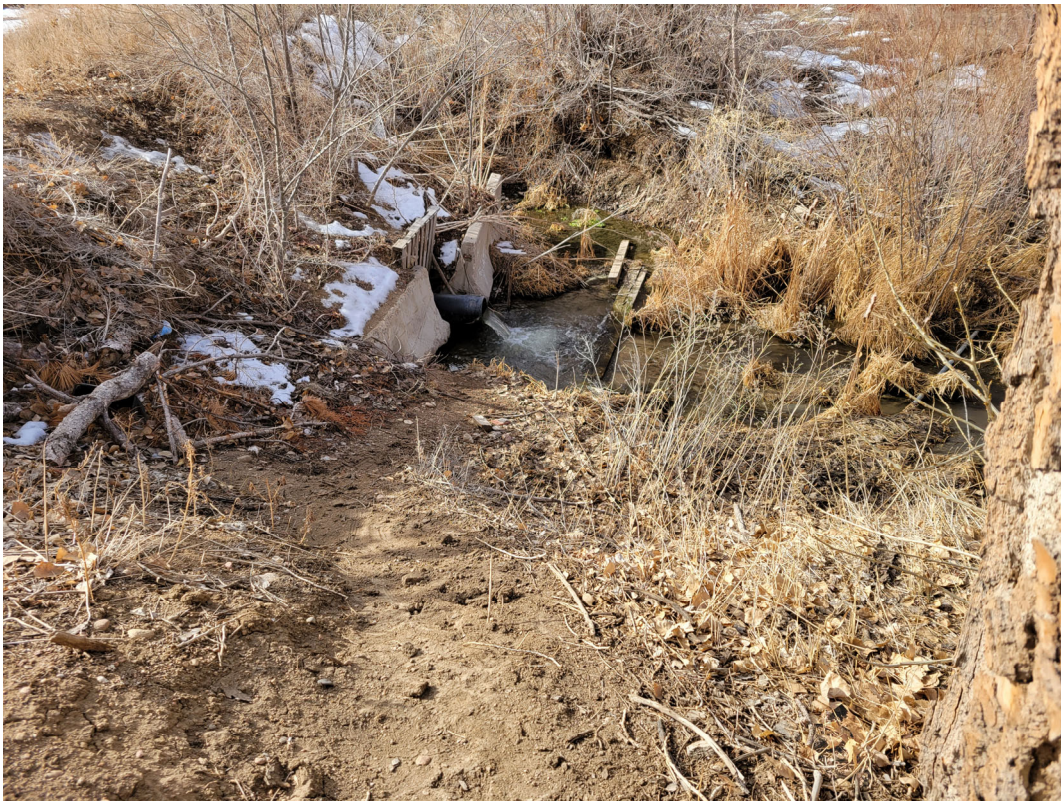
Photo 16. Discharge point into the South Platte River for French drain in the northwestern corner of the permit area.

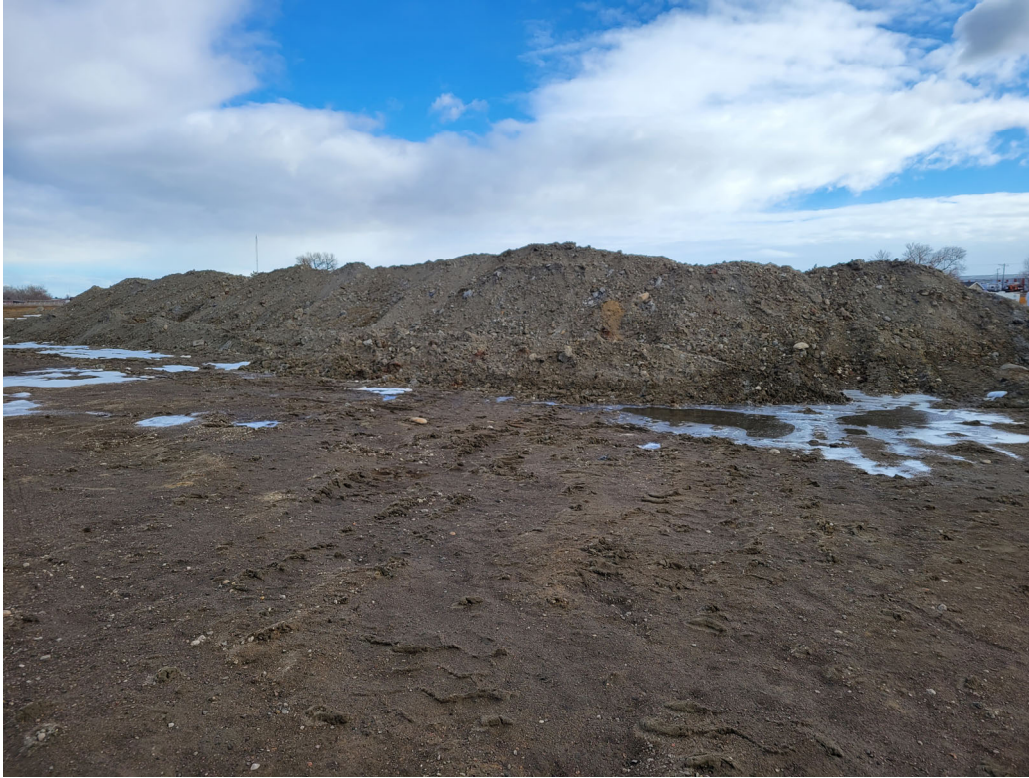
February 2, 2023. During the inspection, the Division observed recent backfilling on the south side of the unlined pond and berms of material stored around the pond for future clay lining and reclamation.

Photo 17. Clay pile stored near the unlined groundwater pond.

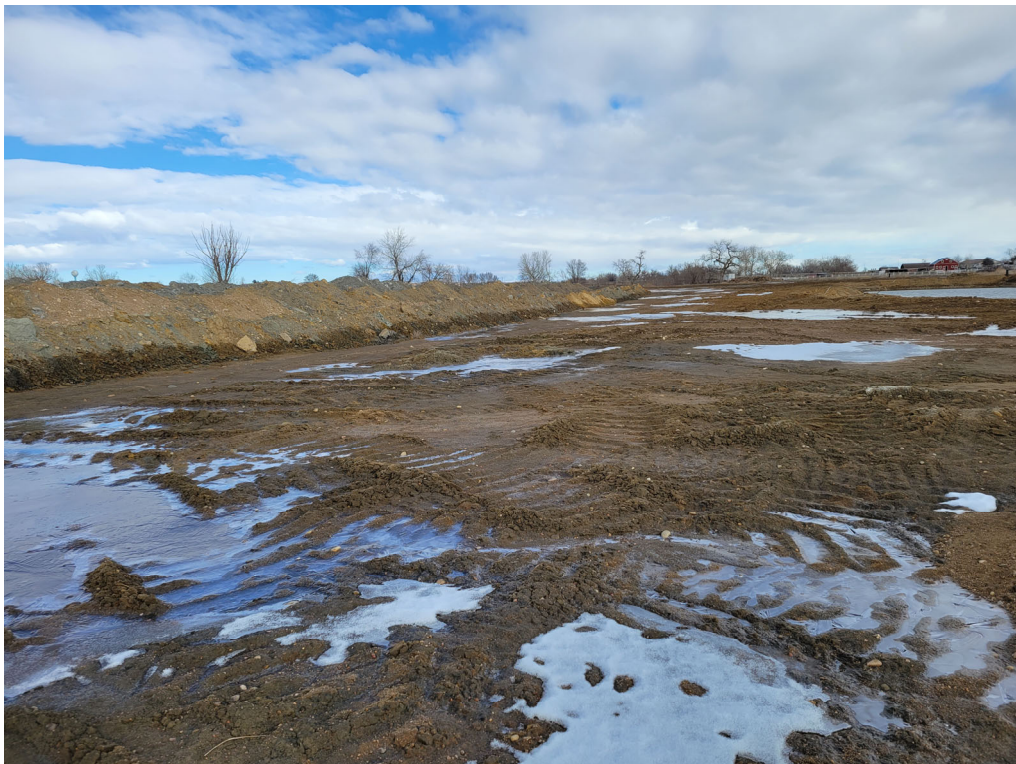
Photo 18. Backfilled area on the western shore of the unlined groundwater pond. Overburden/topsoil on the left.

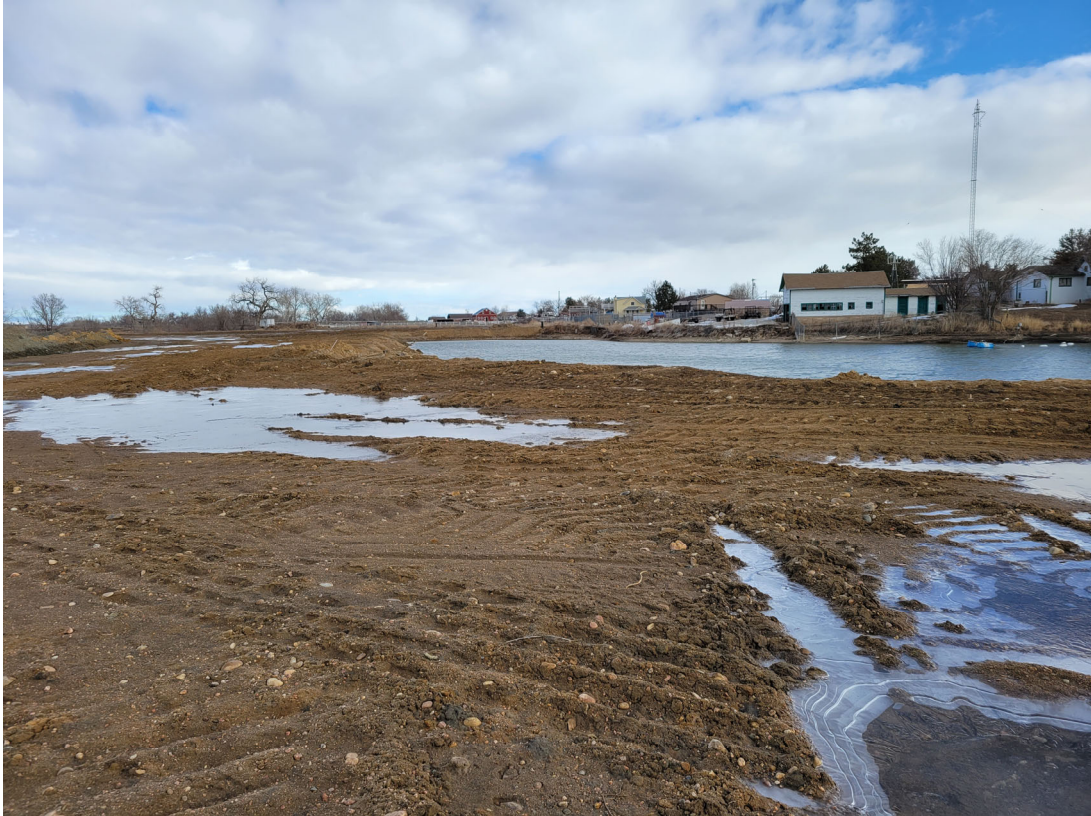
Photo 19. Backfilled area on the western shore of the unlined groundwater pond.

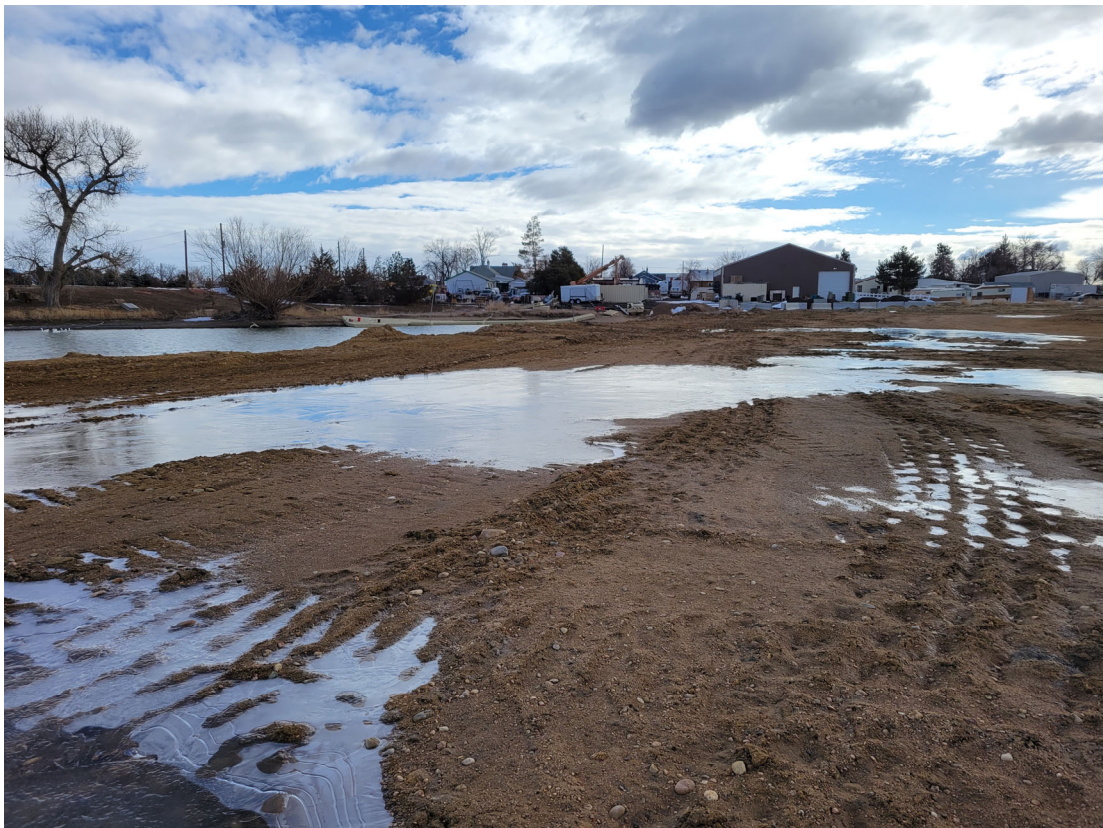
Photo 20. Backfilled area on the southern shore of the unlined groundwater pond.

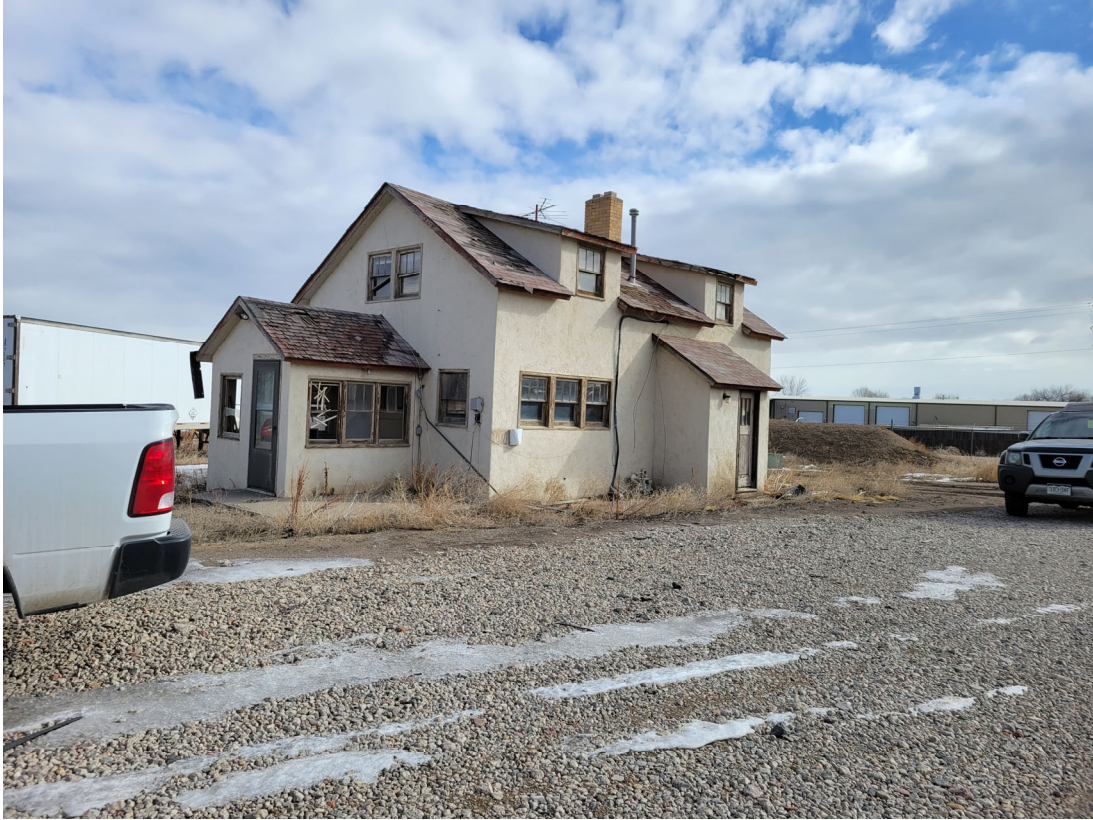
The Division observed remnants of a concrete truck scale, and two buildings including a metal shop and an old house/office that remain in the southern portion of the permit area. The operator indicated a desire to leave these structures for reclamation. However, according to Carla Jandro, the Adams County code enforcement officer who participated in the inspection, in order to leave the buildings, the operator would need to apply for a change of use since the land is currently zoned only for agriculture and ancillary agriculture or residential uses. Additionally, the approved reclamation plan and map for the mine permit (see enclosed reclamation plan map approved with TR-4) do not address these structures, as the area where they are located is shown to be graded, retopsoiled, and revegetated for reclamation. Therefore, the current reclamation plan needs to be updated and clarified pursuant to C.R.S. 34-32.5-116 to address these structures. This issue is cited as a problem in this report (see problem #2 for required corrective actions).

Photo 21. Office building located within the permit area, near the mine entrance.

**CORRECTIVE ACTIONS:** By the corrective action due date, the operator shall modify TR-5, currently under review by the Division, to update and clarify the current approved reclamation plan to reflect existing and proposed activities. Specifically, the reclamation plan must be updated to describe how existing structures will be reclaimed, and including their dimensions, all permanent components requiring demolition (e.g., concrete pads), and removal/disposal information. For any buildings proposed to remain for reclamation, the operator must provide demonstration that leaving these buildings is in compliance with the local land use and zoning laws. Additionally, the revision must include an updated reclamation plan map in accordance with Rules 6.2.1(2) and 6.4.6 which identifies any structures proposed to remain for reclamation. For any structures proposed to be removed for reclamation, the operator must provide an updated bond estimate for the site which includes costs for demolishing, removing, and disposing of such structures.

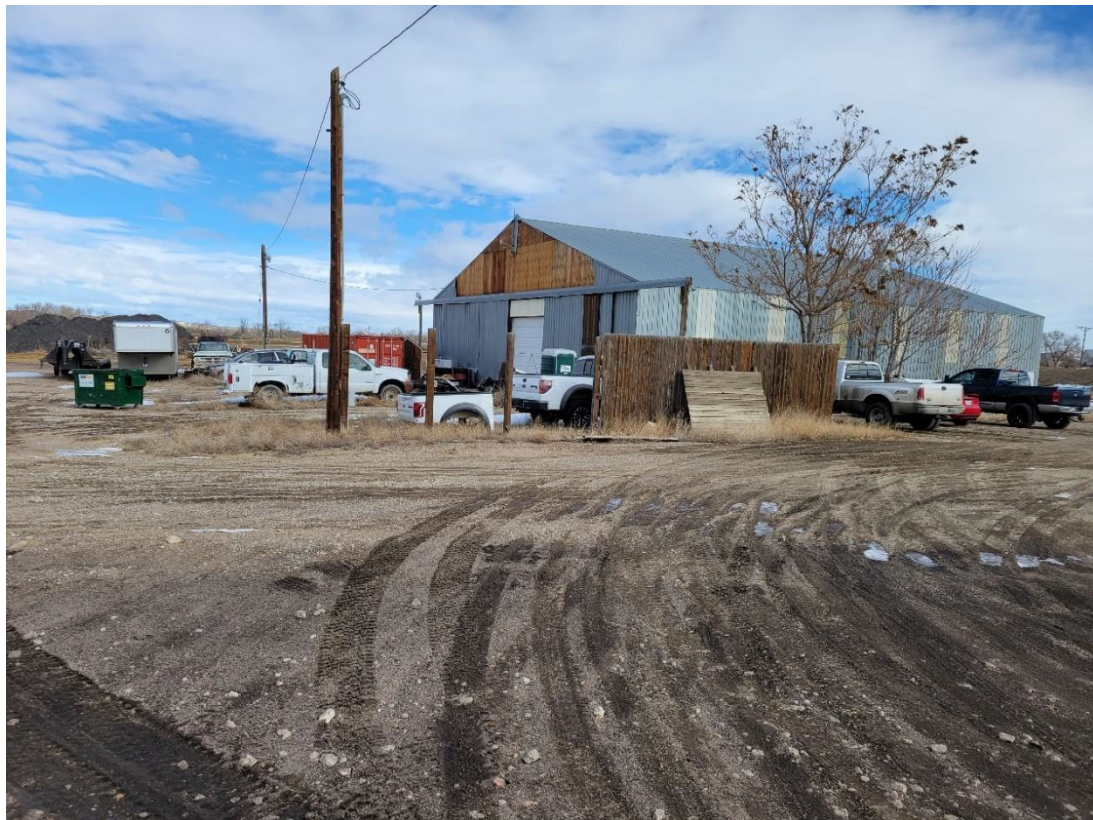
Photo 22. Shop building located within the permit area, near the mine entrance.

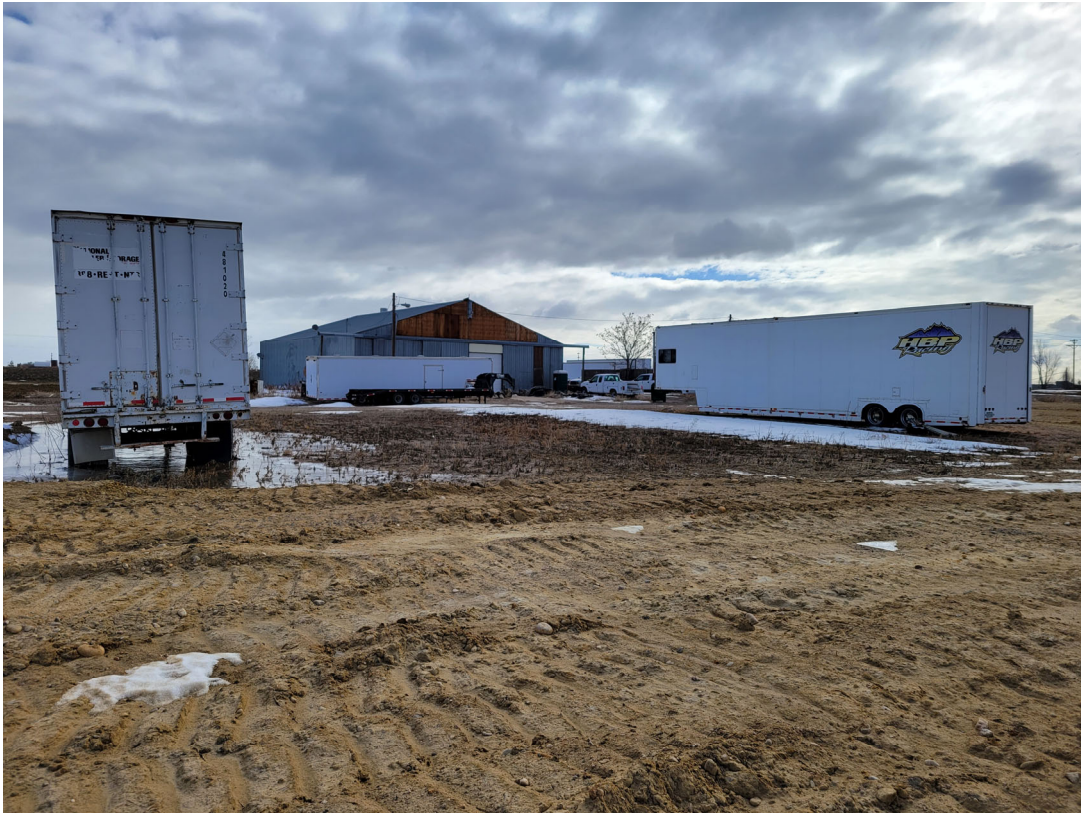
The site was not active during this inspection, however evidence of recent grading was noted across the site, and backfilling had occurred around the exposed groundwater pond and in the northwestern corner of the permit area. In May 2022, ASCI submitted a schedule to complete reclamation activities at the site, with all activities (up to initial seeding) expected to be completed by October 31, 2022. Based on observations during this inspection, the operator has not fully completed the reclamation activities listed on the 2022 schedule (i.e., completing Phase II of the French drain, filling in the stormwater collection area, clay lining the pond, and topsoiling and seeding the entire site). Additionally, ASCI is storing tractor trailers, vehicles, equipment, and a metal shipping container near the shop building.

Photo 23. Tractor trailers stored on site near the shop building.

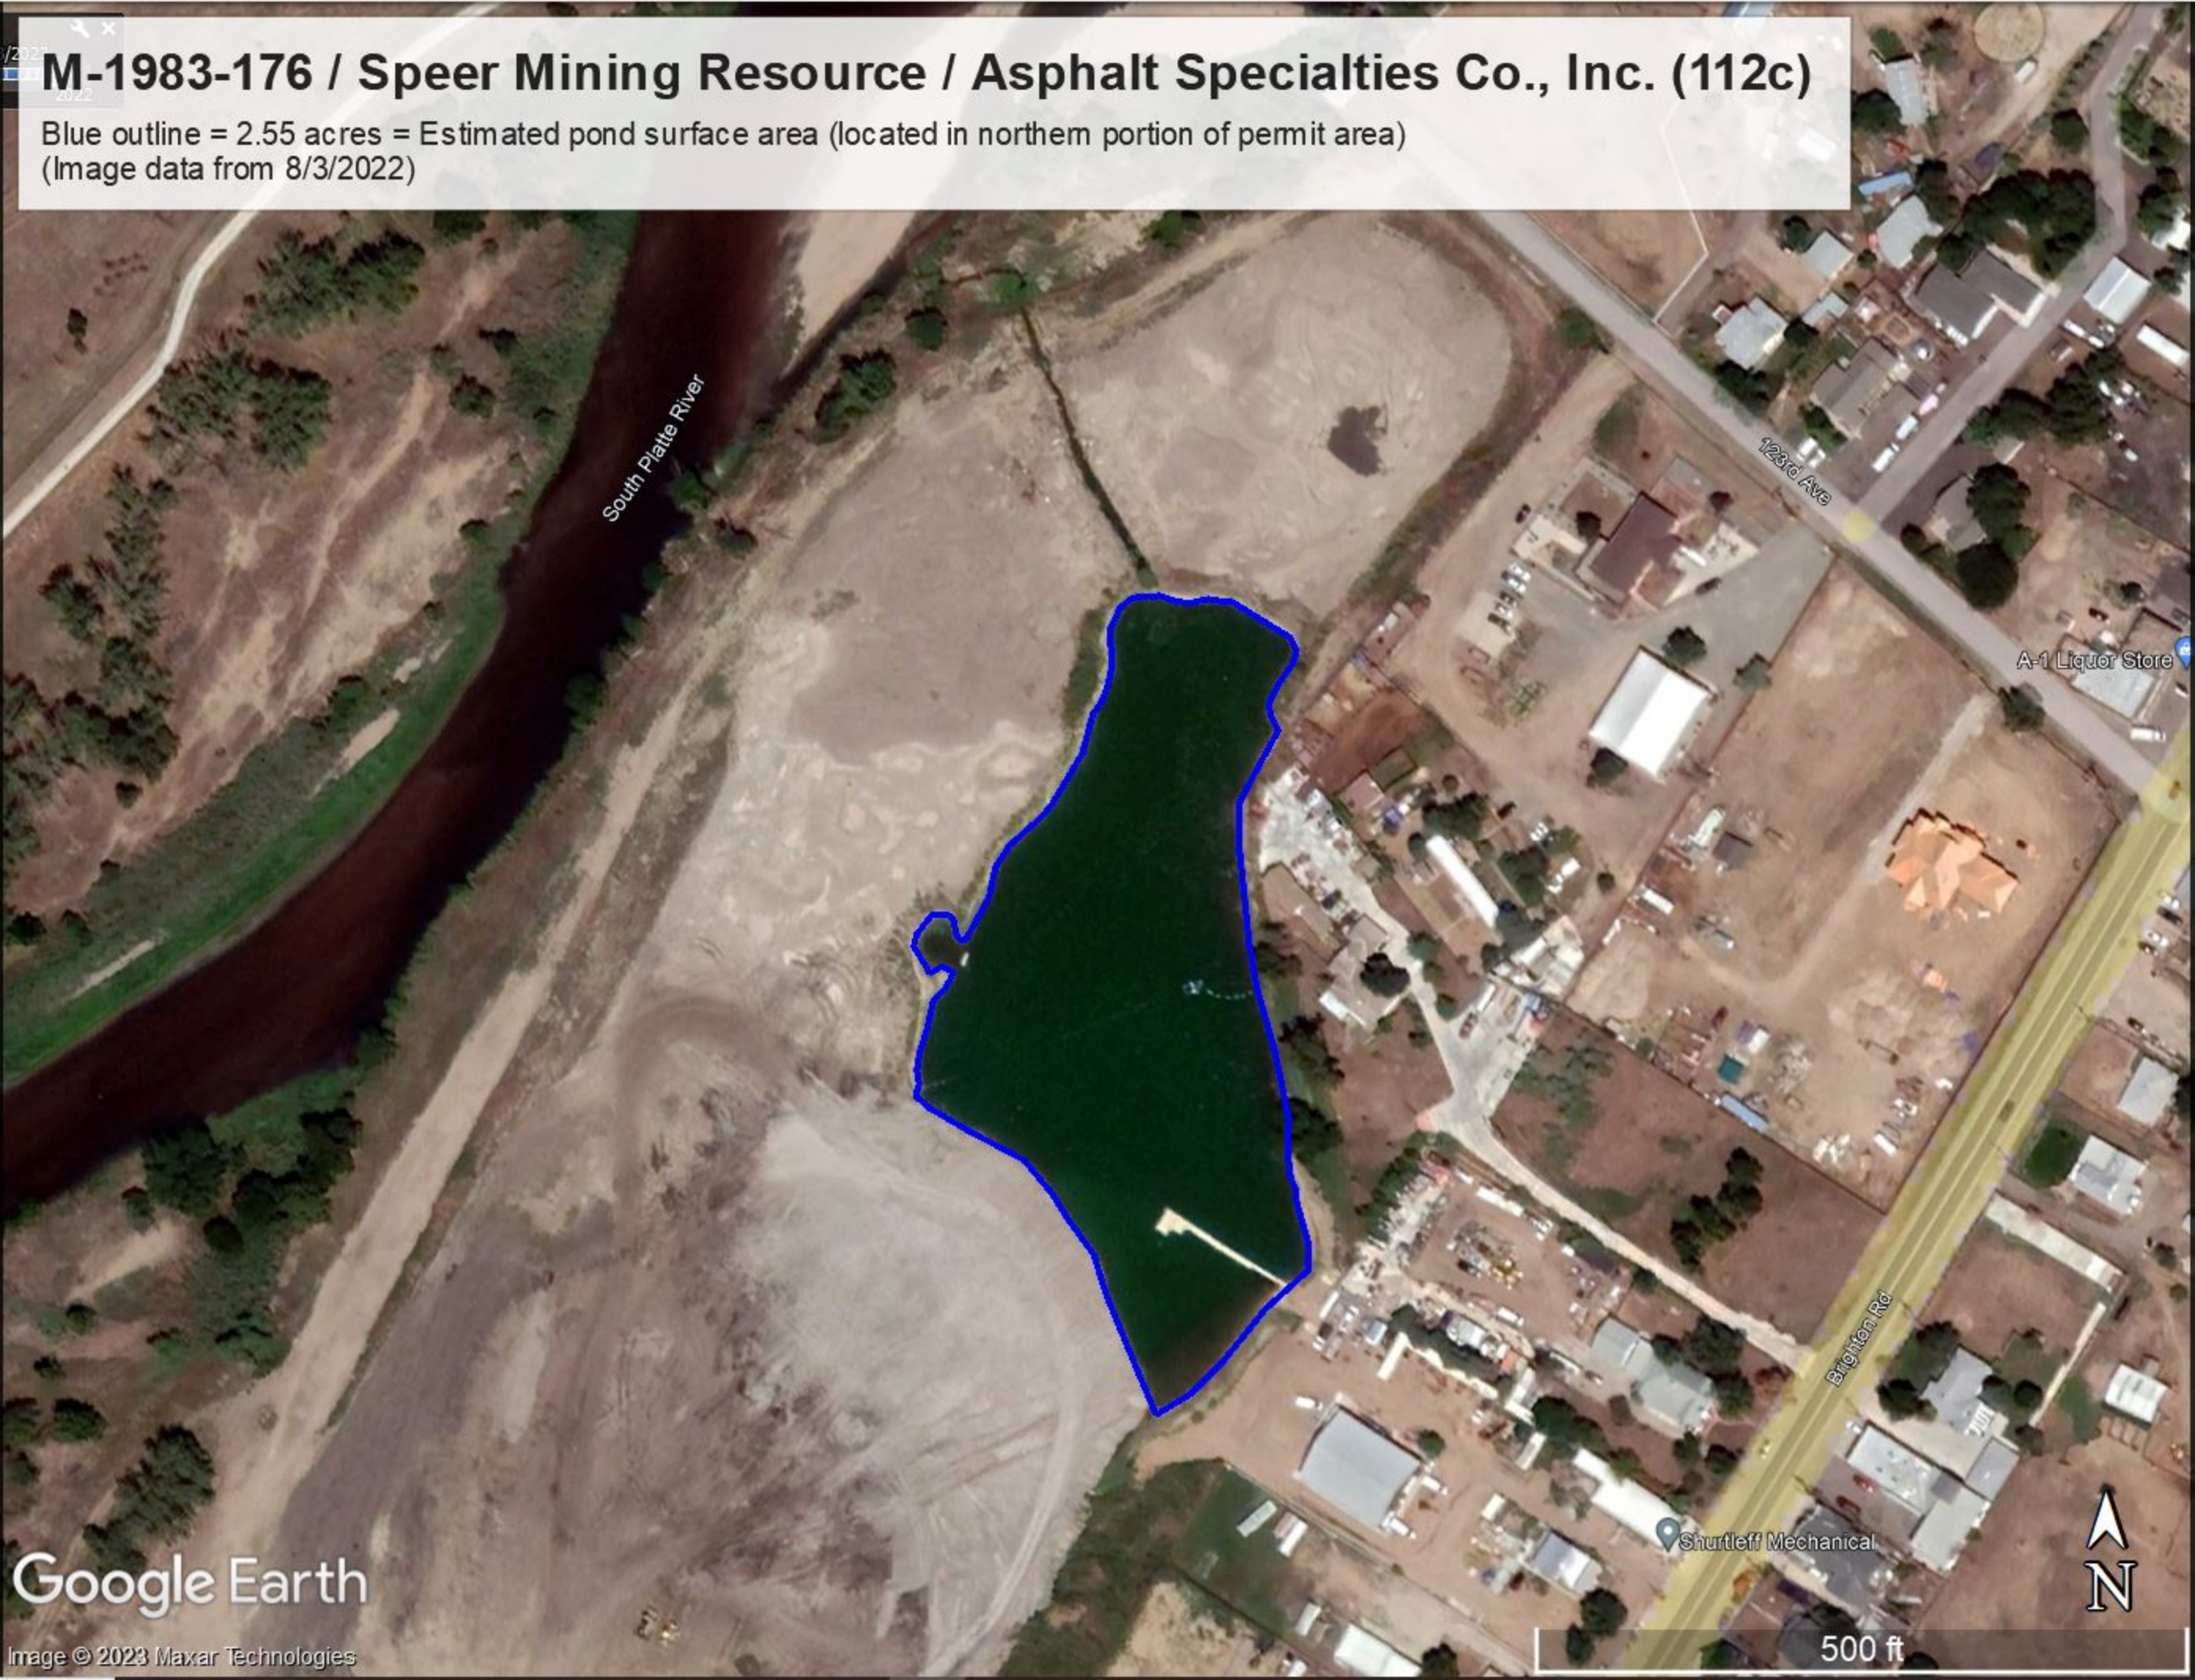
The Division did not survey the current pond size during the inspection. However, according to the most recent aerial imagery available in Google Earth (from August 2022), the Division estimates the pond to be 2.55 acres in size, which is more than the 2 acres approved under the current SWSP (and also more than the 2 acres specified to remain in the approved reclamation plan). If this estimated acreage is still accurate (no additional backfilling has occurred since August 2022), then the amount of exposed groundwater at the site exceeds the amount approved under the SWSP by 0.55 acres. This issue is cited as a problem in this report (see problem #3 for required corrective actions). Additionally, the Division may not hold sufficient bond to backfill the pond to the approved final size of 2 acres.

Blue outline = 2.55 acres = Estimated pond surface area (located in northern portion of permit area)  
(Image data from 8/3/2022)

**CORRECTIVE ACTIONS:** By the corrective action due date, the operator shall demonstrate that the operation is in compliance with the Office of the State Engineer (SEO), show evidence that the operator is taking measures to bring the site into compliance with the SEO, or backfill the portion of the exposed groundwater not covered by the current SWSP to at least two feet above the groundwater surface.
