**PERMIT INFORMATION**

<b>Permit Number:</b> C-1996-083 <b>Mine Name:</b> Bowie No. 2 Mine <b>Operator:</b> Bowie Resources, LLC <b>Operator Address:</b> Mr. Basil Bear P.O. Box 1488 Paonia, CO 81428	<b>County:</b> Delta <b>Operation Type:</b> Underground <b>Permit Status:</b> Active <b>Ownership:</b> Private
	<b>Operator Representative Present:</b>  Basil Bear
<b>Operator Representative Signature:</b> (Field Issuance Only)

**INSPECTION INFORMATION**

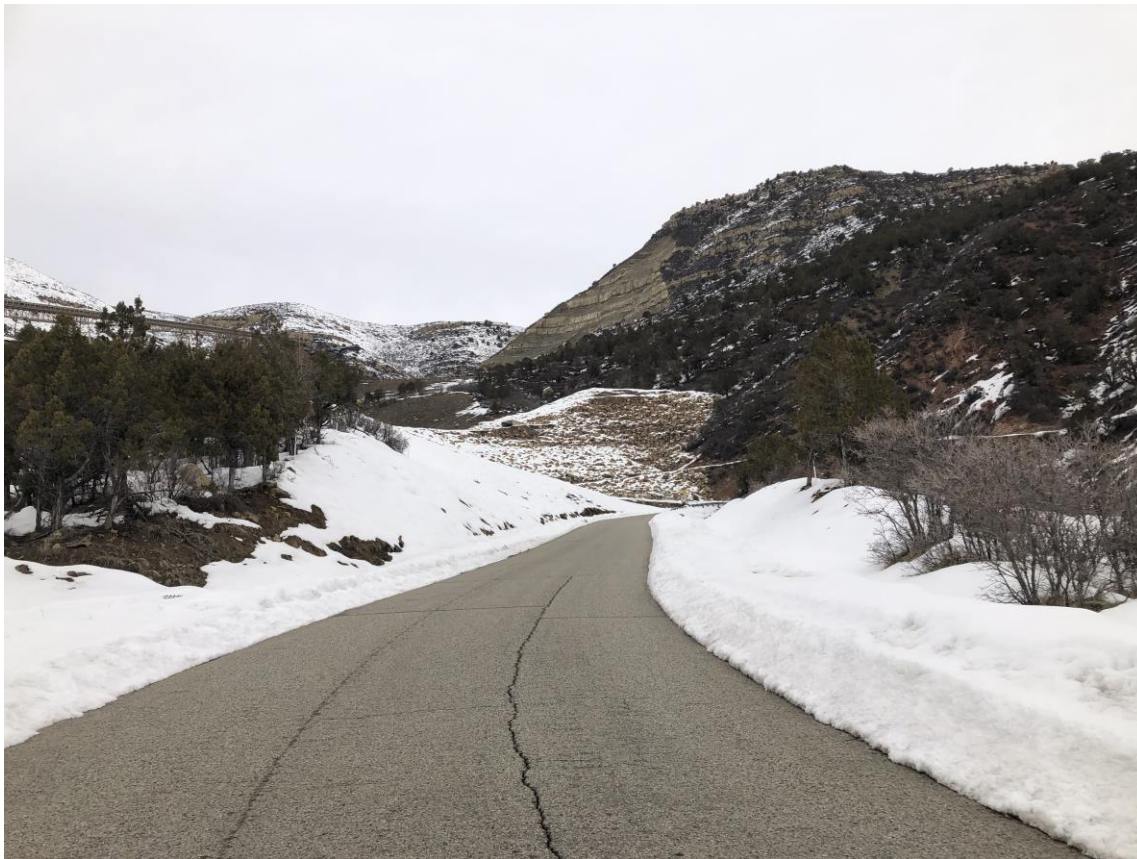
The road to the portals, and the slopes adjacent to the roads, were in good condition.

**Road to portals, with slope above Curve 8 in the center of photo**

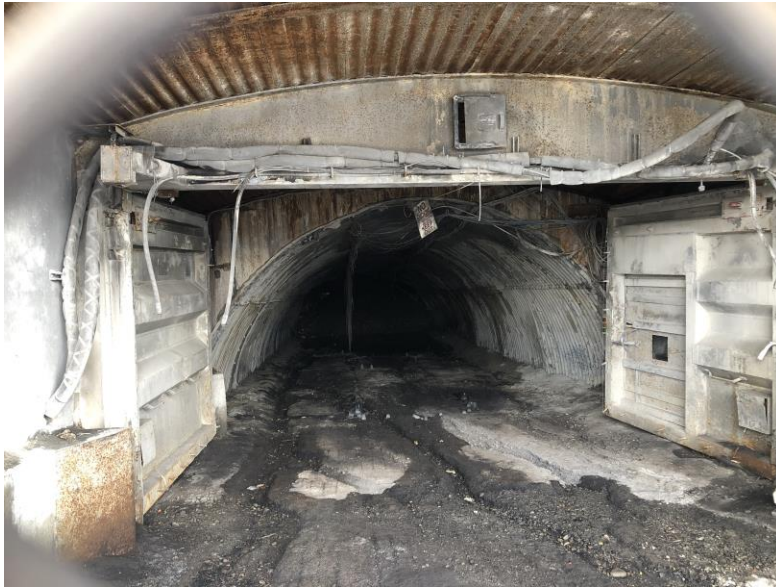
A cave in above the D portal (Bowie II portal) occurred around February 25, 2023, and appeared to be external to the seal. Repairs were performed on February 28, per correspondence with Tamme Bishop of Stover and Associates (email March 1, 2023). This area had not been reclaimed other than temporary seeding for stabilization. The hole on the surface was approximately a circle with a diameter of 16 to 20 feet, per Basil Bear and the photograph from Tamme Bishop. Thus, the approximate surface area of the cave in was 200 - 300 square feet.

**D Portal (Bowie II Portal) where cave in occurred above**

*Access area to cave in*

BRL staff used material from an unreclaimed area of the D Portal Bench to fill the hole. Basil Bear estimated that his crew used approximately 150 cubic yards, and they will add more material as the area settles.

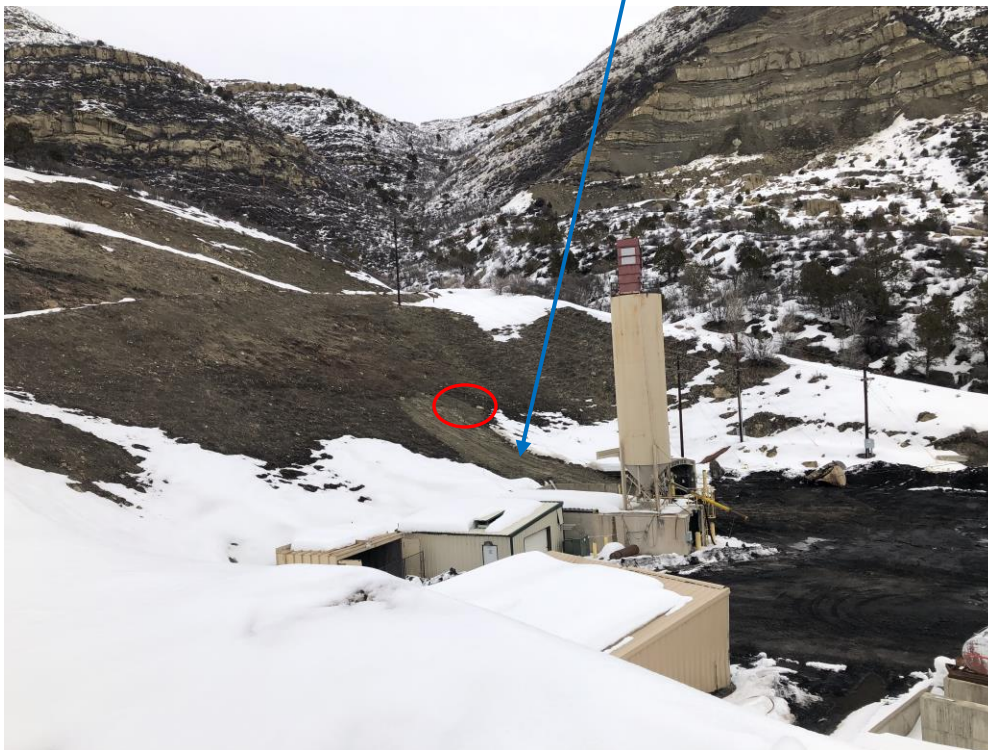
Basil also indicated that data from the operators of the flare at the Utility Bench (Hubbard Creek Coal Gas LLC) suggests that the cave in was external to the seal.

**D Portal – cave in area is circled**

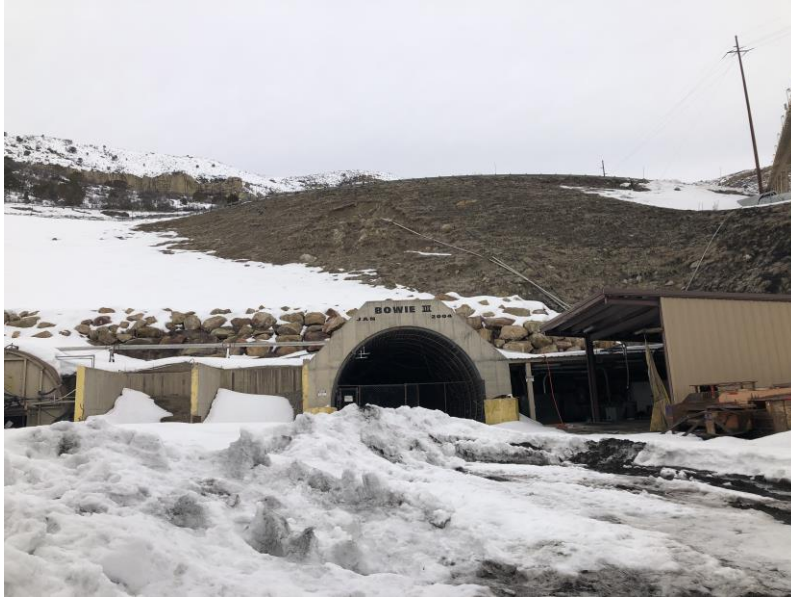
**B Portal entrance tunnel**

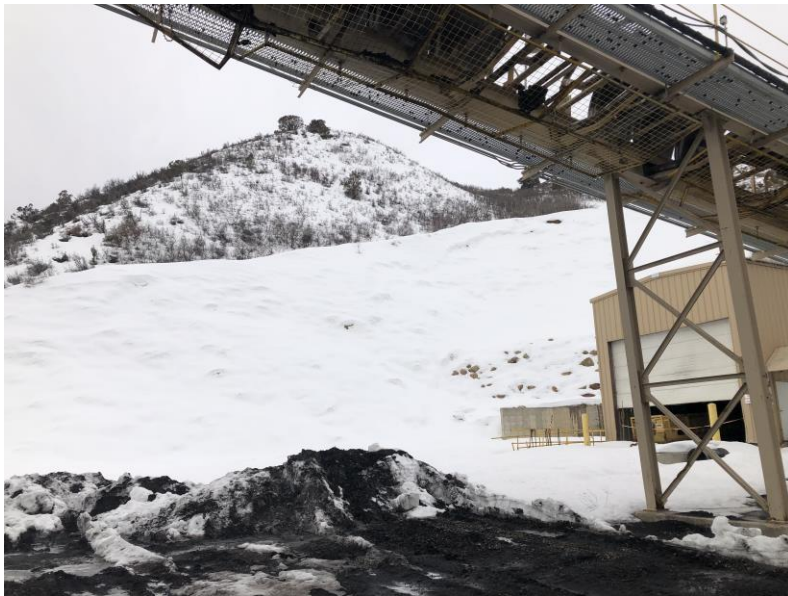
It appears that slumps by the B Portal and by Curve Number 11 along the Haul Road have not moved significantly in the recent past.

**B Portal slope on southwest side**

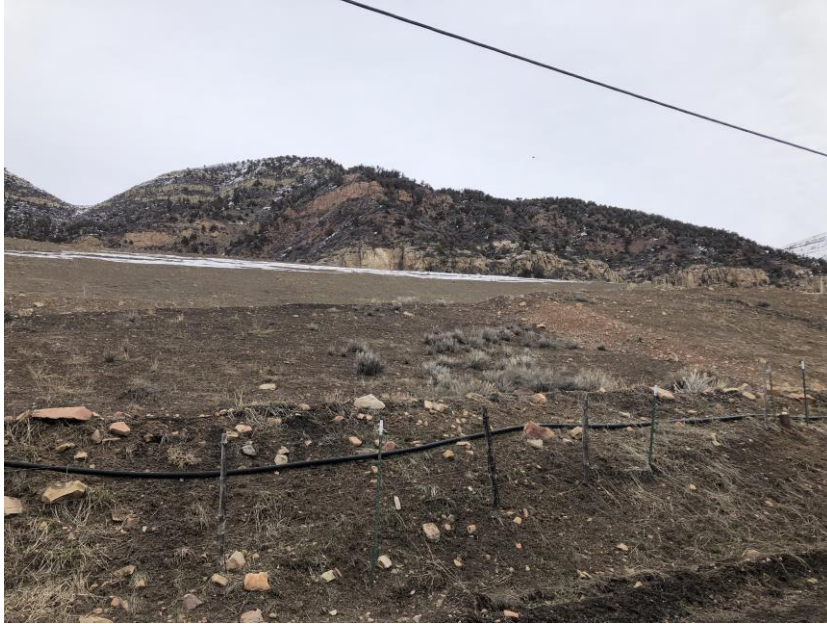
Based on review of Basil Bear's drone video, the ditches and erosion control practices on Gob Pile #2 are functioning well.

**Lower portion of Gob Pile #2**

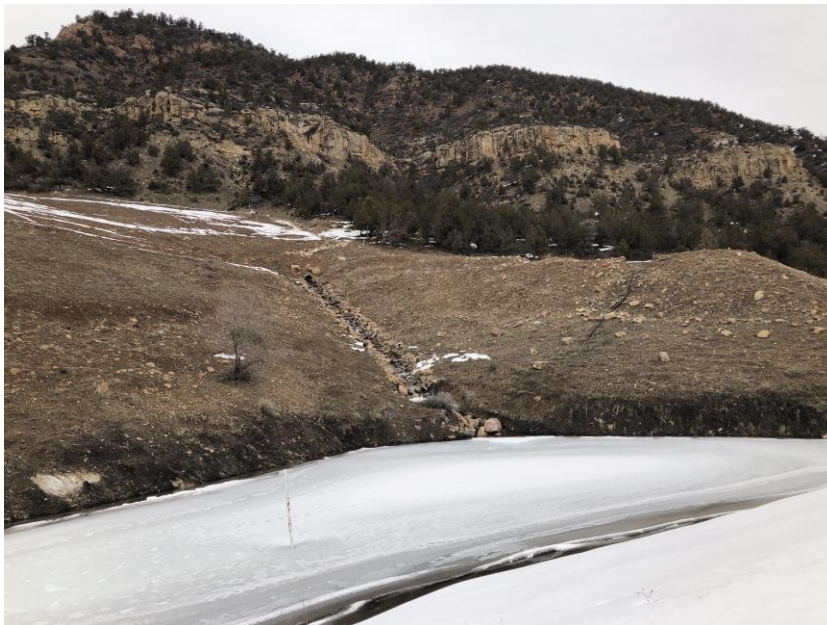
Four sediment ponds were inspected: B, F, J, and K. None of the ponds were discharging. All of the ponds contained water, ice and snow, but it was well below spillways. No significant problems were identified with embankments, spillways, inlet channels, or other features of the ponds.

**Pond F inlet channel, with soil pile on the right**

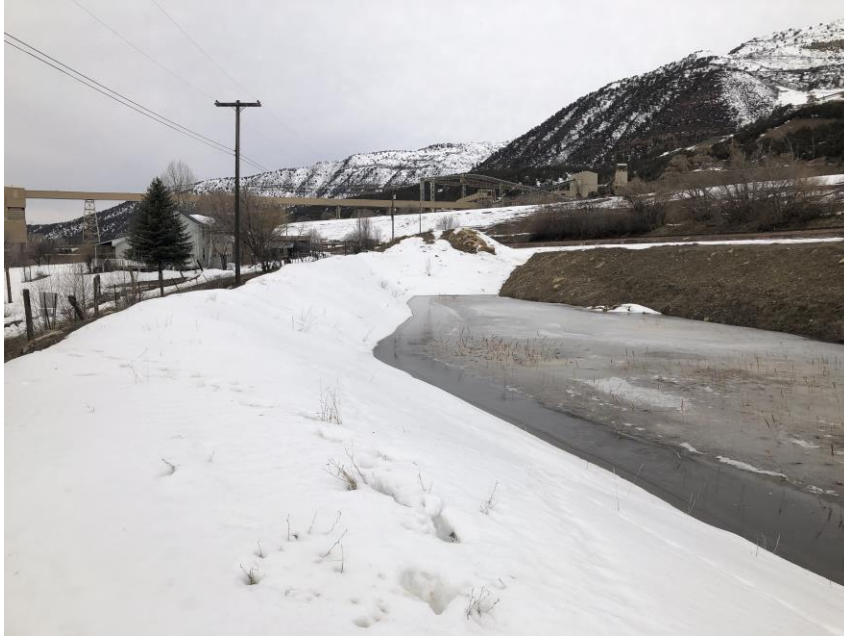
**Pond J embankment**

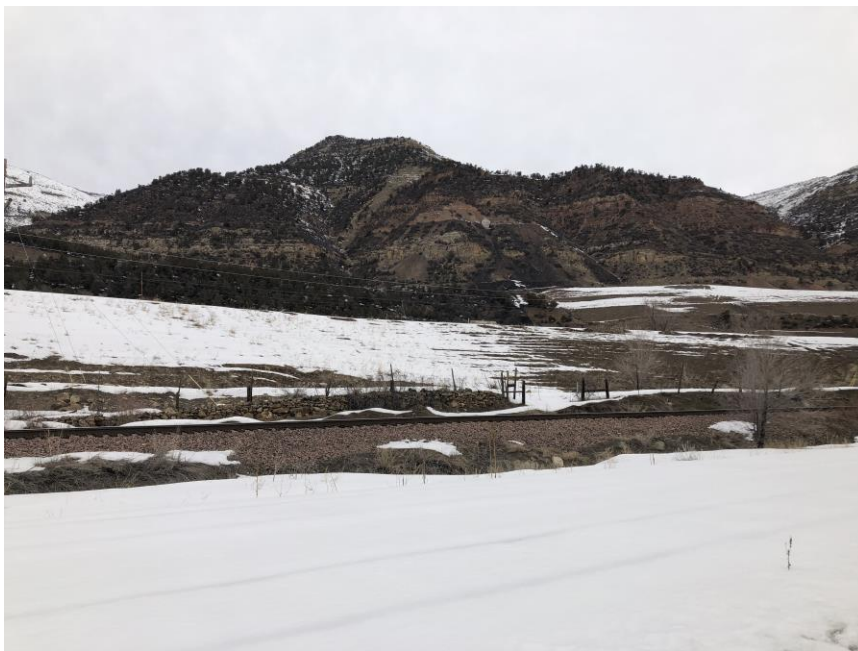
From afar, the gob piles appeared stable.

**Outslope of Gob Pile #3**
