MINERALS PROGRAM INSPECTION REPORT
PHONE: (303) 866-3567

MINE NAME: Lamar East Pit	MINE/PROSPECTING ID#: M-1977-572	MINERAL: Sand and gravel	COUNTY: Prowers
INSPECTION TYPE: Surety Release Inspection	WEATHER: Clear	INSP. DATE: February 24, 2023	INSP. TIME: 11:30
OPERATOR: City of Lamar	OPERATOR REPRESENTATIVE: Pat Mason	TYPE OF OPERATION: 112c - Construction Regular Operation	
REASON FOR INSPECTION: Surety Release Requested	BOND CALCULATION TYPE: None	BOND AMOUNT: \$0.00	
DATE OF COMPLAINT: NA	POST INSP. CONTACTS: None	JOINT INSP. AGENCY: None	
INSPECTOR(S): Nikie Gagnon	INSPECTOR'S SIGNATURE:

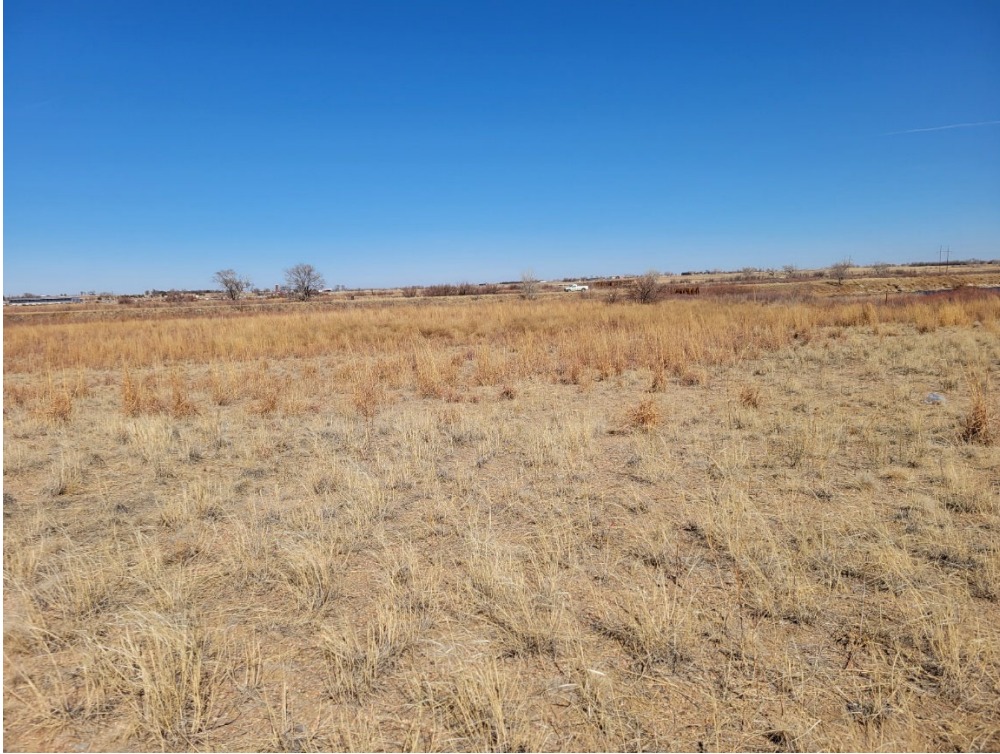
Photo 1. View looking east from parking lot. Grasses established in this area.

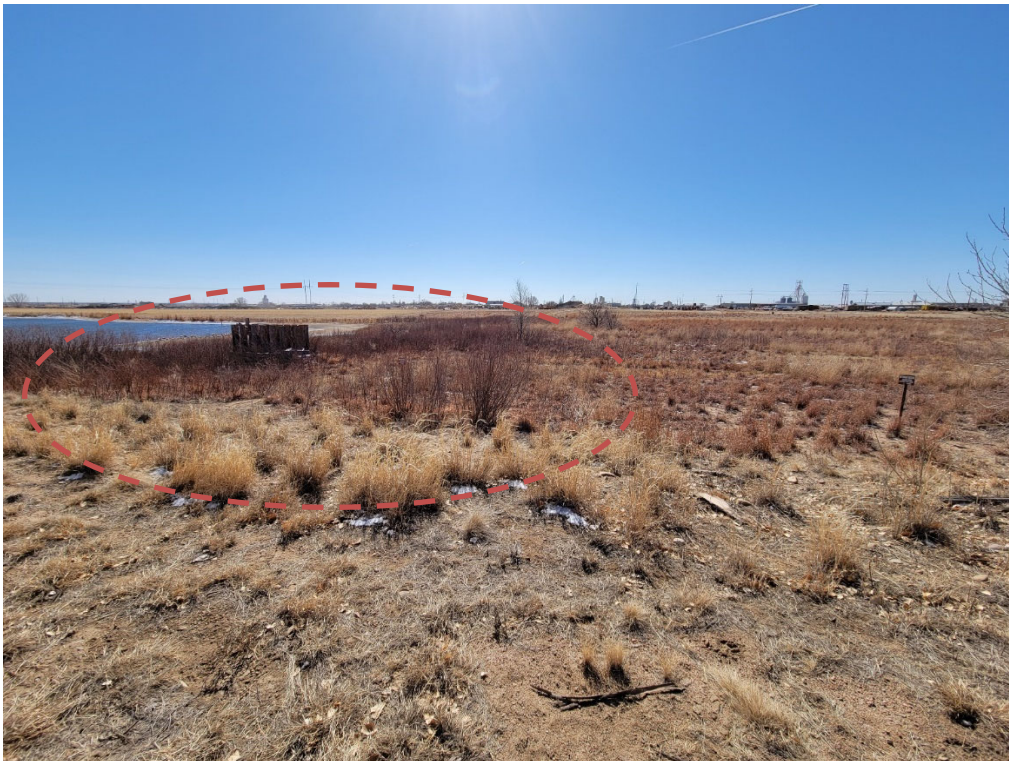
Photo 2. View looking southeast across area of Tamarisk abatement (indicated) on the west end of the middle pond.

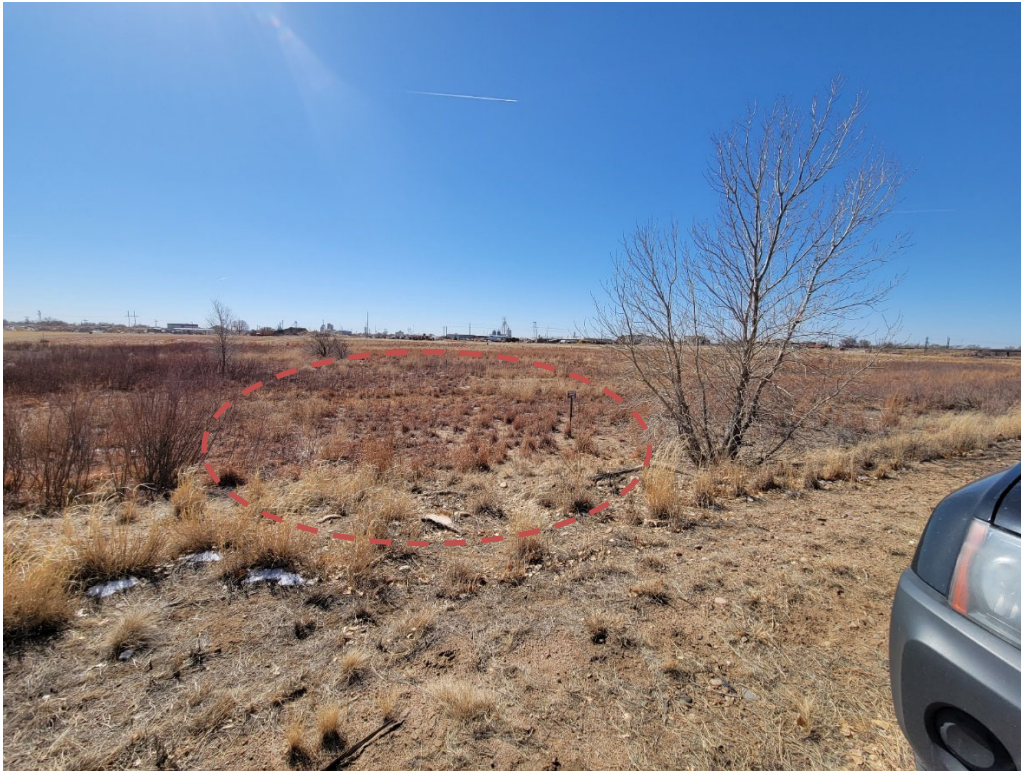
Photo 3. View looking southwest across area of Tamarisk abatement along the road.

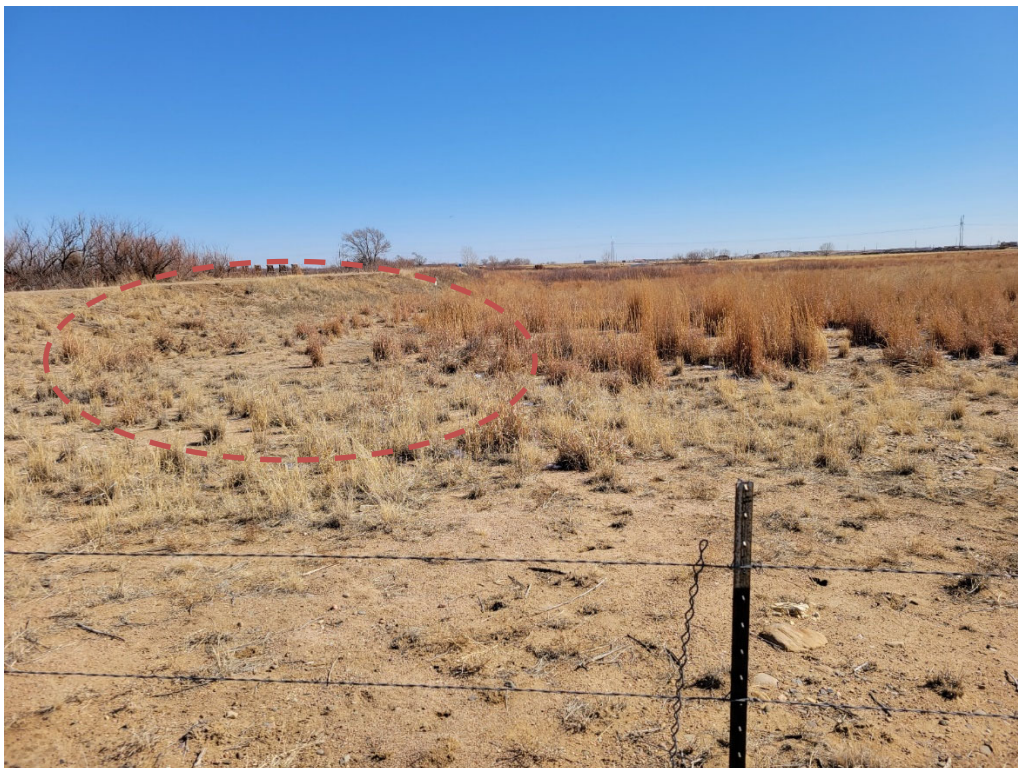
Photo 4. View from the edge of the parking area, looking south across western portion of the backfilled pond. Area of Tamarisk abatement last fall (indicated).

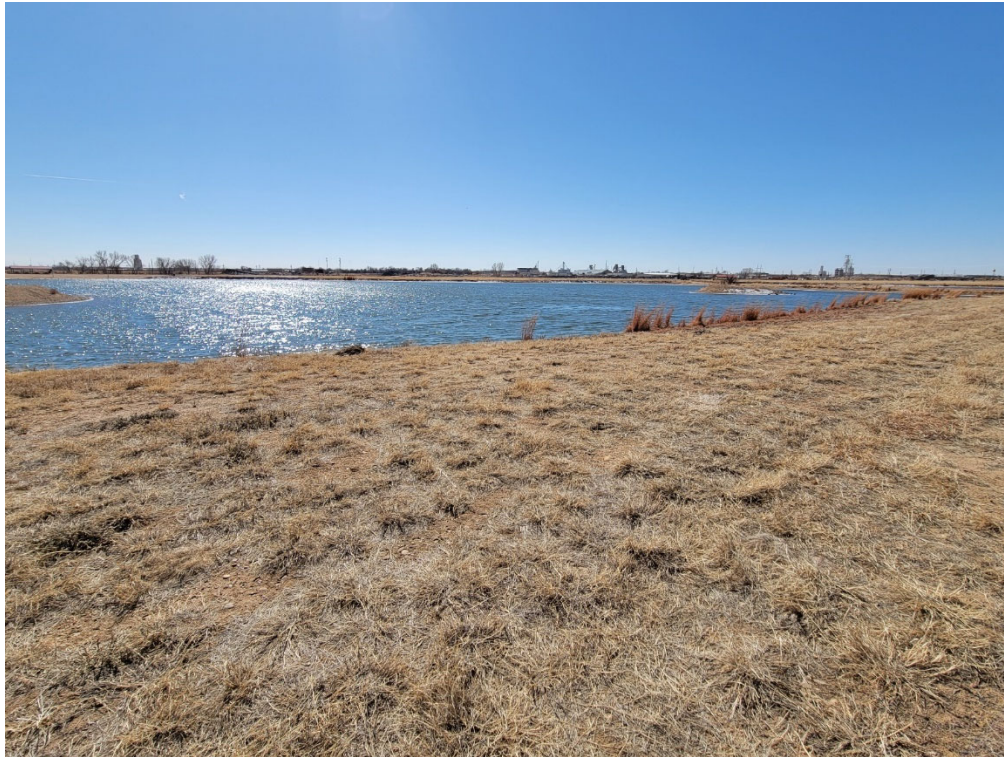
Photo 5. View looking southwest across area located north of middle pond, showing good vegetative cover.

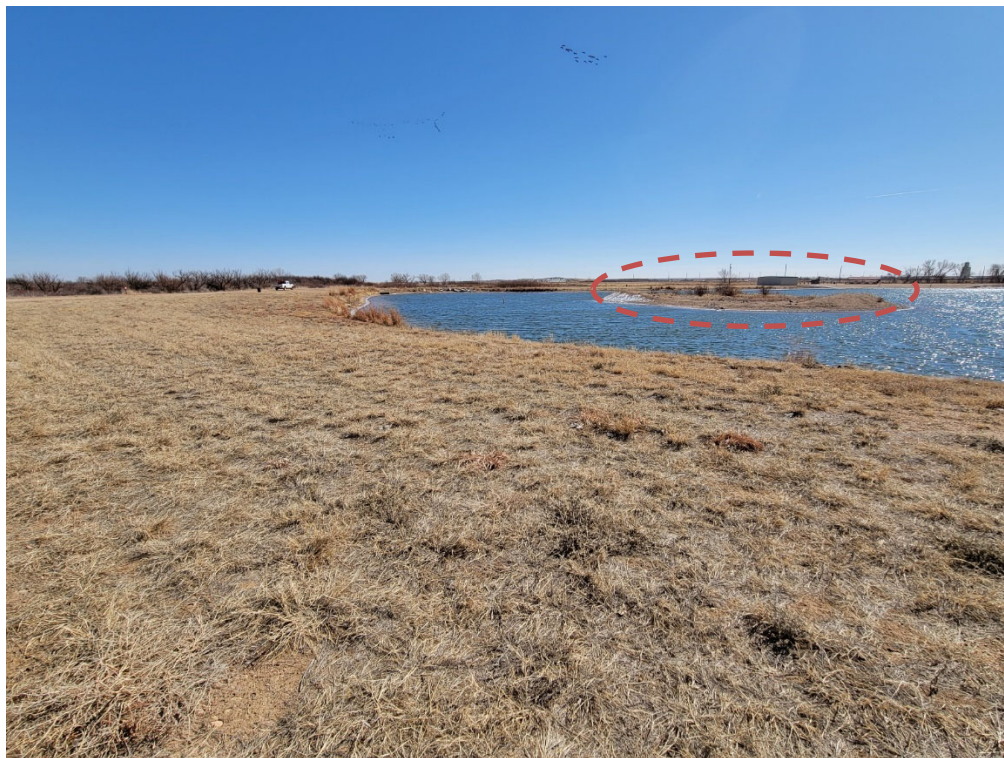
Photo 6. View looking south across area located north of easternmost pond, showing good grass cover in this area. One of two islands present in easternmost pond (indicated).

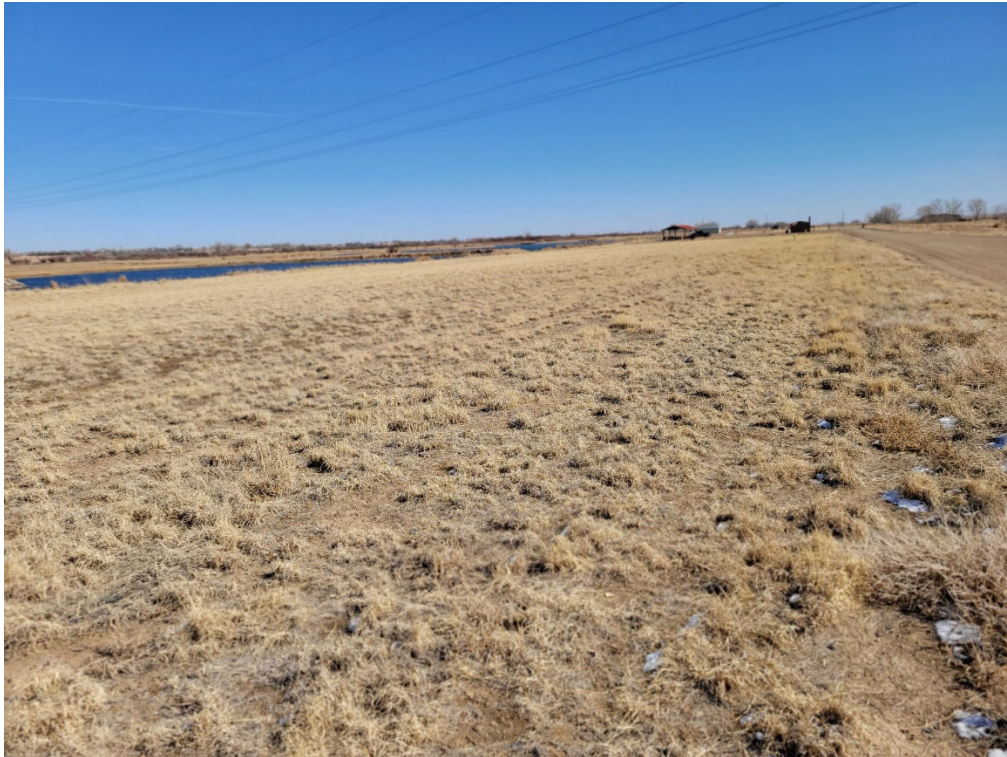
Photo 7. View looking east across area located south of middle and eastern pond, showing good vegetative cover in this area.

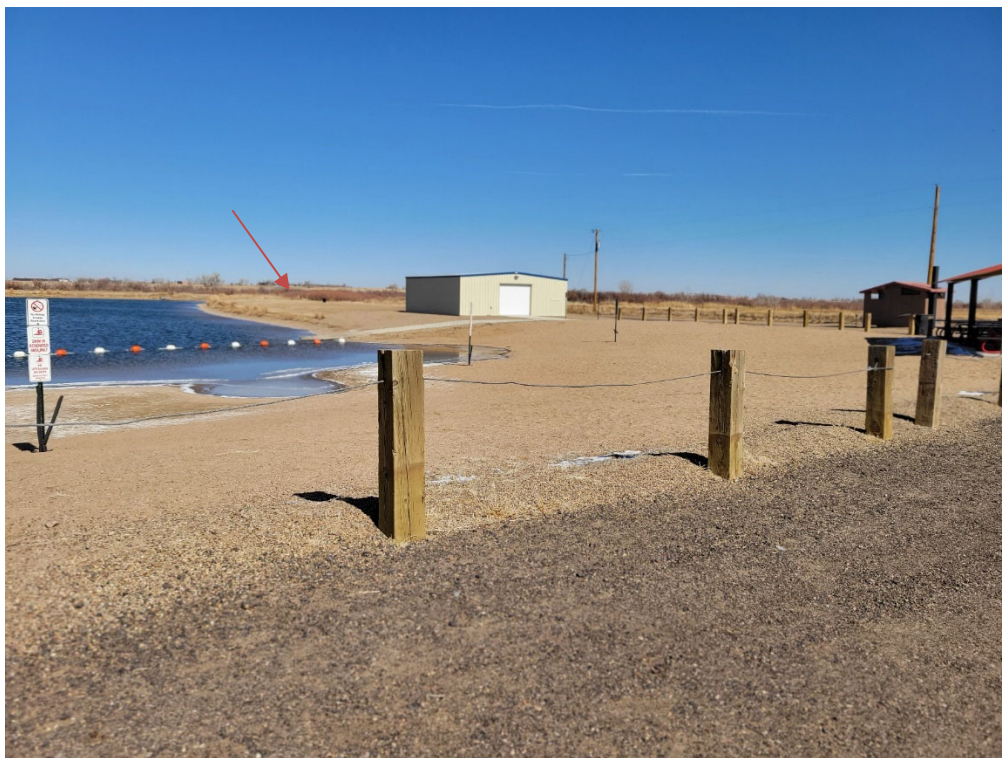
Photo 8. View looking east across area located southeast of easternmost pond, picnic/shade structure, restroom facility, and storage building installed in this area for park use. Area used for kayak and paddleboard storage noted by arrow.

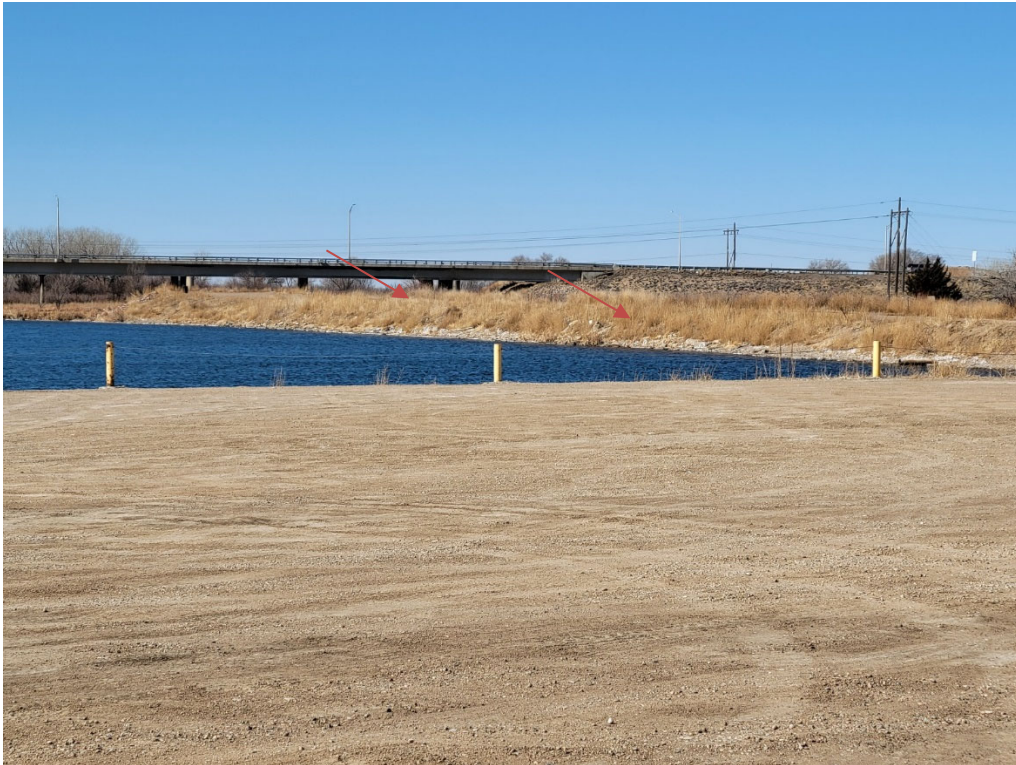
Photo 9. View looking northwest across parking area located in between western and middle ponds. Good vegetative cover established along the banks.

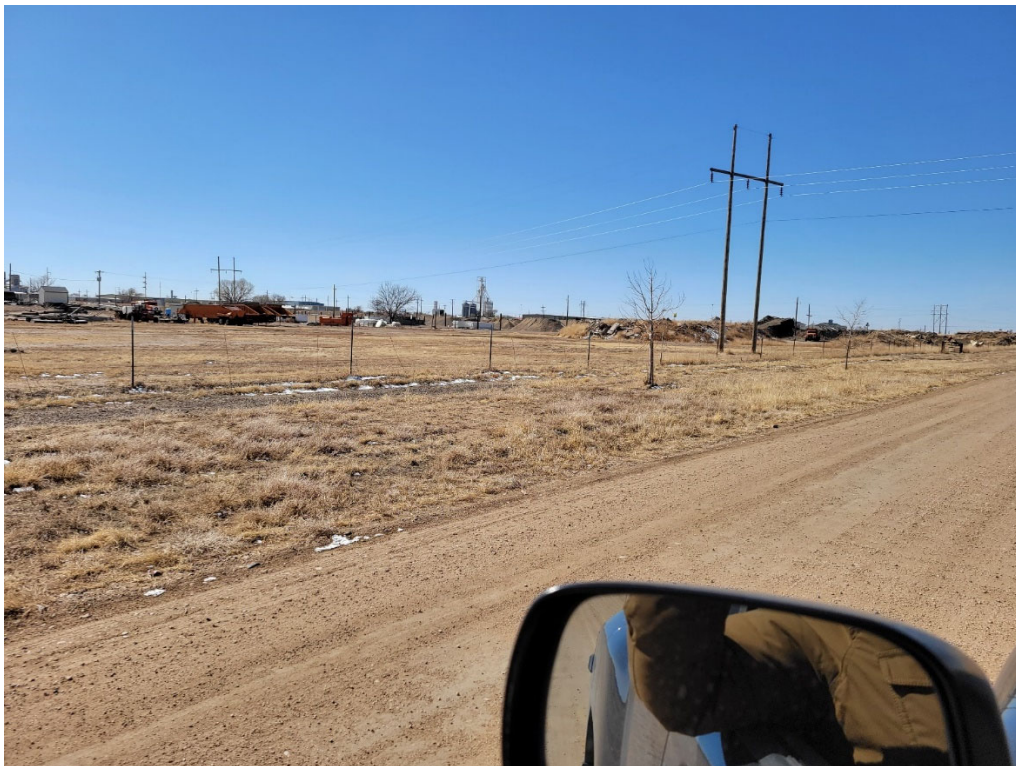
Photo 10. Looking down the southern boundary of permit area. Trees planted along the road and grass is well established.
