**MINERALS PROGRAM INSPECTION REPORT**  
**PHONE: (303) 866-3567**

<b>MINE NAME:</b> Pikeview Quarry	<b>MINE/PROSPECTING ID#:</b> M-1977-211	<b>MINERAL:</b> Limestone (general), granite, granite gneiss and dolomite	<b>COUNTY:</b> El Paso
<b>INSPECTION TYPE:</b> Monitoring	<b>WEATHER:</b> Snowing	<b>INSP. DATE:</b> February 22, 2023	<b>INSP. TIME:</b> 09:00
<b>OPERATOR:</b> Continental Materials Corporation	<b>OPERATOR REPRESENTATIVE:</b> Paul Kos & Leif Neufeld	<b>TYPE OF OPERATION:</b> 112c - Construction Regular Operation	
<b>REASON FOR INSPECTION:</b> High Priority	<b>BOND CALCULATION TYPE:</b> None	<b>BOND AMOUNT:</b> \$13,389,784.00	
<b>DATE OF COMPLAINT:</b> NA	<b>POST INSP. CONTACTS:</b> U.S.Forest Service	<b>JOINT INSP. AGENCY:</b> None	
<b>INSPECTOR(S):</b> Timothy Cazier, P.E	<b>INSPECTOR'S SIGNATURE:</b>

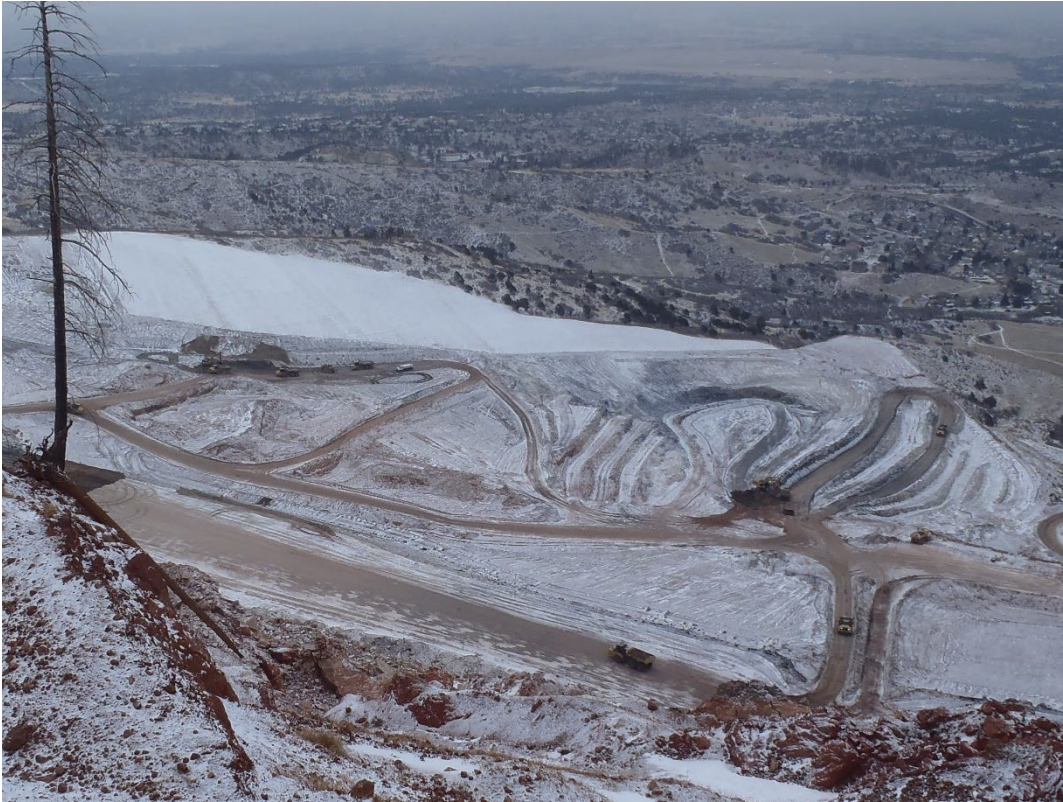
Backfill/Grading: The site was continuing to import backfill from offsite and directing truck drivers to unload offsite material out of the working area. Backfill was being actively excavated from both the north (**Photo 1**) and south borrow areas (**Photo 2**). Site representatives stated the compacted backfill had been placed to an elevation of 7,300 feet (amsl). Light snow was falling during the inspection. Stantec representatives directed the construction crews to remove snow cover on work areas prior to placing backfill (**Photo 3**).

Photo 1. Active excavation of north borrow area (looking north from top of highwall).

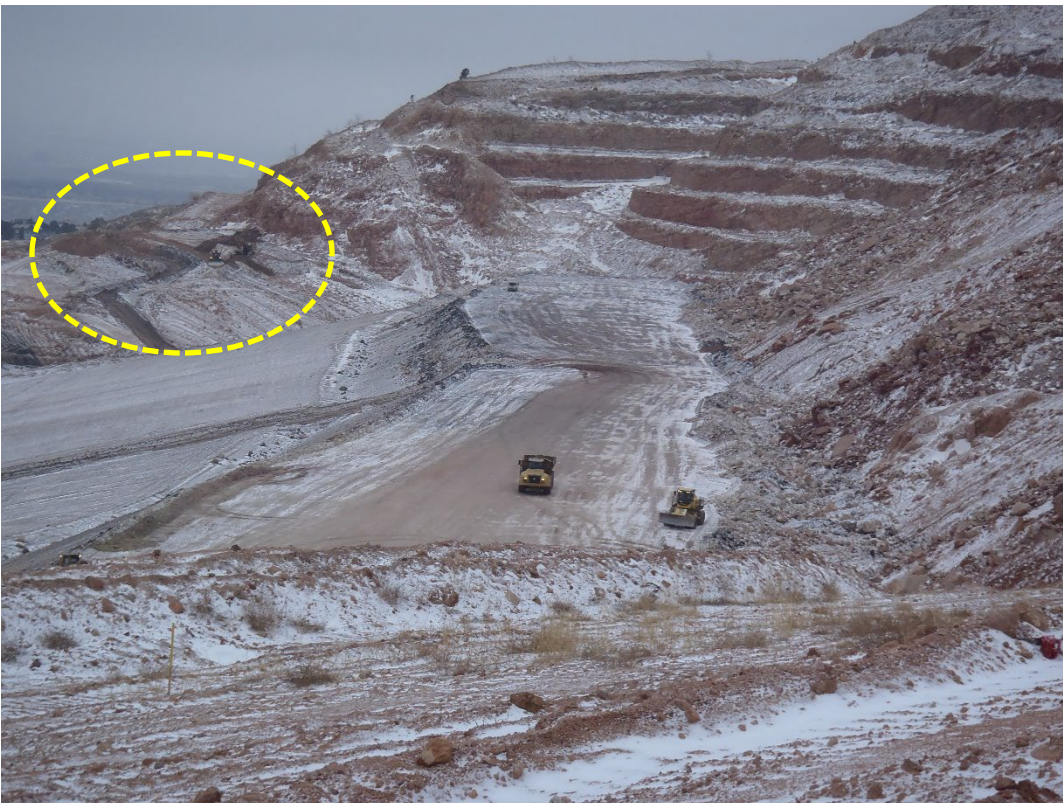
Photo 2. Active excavation of south borrow area (looking south from near north borrow area).

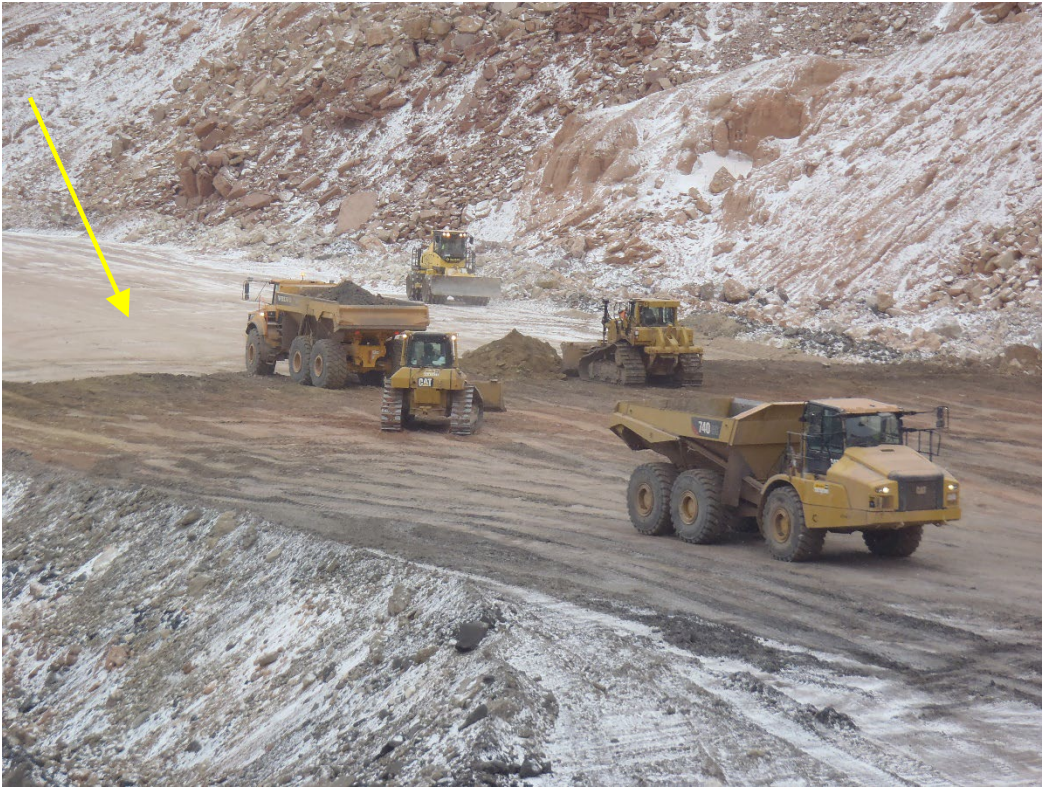
Photo 3. Cleared snow ahead of backfill progressing north to south (looking SW from near north borrow area).

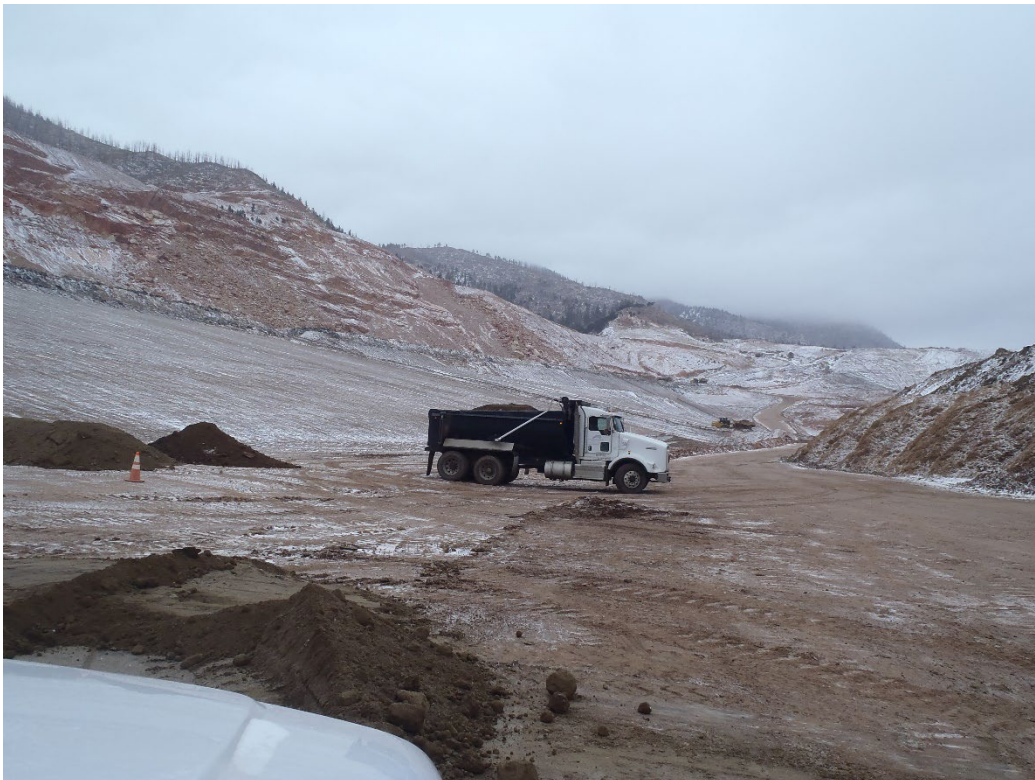
Topsoil: Topsoil is also continuing to be imported. A truck bringing topsoil on site was observed during the inspection. Site representatives directed the driver to place the material at the toe of the backfill near the south end (**Photo 4**). Additional salvaged topsoil is stockpiled north of the office building and is labeled as such (**Photo 5**).

Photo 4. Placing imported topsoil at toe of backfill (looking north).

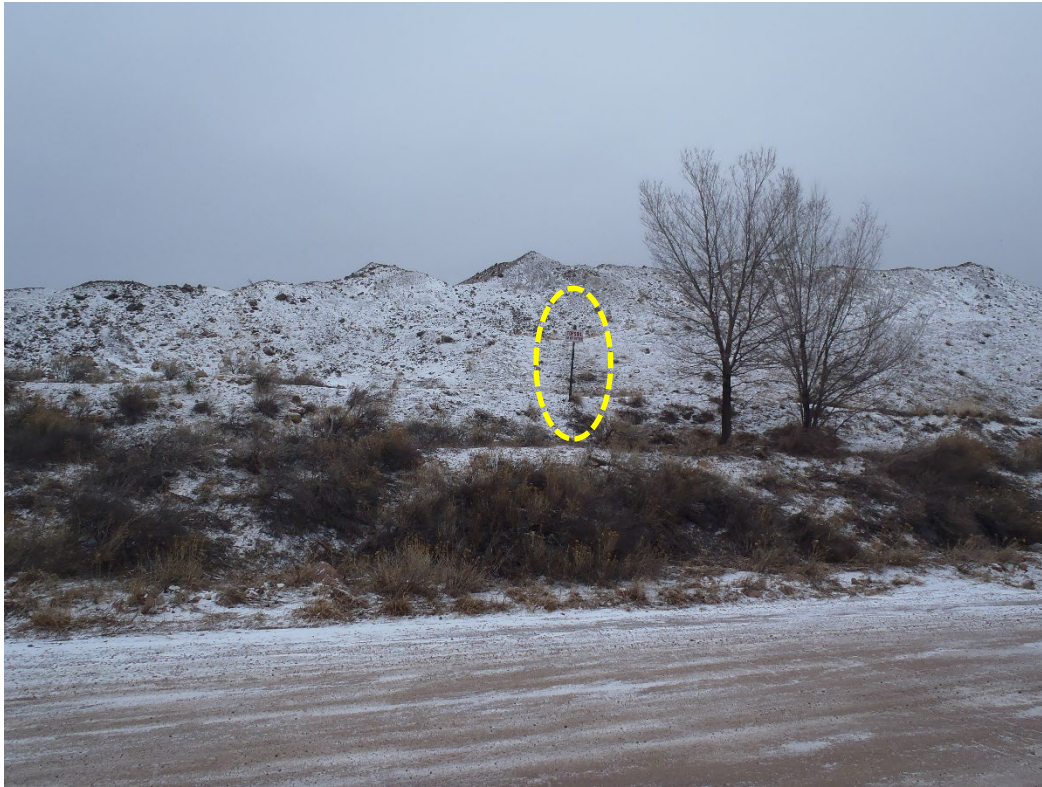
Photo 5. Labeled (circled sign) topsoil stockpile north of office building.
