**MINERALS PROGRAM INSPECTION REPORT**  
**PHONE: (303) 866-3567**

<b>MINE NAME:</b> Raindance Reservoir #2	<b>MINE/PROSPECTING ID#:</b> M-2021-049	<b>MINERAL:</b> Borrow material for construction and clay (general)	<b>COUNTY:</b> Weld
<b>INSPECTION TYPE:</b> Monitoring	<b>WEATHER:</b> Clear	<b>INSP. DATE:</b> March 9, 2023	<b>INSP. TIME:</b> 10:00
<b>OPERATOR:</b> Vima Partners, LLC	<b>OPERATOR REPRESENTATIVE:</b> Cody Wooldridge	<b>TYPE OF OPERATION:</b> 112c - Construction Regular Operation

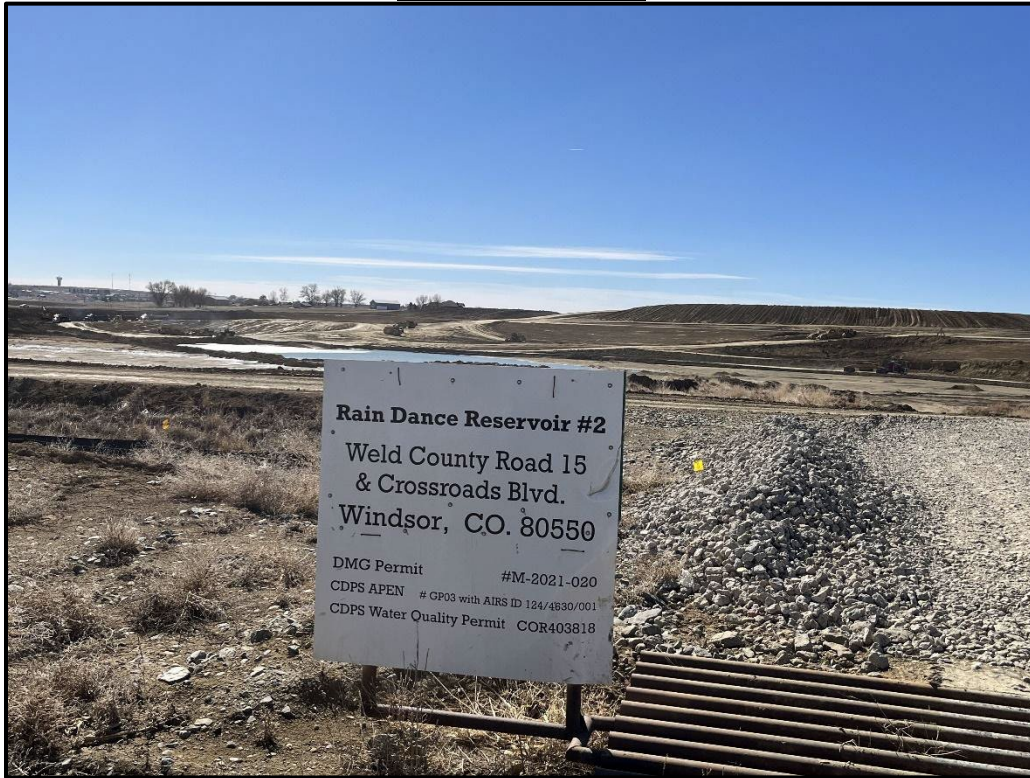
The mine identification sign and affected area boundary markers are in place and in compliance with Rule 3.1.12. The sign is located at the entrance of the site (Photo 1). The perimeter has been marked with posts to clearly delineate the permit boundary. The notice sign required by Rule 1.6.2(1)(b) was posted at the entrance to the mine site.

Photo 1: Appropriate signage located at the mine entrance to the North on E. Crossroads Boulevard.

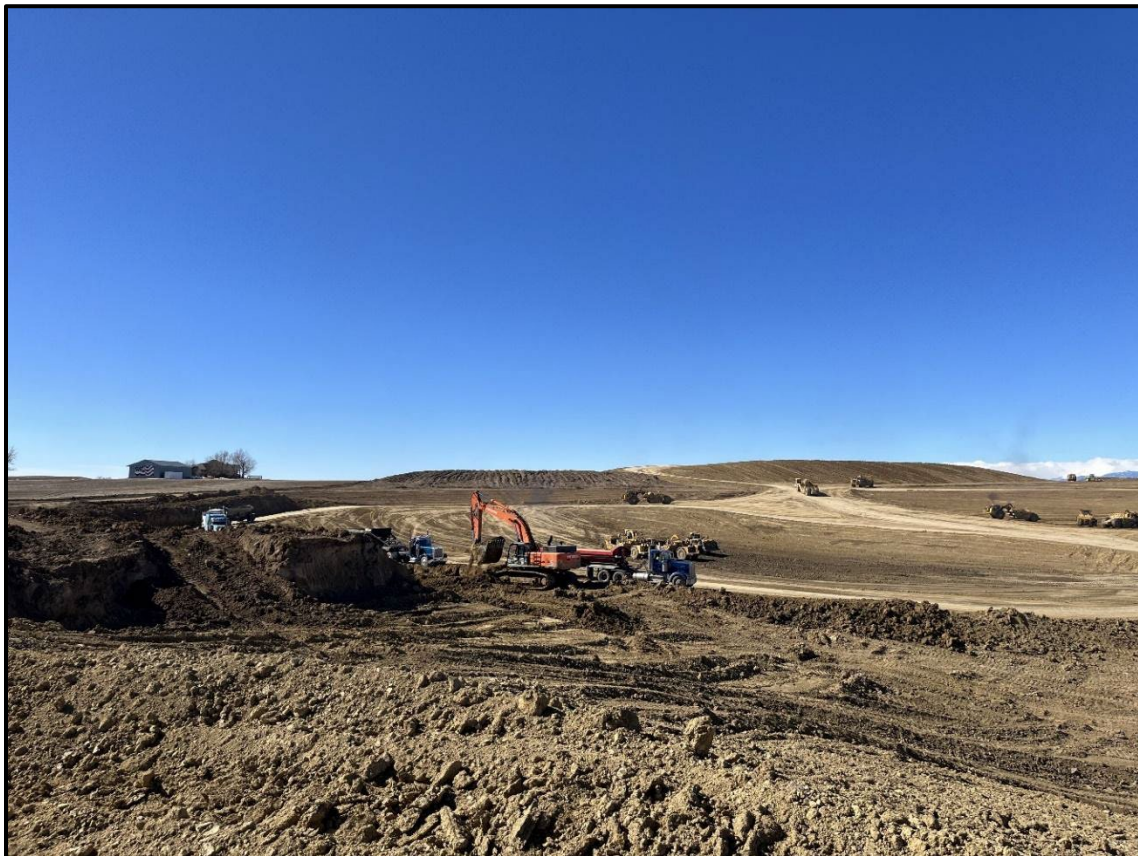
Photo 2: View southeast of mine operation. Site was active at the time of inspection.

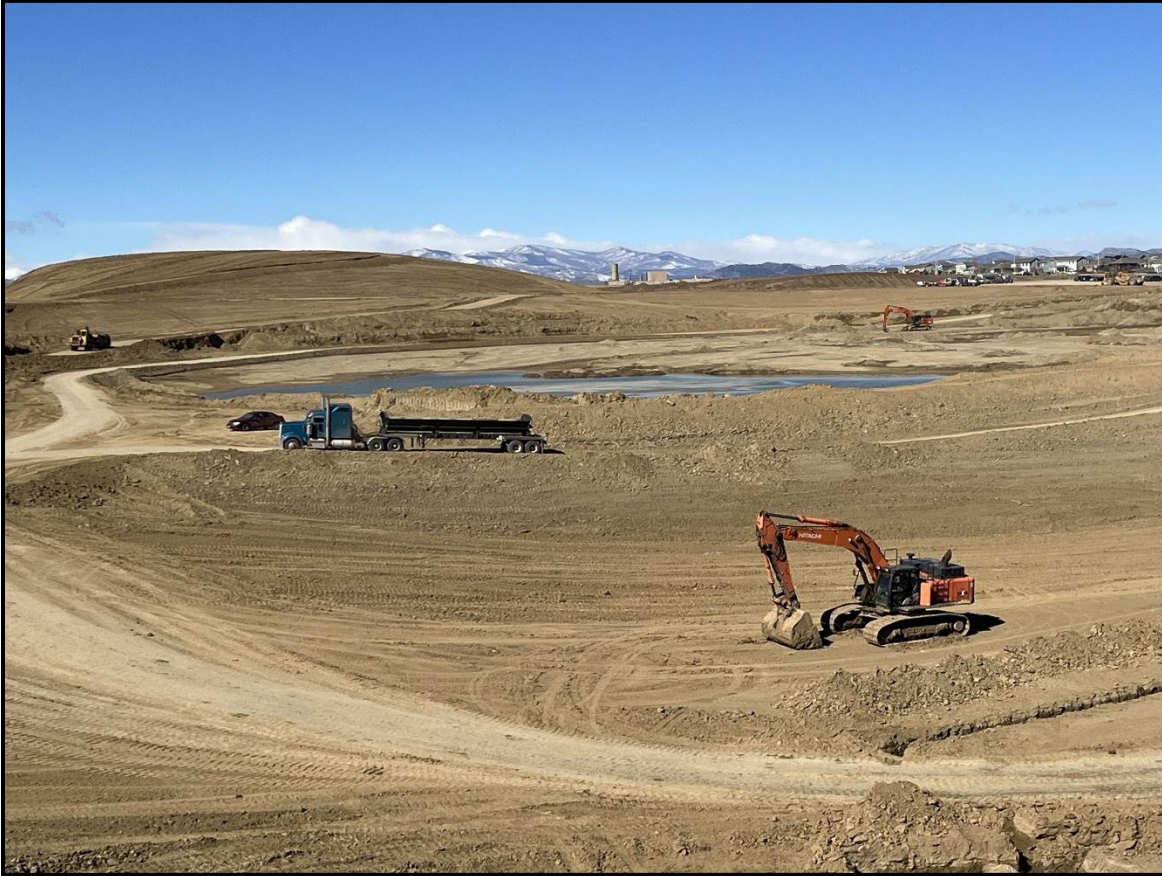
**PROBLEM/POSSIBLE VIOLATION:** Problem: The site is improperly impounding surface drainage/runoff.

The site is composed entirely of sandy clay borrow material with a clay subsurface. The impermeability of this subsurface traps rainwater and snowmelt in the center of the mine site (Photo 3). The operator indicated there is approximate 18" of water currently impounded at the site and said that a similar level of water impoundment has been present in that area for years. Pursuant to State Engineer (Division of Water Resources) statutes, all impounded storm water must be pumped out within 72 hours of the event. Therefore, under Rule 3.1.6(1)(a), the Division is citing a problem for failing to comply with applicable Colorado water laws and regulations governing injury to existing water rights. Corrective action will require submitting evidence to the Division that the impoundment has been pumped by the corrective action due date.

Photo 3: View W of impounded water, approximately 18in deep. Impermeable nature of the surrounding clay subsurface traps snowmelt and rainwater.

**CORRECTIVE ACTIONS:** Corrective action will require submitting evidence to the Division that the impoundment has been pumped by the corrective action due date.

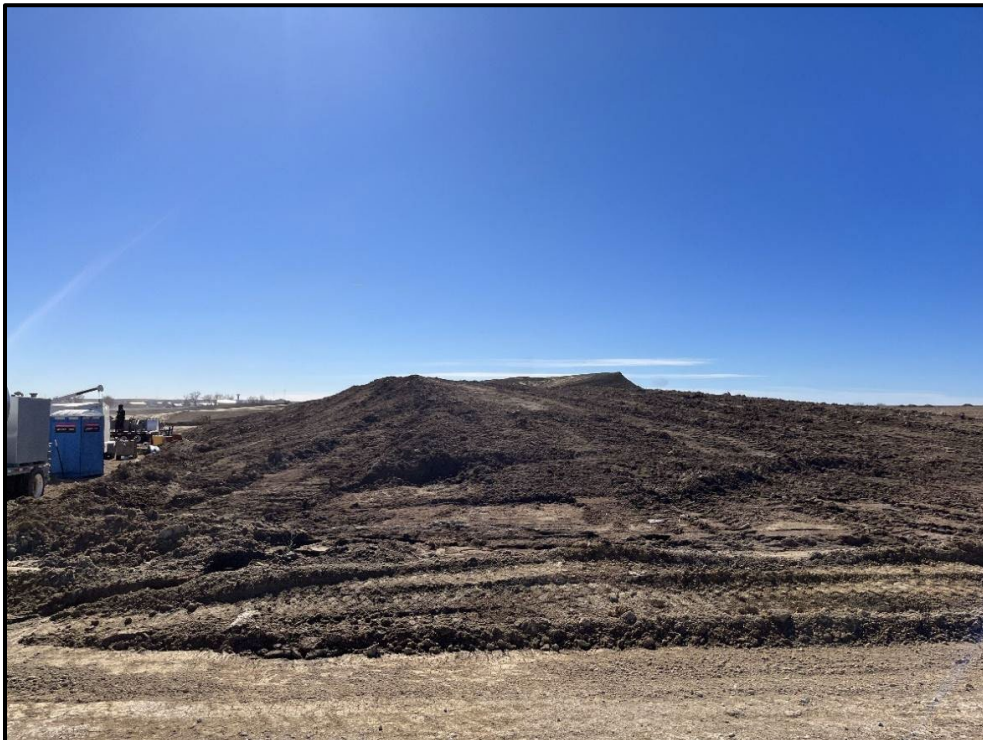
Various topsoil stockpiles were located around the mine site (Photo 4). Please ensure that all topsoil piles are appropriately vegetated in the Spring/Fall season to promote stabilization and prevent erosion as stated in the mine plan and as required by Rule 3.1.9.

Photo 4: Topsoil stockpile located at the northern end of the operation. Currently unvegetated.

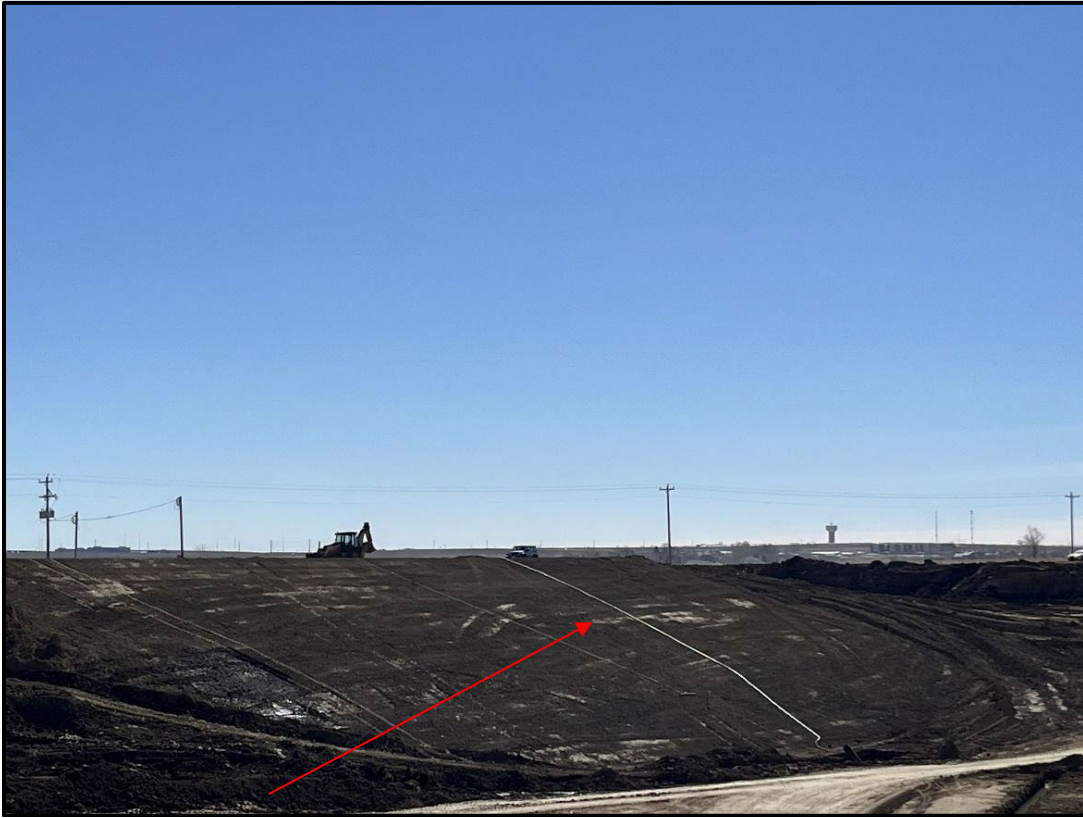
**PROBLEM/POSSIBLE VIOLATION:** Possible Violation: Land has been affected outside of the approved permit boundary. This is a possible violation at this time pursuant to: C.R.S. 34-32.5-116(4)(i) for failure to protect areas outside of the affected land from slides or damages occurring during the mining operation.

While touring the mine site, the operator indicated that storm water is diverted from the site into a trench and pumped up the east side of the site (Photos 5 & 6). Water is then pumped under WCR 15 through a culvert and deposited into two pre-existing sediment ponds which then discharges to a point approximately two miles away into the Cache la Poudre River. This discharge is covered under NPDES Permit No. COR403818. However, these irrigation/sediment ponds currently exist outside of the permit boundary and occupy an approximately 0.5 acre area (Photo 7). Satellite imagery and Google Earth tools were used to calculate approximate acreage. Under Rule 1.1(3), settling ponds constitute 'affected land' (referenced below). Therefore, the Division is citing a possible violation for affecting area outside the permit boundary. The corrective action for this possible violation will require a hearing before the Mined Land Reclamation Board, tentatively scheduled for April 19-20, 2023.

Photo 5: View to the SE of a pump which discharges storm water into two sediment ponds located east across WCR 15.

**CORRECTIVE ACTIONS:** This matter will be scheduled for consideration by the Mined Land Reclamation Board (MLRB) at the April 19, 2023 meeting, during which, the MLRB may issue a violation, assess a civil penalty, and/or order corrective actions. A Reason to Believe a Violation Exists and Notice of Board Hearing letter will be sent to the operator separately from this report.

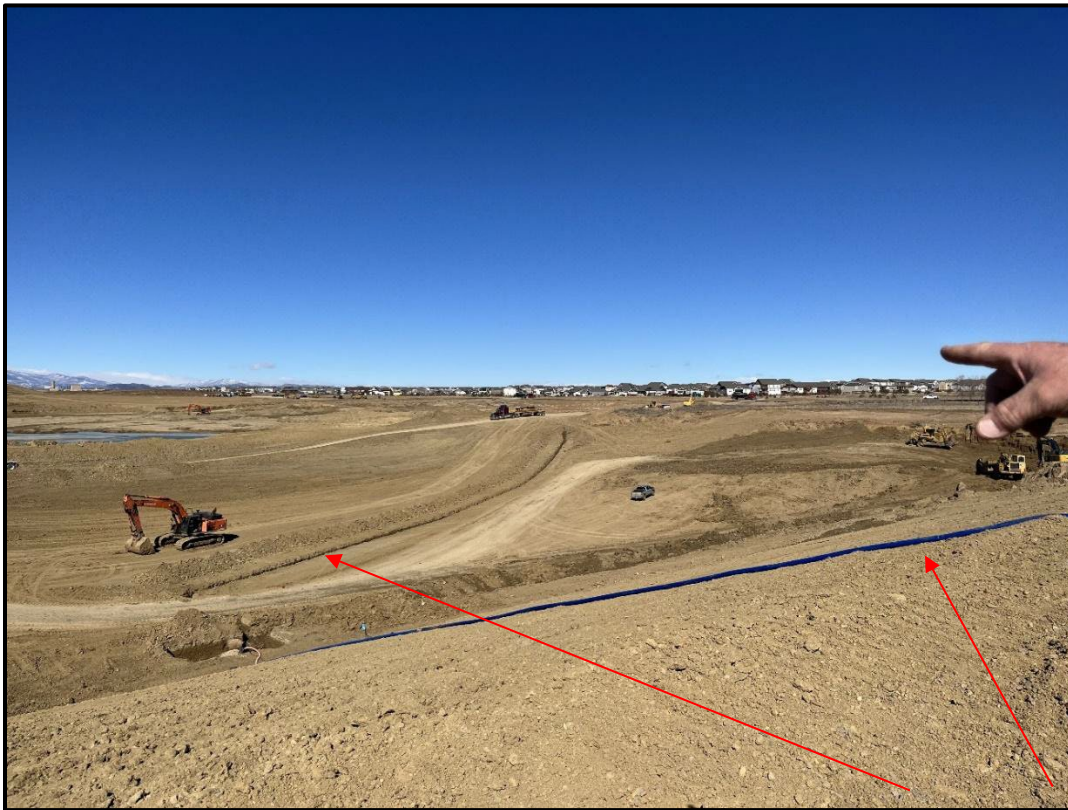
Photo 6: View to the northwest from the eastern boundary of the 111c permit. A trench and blue hose can be seen which pumps storm water across WCR 15 and into two nearby irrigation ponds.

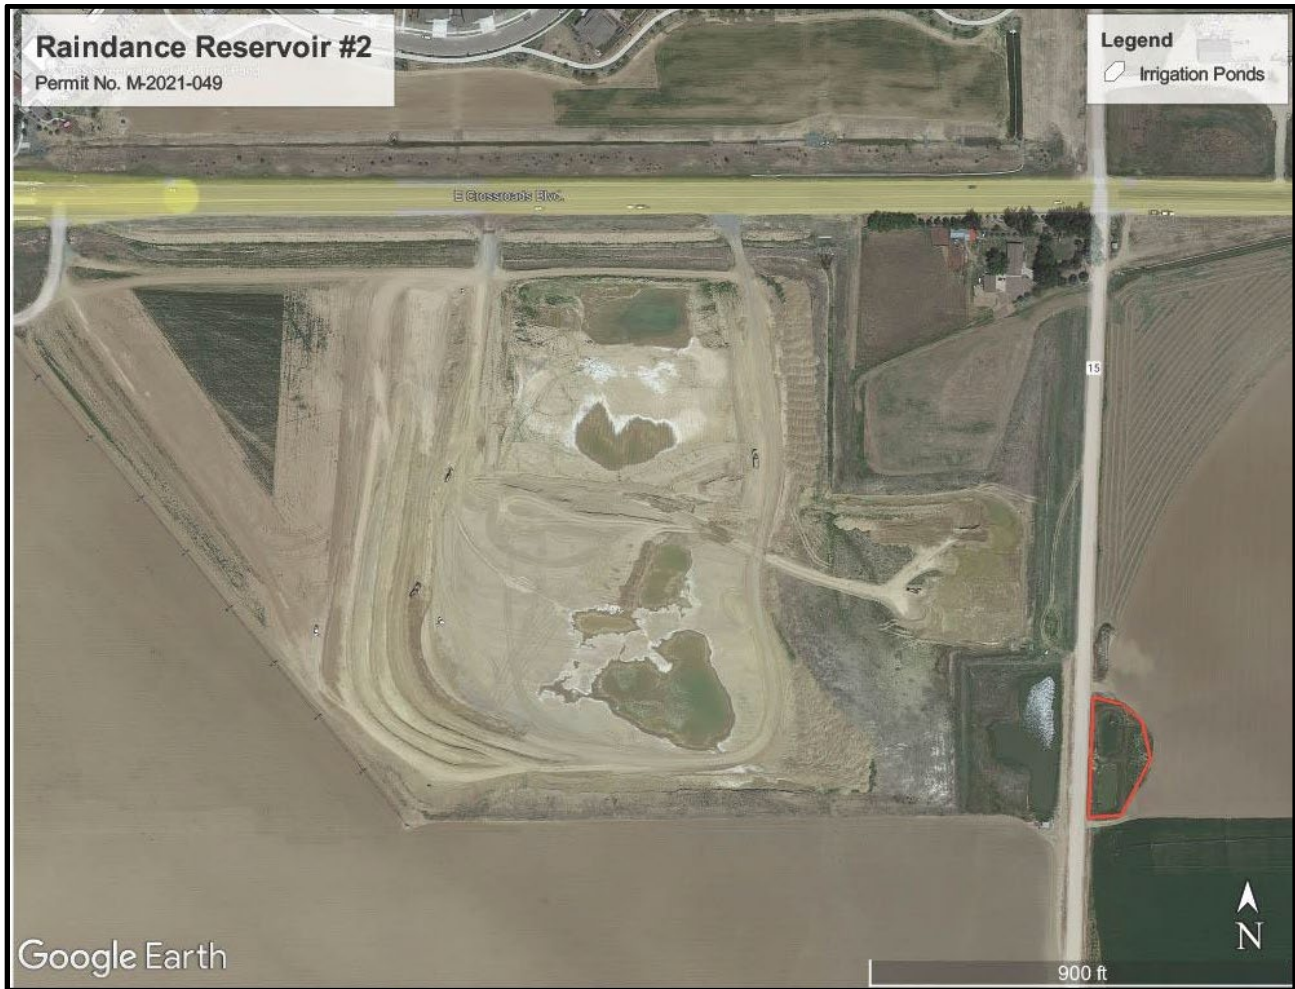
Photo 7: Google Earth screen grab which shows the location of the two irrigation ponds (highlighted in red).

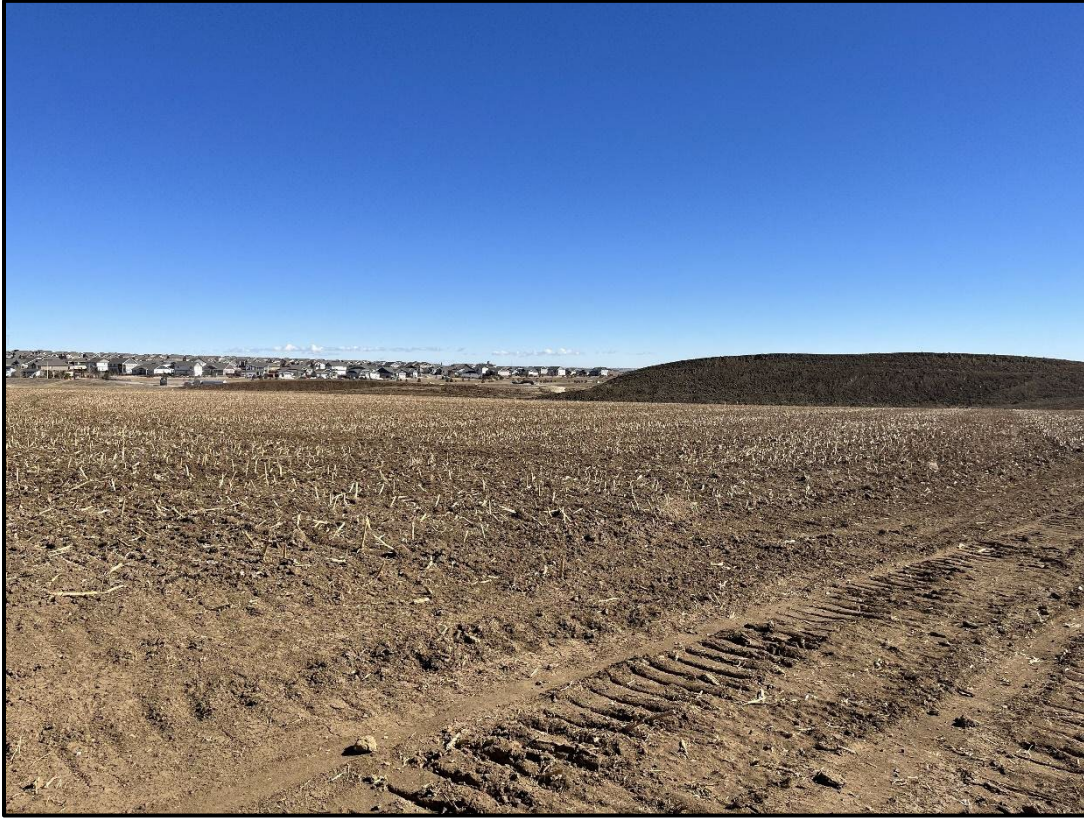
Photo 8: View northeast from the western side of the permit boundary, shows a portion of the area to be added with the AM-01 application.
