MINERALS PROGRAM INSPECTION REPORT
PHONE: (303) 866-3567

MINE NAME: Perdue	MINE/PROSPECTING ID#: M-2000-089	MINERAL: Sandstone	COUNTY: Boulder
INSPECTION TYPE: Monitoring	WEATHER: Clear	INSP. DATE: March 13, 2023	INSP. TIME: 09:00
OPERATOR: Mary Vasquez	OPERATOR REPRESENTATIVE: Doug Ruppel	TYPE OF OPERATION: 110c - Construction Limited Impact	
REASON FOR INSPECTION: Priority	BOND CALCULATION TYPE: None	BOND AMOUNT: \$12,500.00	
DATE OF COMPLAINT: NA	POST INSP. CONTACTS: None	JOINT INSP. AGENCY: None	
INSPECTOR(S): Patrick Lennberg	INSPECTOR'S SIGNATURE:

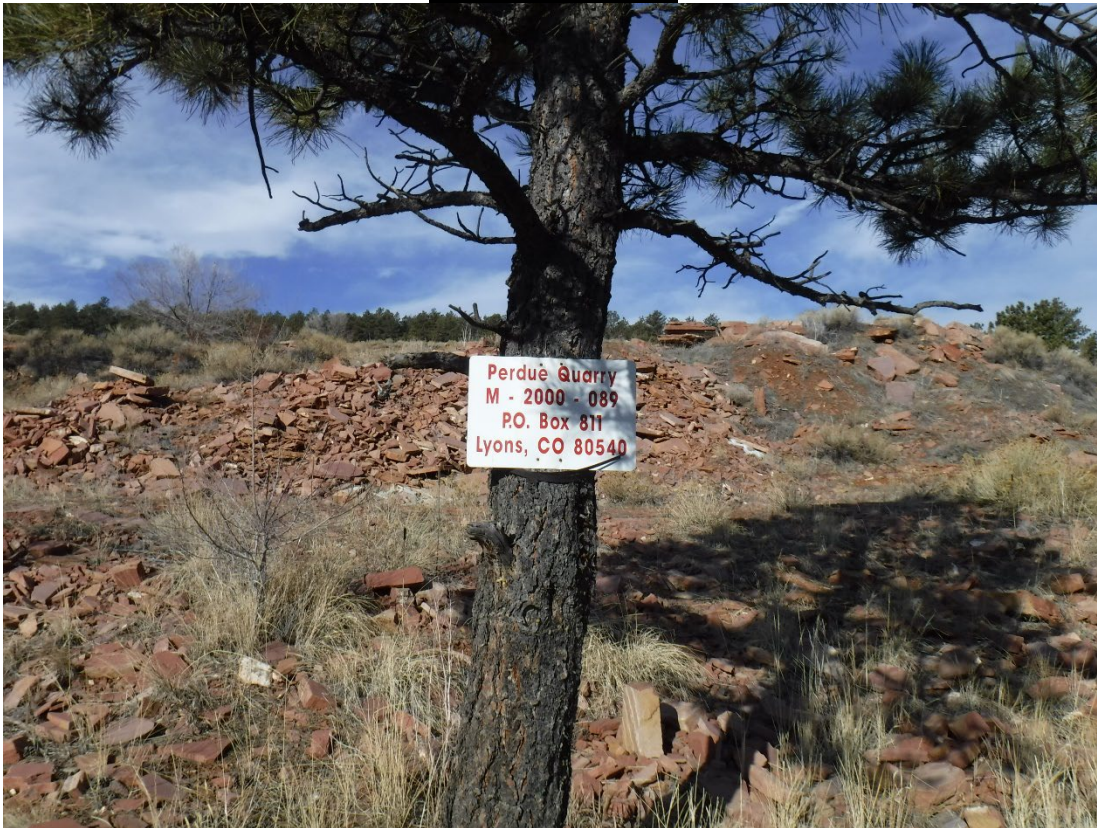
The Perdue site is a 110c operation permitted for 9.7 acres. The permit is for the mining of sandstone for building materials and decorative use. The mine is located in Boulder County and the site entrance is located approximately 3 miles north of Lyons, CO via Stone Canyon Drive. The approved post-mining land use is rangeland. A mine sign was posted at the mine entrance pursuant to Rule 3.1.12.

Photo 1: Mine sign at primary mine entrance

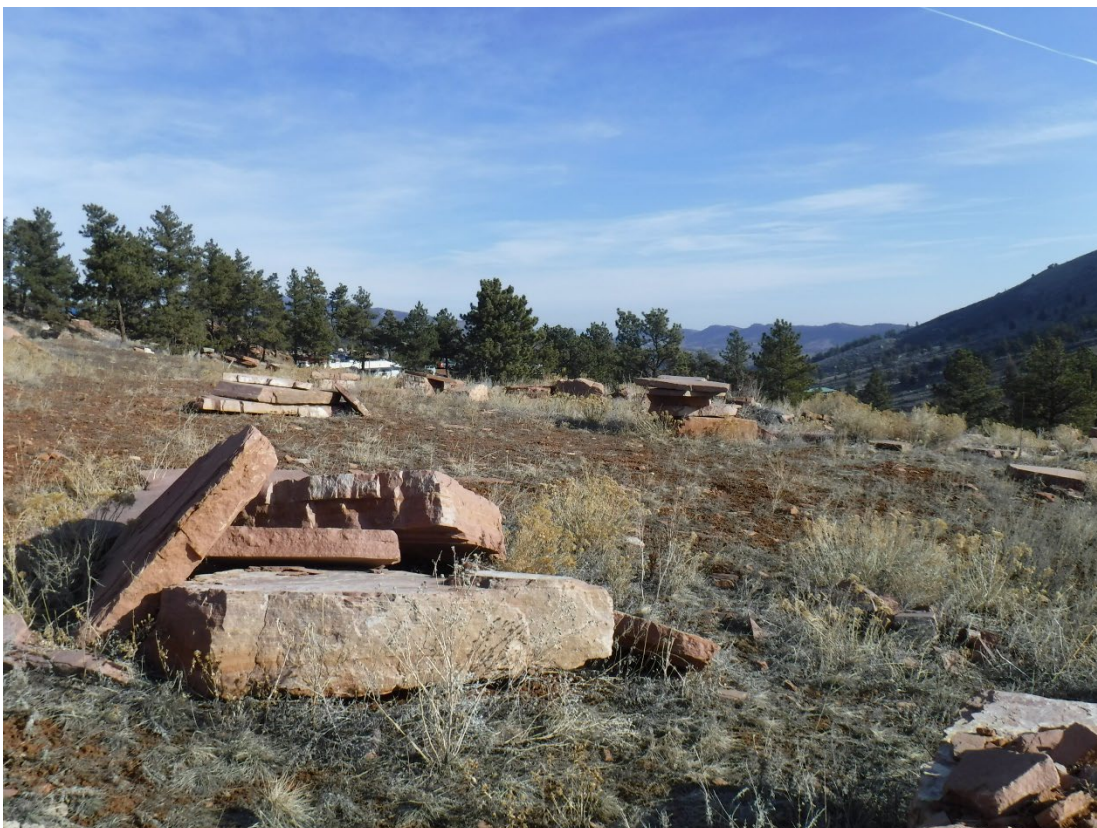
The approved reclamation plan calls for backfilling mined areas with overburden and/or waste rock to a 3H:1V or flatter slope gradient, replacing topsoil on disturbed land at a minimum depth of 3 inches, and revegetating the site for rangeland use. The existing driveway used to access the site from Stone Canyon Drive is to remain after reclamation. There are several steep mine faces that need to be backfilled in the southeast and southwestern areas of the permit. Along with backfilling, any available topsoil needs to be spread and seeded with approved seed mix. Additionally, there are several piles and stacks of marketable material that remain onsite.

Photo 2: Marketable material remaining at the site

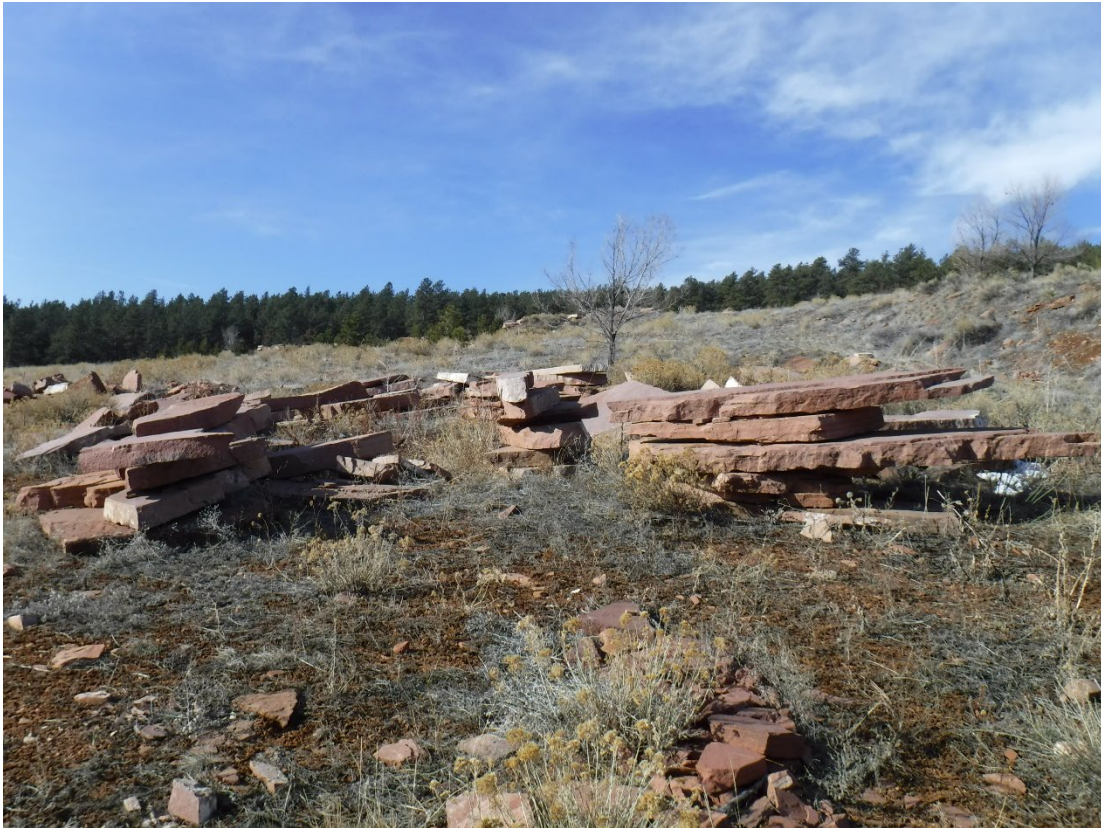
Photo 3: Marketable material remaining at the site

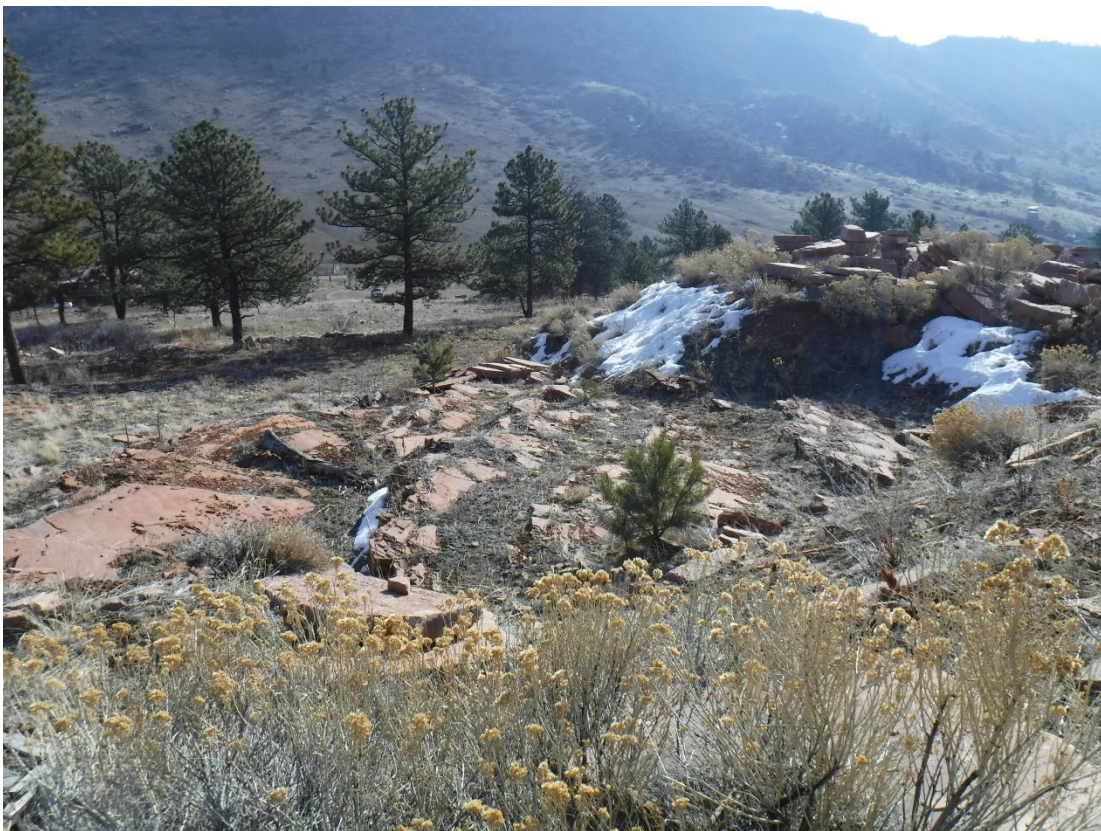
Photo 4: Open quarry

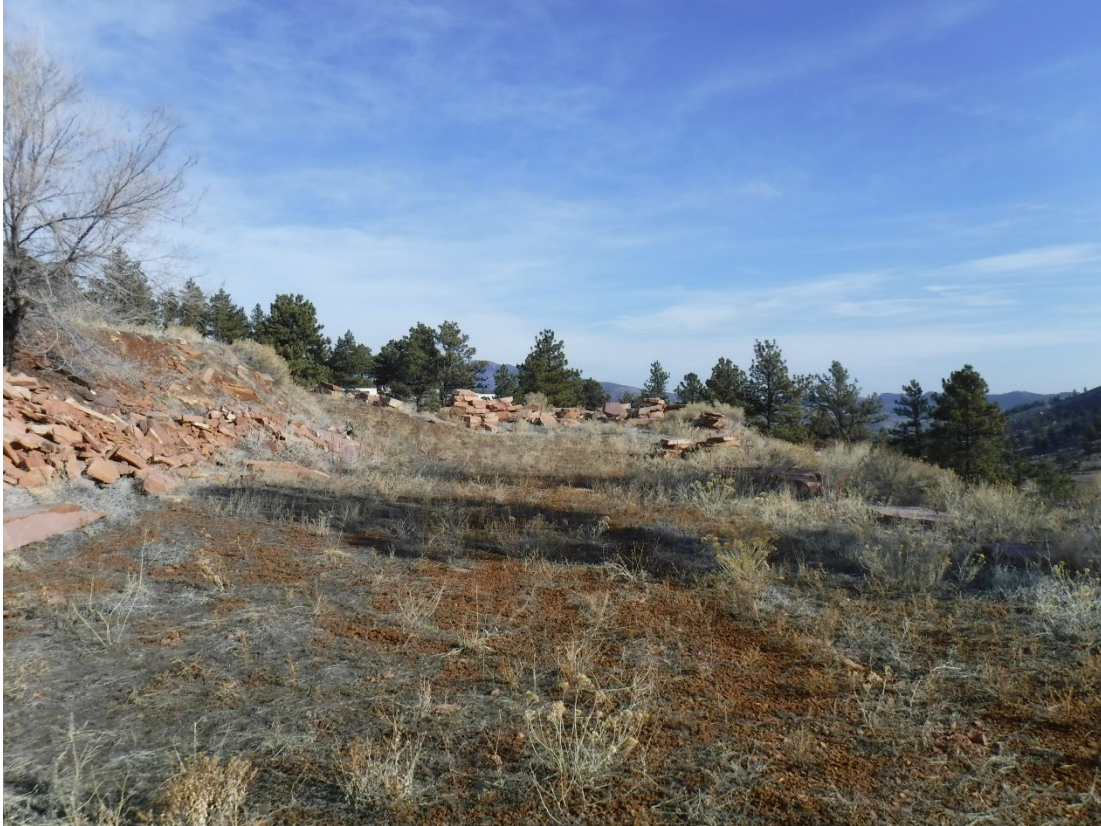
Photo 5: Typical site conditions looking north

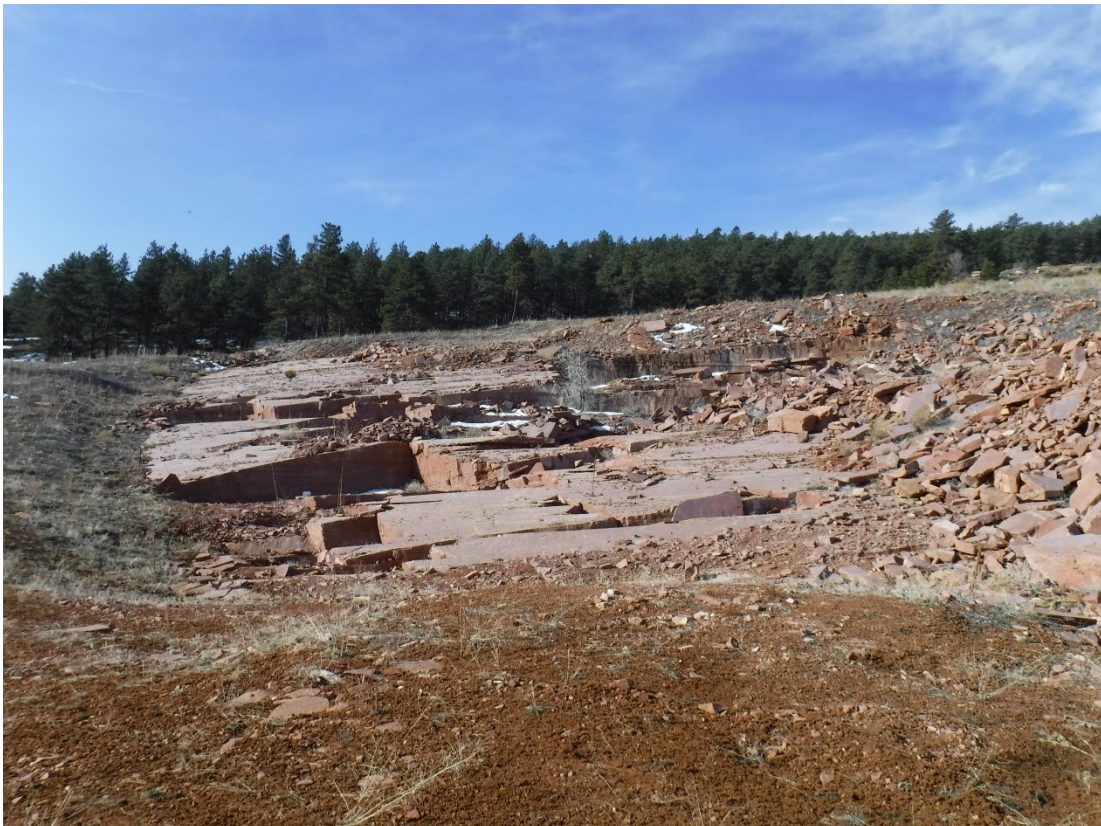
Photo 6: Open quarry
