Division of Reclamation,  
Mining and Safety

<b>Permit Number:</b> C-1981-012 <b>Mine Name:</b> New Elk Mine <b>Operator:</b> New Elk Coal Company, LLC <b>Operator Address:</b> Mr. Mark Gray 12250 Highway 12 Weston, CO 81091	<b>County:</b> Las Animas <b>Operation Type:</b> Underground <b>Permit Status:</b> Active <b>Ownership:</b> Private
	<b>Operator Representative Present:</b>  Bill Roddy
<b>Operator Representative Signature: (Field Issuance Only)</b>

<b>Inspection Start Date:</b> March 8, 2023 <b>Inspection Start Time:</b> 08:00 <b>Inspection End Date:</b> March 8, 2023 <b>Inspection End Time:</b> 12:00		<b>Inspection Type:</b> Coal Partial Inspection <b>Inspection Reason:</b> Normal I&E Program <b>Weather:</b> Clear	
<b>Joint Inspection Agency:</b>  None		<b>Joint Inspection Contacts:</b>  	
<b>Post Inspection Agency:</b>  None		<b>Post Inspection Contacts:</b>  	
<b>Inspector(s):</b>  Brock Bowles	<b>Inspector's Signature:</b>

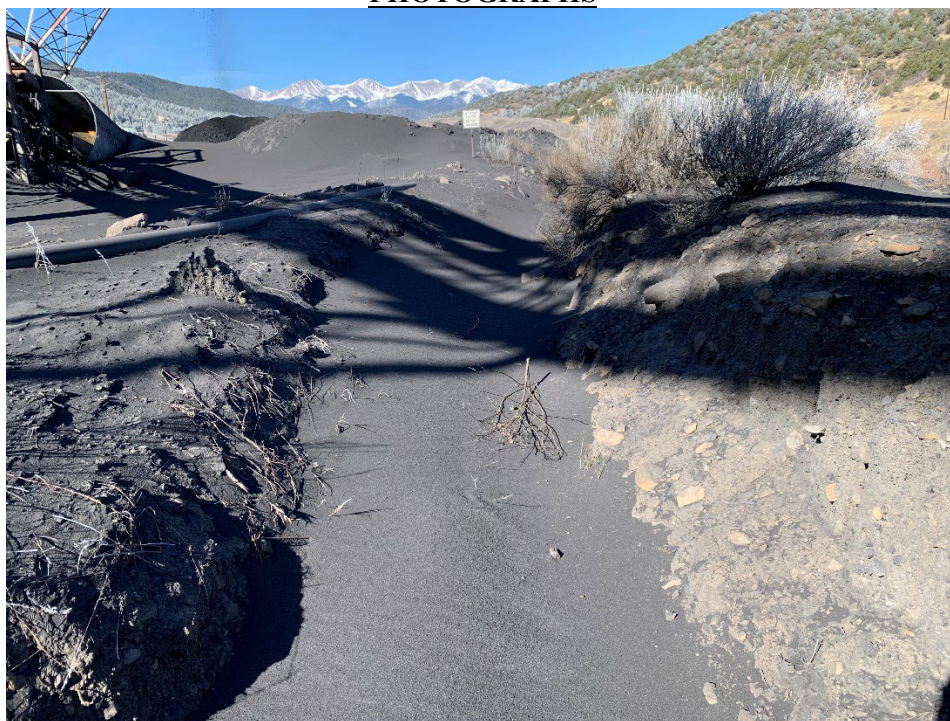
The raw coal storage area is located south and adjacent to the Middle Fork of the Purgatoire River. Raw coal from the mine is deposited in this area by an elevated conveyor belt which is situated more than 50 feet above the pile. The coal at this point in the mining process is very dusty. As the coal is falling from the conveyor onto the stockpile below, the prevailing westerly wind blows coal dust beyond the coal pile and into the surrounding area. Coal dust was documented more than 200 feet east of the storage pile. The coal dust is thick enough to obstruct ditch D32 (photo 1) and culvert C64 (photo 2). The dust also covers an area in the river's stream buffer zone that is approximately 250 feet long (photos 3-6), and is in the river (photo 7).

Photo 1 - Ditch D32 filled with coal fines/dust

- All coal fines/dust must be removed from all areas of the stream buffer zone including grassy areas, the willows, stream banks and the rocky riprap (Rule 4.05.18(1)(a)-(b)).
- Clean ditch D32 and culvert C64 (all the way through, as both ends are obstructed) (Rule 4.05.5(1))
- Develop a plan to implement best management practices to prevent coal dust from being blown beyond the stockpile area (Rule 4.04(1)(a)-(b)).

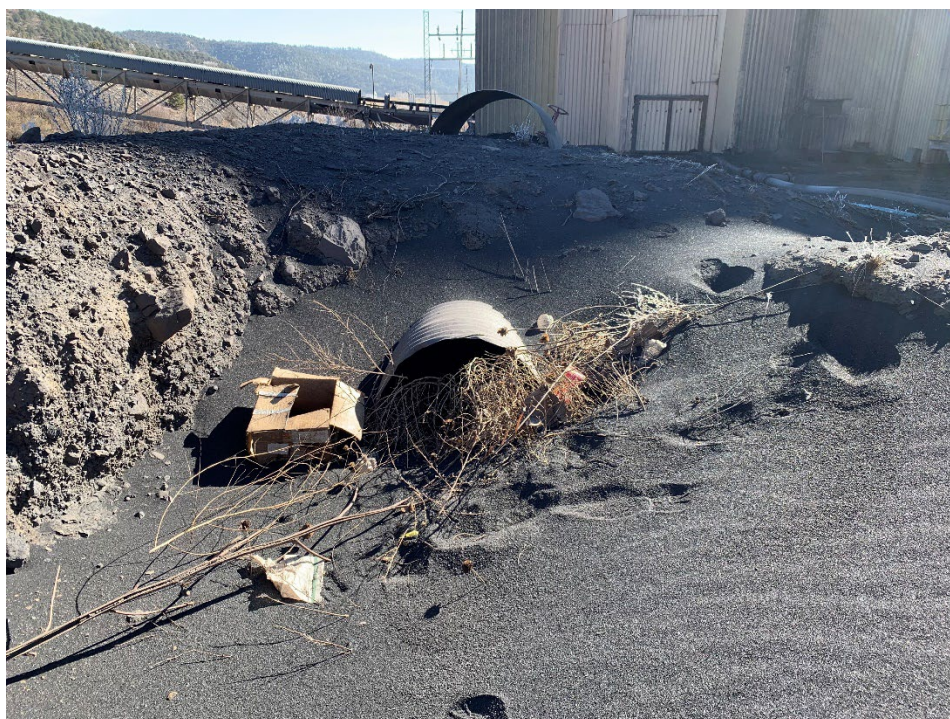
Photo 2 – Culvert C64 obstructed by coal fines/dust

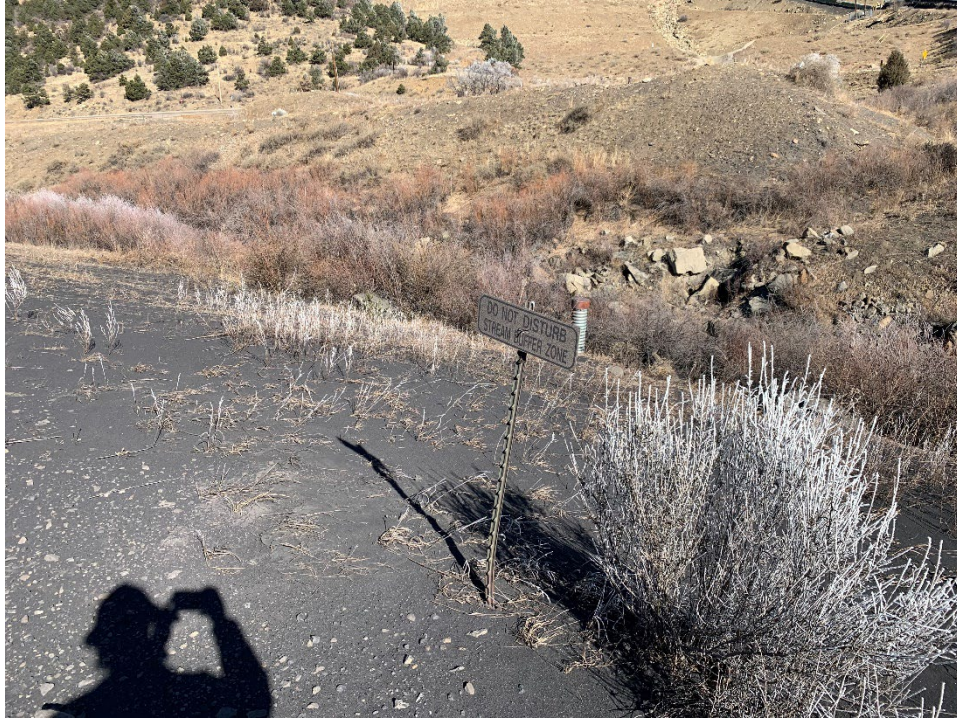
The land between the Middle Fork of the Purgatoire River and ditch D32 is designated as a stream buffer zone and is clearly marked with signs. Stream buffer zones areas are protected by Rule 4.05.18(1) which states that no land within this area shall be disturbed by surface coal mining operations, the mining operations will not cause or contribute to the violation of applicable water quality standards (Rule 4.05.18(1)(a)), and during and after mining, the water quantity and quality, and other environmental resources of the stream shall not be adversely affected

Photo 3 – Coal fines/dust in the Stream Buffer Zone

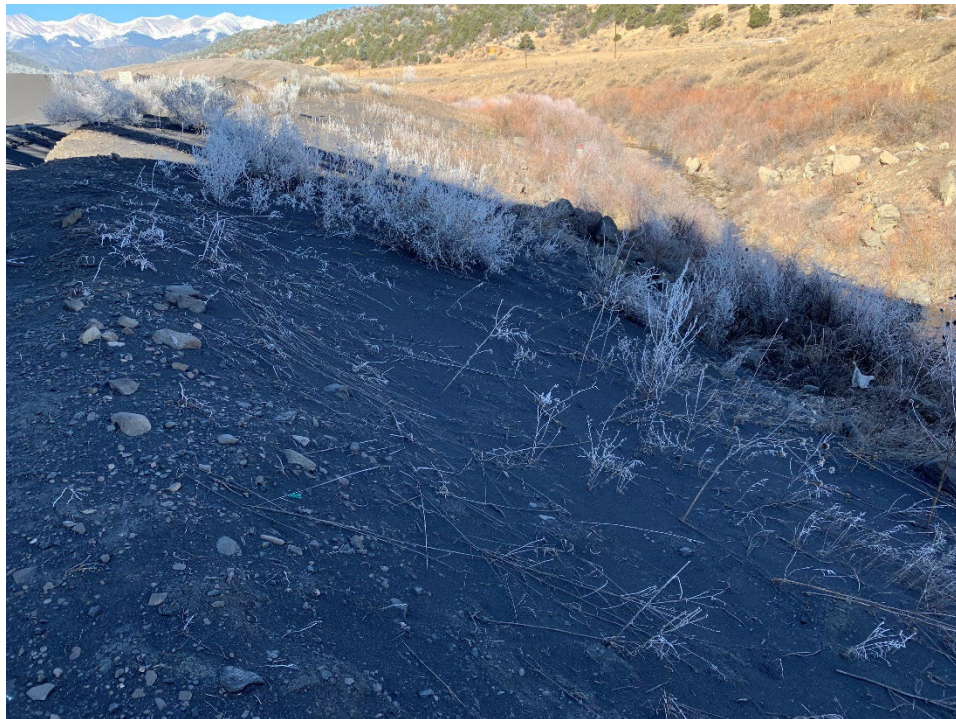
Photo 4 – Coal fines/dust on the hillside above the Middle Fork of the Purgatoire River

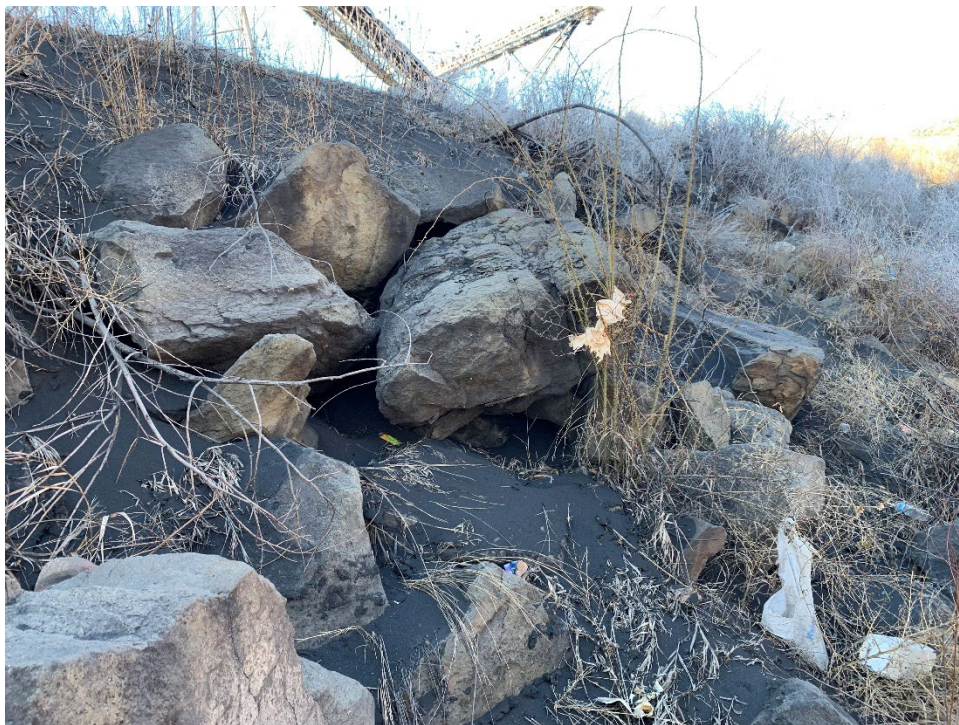
Photo 5 – Coal fines/dust in riprap, elevated conveyor in background (source of dust)

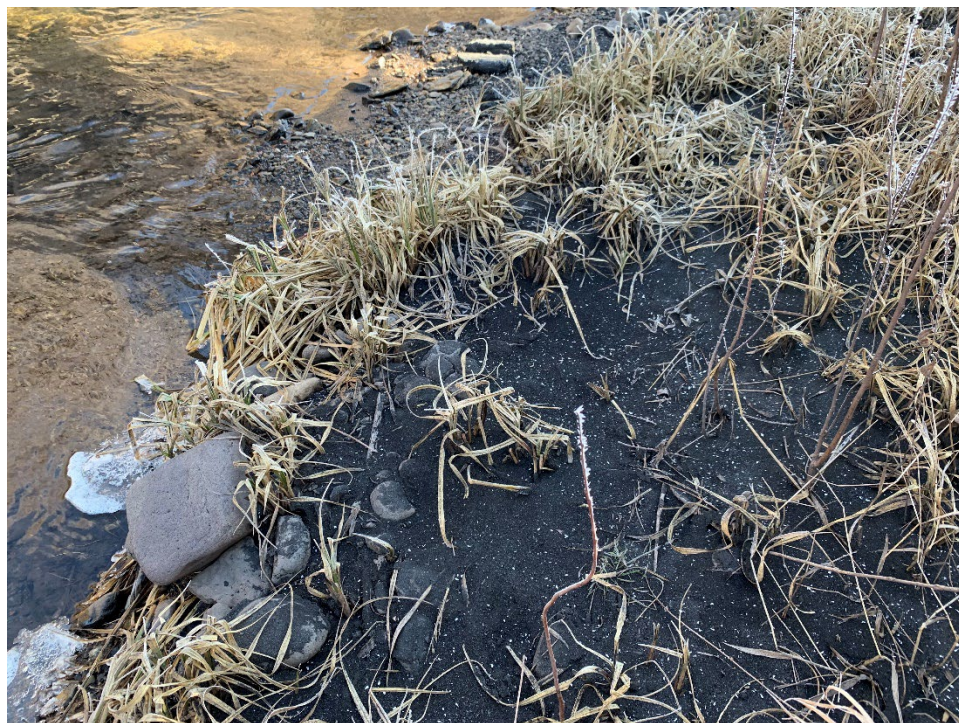
Photo 6 – Coal fines/dust on Purgatoire River bank

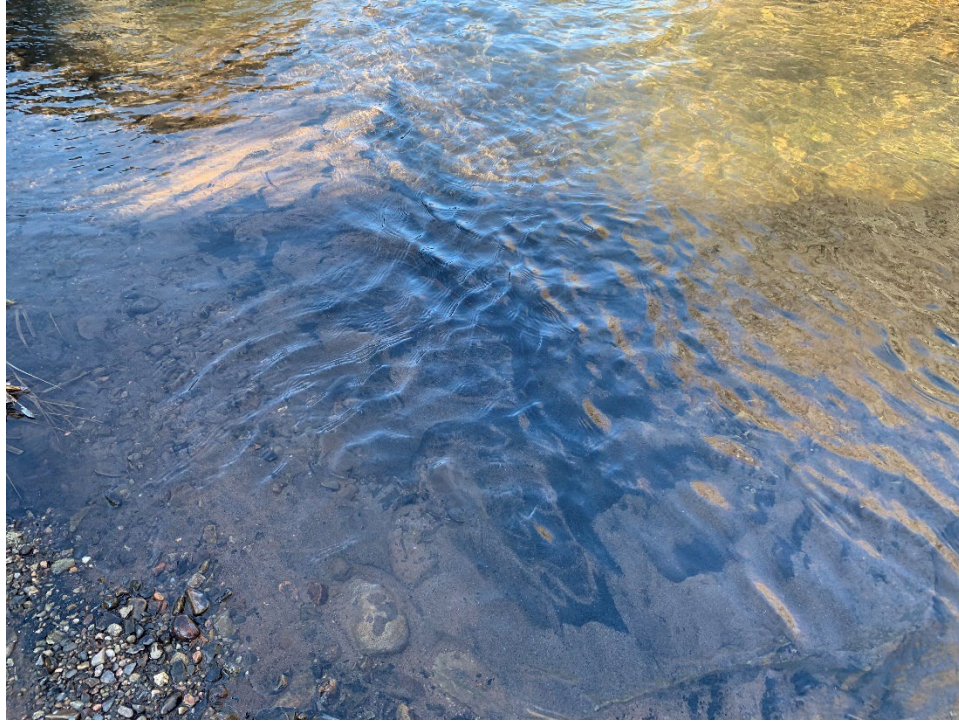
Photo 7 – Coal fines/dust in the sandbar of the Purgatoire River

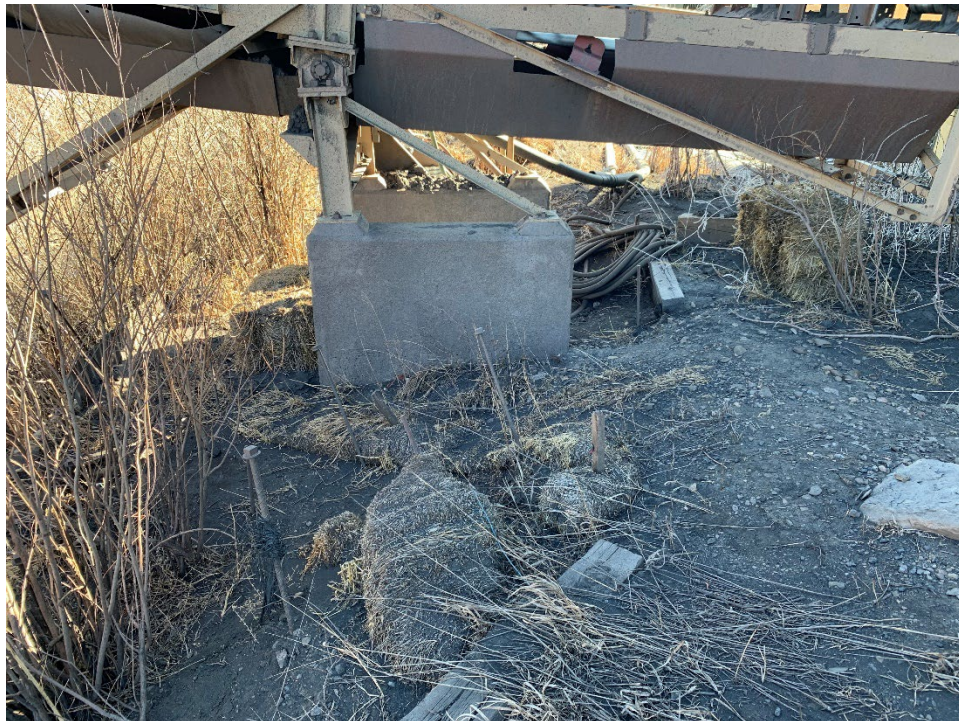
The coal refuse conveyor comes out of the wash plant on the north side of building moving refuse to the RDA. The area under the conveyor belt contains coal waste that fell off the belt and does not have adequate sediment controls in place (photo 8). Water and coal waste sediment can flow from this area downhill into the stream buffer zone and into the river. Map 13 of the permit shows that a berm is supposed to be maintained in this area to prevent water from entering the stream buffer zone and direct water east to ditch D32A. **The berm shown on Map 13 needs to be reestablished up to and under the coal refuse conveyor belt and direct the water to the east towards ditch D32A within 30 days of the issuance of this inspection report (Rules 4.05.5(1), 4.05.18(1)(a)-(b)).**

Photo 8 – Sediment control structures under coal refuse conveyor belt

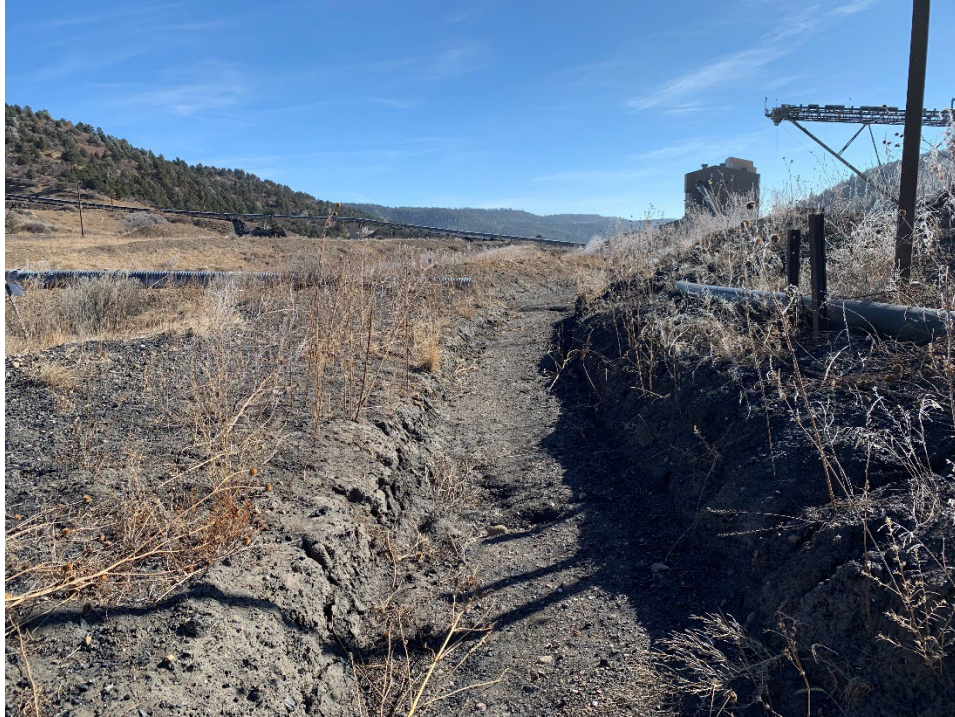
The ditches and culverts located on the south side of the Purgatoire River, from the where entrance haul road crosses the river to Pond 7, were inspected. The berm in this area was also inspected. With the exception of the areas noted above, ditches D13, D15, D32A, D32B, D22A, and culverts C72, C73, C74, C65, C22 and C32 were clean and in working order. The berm appeared to be stable. No erosion or signs of instability were seen (photo 9).

Photo 9 – Ditch D15

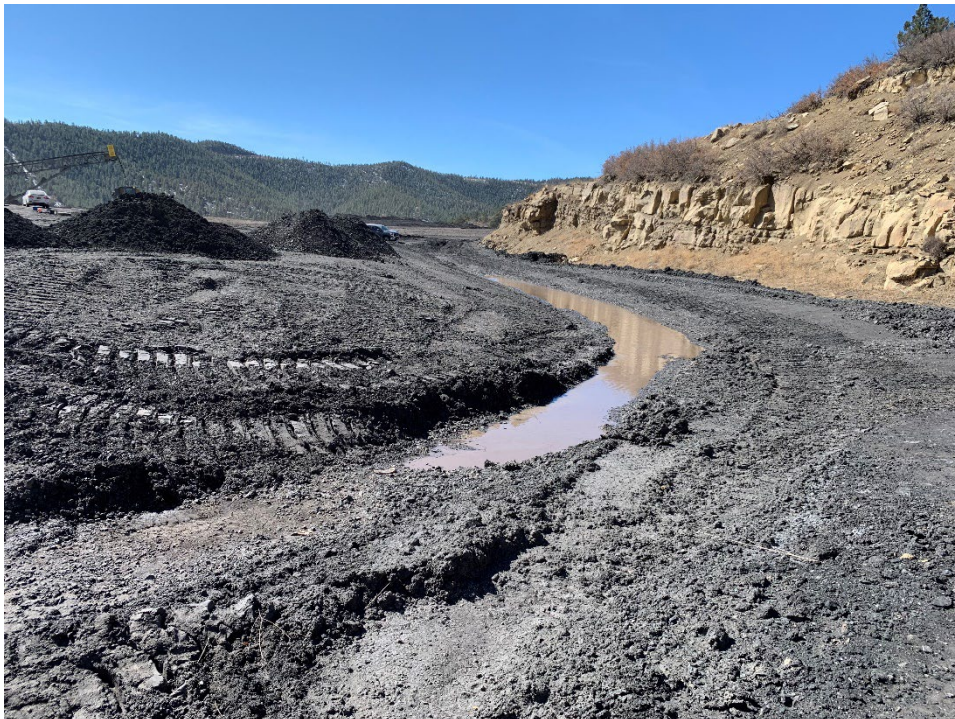
Standing water was noted on top of the RDA in the northeast corner (photo 10). The perimeter drainage ditch that directs water to the east side of the RDA was obstructed preventing water from properly draining. The drainage ditch needs to be reestablished to direct water off the top of the pile (Rules 4.10.3(2) and 4.09.2(7)).

Photo 10 – Standing water in the northeast corner of the RDA

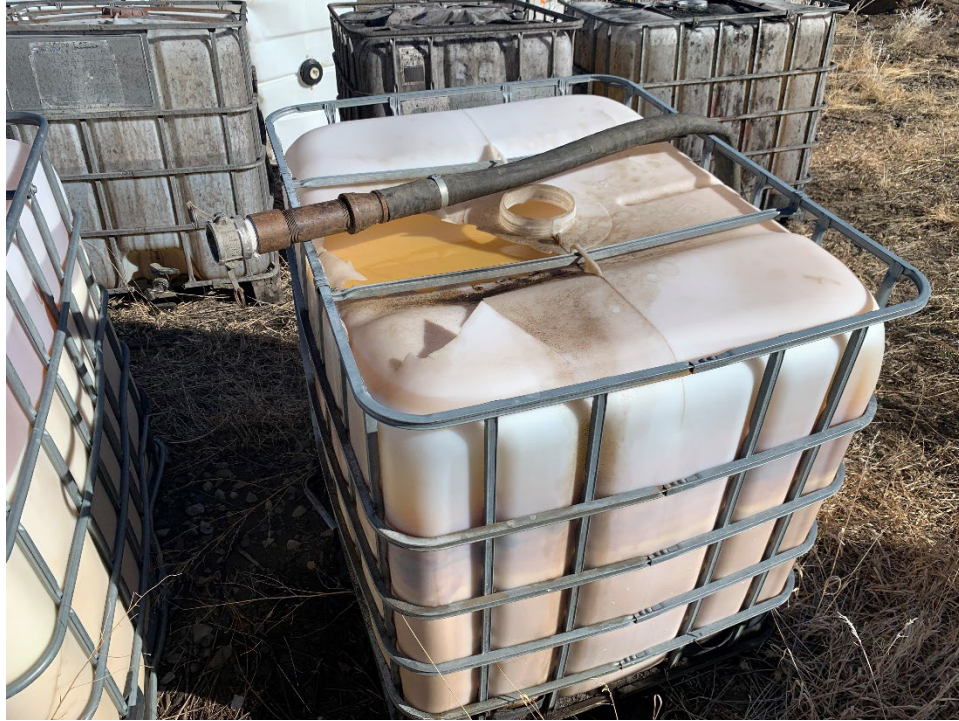
Several large liquid containers are being stored in the Portable Explosives and Chemical Storage Area, east of the old train shop. The containers are constructed of plastic, wrapped in a metal framework and sit on an integrated pallet. The containers are approximately 3'x4'x3' in size and have an approximate capacity of 270 gallons each. It appears the plastic is getting brittle from sitting in the sun and several tops of these containers are cracked and missing pieces (photo 11). The missing pieces allow precipitation to get into the containers and are filling them up. The containers that are broken are nearly full and will leak solution with additional precipitation. The contents of each container is unknown because the labels are too weathered to read or are missing. The operator said most of the liquids were either mag-chloride or flocculent used in the wash plant. This issue was raised in the November 2022 inspection report and has not been resolved. These products and containers are not being stored and maintained in a manner that will control and minimize diminution or degradation of water quality (Rule 4.04(2)), and stored to ensure leachate and surface runoff do not degrade surface or groundwater and that the area remains stable and suitable for reclamation and revegetation (Rule 4.11.4(1)). **These chemicals need to be stored in a manner that meet the standards of Rules 4.04(2) and 4.11.4(1) within 30 days of the issuance of this inspection report.**

Photo 11 – Broken chemical storage containers
