Permit Number: C-1996-084 Mine Name: Lorencito Canyon Mine Operator: New Elk Coal Company, LLC Operator Address: Mr. Mark Gray	County: Las Animas Operation Type: Surface Permit Status: Permanent Cessation Ownership: Private		
12250 Highway 12	Operator Representative Present:		
Weston, CO 81091	The same of the sa		
	Bill Roddy		
Operator Representative Signature: (Field Issuance Only)

INSPECTION INFORMATION

This partial inspection was conducted by Brock Bowles of the Division of Reclamation, Mining and Safety (Division). Bill Roddy of the New Elk Coal Company was present for the inspection. The weather was sunny, cold and the ground conditions were dry.

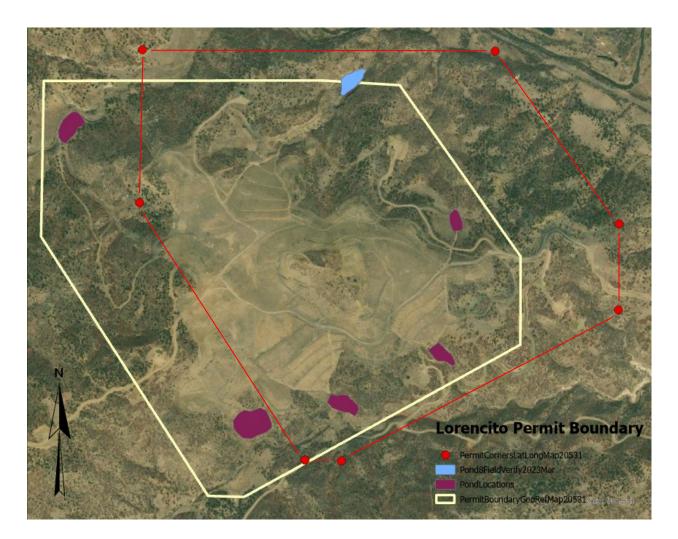
The following discussion references the Lorencito Permit Boundary map below.

The permit boundary for the Lorencito Mine was reduce in size through TR18 in 2013 shown on permit Map 2.05.3-1. Map 2.05.3-1 was digitized and imported into ArcPro and then georeferenced to the mine area. The revised permit boundary was copied and projected onto the Lorencito Permit Boundary map below (yellow outline). During this process it was noticed that Pond 8 was not completely within the permit boundary. Approximately 1 acre of the pond and its embankment are outside the permit boundary to the north.

To eliminate the possibility of mapping and geo-referencing errors, the location of Pond 8 (photo 1) was field verified during this inspection. The perimeter of Pond 8 was walked and a point was recorded approximately every 20 feet around the entire pond and embankment using ArcGIS Field Maps. The field data collected for Pond 8 is shown as the blue pond on the map below. The other ponds of the Lorencito Mine are shown in purple and are included for reference.

The next step was to verify the permit boundary location as the geo-referencing process may introduce error. The permit boundary corner point coordinates are provided in a table on Map 2.05.3-1. These points were plotted in ArcPro and are shown on the below map as red dots.

The map shows that the geo-referenced permit boundary (yellow outline) and the plotted point boundary (red dots) are offset by approximately 1,400 feet. Neither version of the permit boundary includes all the ponds and their associated disturbance footprint. All areas of land which are affected by surface coal mining operations need to be included in the permit area (Rule 1.04(89)).

Number of Partial Inspection this Fiscal Year: 6 Number of Complete Inspections this Fiscal Year: 3 The permit boundary needs to be updated to include all the mine related disturbed areas including pond embankments. This can be accomplished with an incidental permit boundary change through a technical revision.

Please submit a technical revision within 90 days of this report to adjust the permit boundary so all mine related disturbance is within the permit boundary.

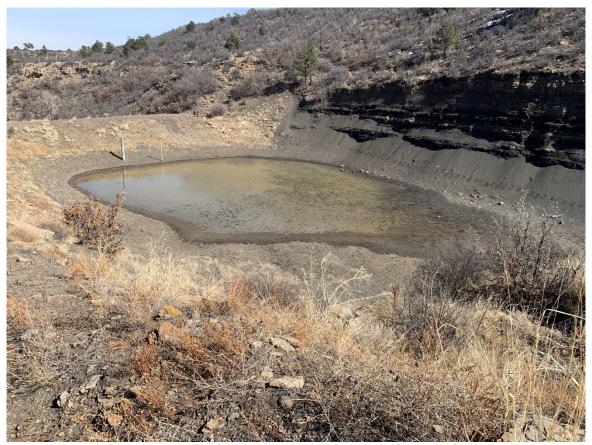
Photo 1 – Pond 8 facing east, embankment at far end of pond
