# Cripple Creek & Victor Gold Mining Company Valley Leach Facility 2 Phase 3 Stage A.1 Record of Construction Underground Working Summary

VLF2 PHASE 3 STAGE A.1

HONDA UG WORKING

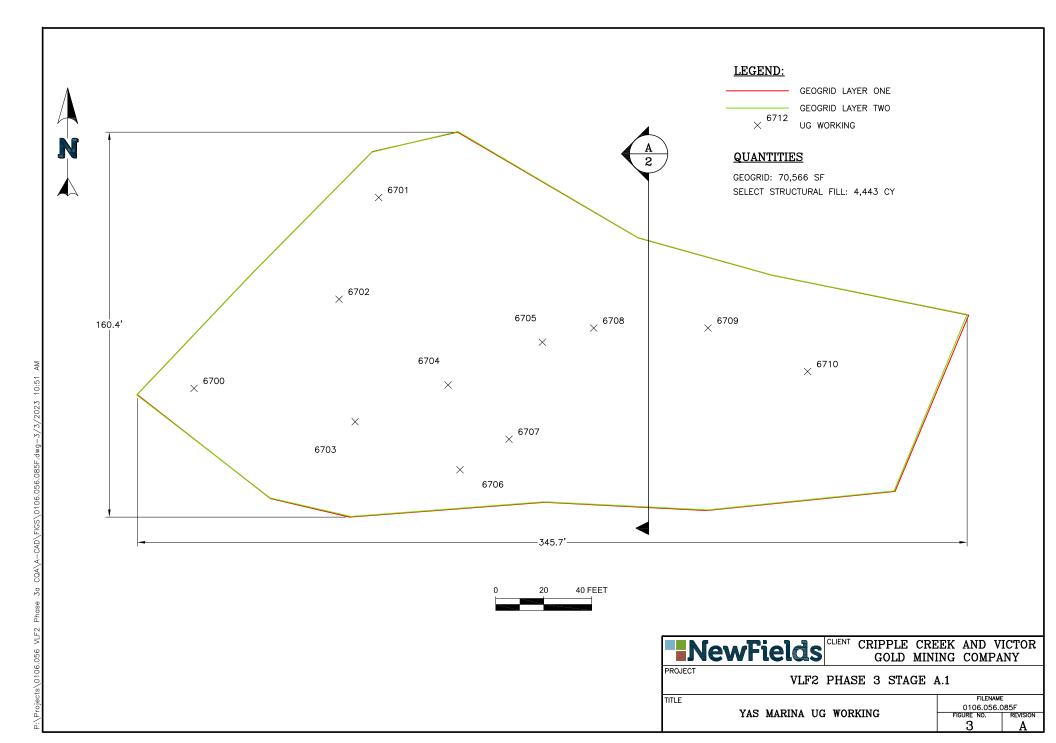
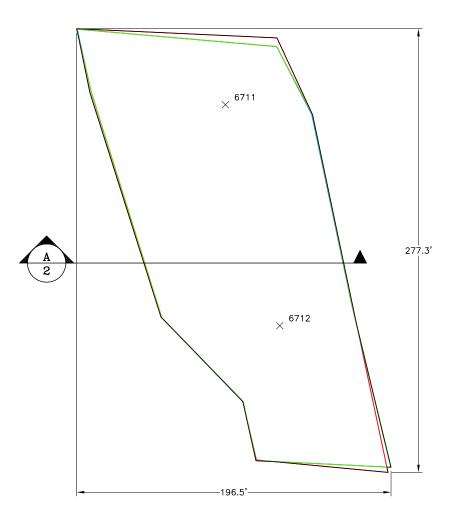
Un- known	6712	Honda	58749.2	35696.3	10046.7	Unknown	Known	7/7/2022	Unknown	No	Yes	Yes	Geogrid (Three Layers)	None		See Working UG#6711					REMEDIATED as part of UG#6711

- CONTRACTOR TO INSTALL DIRECTION OF MAXIMUM STRENGTH FOR THE SECOND LAYER OF UX1700HS OR EQUIVALENT HS GEOGRID TRANSVERSE TO THE DIRECTION OF MAXIMUM STRENGTH FOR THE FIRST LAYER OF UX1700HS GEOGRID.
- A THIRD GEOGRID LAYER MAY BE ADDED IN AREAS UNDER HIGH NORMAL LOAD. AREAS REQUIRING THIRD GEOGRID WILL BE DETERMIN3D DURING REMEDIATION.
- 3. GEOGRID CAP TO EXTEND MINIMUM 15 FEET BEYOND MINE WORKING LIMIT.
