MINERALS PROGRAM INSPECTION REPORT
PHONE: (303) 866-3567

MINE NAME: Pikeview Quarry	MINE/PROSPECTING ID#: M-1977-211	MINERAL: Limestone (general), granite gneiss and do	COUNTY: El Paso
INSPECTION TYPE: Monitoring	WEATHER: Clear	INSP. DATE: March 20, 2023	INSP. TIME: 10:00
OPERATOR: Continental Materials Corporation	OPERATOR REPRESENTATIVE: Jerry Schnabel	TYPE OF OPERATION: 112c - Construction Regular Operation	
REASON FOR INSPECTION: Normal I&E Program	BOND CALCULATION TYPE:	BOND AMOUNT: \$13,389,784.00	
DATE OF COMPLAINT: NA	POST INSP. CONTACTS: None	JOINT INSP. AGENCY: None	
INSPECTOR(S): Zach Trujillo	INSPECTOR'S SIGNATURE:

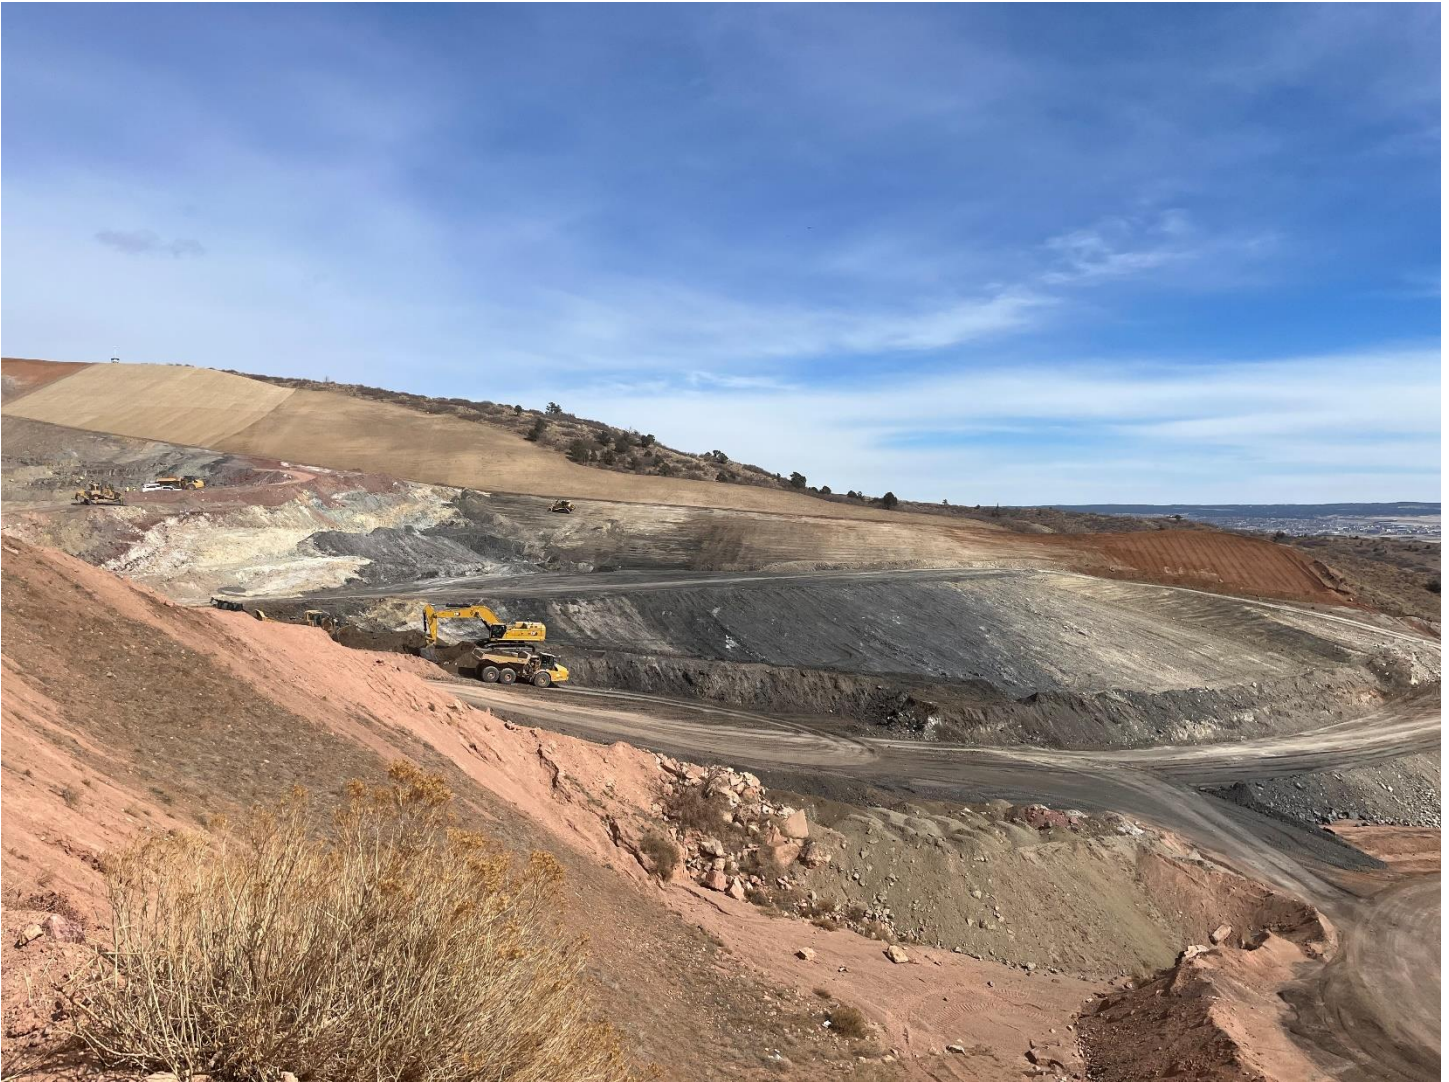
Backfill and compaction efforts were occurring during the inspection. All backfill was being placed along the southern end of the slope buttress. After placement, the backfill was being compacted. Compaction testing was occurring during the inspection by CTL Thompson under the supervision of CMC and Stantec. The first portion of the buttress has been completed at a 3h:1v slope. The second benching of the buttress that was occurring will be graded to a steeper 2h:1v slope. The benched excavation area located at the previous maintenance shop has almost all borrow material removed with the remaining amount located at the lower elevation. The upper excavated benches were being be graded to a continuous slope for final reclamation. A portion of the area has been graded as a pad for future post-mining land use. Additional backfill excavation was occurring along the southern portion of the permit along the USFS property.

Graded slope along north-eastern end of permit as well as continued excavation.

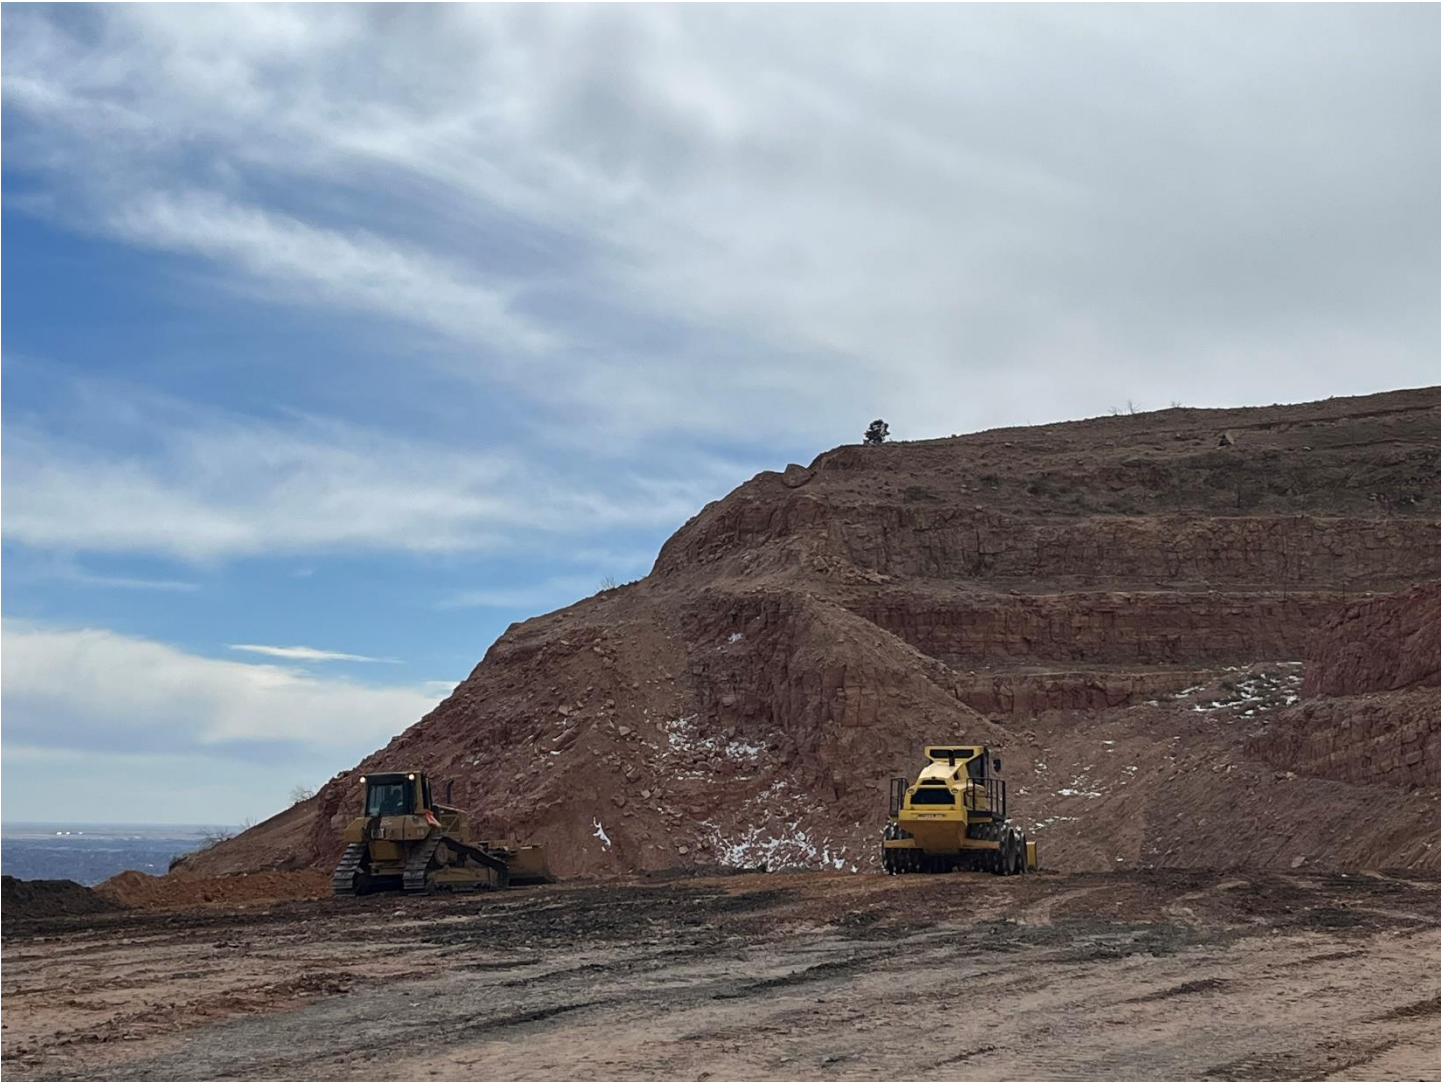
Compactor working recent backfill.

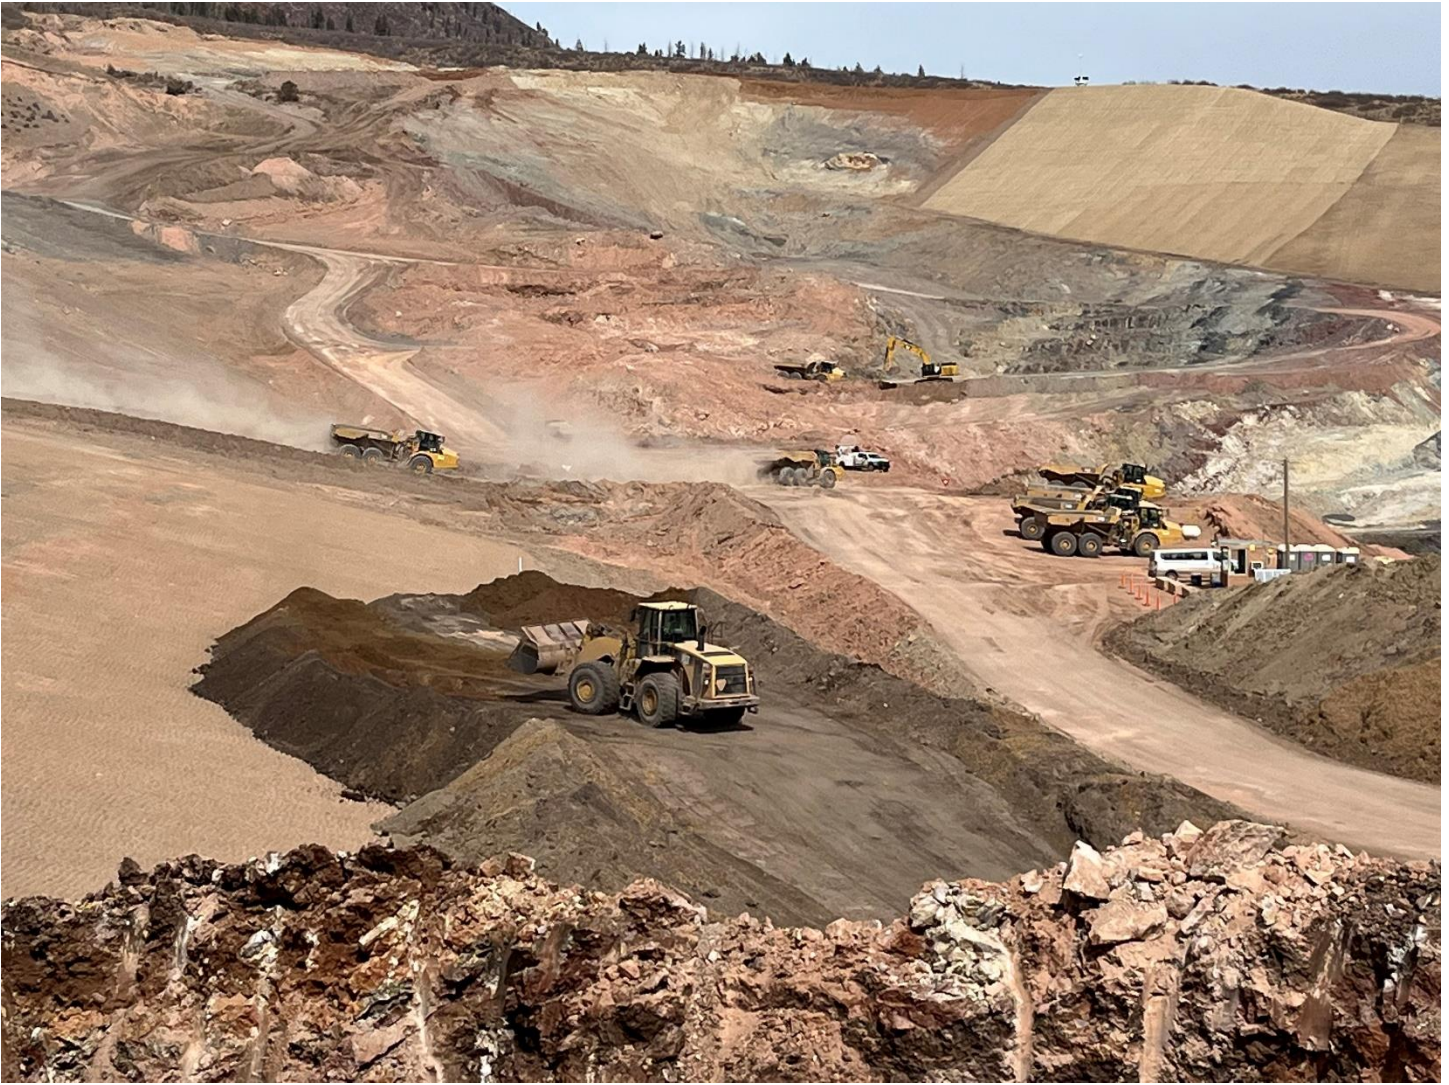
Topsoil placement was observed along the very north-east portion of the regraded slope which was previously excavated for borrow material. Topsoil has also been staged along the initial southern buttress slope. The topsoil material was being blended with mulch by a loader. CMC stated the topsoil will be used along the lower end of the buttress as part of contemporaneous reclamation efforts.

Topsoil blending and staging along buttress.

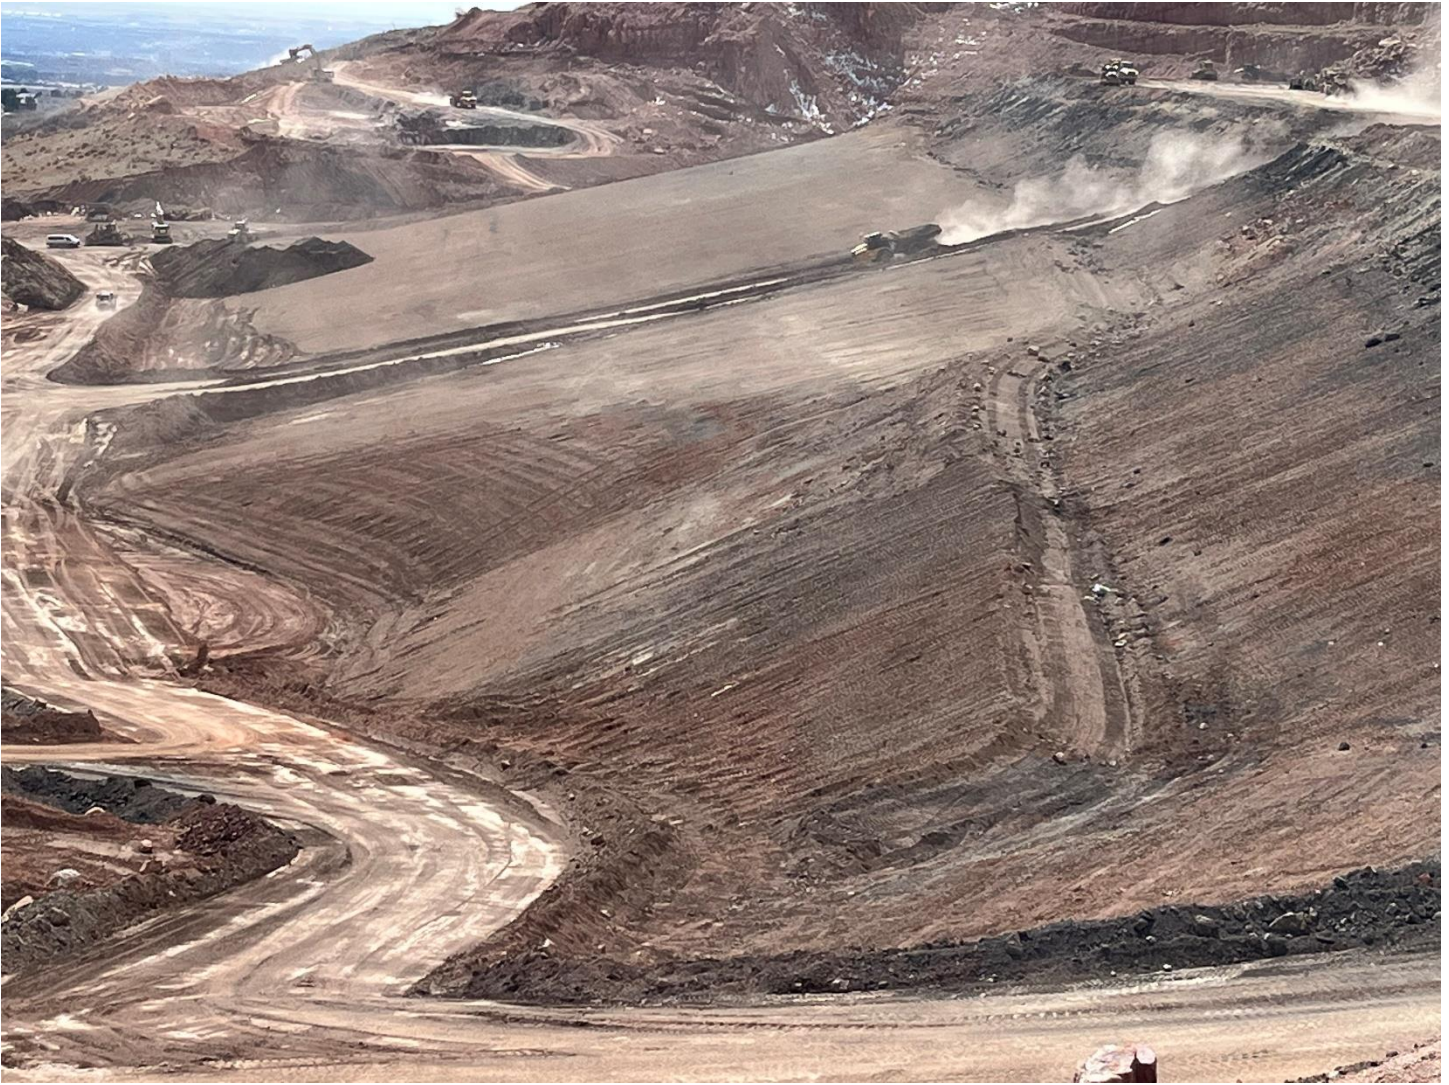
Post-mining channel has been constructed along the lower portion of the buttress. The channel is graded down gradient to the north.

Post-mining channel along buttress.
