MINERALS PROGRAM INSPECTION REPORT
PHONE: (303) 866-3567

MINE NAME: Fountain Colony Pit	MINE/PROSPECTING ID#: M-1987-171	MINERAL: Sand and gravel	COUNTY: El Paso
INSPECTION TYPE: Surety-Related Inspection (2/23/2023) Noxious Weed Follow-up (3/21/2023)	WEATHER: Snowing (2/23/2023) Clear (3/21/2023)	INSP. DATES: February 23, 2023 March 21, 2023	INSP. TIME: 12:40 9:30
OPERATOR: Kiewit Infrastructure Co.	OPERATOR REPRESENTATIVE: Misty Gothard	TYPE OF OPERATION: 112c - Construction Regular Operation	
REASON FOR INSPECTION: Surety Related	BOND CALCULATION TYPE: None	BOND AMOUNT: \$200,000.00	
DATE OF COMPLAINT: NA	POST INSP. CONTACTS: None	JOINT INSP. AGENCY: None	
INSPECTOR(S): Timothy Cazier, P.E.	INSPECTOR'S SIGNATURE:

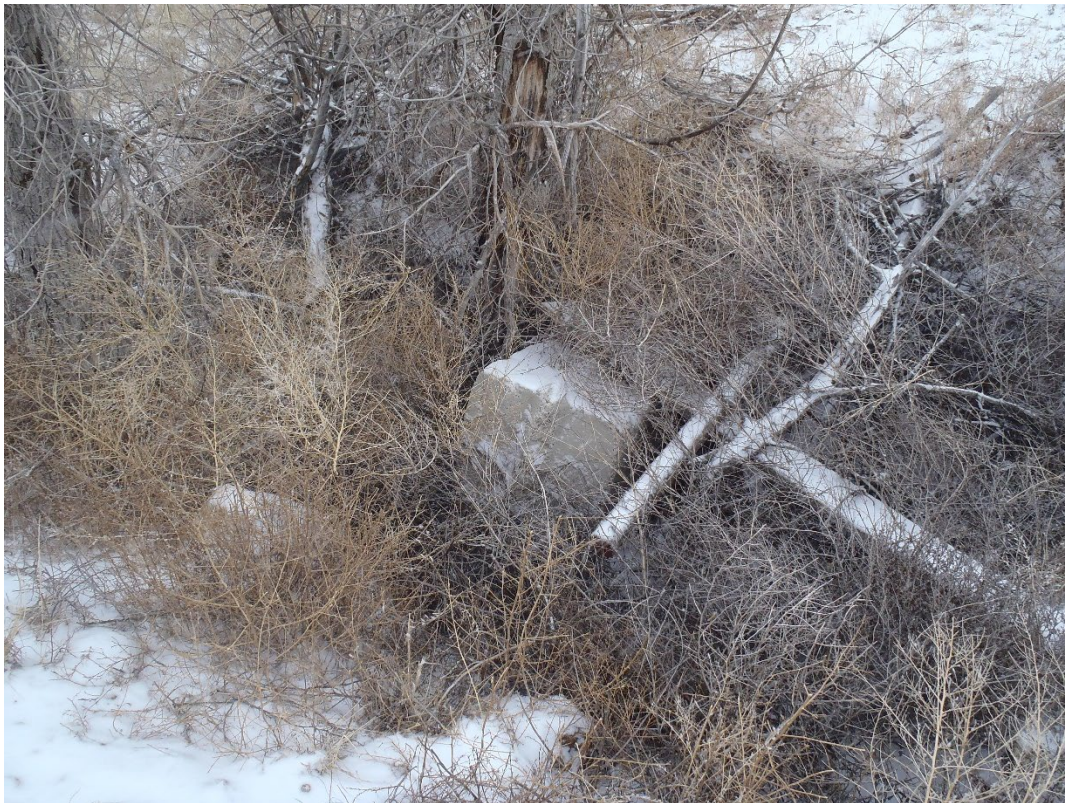
Reclamation Success: With one exception, the previously observed concrete/mafia blocks not covered by vegetation had been removed. A few blocks remained in a drainage immediately east of the west side access road (see **Photo 1**). All other reclamation appeared adequate. On March 6th Kiewit emailed photo documentation of having removed the aforementioned blocks.

Photo 1. Concrete/mafia blocks needing to be removed (east side of drainage on west access road).

Summary and Recommendations: As no List A noxious weeds were found, the concrete/mafia blocks had been removed, and the salt cedar has been adequately treated; the DRMS will recommend approval of the requested 289.2-acre acreage release. Any request to reduce the financial warranty as a result should be submitted via a surety reduction request.

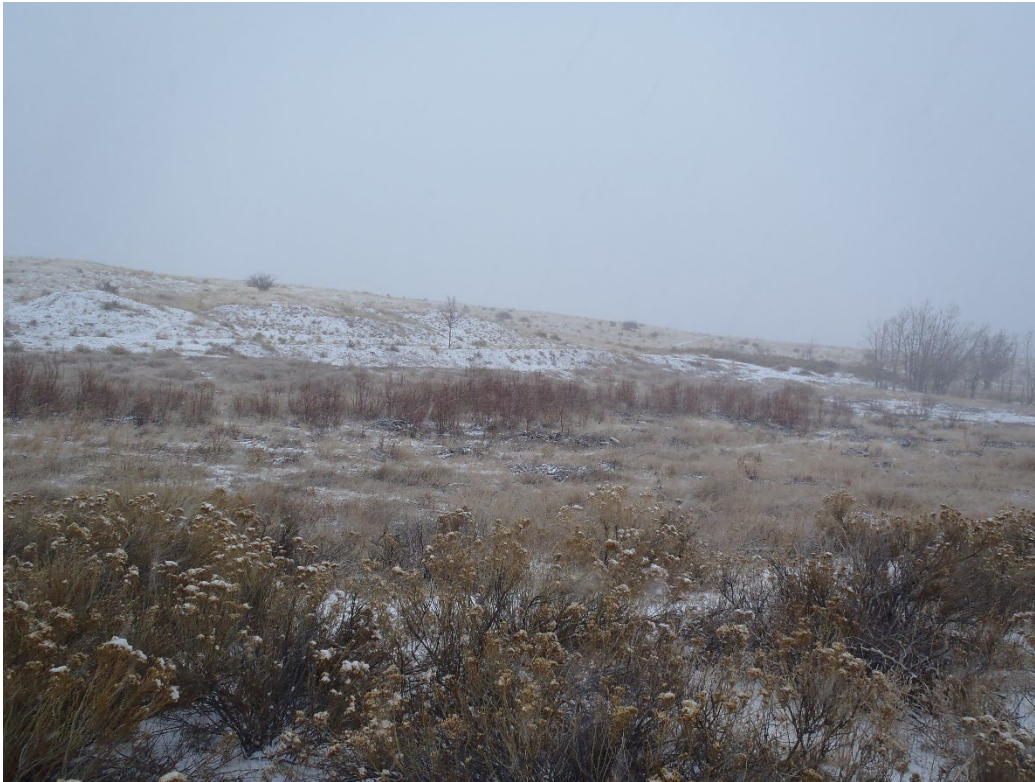
Revegetation: Prior to the February inspection, Kiewit provided documentation for having treated the tamarisk (salt cedar) observed in the third downstream sediment pond, and the Russian thistle observed in Phase V, both in during the October inspection. The salt cedar treatment was deemed to be adequate (see **Photo 2**). Ms. Gothard mentioned their weed contractor had also treated "mustard weed" in an area near the south end of the paved road section. Photos were not taken at the time due to the snow on the ground. The DRMS requested Kiewit find out from their contractor what kind of mustard weed was treated as there are two types on the Colorado Noxious Weed List. Subsequent to the February inspection, Kiewit informed the DRMS their weed contractor was nearly certain the mustard weed treated was elongated mustard (*Brassica elongata*), which is a List A species requiring eradication. As such, the DRMS contacted El Paso County Parks and Community Services and the City of Fountain to coordinate an inspection for the purpose of confirming the List A species and determining a path forward.

Photo 2. Treated salt cedar (tamarisk) near third sediment pond (looking east).

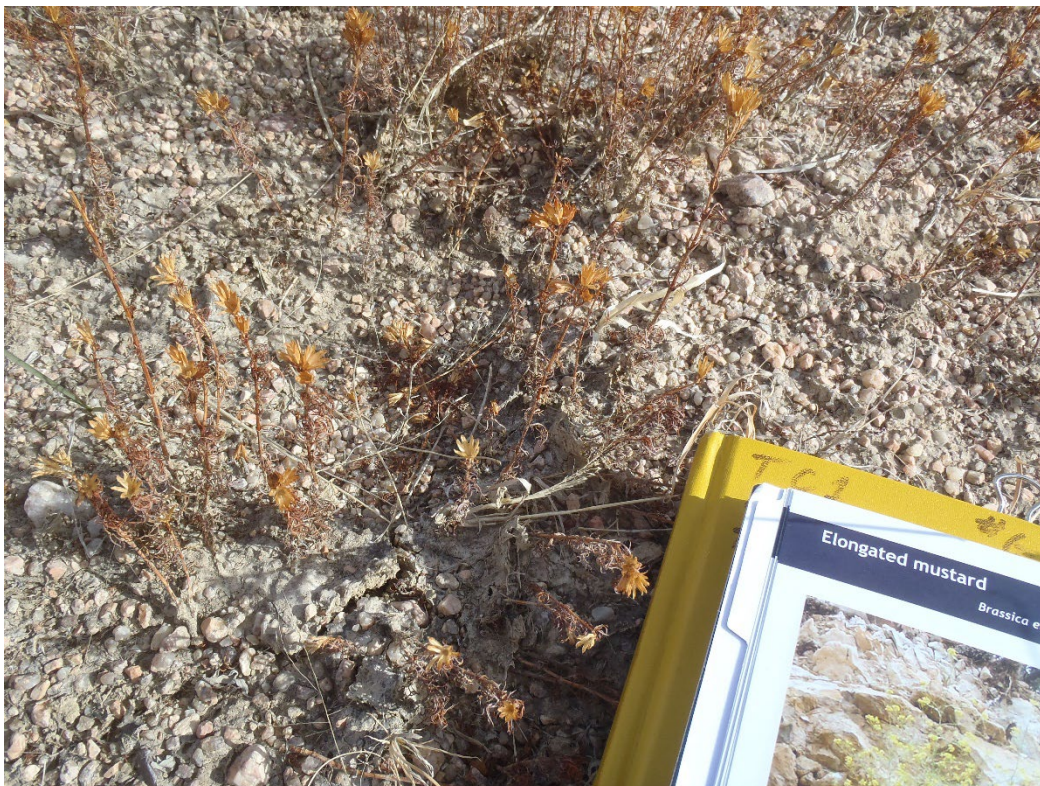
The March inspection focused solely on the area treated for mustard weed. Mr. Daniel examined the treated plants (see **Photo 3**) and determined it was not elongated mustard, as it was too short and, lacked the base rosette and other identifying features. He also concluded it was not any other species on the Noxious Weed List. As such, no further action was deemed necessary.

Photo 3. Treated plant – **NOT** elongated mustard (*Brassica elongata*) – March Inspection photo.

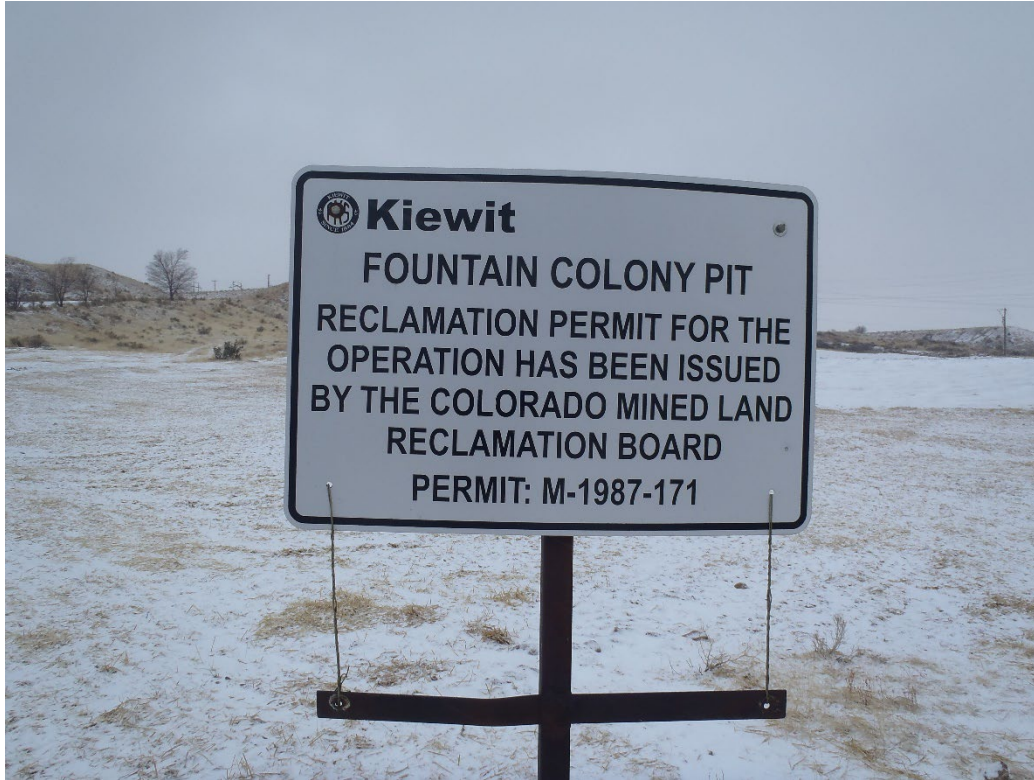
Signs and Markers: The permit sign was properly posted (see **Photo 4**) and survey stakes (see **Photo 5**) were observed to delineate the proposed release area from the remaining Phase V area.

Photo 4. Permit sign at entrance off Charter Oak Ranch Rd.

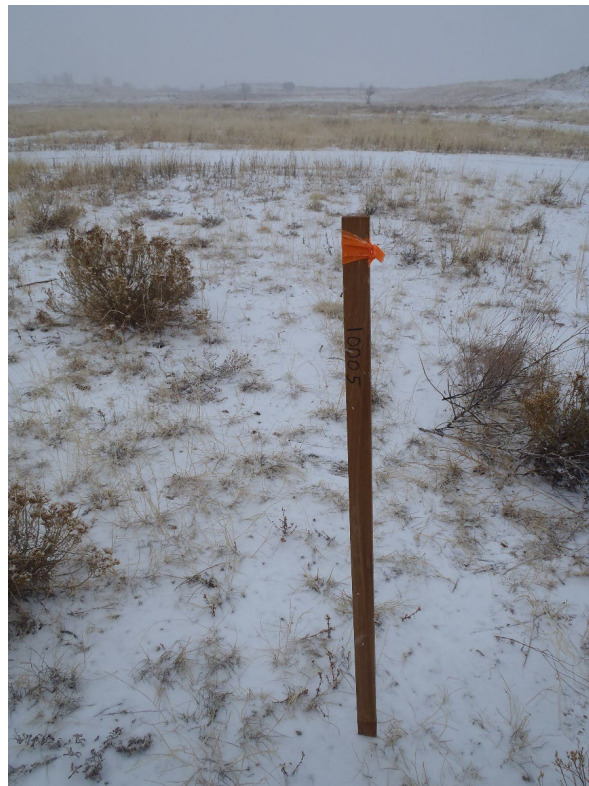
Photo 5. Typical survey stake delineating the boundary between the release area and Phase V.
