File: February 2023 Monitoring Summary

Date: March 24, 2023

**Reference: February 2023 Geotechnical Monitoring Summary Pikeview Quarry**

PIKEVIEW QUARRY SLOPE  
MONITORING

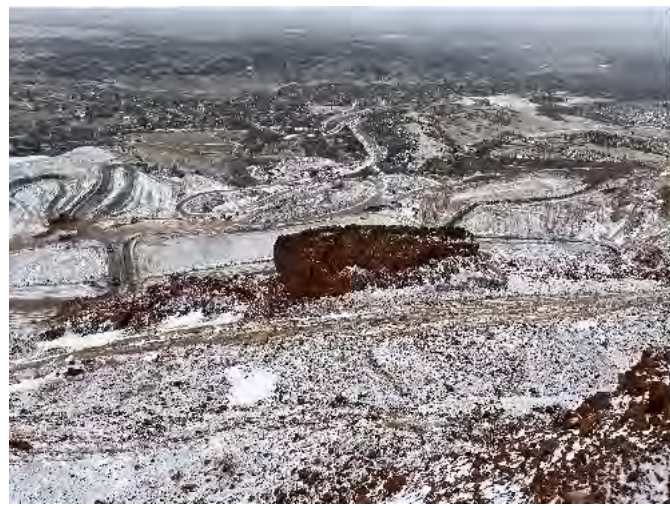
6. View east to pit floor from the haul road

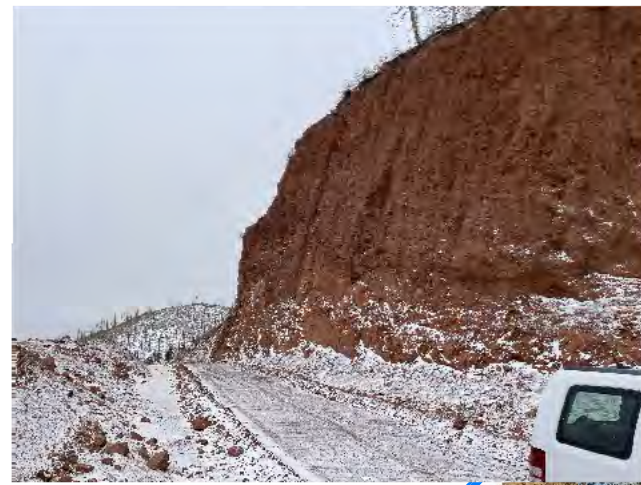
5. South peak along the haul road

NOTE 1:  
NO CRACKS

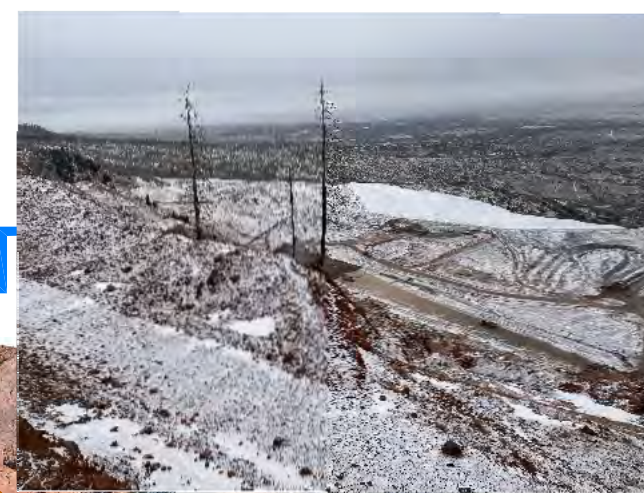
4. View northeast of Pit Floor and NBA benches

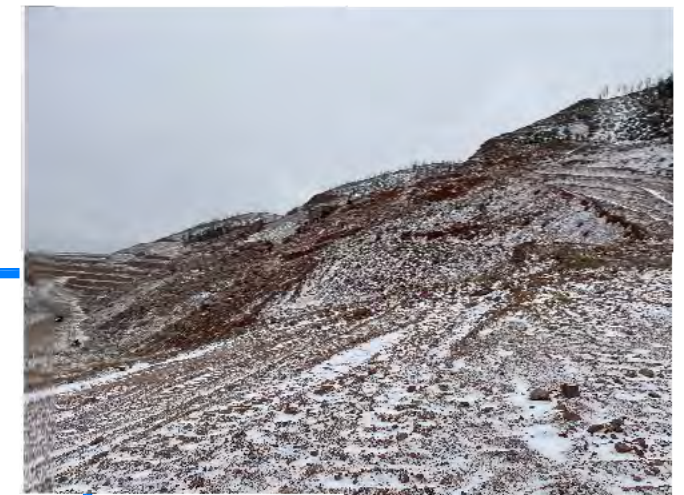
3. View from the haul road in North Borrow Area

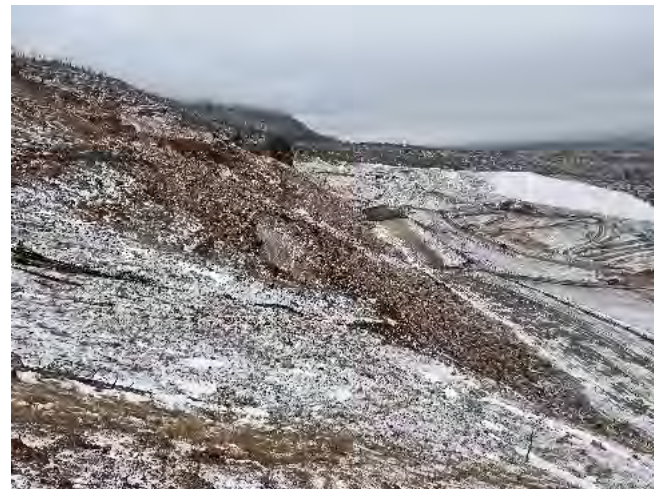
- No cracking was observed on the native granite slopes above the extents of the disturbed area (Photo 7).
- Compaction testing continues at the rate of at least one test per 5,000 cubic yards of fill placed in the buttress area. (Photo 8)

- Known cracks were monitored for changes. Currently the cracks are not growing in any of the areas on the slopes of the site. The hummocky field in the area immediately above the southern extent of the slide shows evidence of cracking, but they are not fresh or active. No new or open cracks were found immediately inside or next to the slide area. (Photo 7 and 8)

7. View north of slopes above the disturbed area

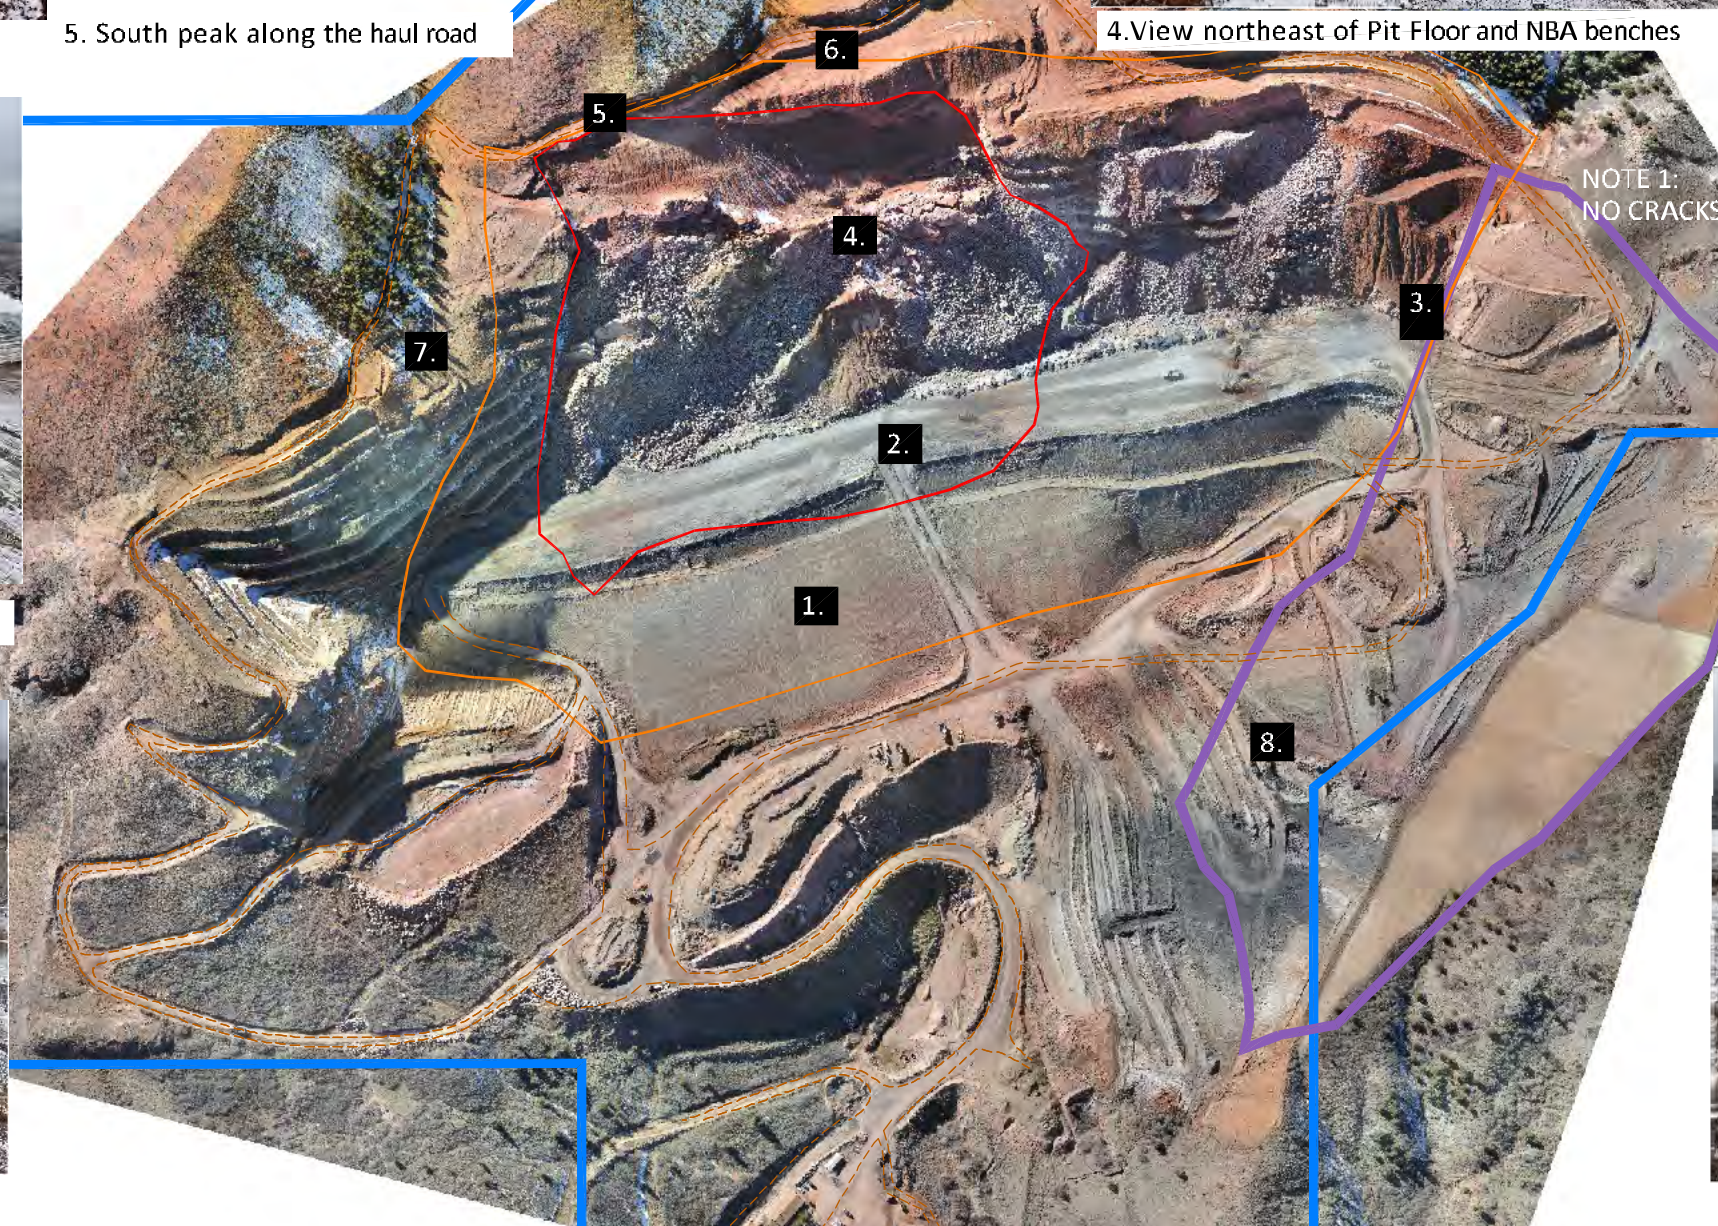
Figure No.  
2

NOTE 1:  
NO CRACKS

1. NO CRACKS OBSERVED IN THIS AREA.
2. ALL PHOTOS TAKEN FEBRUARY 27, 2023.

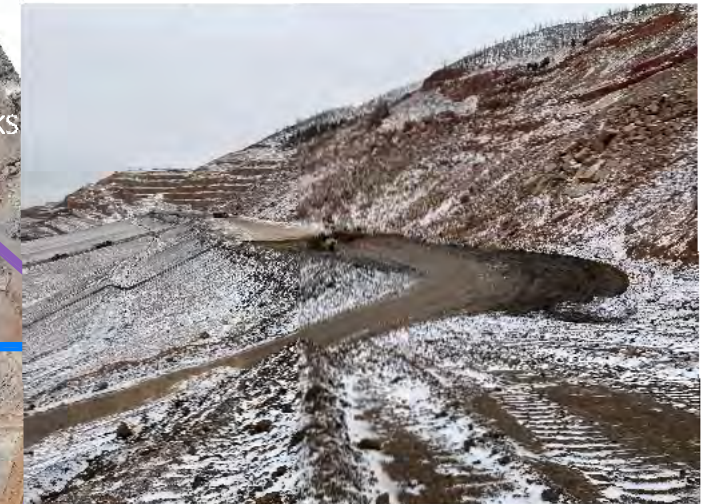
- Operators continue to place compacted material in the buttress zone. Material is excavated from the North and South Borrow Areas. Material is initially excavated in benches for the majority of the excavation to efficiently remove the material; these benches are removed for final grading to create the reclamation surface (Photo 2).

2. Material is placed and compacted on first bench

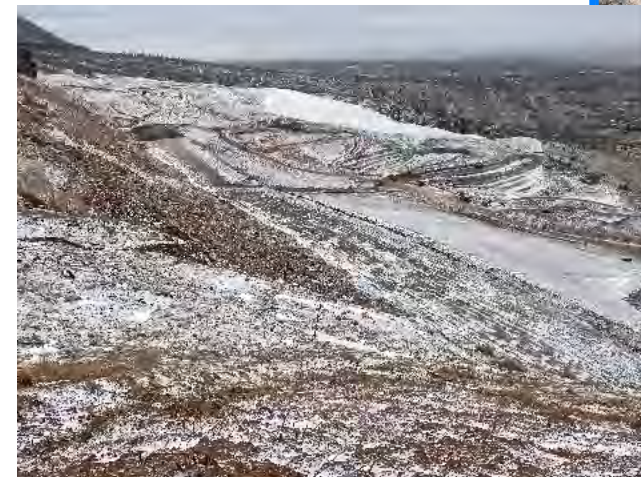
8. View to the north of compaction area and NBA

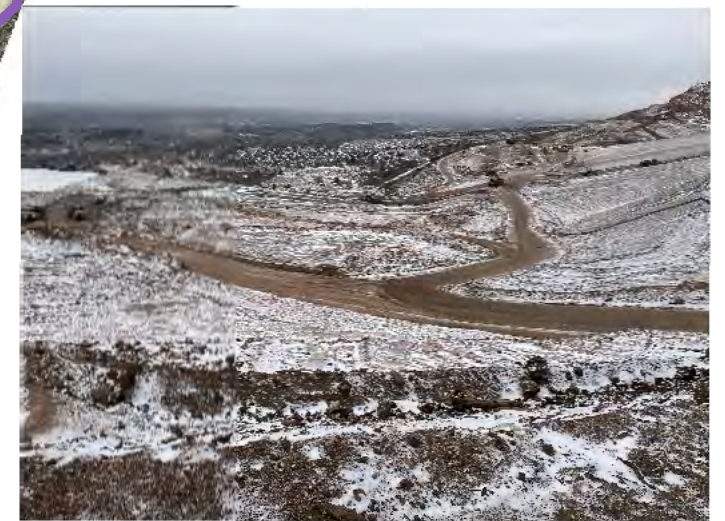
- Reclamation grading began in February 2022 and continued throughout February 2023.
- The slope below the first bench has been placed to the final grade, and this slope was traversed on foot and examined for cracks or signs of instability by Stantec engineers. No cracks or signs of instability were identified (Photo 1).

1. View south of first bench slope, NBA and SBA

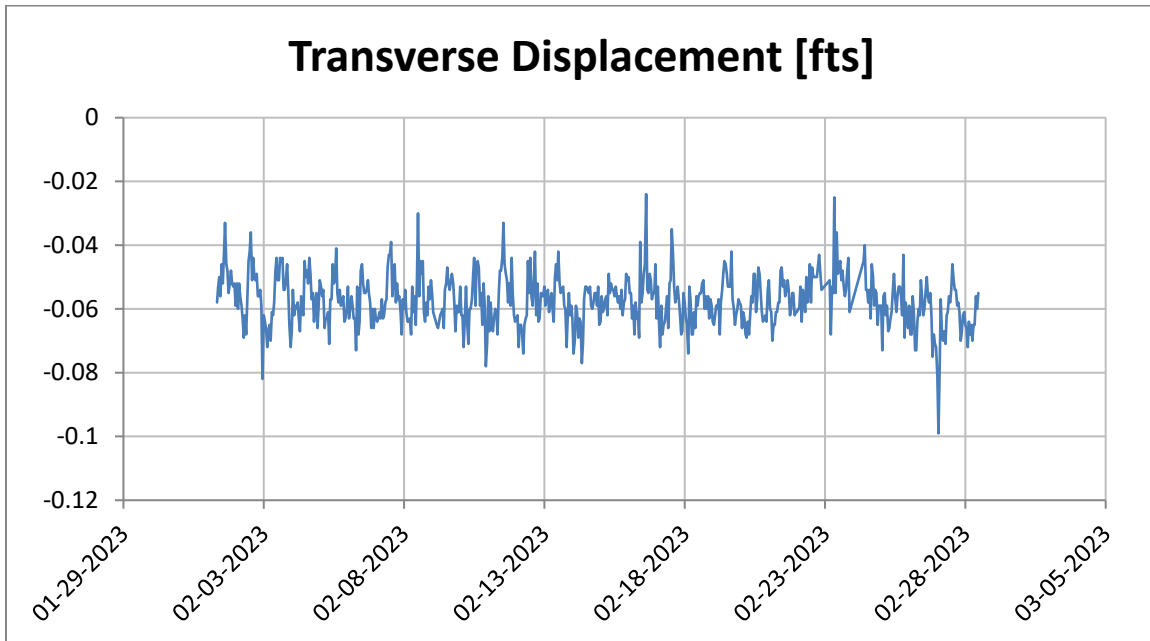
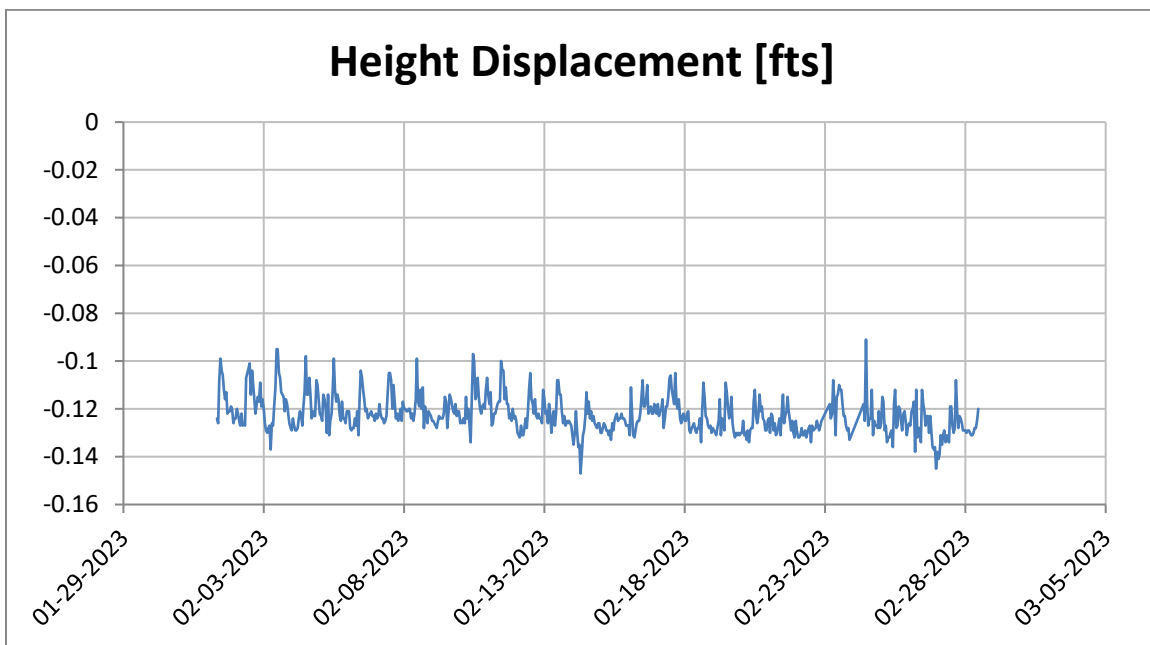
## Prism BR1

The data show stable conditions with no movement for 12 of 15 prisms with recorded displacements limited to data scatter and not actual movements. Prisms BR1, BR2, and NP66 are located above the landslide, and these prisms also recorded slope creep movements at slow velocity. This settlement is likely related to the landslide material consolidating under its own weight. New prisms are placed in areas where slope creep movements are likely to be recorded; therefore, slope creep movements being recorded at more locations is expected to occur. Plots of the transverse and height displacements for each prism are included in Appendix B.

1. Survey accuracy is  $\pm 0.016$  feet.
2. Alarm threshold is  $\pm 0.35$  feet.
3. Transverse displacement is in the horizontal direction. Positive direction means closer to the robotic station.
4. Height displacement is in the vertical direction. Positive direction means higher in elevation.
5. Prism records slope creep movements with slow velocity.

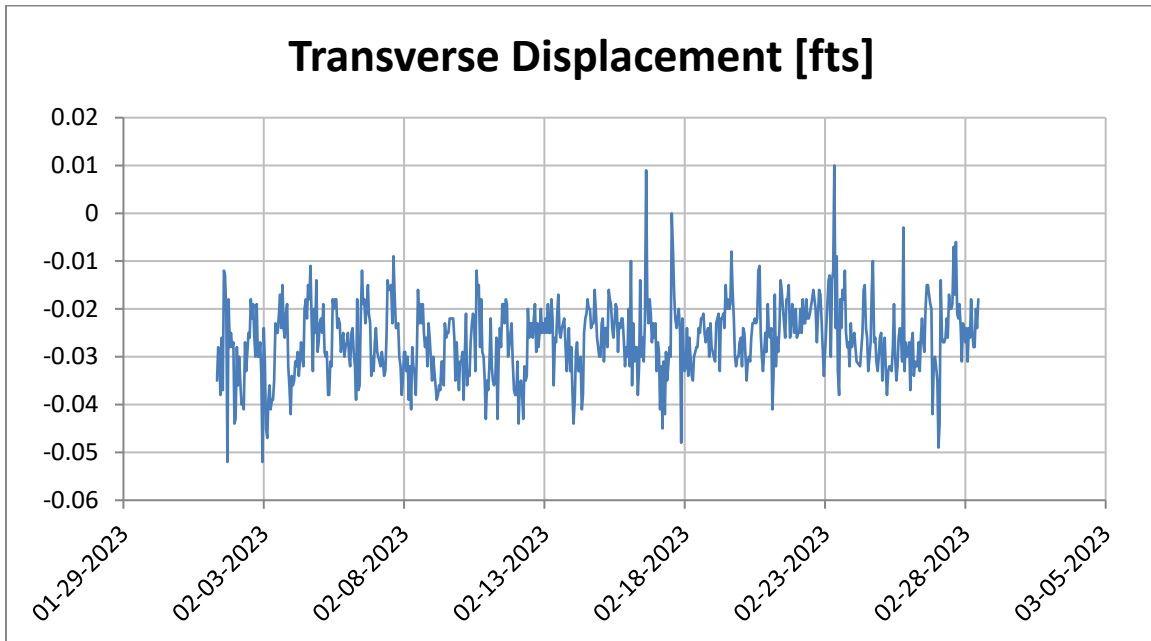
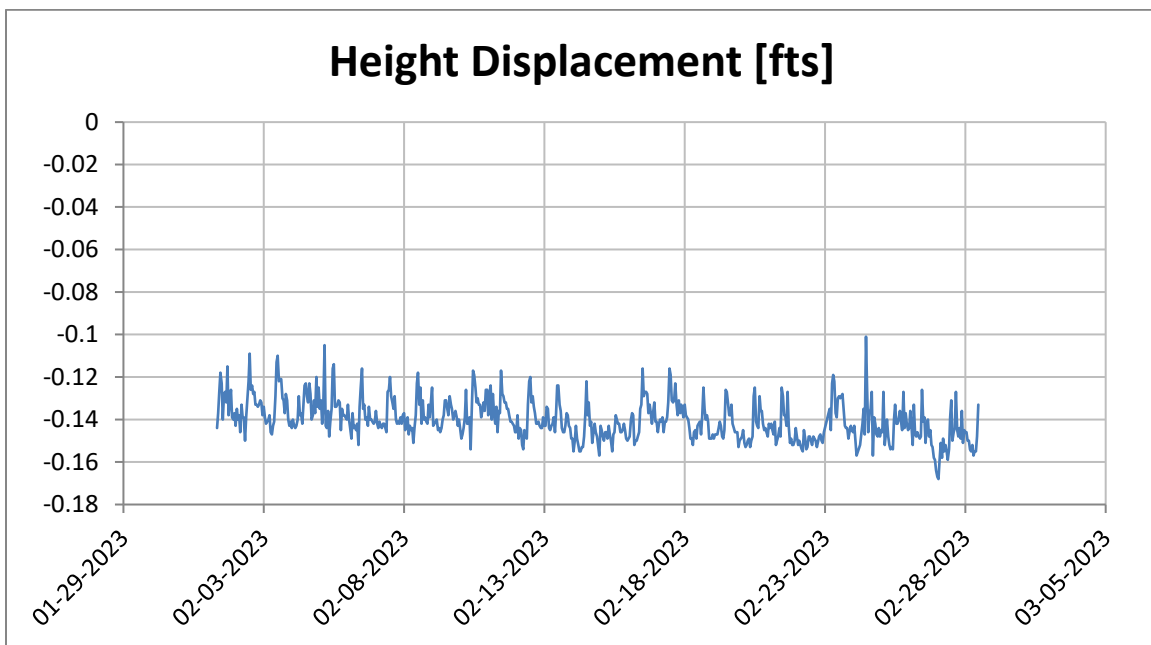
## Prism BR2

1. Survey accuracy is  $\pm 0.016$  feet.
2. Alarm threshold is  $\pm 0.35$  feet.
3. Transverse displacement is in the horizontal direction. Positive direction means closer to the robotic station.
4. Height displacement is in the vertical direction. Positive direction means higher in elevation.
5. Prism records slope creep movements with slow velocity.

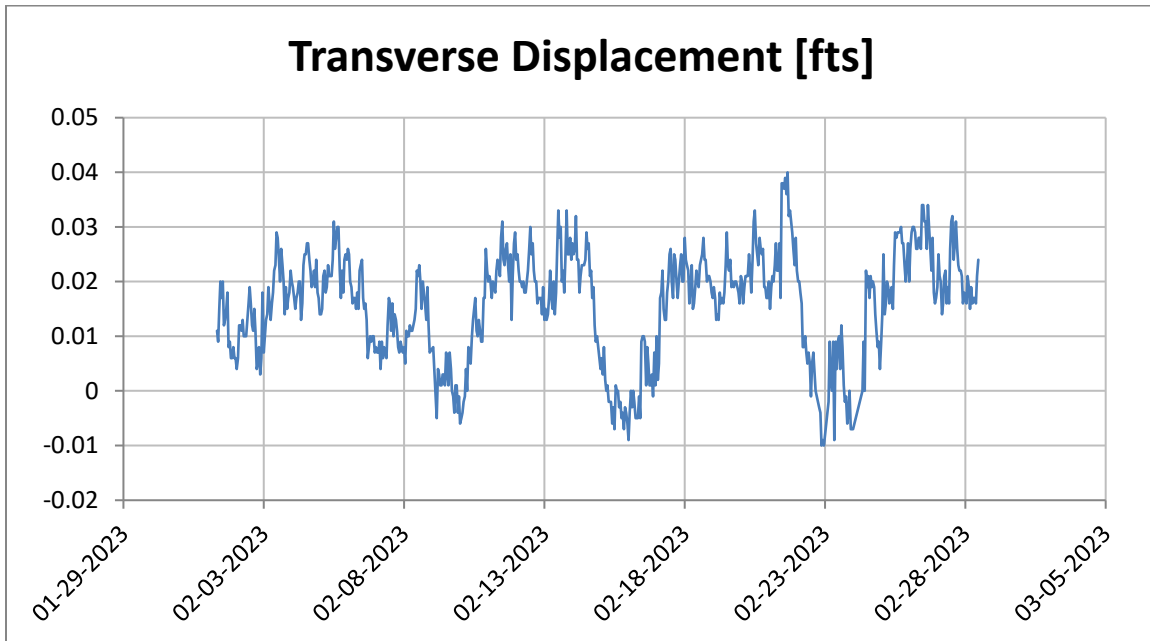
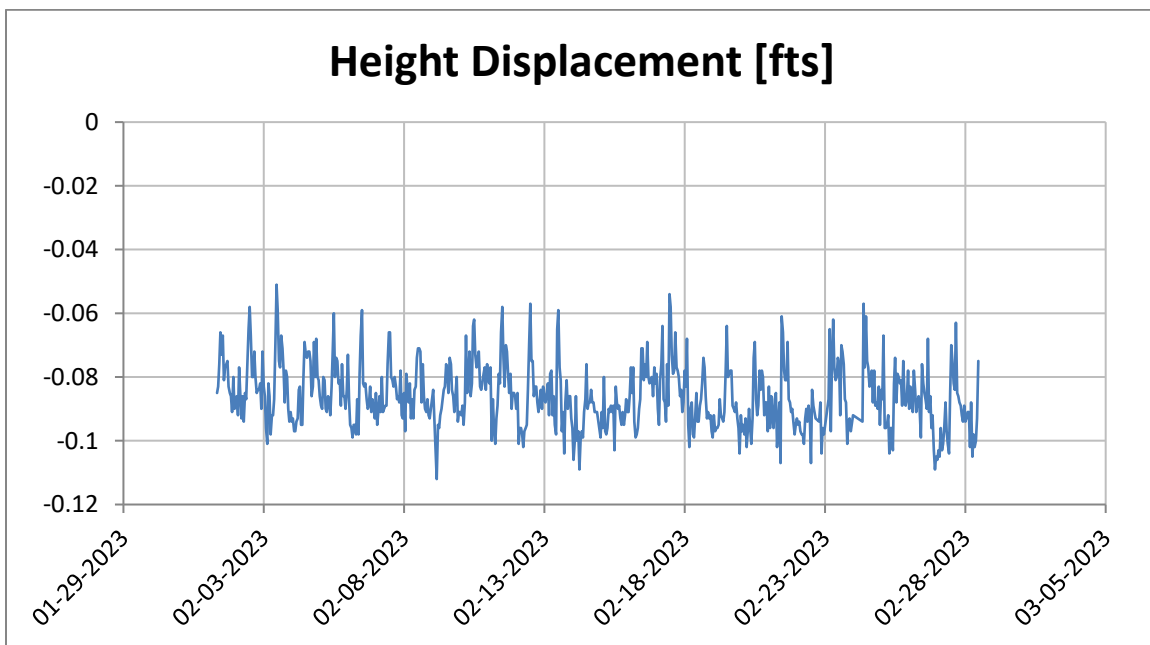
## Prism NP66

1. Survey accuracy is  $\pm 0.016$  feet.
2. Alarm threshold is  $\pm 0.35$  feet.
3. Transverse displacement is in the horizontal direction. Positive direction means closer to the robotic station.
4. Height displacement is in the vertical direction. Positive direction means higher in elevation.
5. Prism records slope creep movements with slow velocity.

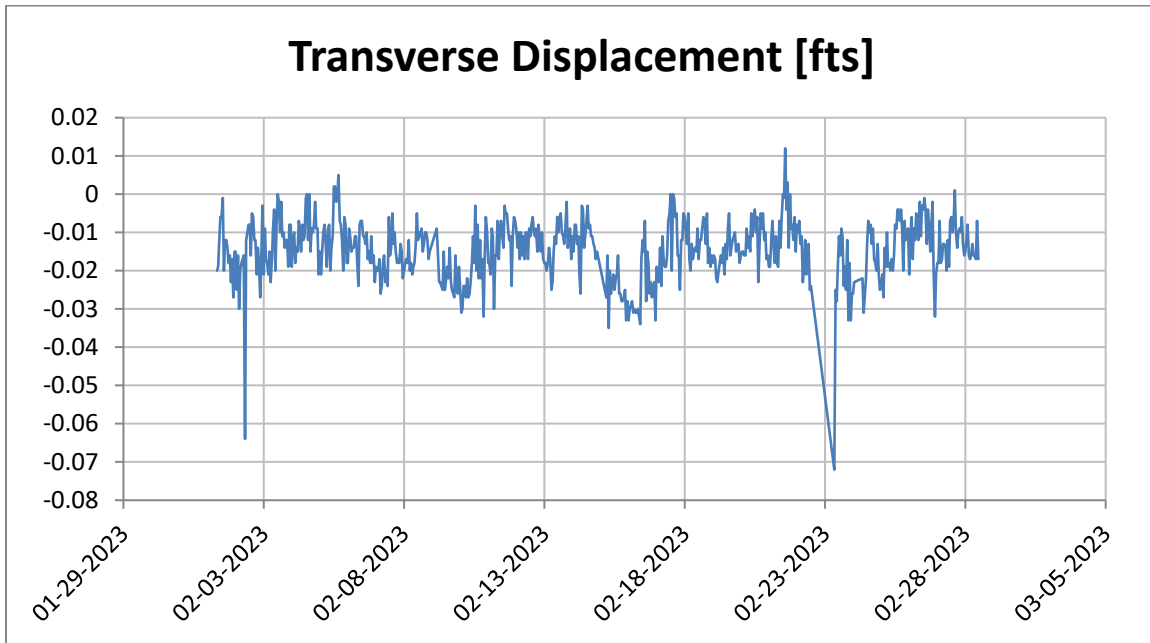
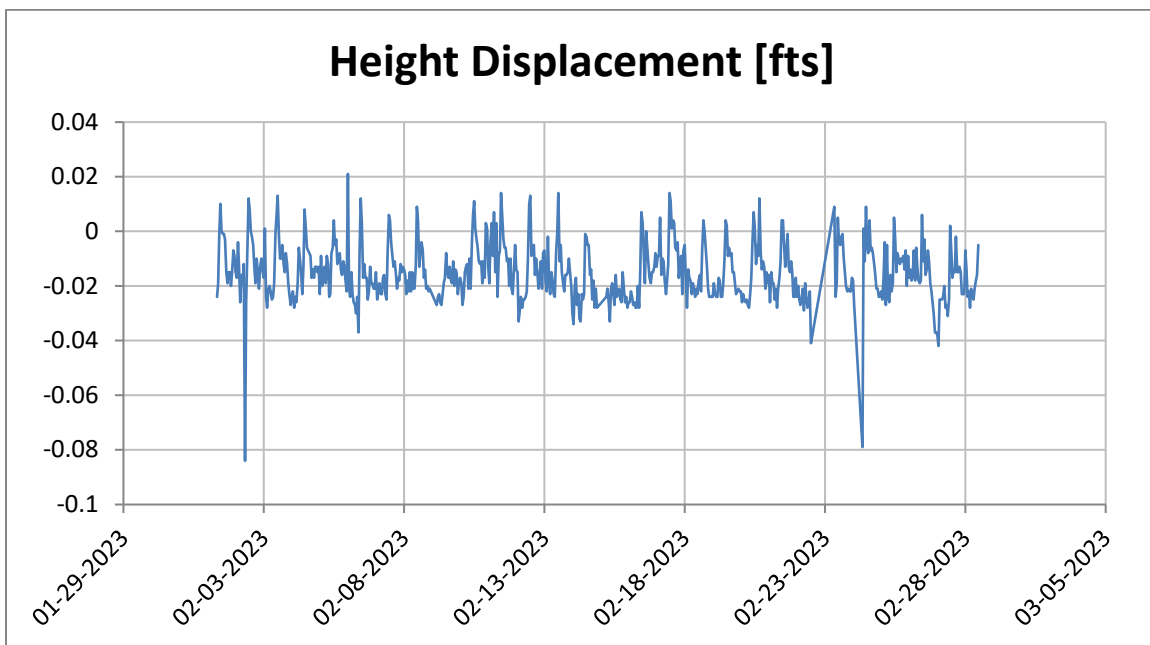
## Prism P2

1. Survey accuracy is +/-0.016 feet.
2. Alarm threshold is +/-0.35 feet.
3. Transverse displacement is in the horizontal direction. Positive direction means closer to the robotic station.
4. Height displacement is in the vertical direction. Positive direction means higher in elevation.
5. Regression limit alert received on February 2.

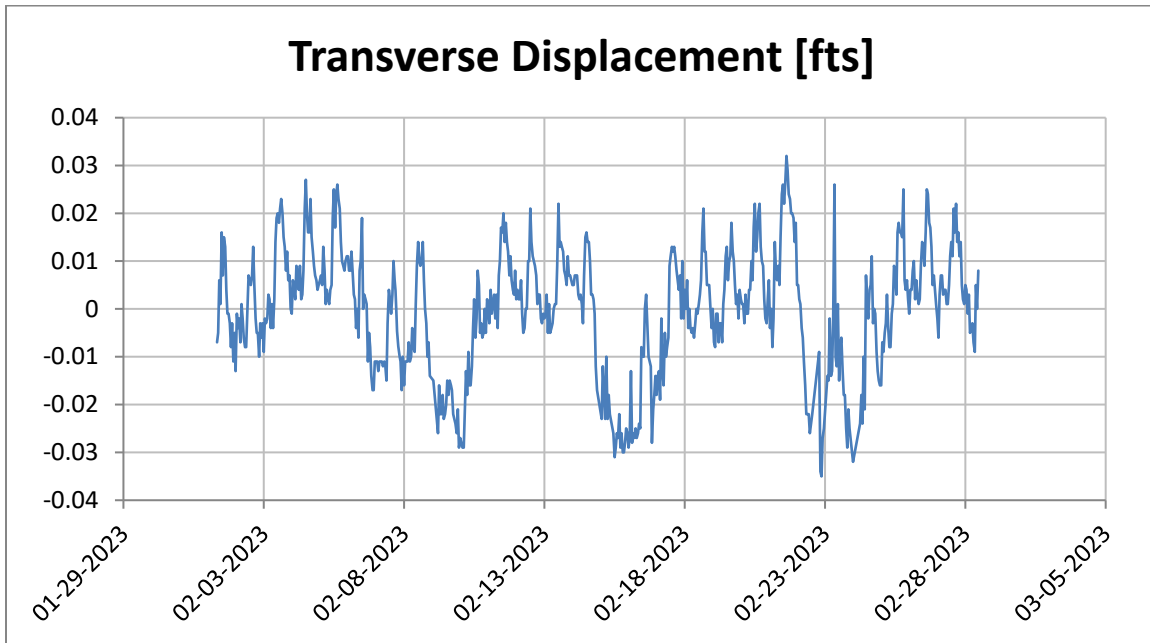
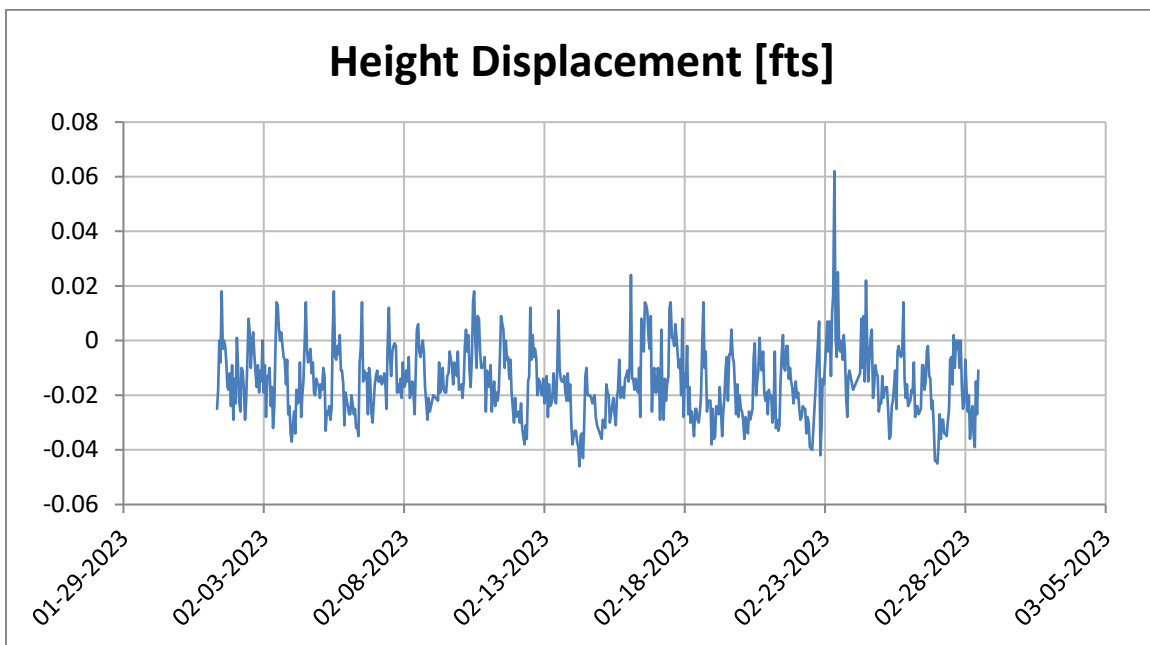
## Prism P33

24-Feb	P33 regression limit received	Single event. Weather related data error. No work during alert.	24-Feb

1. Survey accuracy is  $\pm 0.016$  feet.
2. Alarm threshold is  $\pm 0.35$  feet.
3. Transverse displacement is in the horizontal direction. Positive direction means closer to the robotic station.
4. Height displacement is in the vertical direction. Positive direction means higher in elevation.
5. Regression limit alert received on February 24.

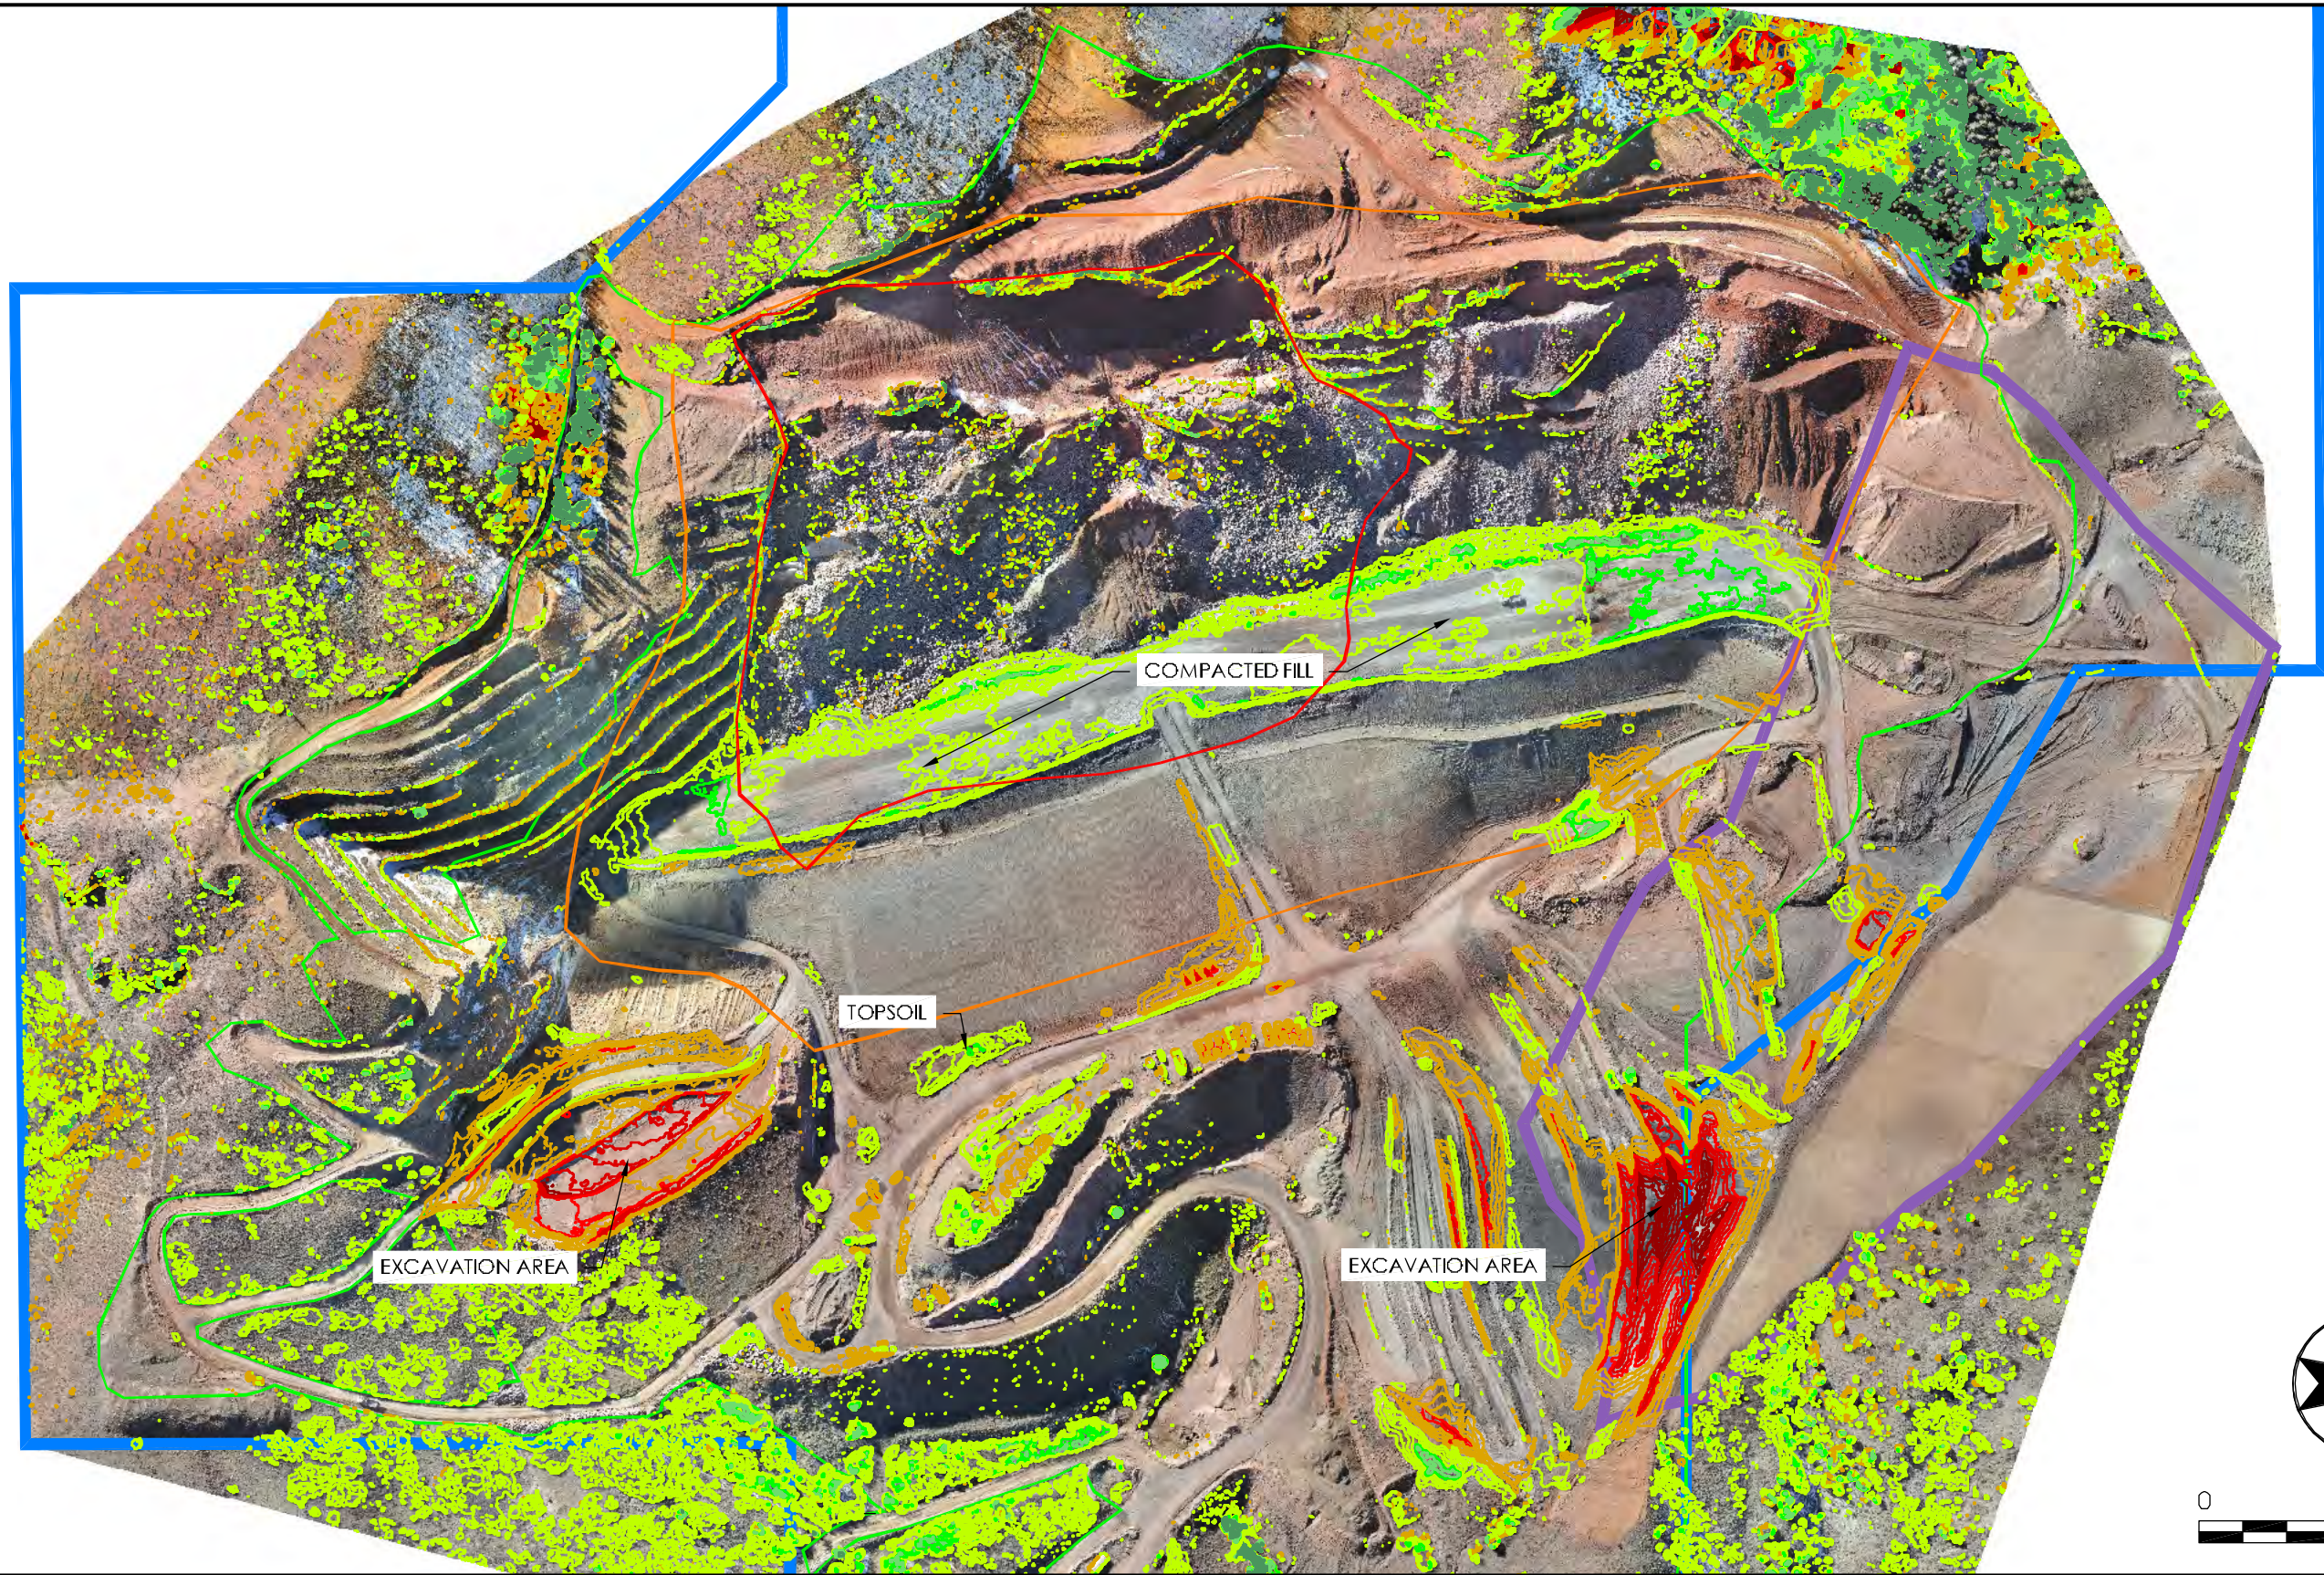
The February topography was also compared to the January topography to identify changes in the site topography. Comparison of the two surveys showed the placement of the fill material at the toe of the landslide. Fill material is excavated from the Shop Borrow Area or imported from offsite projects, including the North Borrow Area. No slope movements or other changes in topography were identified. The current imagery and topography are included in Figures 1 and 3, and the comparison surface is included as Figure 5 in Appendix C.

As previously reported in the September 2020 monitoring report, there are limitations with the method of comparing drone surveys from different months. The drone data indicate changes in the slopes along each of the reclamation benches, buildings, and areas with trees or shrubs. These areas are stable, and the changes are the result of survey limitations on or near vertical slopes.
