**MINERALS PROGRAM INSPECTION REPORT**  
**PHONE: (303) 866-3567**

<b>MINE NAME:</b> Climax Mine	<b>MINE/PROSPECTING ID#:</b> M-1977-493	<b>MINERAL:</b> Molybdenum	<b>COUNTY:</b> Lake, Summit
<b>INSPECTION TYPE:</b> Monitoring	<b>WEATHER:</b> Snowing	<b>INSP. DATE:</b> March 21, 2023	<b>INSP. TIME:</b> 13:00
<b>OPERATOR:</b> Climax Molybdenum Company	<b>OPERATOR REPRESENTATIVE:</b> Eric Detmer	<b>TYPE OF OPERATION:</b> 112d-3 - Designated Mining Operation	
<b>REASON FOR INSPECTION:</b> Normal I&E Program	<b>BOND CALCULATION TYPE:</b> None	<b>BOND AMOUNT:</b> \$63,246,088.00	
<b>DATE OF COMPLAINT:</b> NA	<b>POST INSP. CONTACTS:</b> None	<b>JOINT INSP. AGENCY:</b> None	
<b>INSPECTOR(S):</b> Amy Yeldell	<b>INSPECTOR'S SIGNATURE:</b>

<b>SIGNATURE DATE:</b> March 27, 2023

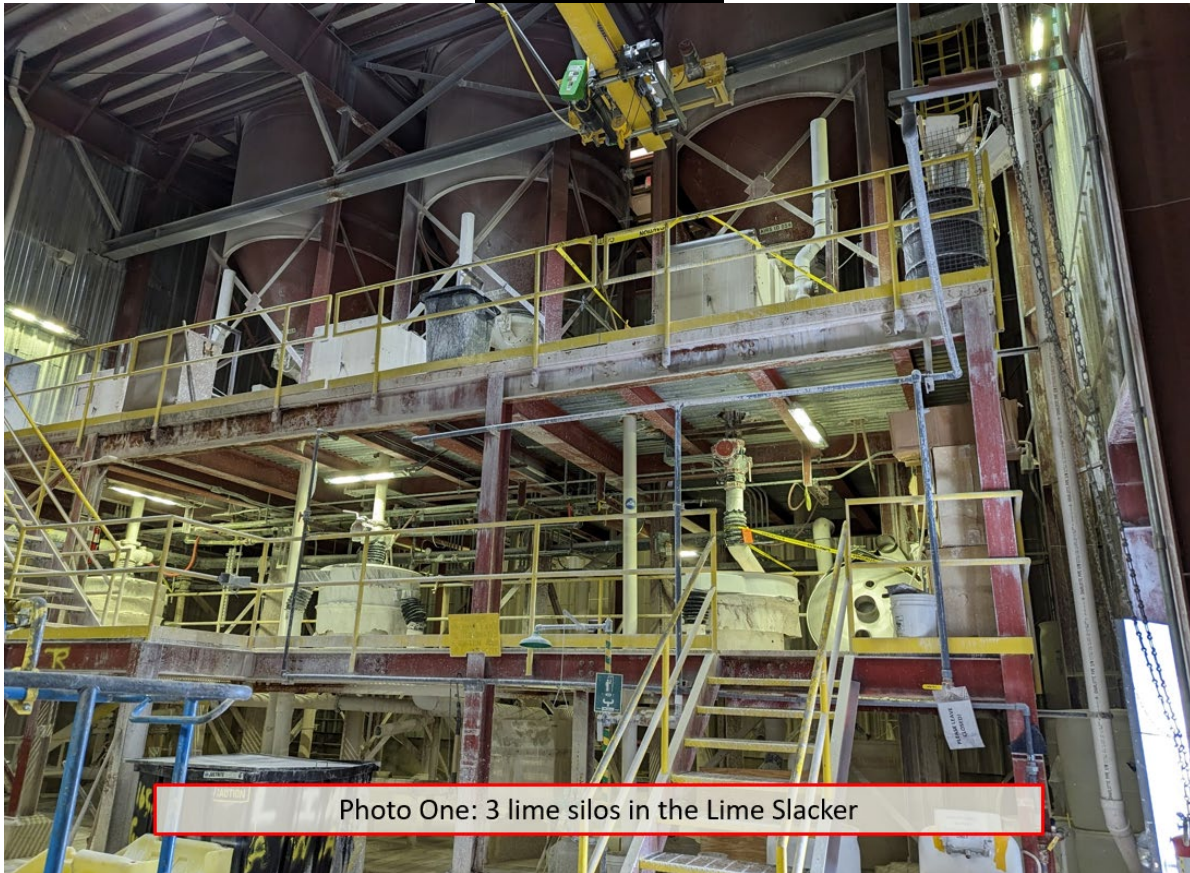
First we inspected the Lime Slacker which provides slacked lime to the SDP. Three lime silos contain the dry pebble lime (photo one). The dry pebbled lime is mixed with fresh water in the lime slacker, which creates the slacked lime slurry. This slacked lime slurry is then pumped to the SDP.

Residual dried lime is present throughout the building as everything was covered in a white layer. All floors within the buildings were dry indicating no recent spills or loss of containments. Floor drains and sumps were also dry.

Photo One: 3 lime silos in the Lime Slacker

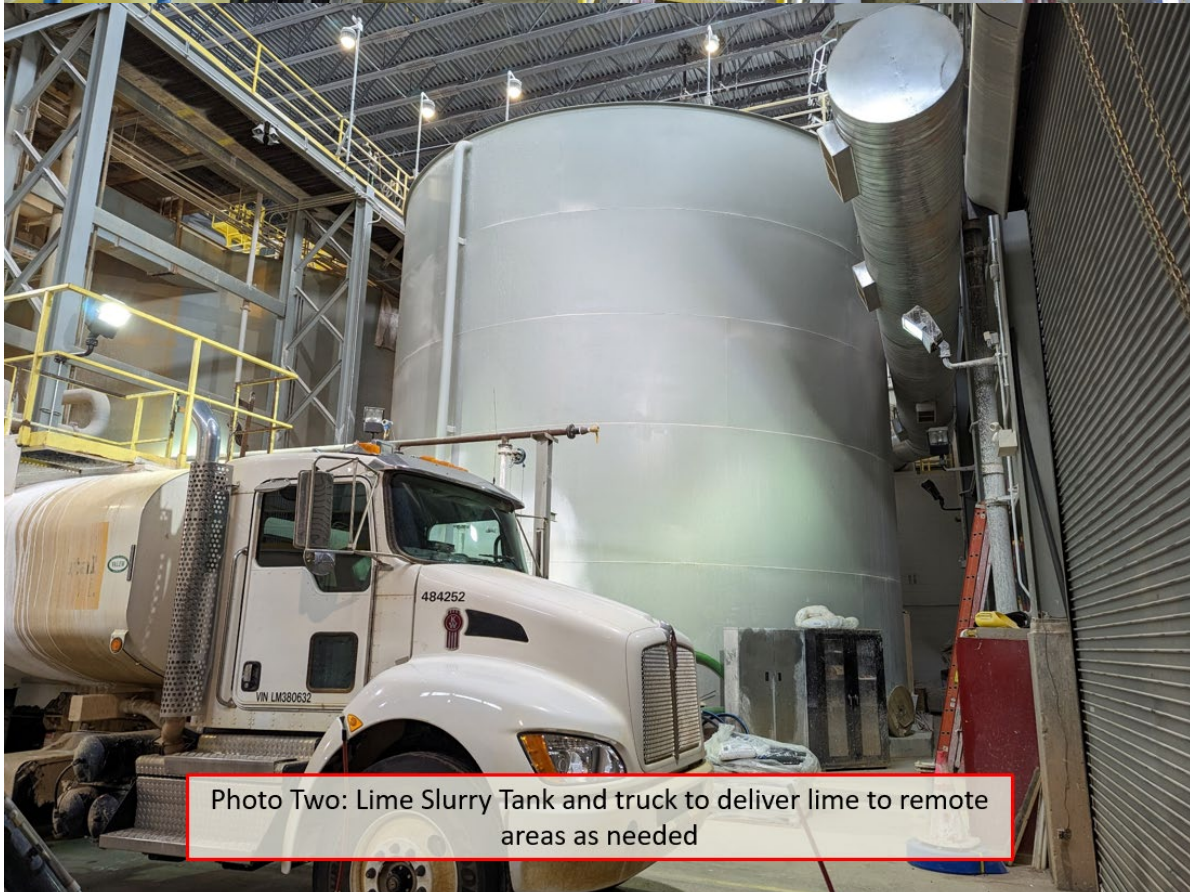
Slacked lime from the lime slacker is pumped into a large holding tank called the Lime Slurry Tank which is located within the SDP building. Slacked lime is also used at a few other locations as needed. A water truck is parked next to the Slacked lime tank to transport the lime slurry to these locations on an as needed basis (photo two).

Photo Two: Lime Slurry Tank and truck to deliver lime to remote areas as needed

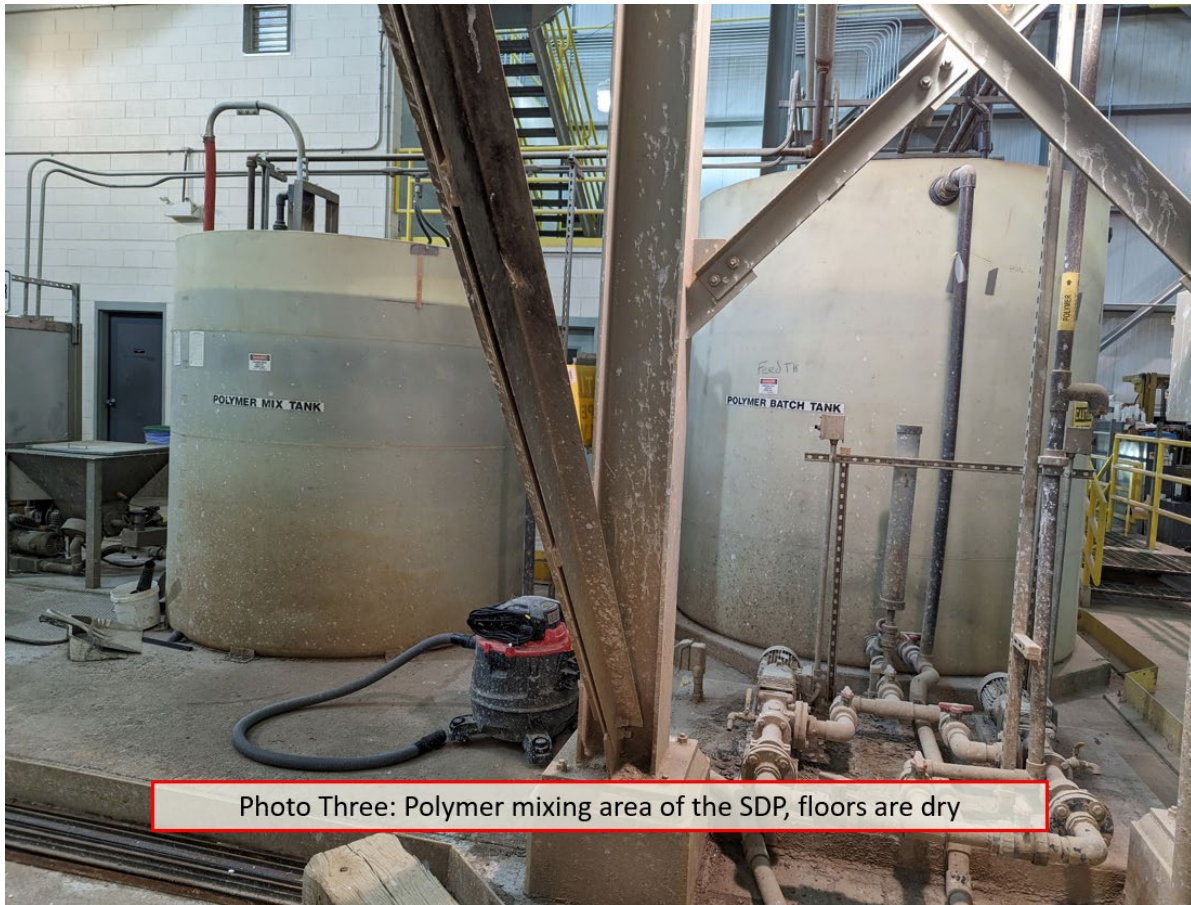
Two polymer tanks were also located within the SDP building. One tank is for mixing the other is the batch feed tank (photo three). The dry polymer sacks are neatly stacked on pallets in the back of the building. Near the dry polymer storage is a fresh water storage tank, which is used to mix with the dry polymer. The polymer is used to facilitate solids settling out.

Photo Three: Polymer mixing area of the SDP, floors are dry

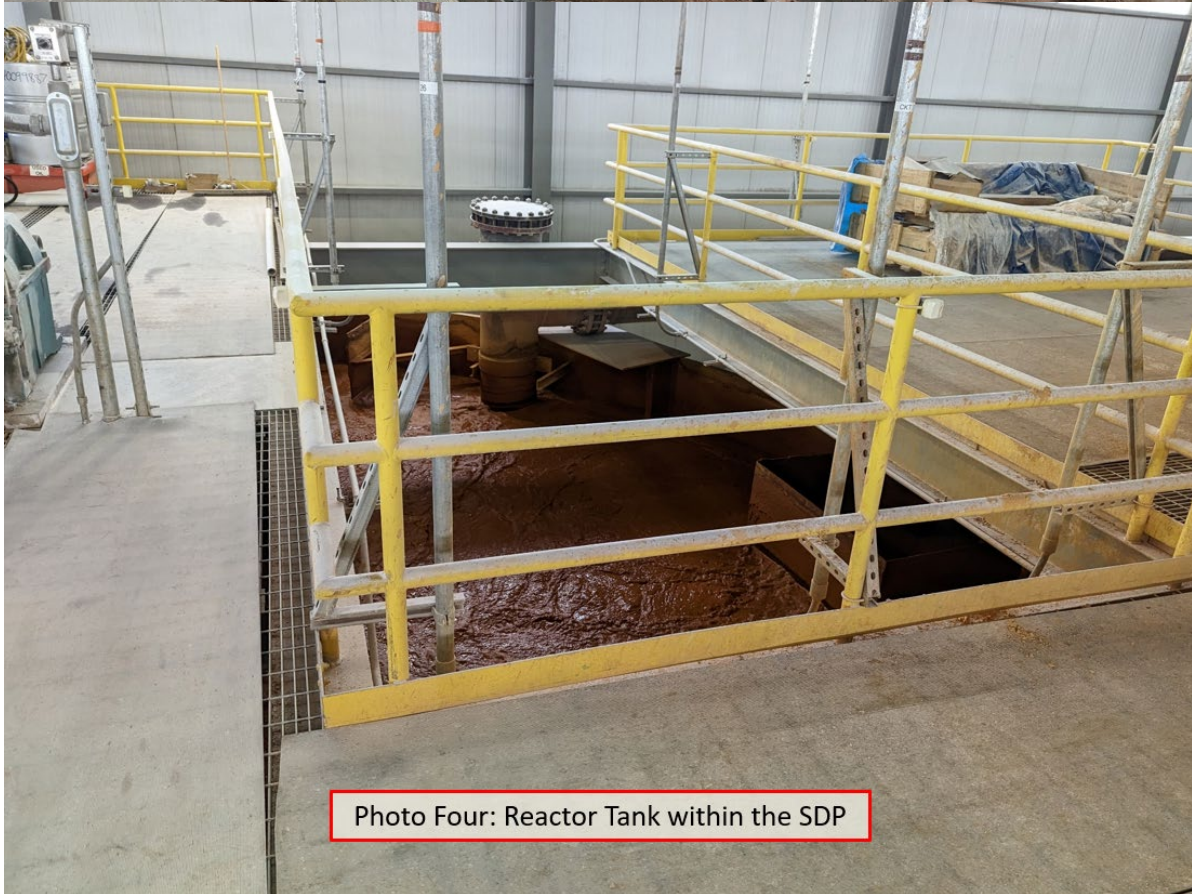
Impacted water is delivered via the ETDL. Additionally collected seepwater from Tim's Pond and Warrens Pump Station is delivered to the SDP via the 2 Dam Pipeline. There are two reactor tanks at the SDP. The reactor (neutralizer) tanks mixes the impacted water with the slacked lime. Sludge is recirculated to maximize neutralization with lime and to increase coagulation and settling (photo four). Once thoroughly mixed the sludge mixture goes into the clarifier which is located outside. In the clarifier (thickener) sludges are recirculated so that the treated water overflows out the top and the sludges are consolidated and drop out the bottom. The consolidated sludges go to the sludge cell (photo five). Stage 1 treated water goes to Tenmile TSF where natural evaporation and freeze/thaw cycles increase the sludge density.

Photo Four: Reactor Tank within the SDP

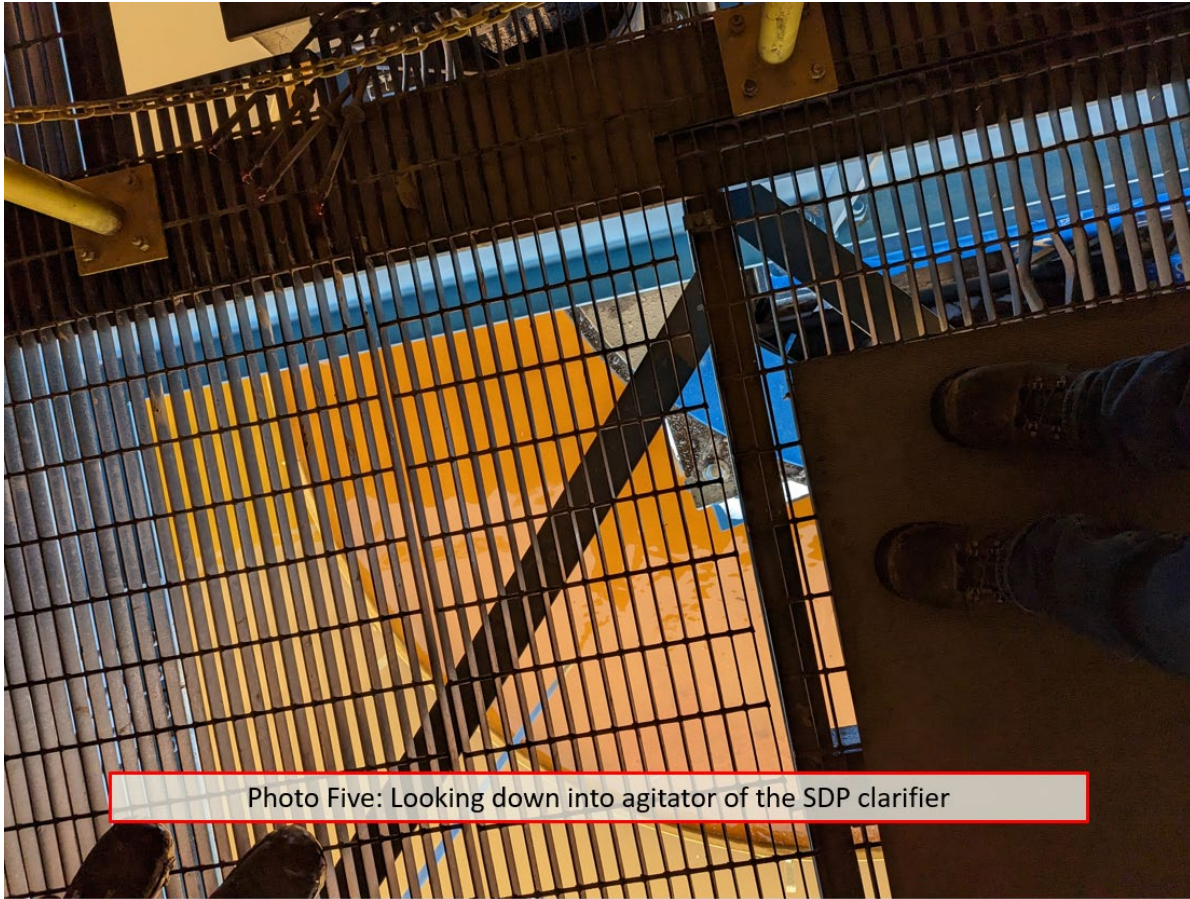
Recently the clarifier was down due to mechanical issues. The water at the top had begun to freeze. Shortly before beginning our inspection it was made operational again and water treatment had recommenced.

Photo Five: Looking down into agitator of the SDP clarifier

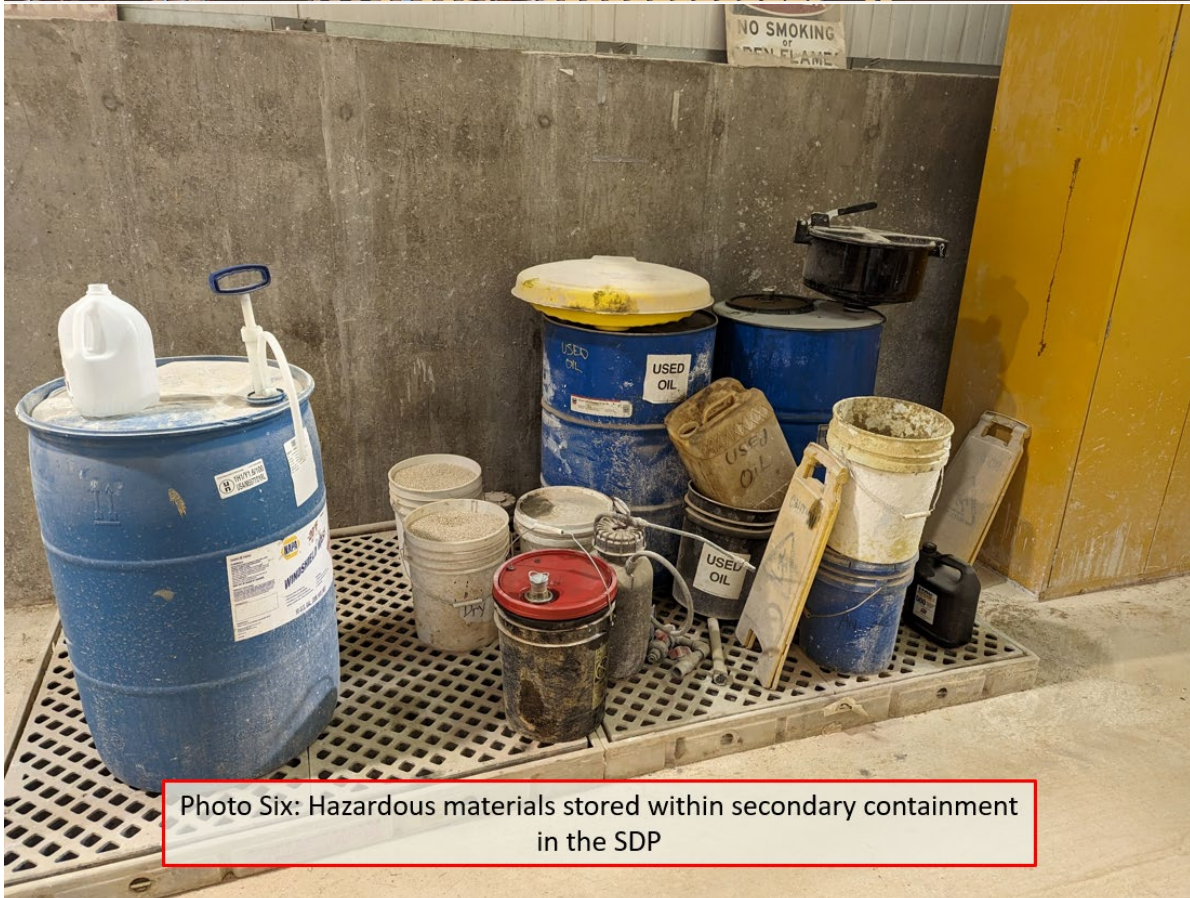
Contained within the SDP building is a small spill pallet for storage of hazardous materials (photo six). Used oil and other hydrocarbons were stored on this pallet. No other materials were observed outside of containment within the SDP. Located throughout the SDP are floor drains. Spills go into floor drains and overall are contained within the drainage area of the Tenmile TSF. All containments within the SDP appeared to be dry at the time of inspection.

Photo Six: Hazardous materials stored within secondary containment in the SDP

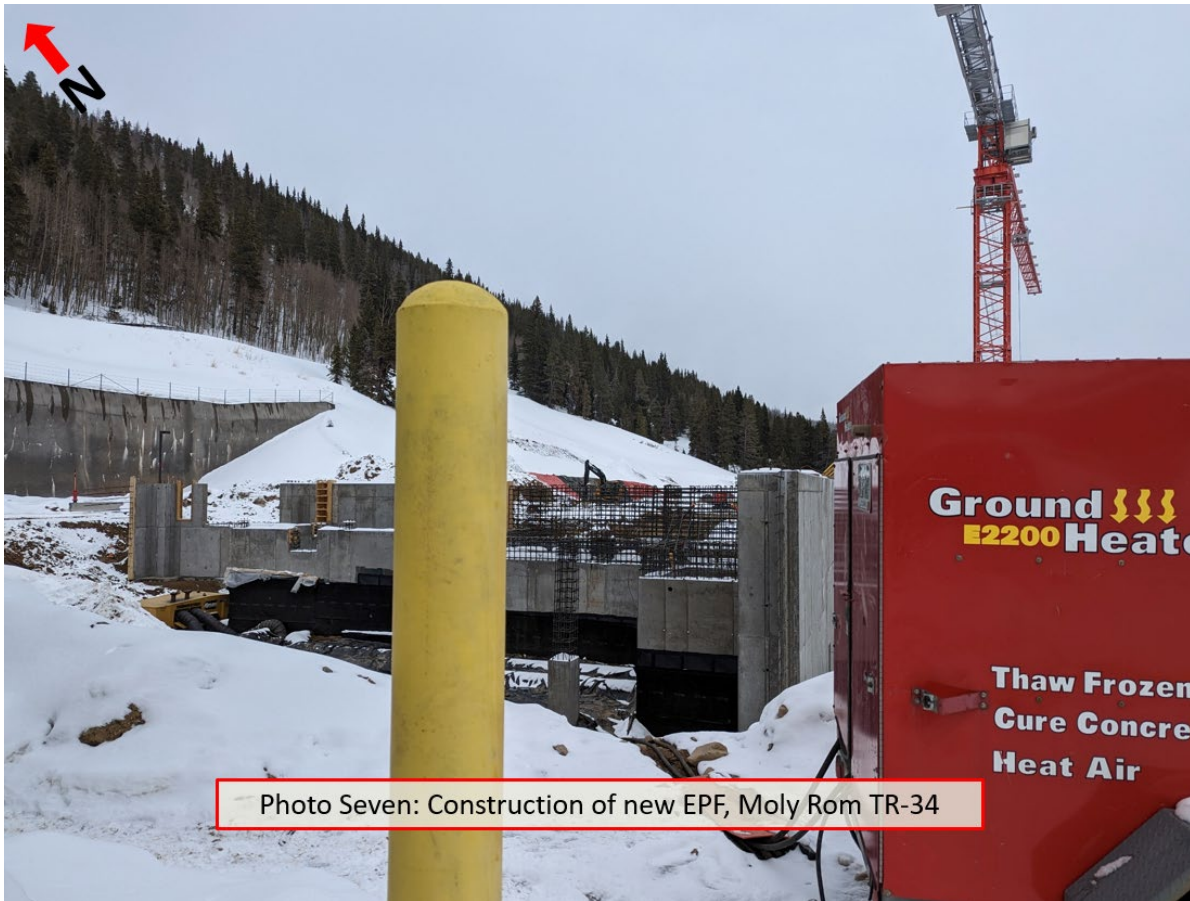
The new molybdenum building (TR-34) is under construction (photo seven). This is a supplementary process to Climax's existing Property Discharge Water Treatment Plant (PDWTP). Currently the foundations and sumps are being constructed. Rebar forms were observed as well as some areas where concrete has been poured. A crane and several crews were on site actively working on this new EPF. Once online the raw water will first go into the Moly building, then water will go to the existing PDWTP building and finally the existing Metals Filter Building before discharge. The PDWTP provides stage 2 metals removal and treats up to 14,000 gpm. The primary contaminants in the water targeted for treatments are manganese, iron, copper and zinc (and soon molybdenum).

Photo Seven: Construction of new EPF, Moly Rom TR-34

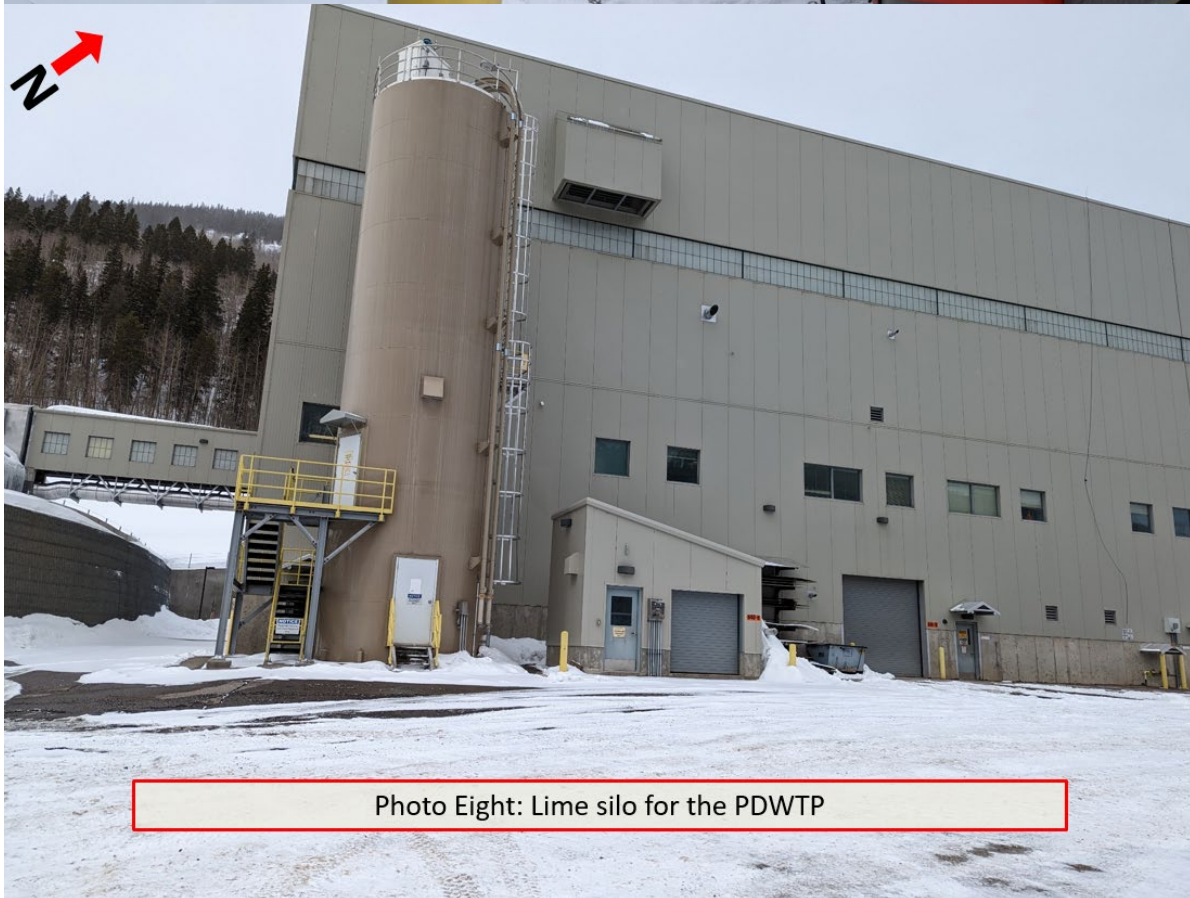
A lime silo is located outside of the PDWTP to feed pebbled lime into the Lime slacker within the PDWTP (photo eight). Raw water from the Mayflower Pond and the slacked lime are fed into the Metals Reactor tank where it's mixed. There are two Metals Reactor (neutralizer) tanks in series within the PDWTP (photo nine). The sludge is re-circulated to maximize the neutralization potential of the added lime (pH of about 10) and to enhance coagulation and settling.

Photo Eight: Lime silo for the PDWTP

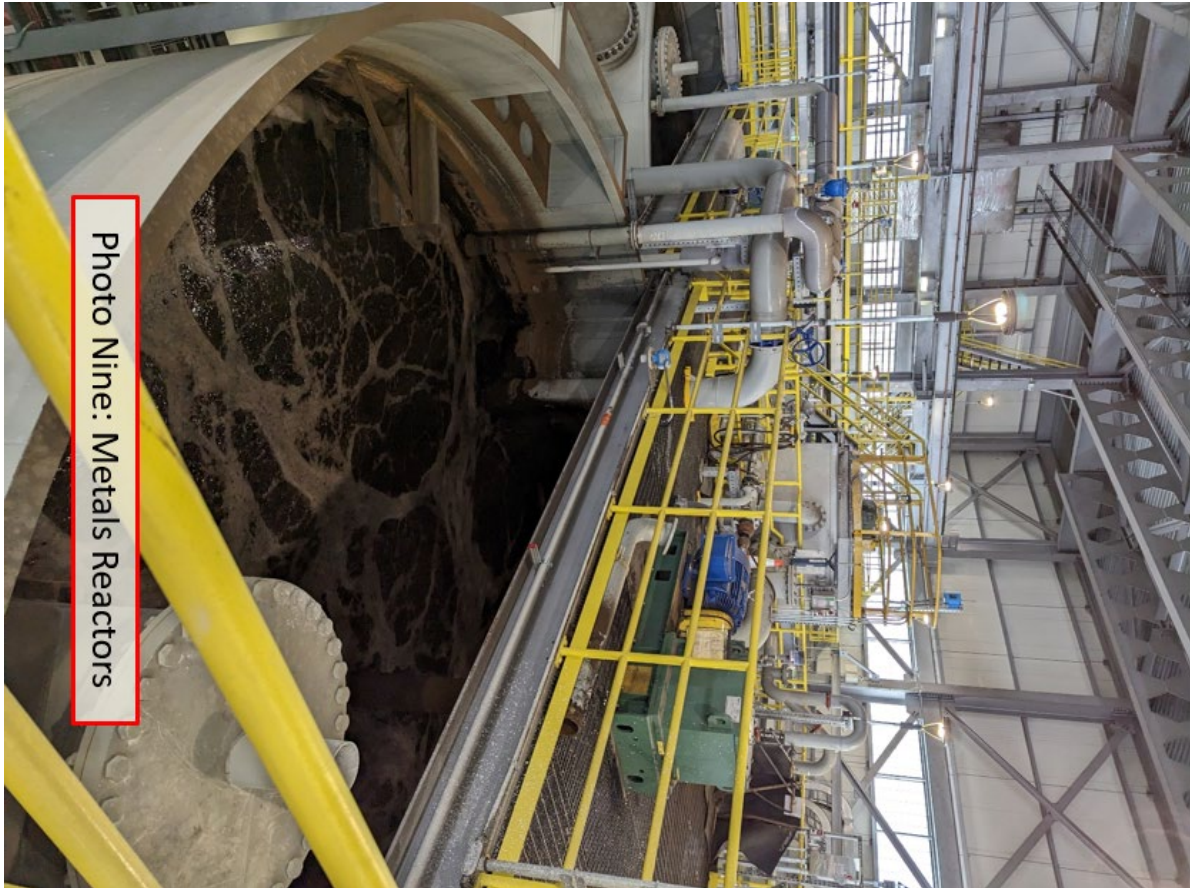
Photo Nine: Metals Reactors

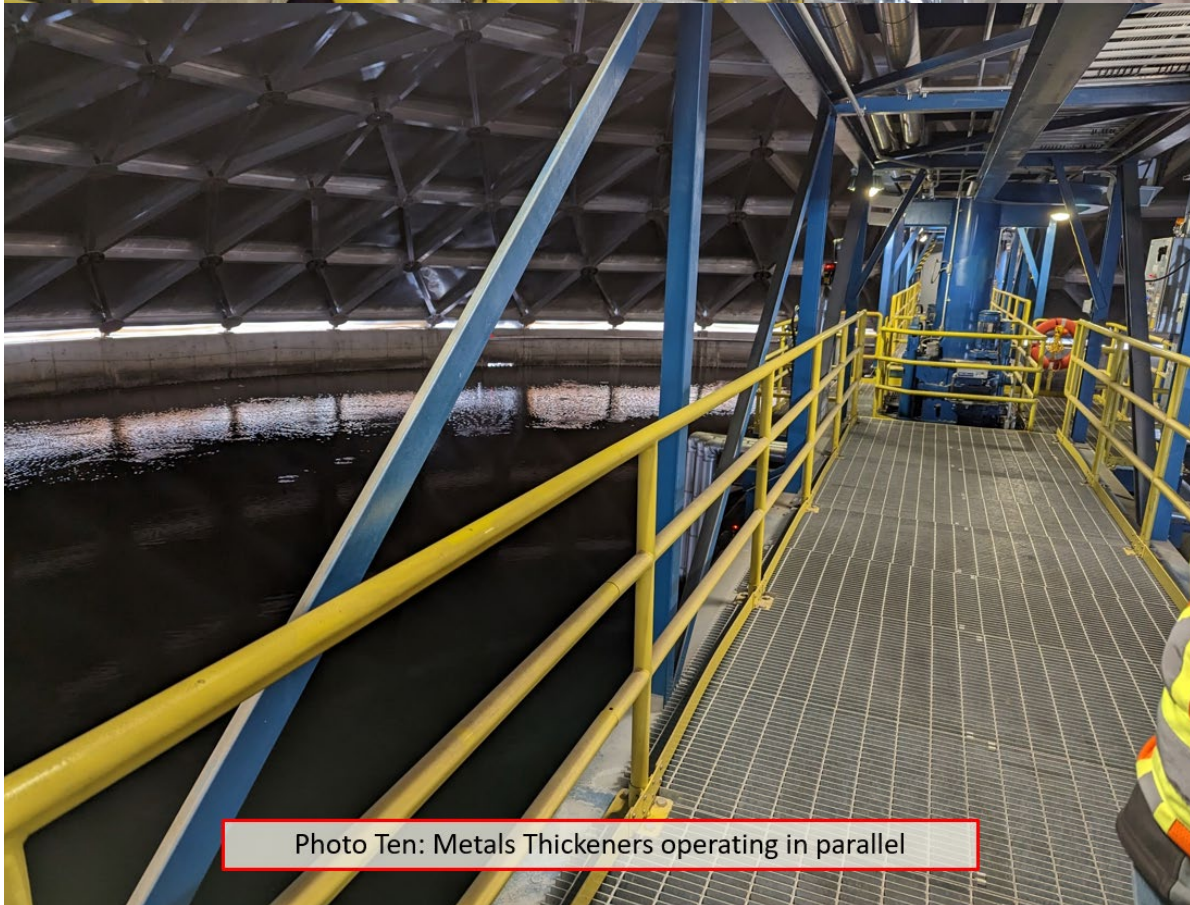
The resulting slurry/precipitate then goes into the one of two Metals Thickeners (clarifiers) that are in parallel. The clarifiers are located outside of the PDWTP under an enclosed dome that is connected via walkways (photo ten). Within the clarifiers the sludges are further thickened/precipitated and then the overflow water will proceed to the Metals Filter building.

Photo Ten: Metals Thickeners operating in parallel

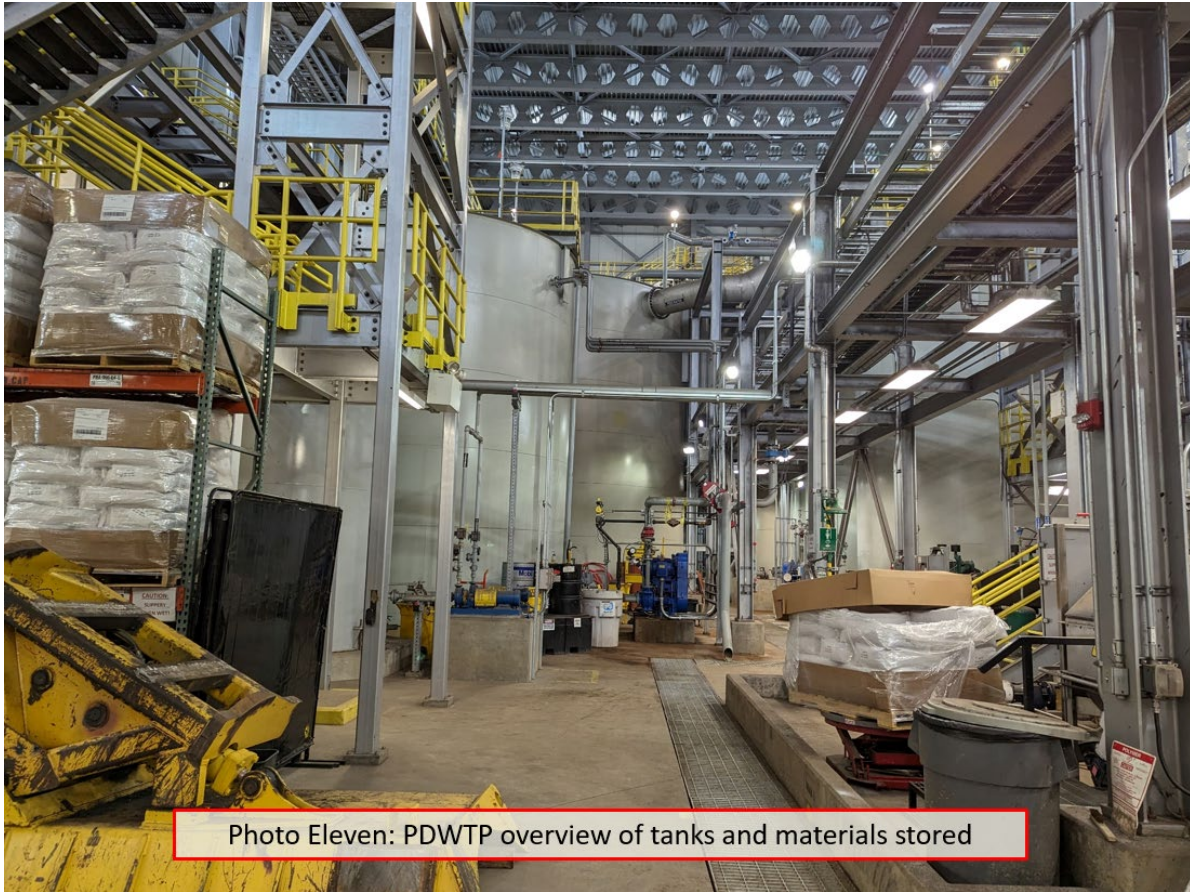
Also located within the PDWTP building are a Metals Sludge Tanks, Metals Filtrate Tank, a Metal Flocculent Storage Tank, Metals Mixed Flocculent Tank and a Fresh Water Tank. There is a large sump built into the foundation of the PDWTP. All floor drains discharge into the cellar which was dry at the time of the inspection. Floor drains in some areas were wet but with ample storage capacity. The floor between the slacked lime tank and reactor was wet, but no apparent leak source was identified. Miscellaneous hydrocarbons are stored on spill pallets located throughout the building (photo eleven).

Photo Eleven: PDWTP overview of tanks and materials stored

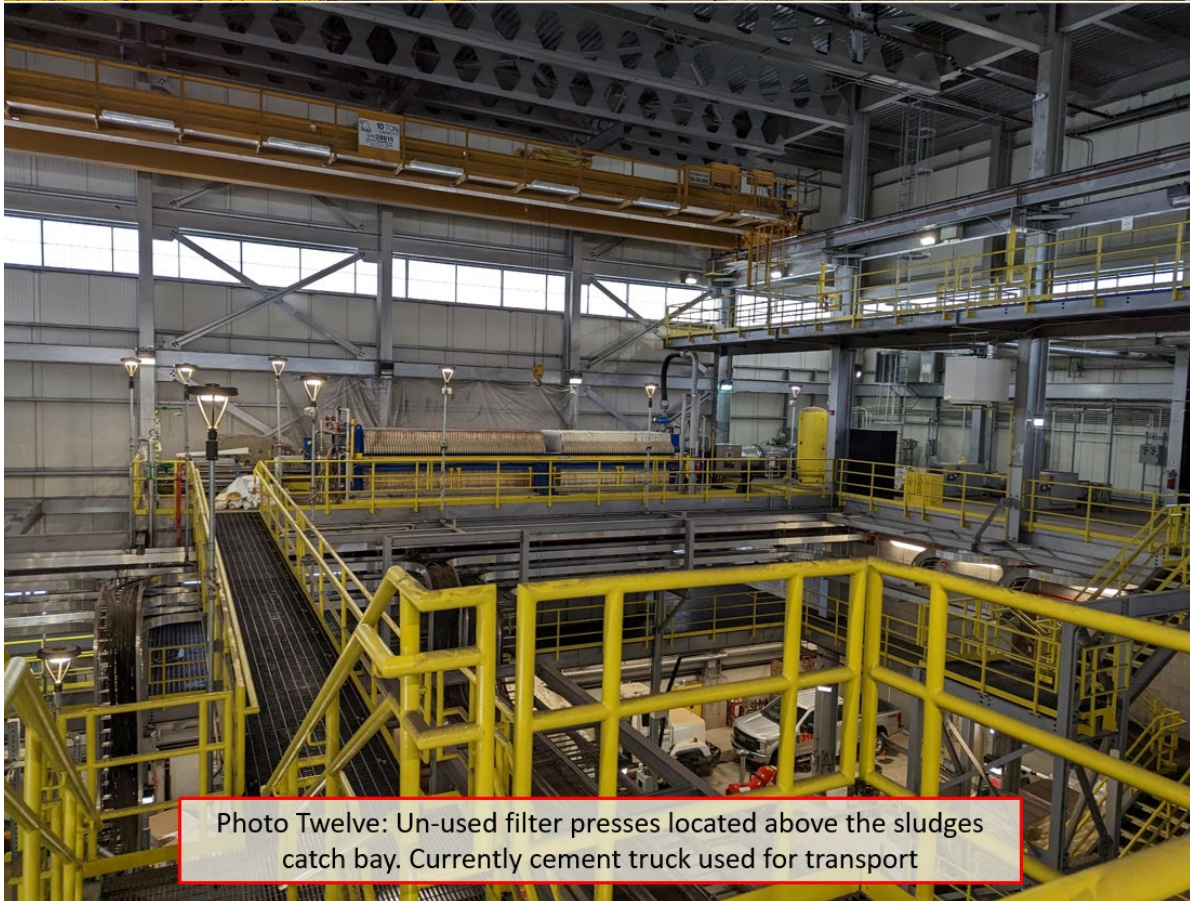
Solids from the PDWTP are transported via a cement truck to the Sludge cells. There are two un-use filter presses that the Operator is working on making operational to help combat the volume of sludges that will require off-site disposal per the new T-Norm Rules (photo twelve).

Photo Twelve: Un-used filter presses located above the sludges catch bay. Currently cement truck used for transport

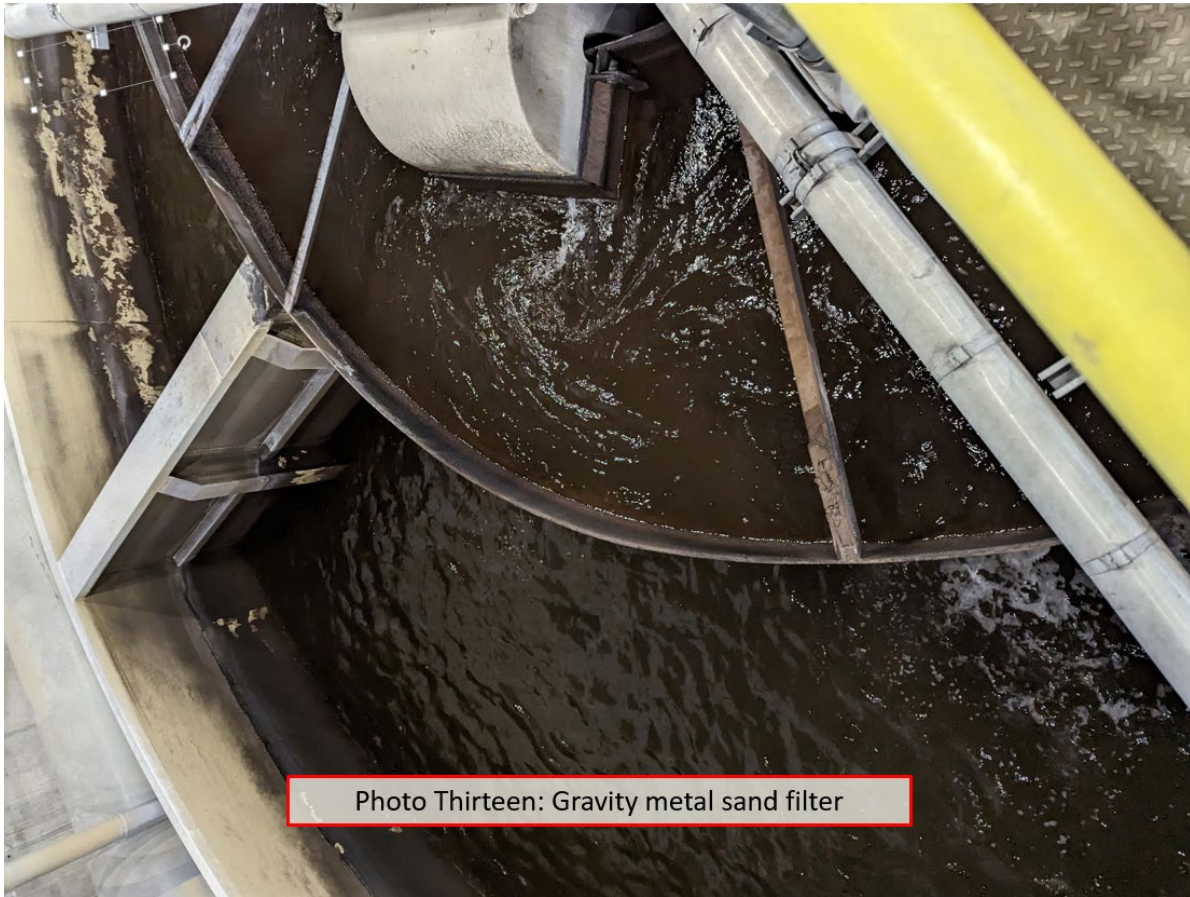
The Metals Filter Building is located next to the thickeners of the PDWTP. Located within the metals filter building are three Metal Sand Filters which remove any remaining precipitate solids (photo thirteen). Additional polymer is added in the square tanks to settle out solids. When treated water is in the sand filter it has a pH of about 10. The sand filters are regularly backwashed.

Photo Thirteen: Gravity metal sand filter

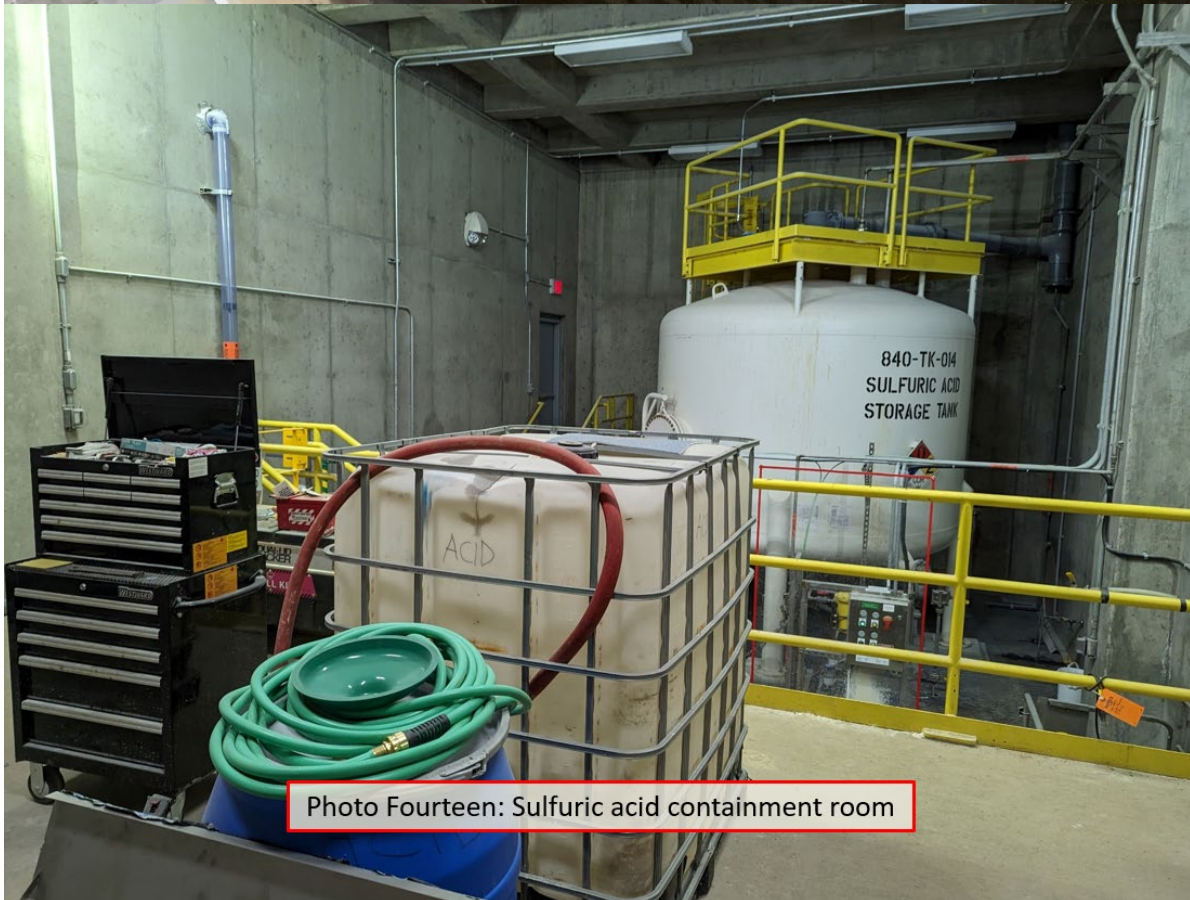
Currently a temporary Sulfuric Acid delivery line was in place, as there was issues with the line caking up. The temporary line is in double walled pipe for secondary containment. Within the Metals Filter Building is a separate enclosed room for the sulfuric acid (Photo fourteen). It is stored in a carbon steel tank which sets over an epoxy coated concrete built in floor sump. The sump within the sulfuric acid room was free of any spills.

Photo Fourteen: Sulfuric acid containment room

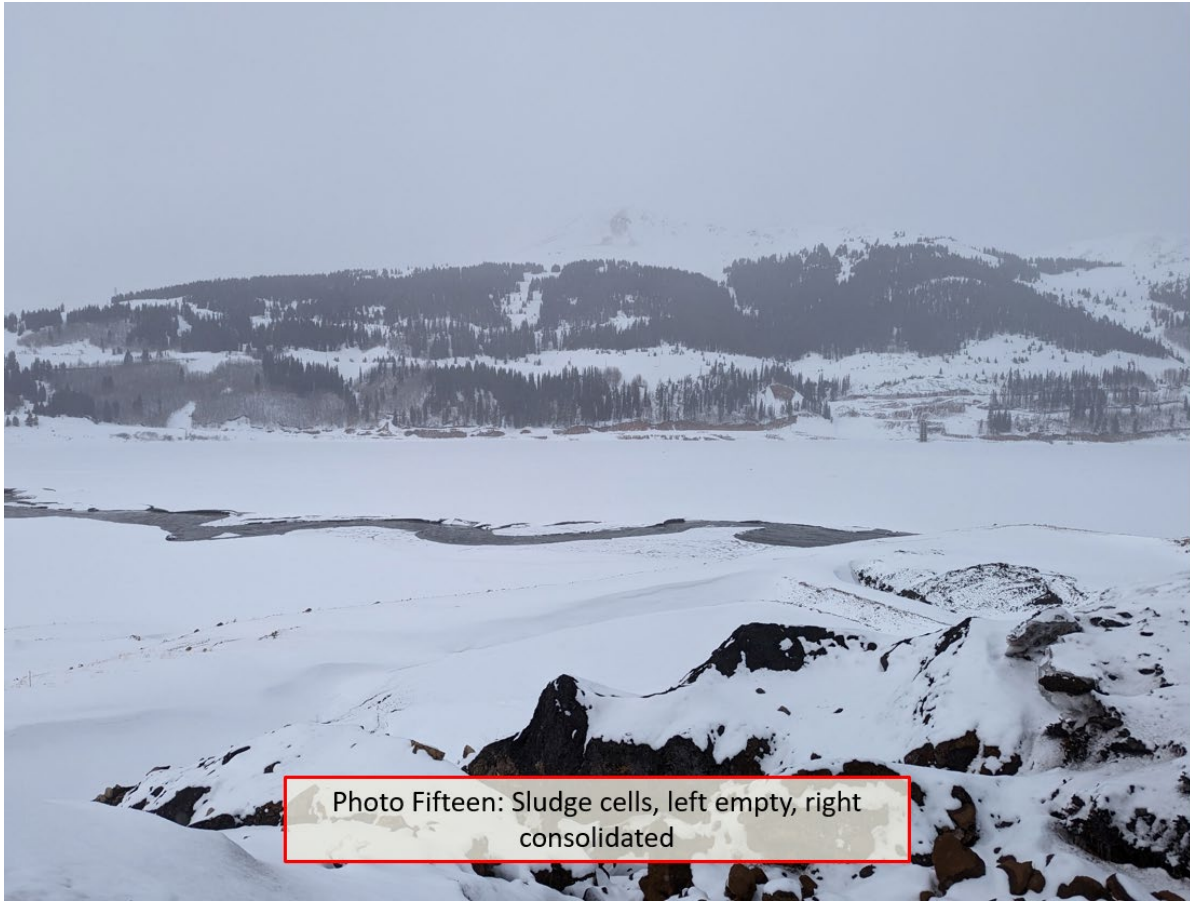
Lastly the sludge cells were observed (photo fifteen). Currently one cell has been completely cleaned out for new dry material that would pass the paint filter test and be accepted for off-site disposal per the new T-Norm Rules. The other cell has all of the consolidated existing sludge material.

Photo Fifteen: Sludge cells, left empty, right consolidated
